10. Management assurance

Purpose of this summary

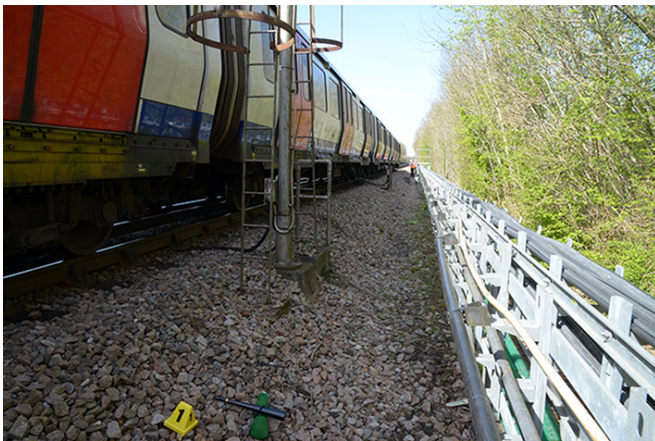
Location of the accident at Chalfont & Latimer.

A track worker was struck and injured by a train near to Chalfont & Latimer station in 2022 ([report 05/2023](#)). Our investigation found that the track worker was not familiar with the location where they were working, and that the information provided to them was not sufficient to allow them to work safely.

The risk controls in place to mitigate against track workers being struck by a train included following defined rules and procedures and giving briefings about the location and system of work, which would be recorded in logbooks. RAIB found that the assurance regime had

not identified non-compliances with some of these rules nor that the processes in place to ensure safety were not being followed. Assurance activities such as checking logbooks were not being undertaken, safety issues observed by managers during site visits were not being recorded and collated to identify trends, and compliance inspections did not take place in traffic hours when trains were running.

This lack of assurance meant that the ineffectiveness of control measures was not understood and that managers had an incomplete understanding of the risk of track workers being struck by trains on the network.

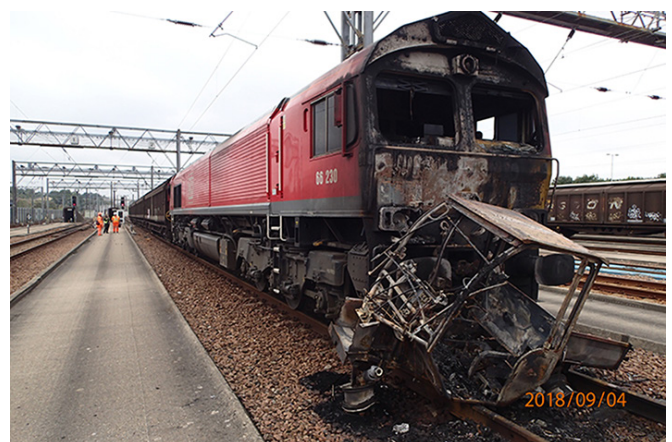
At Dollands Moor in 2018, a train arriving at Dollands Moor freight yard struck a small buggy that was stationary on a level crossing. The shunter operating the buggy attempted to jump clear of the approaching train but suffered life changing injuries as a result ([report 05/2019](#)).

Our investigation found that a subway was provided, which could accommodate the buggies, but that the requirement to use it instead of the crossing had been removed from safety documentation. RAIB also found that only one of the two subways remained open and that the lighting did not work in the one which remained. As the use of this subway was not enforced, most shunters chose instead to drive across level crossings.

The locomotive and damaged buggy following the accident at Dollands Moor.

RAIB found that, at the time of the accident, there were no clear rules or processes defining where the buggies could be operated and that the arrangements in place for monitoring the safety of the site had overlooked the issue of using buggies on a level crossing without signal protection. RAIB recommended improvements in safety management arrangements including checking and supervising safe systems of work.

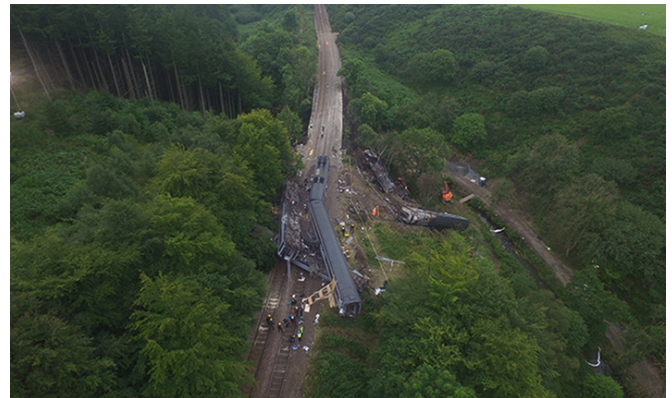
The accident in 2020 where a passenger train collided with debris washed from a drain onto the track near Carmont in Aberdeenshire resulted in the death of three people. Among other matters, RAIB's investigation found that the assurance processes put in place did not highlight any areas of weakness in the implementation of extreme weather processes within route control centres.

Our investigation also highlighted that operational controllers did not have the skills and resources to effectively manage complex weather-related situations. RAIB recommended improving the management assurance system relating to the safety critical function of the route control rooms to provide a more realistic assessment of the extent to which mandated safety systems were applied.

The scene following the accident at Carmont.
