10. Management assurance

Purpose of this summary

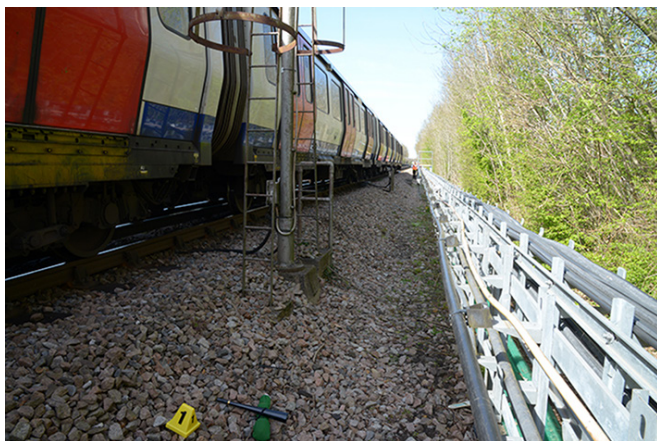
Location of the accident at Chalfont & Latimer.

A track worker was struck and injured by a train near to Chalfont & Latimer station in 2022 ([report 05/2023](#)). Our investigation found that the track worker was not familiar with the location where they were working, and that the information provided to them was not sufficient to allow them to work safely.

The risk controls in place to mitigate against track workers being struck by a train included following defined rules and procedures and giving briefings about the location and system of work, which would be recorded in logbooks. RAIB found that the assurance regime had

not identified non-compliances with some of these rules nor that the processes in place to ensure safety were not being followed. Assurance activities such as checking logbooks were not being undertaken, safety issues observed by managers during site visits were not being recorded and collated to identify trends, and compliance inspections did not take place in traffic hours when trains were running.

This lack of assurance meant that the ineffectiveness of control measures was not understood and that managers had an incomplete understanding of the risk of track workers being struck by trains on the network.

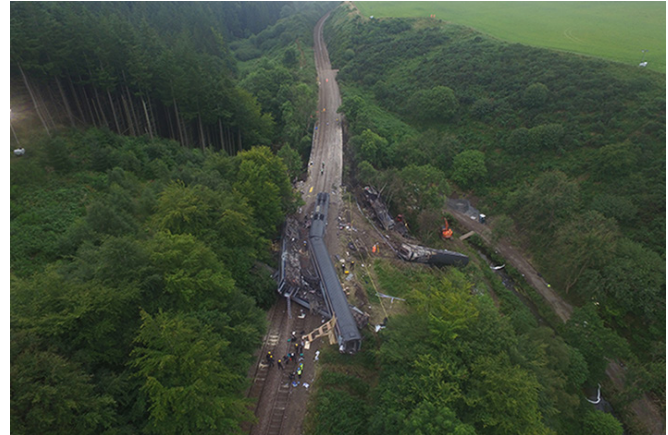
The accident in 2020 where a passenger train collided with debris washed from a drain onto the track near Carmont in Aberdeenshire resulted in the death of three people. Among other matters, RAIB's investigation found that the assurance processes put in place did not highlight any areas of weakness in the implementation of extreme weather processes within route control centres.

Our investigation also highlighted that operational controllers did not have the skills and resources to effectively manage complex weather-related situations. RAIB recommended improving the management assurance system relating to the safety-critical function of the route control rooms to provide a more realistic assessment of the extent to which mandated safety systems were applied.

The scene following the accident at Carmont.
