Accident

Aircraft Type and Registration:	Schleicher ASW 24, G-CHBB	
No & Type of Engines:	None	
Year of Manufacture:	1991 (Serial no: 24132)	
Date & Time (UTC):	16 August 2023 at 1125 hrs	
Location:	Dunstable Airfield, Bedfordshire	
Type of Flight:	Private	
Persons on Board:	Crew - 1	Passengers - None
Injuries:	Crew - 1 (Fatal)	Passengers - N/A
Nature of Damage:	Unknown	
Commander's Licence:	Sailplane Pilot's Licence and BGA Certificate	
Commander's Age:	47 years	
Commander's Flying Experience:	131 hours (26 of which were on type) Last 90 days - 11 hours Last 28 days - 0 hours	
Information Source:	AAIB Field Investigation

Synopsis

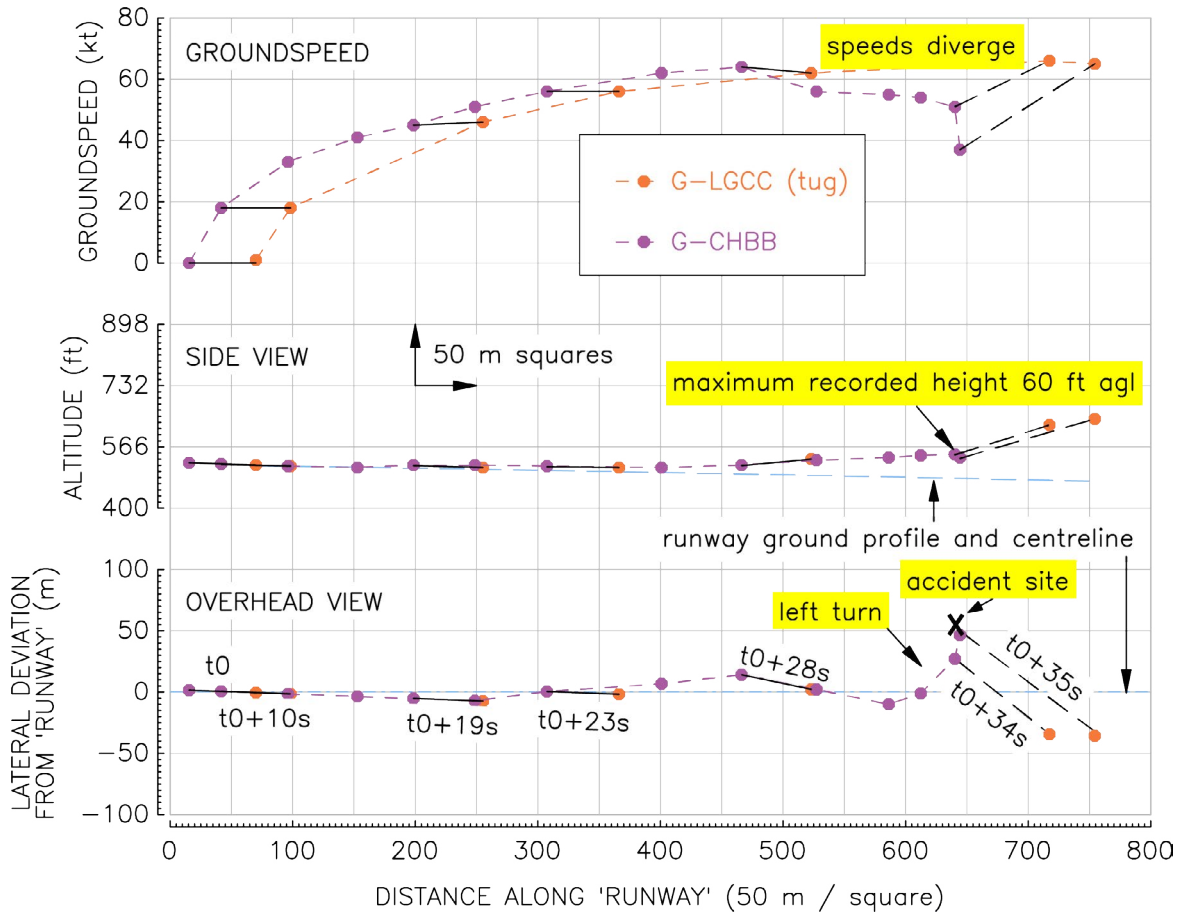
Figure 2

Data for the takeoff rolls of both G-CHBB and G-LGCC on the accident flight are presented at Figure 2. This figure presents the information relative to the runway so that from above and side, the distance between the two aircraft can be visualised. It also compares the groundspeed of both aircraft.

GPS-derived data comparing speed and relative positions of G-CHBB and G-LGCC (note that points for both aircraft that share the same time and linked with a line that is solid if the distance between them is approximately the length of the tow cable)

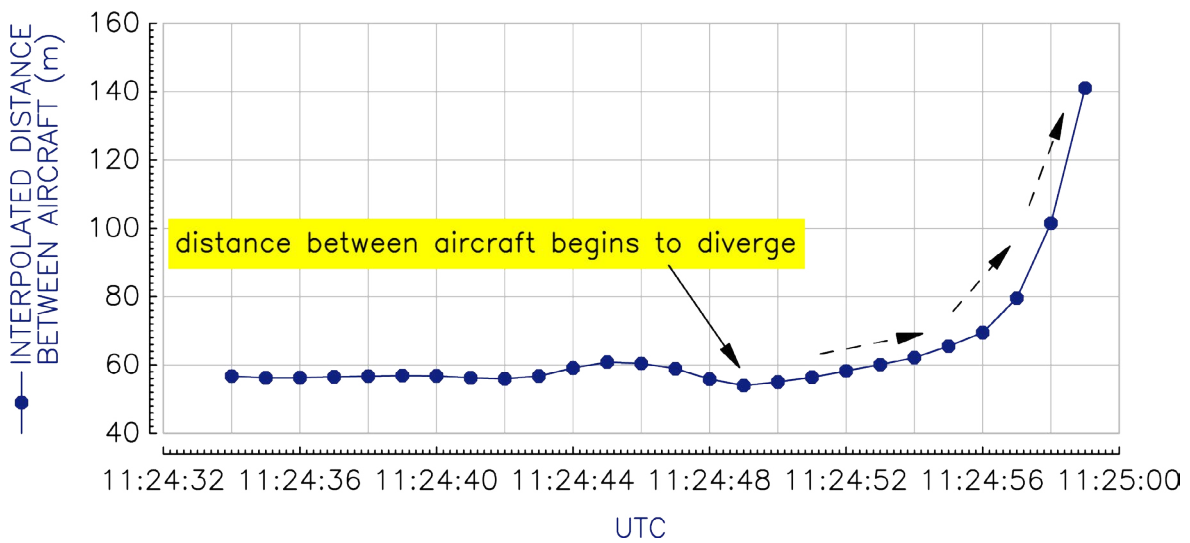
Figure 3 plots the calculated distance between the aircraft, based on interpolations of their position each second. This figure highlights that the distance begins to diverge from about time 11:24:49, which corresponds to 1 s before G-CHBB reached 400 m distance on Figure 2. G-CHBB then veers slightly left, then right, before beginning the final steep turn to the left. The maximum recorded height was 60 ft agl.

Interpolated distance between aircraft

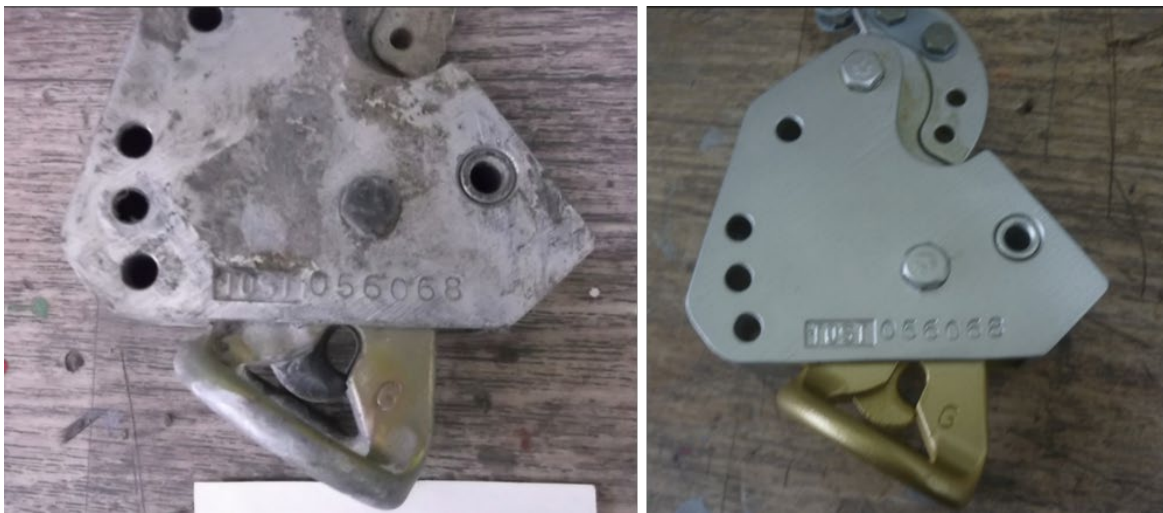
Figure 4

Photographs taken during the life extension inspection in 2016 (at 2,473 FH and 1,138 launches) showed that the tow release had been removed from the glider, cleaned and repainted after which it looked as if new (Figure 4). While the associated worksheets and life extension inspection checklist indicated that the hook had been inspected, no other maintenance on the tow release was documented.

G-CHBB tow release before (left) and after (right) cleaning and repainting in 2016

The investigation noted that G-CHBB's more recent technical records did not accurately reflect the overhaul status of the tow release. The tow release had never been overhauled and had not reached the 2,500 launch overhaul criteria. However, an erroneous entry in the maintenance documentation implied that it had been overhauled at 1,138 launches. The reason for this was not determined, but it is possible that repainting of the release during maintenance in 2016, which gave it the appearance of a new or overhauled release,

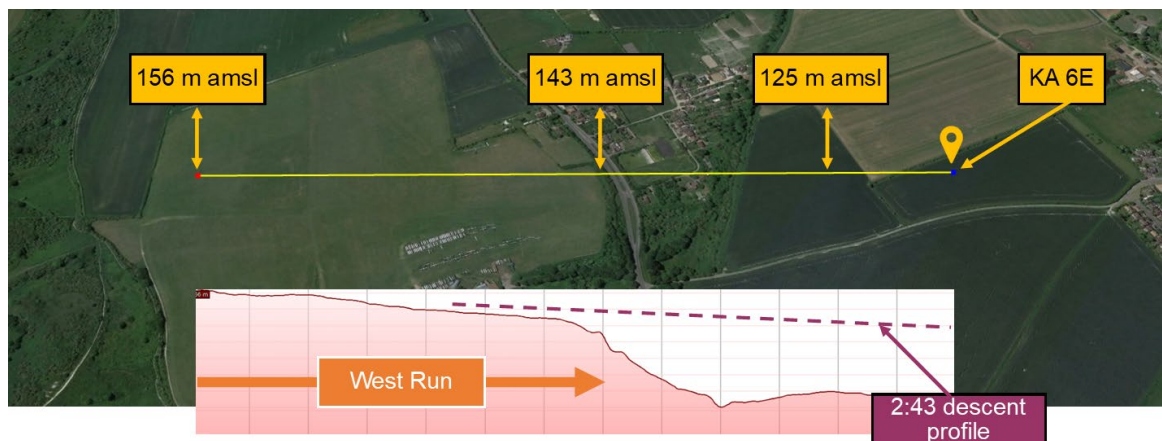
Figure 6

The West Run's average gradient is 2.4% downhill from the launch point to the airfield's north-western boundary. Beyond the boundary the ground falls away more steeply toward the B489 road, residential buildings, and trees before rising gently over open farmland beyond (Figure 6). In part to avoid overflying the hazards west of the road, but also for noise abatement considerations, tug pilots aerotowing on the West Run would aim to turn right onto a more north/northeasterly track once safely airborne.

Cross sectional elevation of the West Run^{4,5}
(imagery ©Google Earth 2023)

Comparing a notional 2:43 glide angle with the terrain elevation profile of the West Run (Figure 3), from the earliest point of disconnection it could theoretically have been possible for the pilot to glide past the B489 and land in the open fields beyond. While theoretically possible, this may not have been apparent to the accident pilot at the time and it was not known if he was aware of the successful field landing carried out by the KA 6E pilot in July 2022. From below 100 ft agl the pilot would have been largely unsighted on the low ground and intervening hazards between the airfield boundary and the fields to the northwest (Figure 5), making it more challenging to judge the distance to a safe landing area.

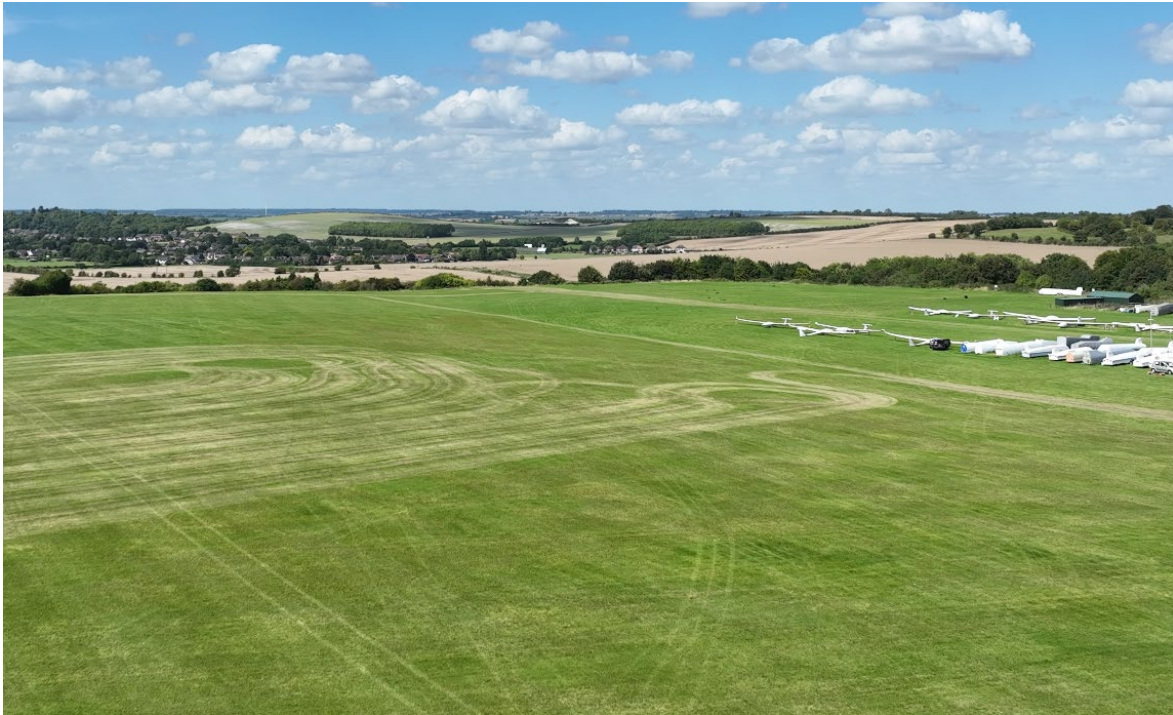
Figure 7

View from the estimated earliest position when the tow rope became disconnected

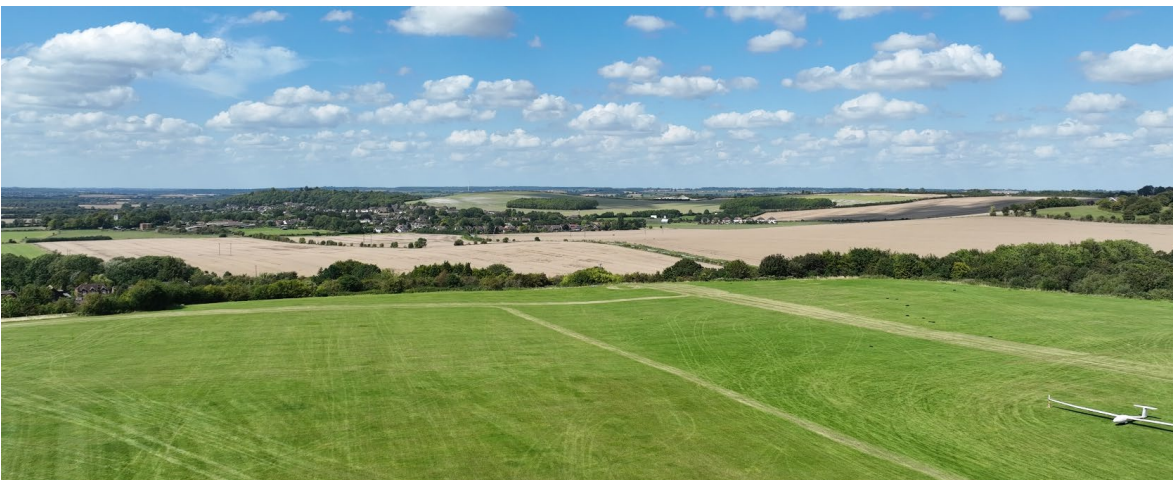
Figure 8

View from the approximate position of G-CHBB immediately before the left turn

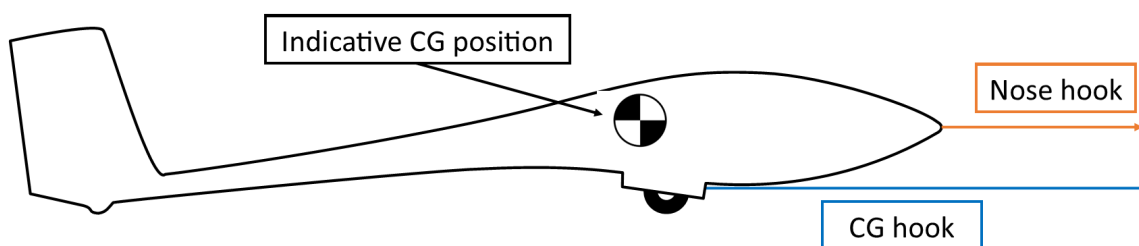
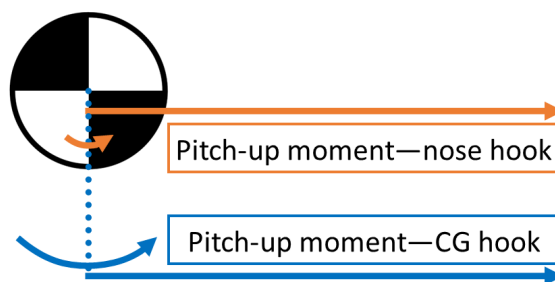
Figure 9

For either winch or aerotow launching, gliders need to be fitted with an appropriate hook to which the launching cable or tow rope can be attached. Gliders are primarily equipped with a CG hook which has a back release capability and is compatible with either winch or aerotow launch methods. While the CG hook can be used for aerotowing, having the tow cable attached lower than the glider's vertical CG position generates an undesirable, but unavoidable, nose-up pitching moment. Where fitted, a nose hook is preferred for aerotowing because, while the pull force from the nose hook might not always be vertically aligned with the CG, the magnitude of any resultant pitching moment would be significantly less than when using the CG hook (Figure 9). G-CHBB did not have a nose hook, therefore the CG hook was necessarily used for both winch and aerotow launching.

The club explained that the mitigations to compensate for the CG hook pitch-up moment, "setting the correct trim position and applying modest forward inputs on the control stick," are drawn to the attention of pilots when they are first converting to the ASW 24 type.

(a) Nose vs CG hook configuration

(b) Exemplar comparison of nose vs CG hook, pitch-up moment about CG
