Rail Accident Investigation Branch

Rail Accident Report

Runaway wagon at Kineton, Warwickshire 25 May 2023

Report 04/2024
May 2024

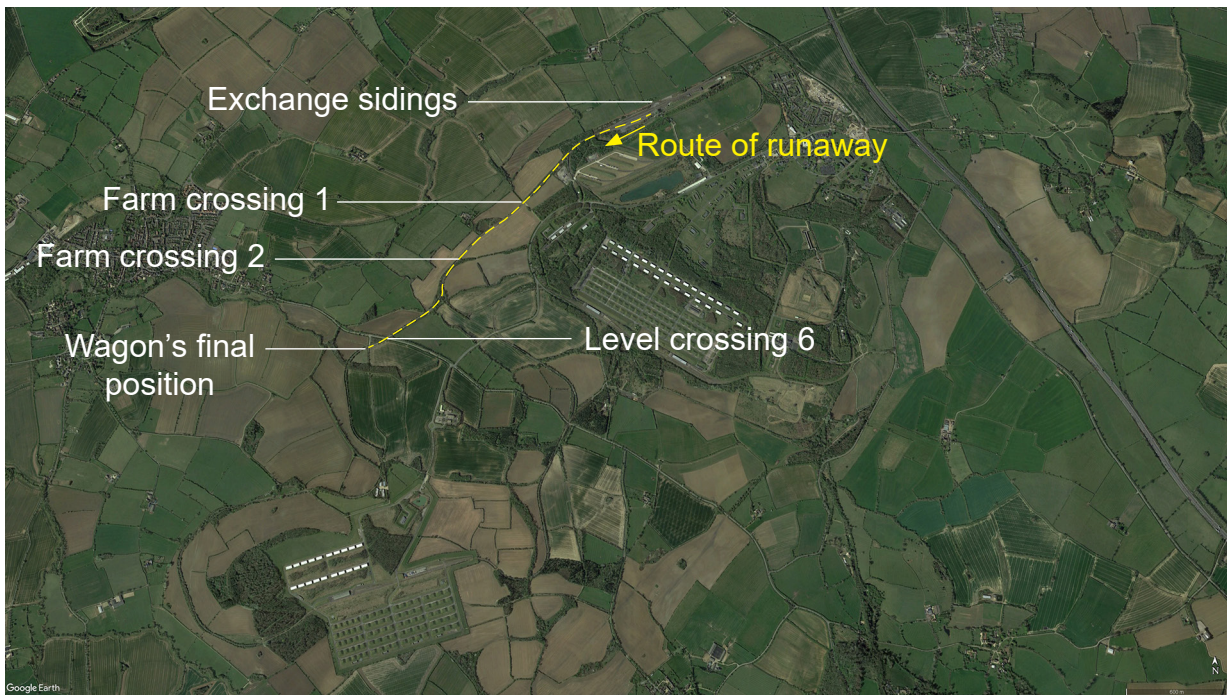
- 5 The gradient starts to level and then to rise on approach to level crossing 6 and the wagon came to rest around 65 metres beyond it. The wagon travelled a total distance of around 1.5 miles (2.4 km) during the runaway. Because the wagon ran away after the staff had left site for the day, the runaway was not discovered until staff returned to work the following day. They noticed that the wagon was missing, and that the sidings' gate appeared to be open.

Figure 2: Annotated aerial photograph showing the route of the runaway and main features (courtesy of Google Maps with RAIB annotation).

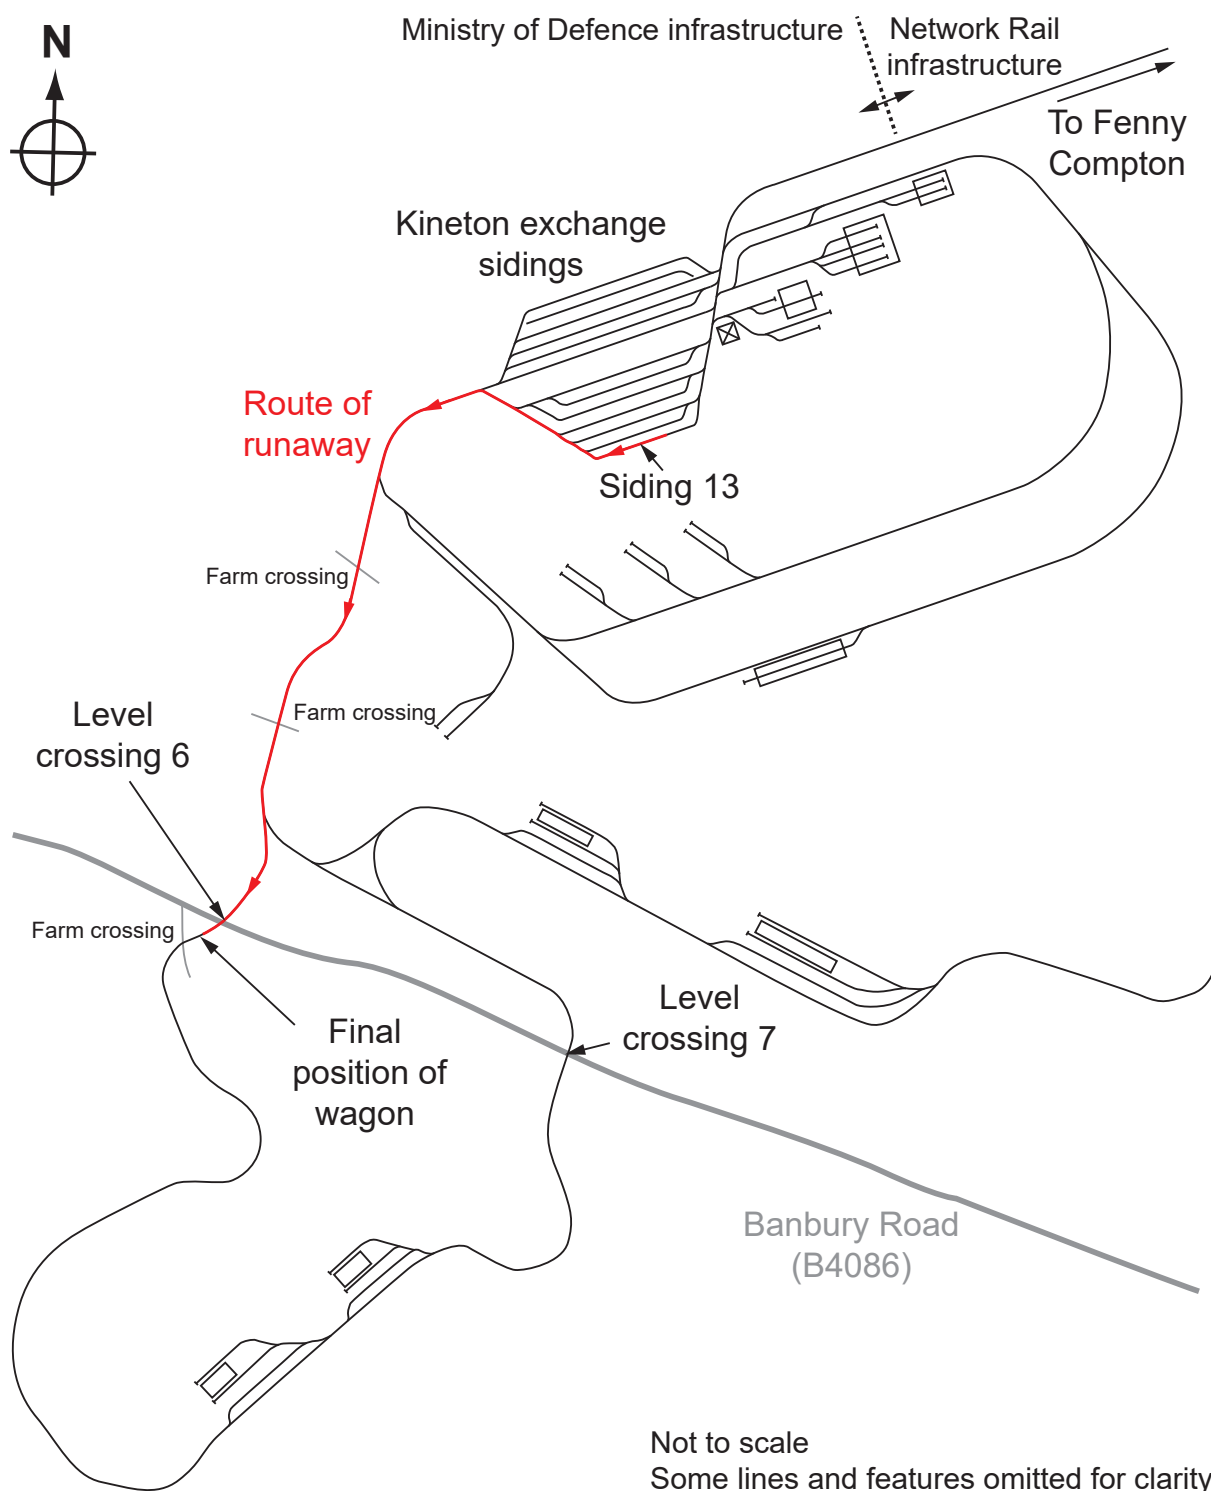
Figure 3: Diagram showing the track layout and main features of the railway at Kineton munitions depot.

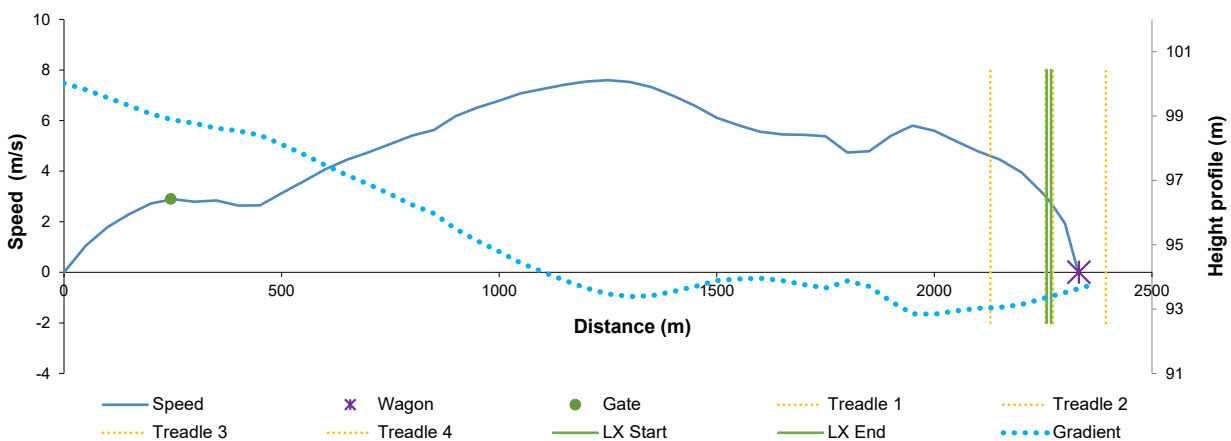
- 13 The track gradient falls from the Fenny Compton side of the exchange sidings towards the south-west end of the sidings. Once outside the sidings, the gradient continues to fall, before passing over a small incline and eventually starting to rise steadily approximately 250 metres on approach to level crossing 6 (figure 4).

Figure 4: Gradient profile of the track traversed by the wagon during the runaway.

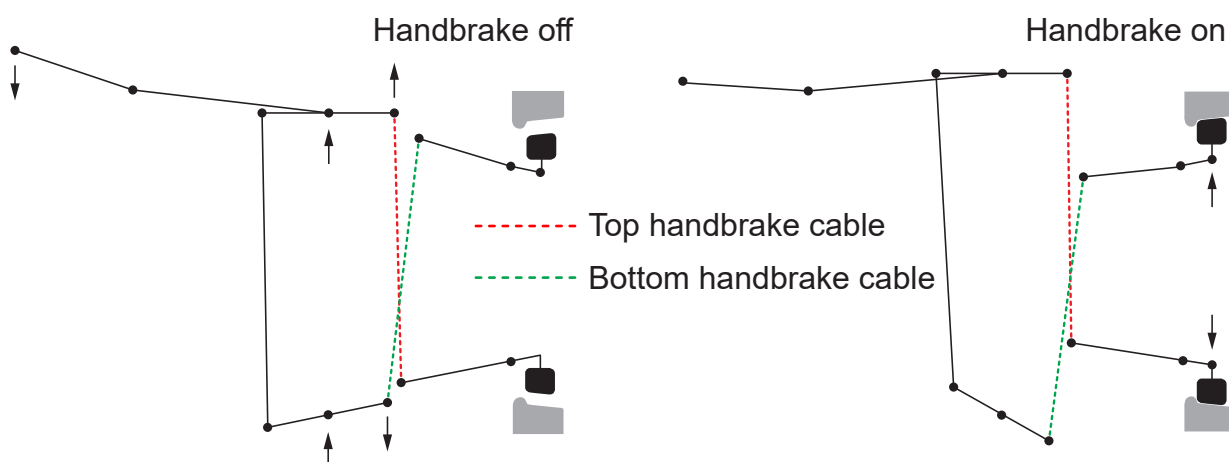
- 85 The FAA wagon's handbrake is applied by turning a control wheel on the outside of the wagon. This control wheel transmits a turning force down to a threaded bar which runs longitudinally down the centre of the wagon. The handbrake indicator on the side of the wagon takes a feed from this threaded bar and indicates only the position to which the control wheel has been turned. The handbrake indicator does not confirm the application of the brake blocks on the wheels. The turning force from the central bar is then translated, through a series of pivots, into a pulling force acting on a pair of Bowden cables (known as handbrake cables). These cables act together to pull on another pivot to push the brake blocks onto the wheels (figure 8). This brake block force is only applied to two wheels.

Figure 8: Handbrake moving from a 'brake off' to 'brake on' position with the handbrake cable intact.

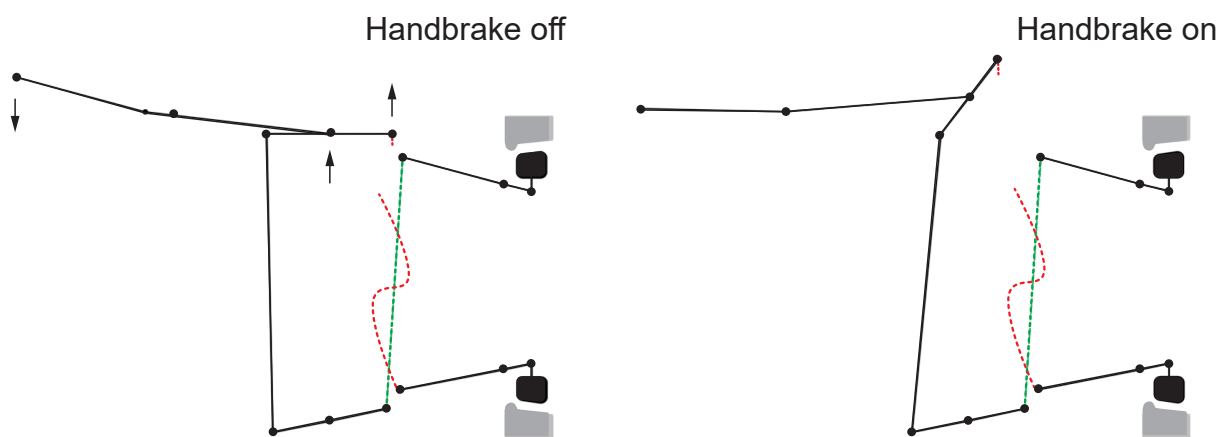
84 Effective handbrake operation was reliant on a single handbrake cable that if broken meant the system provided no brake force while indicating that the handbrake was on.

- 86 Because the cables need to work together, if one of the cables fails or becomes disconnected then the handbrake will cease to apply any force to either of the brake blocks. In this condition, however, the handbrake indicator will still show that the handbrake has been applied (figure 9).

Figure 9: Handbrake moving from a 'brake off' to 'brake on' position with the handbrake cable snapped.

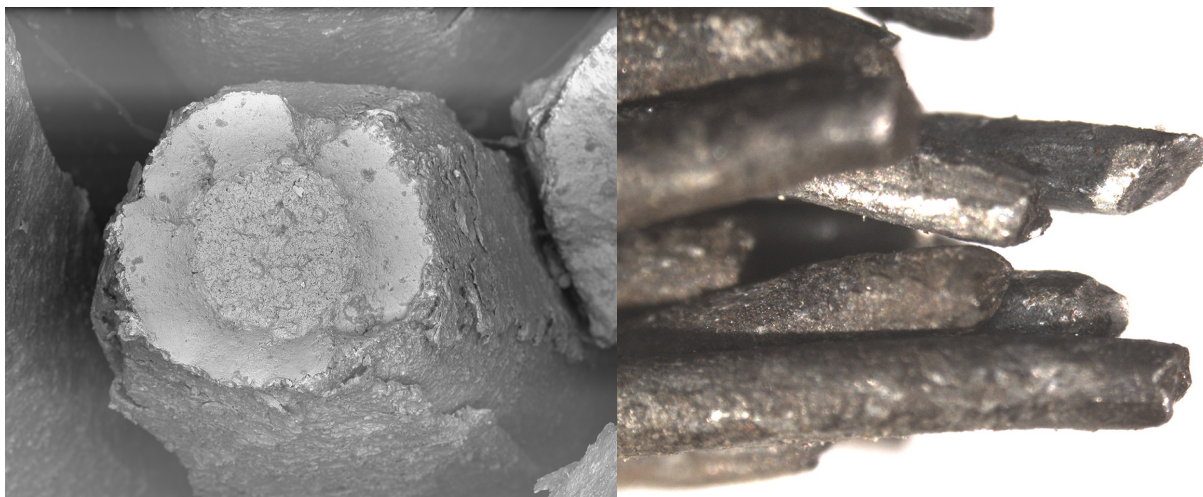
88 The handbrake cable was mechanically overloaded, leading to its failure.

89 When the wagon was inspected after the runaway, one of its handbrake cables was found to have snapped, rendering the handbrake system ineffective. RAIB commissioned a metallurgical examination of the snapped cable. This found that the fracture faces of the wire strands demonstrated characteristic cup and cone shapes, indicative of an overload failure (figure 10). The examination concluded that the cable had failed due to repeated mechanical overload, rather than through fatigue.

Figure 10: Fracture faces on the snapped handbrake cable.

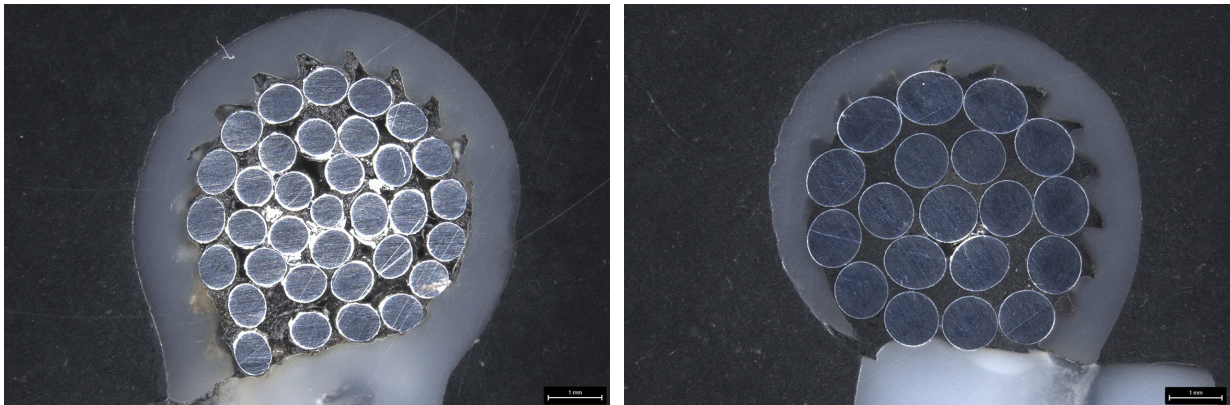
- 110 Had the cable been replaced during the wagon's service life, it is likely that a more modern cable design would have been used in its place. This is because the original cable make-up (5x11x17) is not available to purchase in the UK, leading to DB Cargo specifying a replacement design of cable. Although the cable to the new design has the same nominal diameter as the original cable (5 mm), it is manufactured to a diameter of 5.12 mm, whereas the original cable was manufactured to a diameter of 4.75 mm. Overall, this means that a modern cable has a 19% larger cross-sectional area than an original cable (16.77 mm² for a modern cable compared to 14.09 mm² for the original cable, figure 13). As well as having a larger cross-sectional area, a modern cable is manufactured of a higher strength steel than the original cable (approximately 55% stronger than the original cable).

Figure 13: Original equipment manufacturer's cable (left), compared to a cable of more modern design (right).
