Annual Safety Review 2023

Air Accidents Investigation Branch
Farnborough House
Berkshire Copse Road
Aldershot
Hampshire
GU11 2HH.

CIAA Foreword

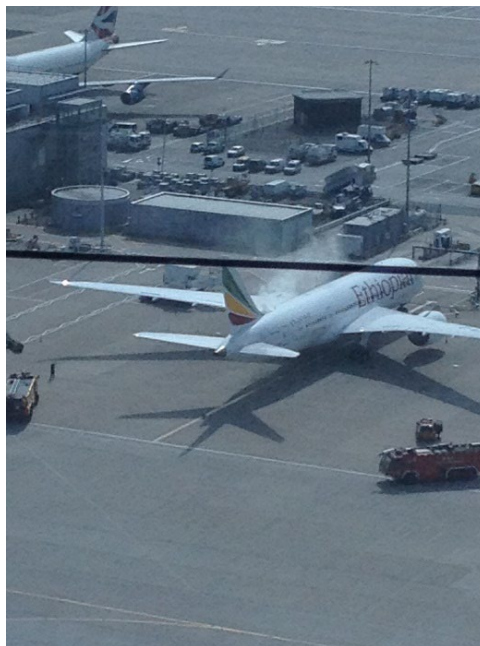
Figure 1

In July 2013 a ground fire started in a parked and unoccupied Boeing 787-8 at London Heathrow Airport (Figure 1). The circumstances surrounding the occurrence did not fall within the definitions of an Accident or Serious Incident as defined in ICAO Annex 13, however, the Chief Inspector, exercised his powers under the Civil Aviation (Investigation of Air Accidents and Incidents) Regulations 1996, initiated an investigation, treating the occurrence as a Serious Incident and invoking the protocols of ICAO Annex 13 with regard to the participation of other interested States. An investigation was commenced immediately and a team of AAIB Inspectors was deployed.

ET-AOP on a remote stand at Heathrow during the incident

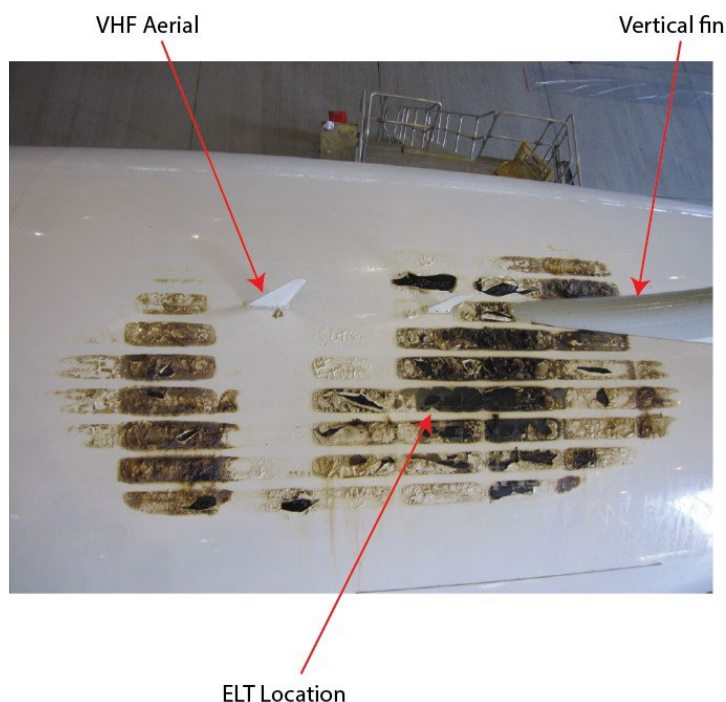
Figure 2

The aircraft suffered extensive heat damage in the upper portion of the aircraft's rear fuselage, in an area coincident with the location of the Emergency Locator Transmitter (ELT) shown in Figure 2. The absence of any other aircraft systems in this area containing stored energy capable of initiating a fire, together with evidence from forensic examination of the ELT, led the investigation to conclude that the fire originated within the ELT.

ET-AOP heat damage to the upper fuselage

The ground fire on ET-AOP was initiated by the uncontrolled release of stored energy from the lithium-metal battery in the ELT. It was identified early in the investigation that ELT battery wires, crossed and trapped under the battery compartment cover-plate, probably created a short-circuit current path which could allow a rapid, uncontrolled discharge of the battery. Root Cause testing performed by the aircraft and ELT manufacturers confirmed this latent fault as the most likely cause of the ELT battery fire, most probably in combination with the early depletion of a single cell.

Fourteen Safety Recommendations were made during the course of the investigation. In addition, the ELT manufacturer carried out several safety actions and is redesigning the ELT unit taking into account the findings of this investigation. Boeing and the FAA have also undertaken safety actions.

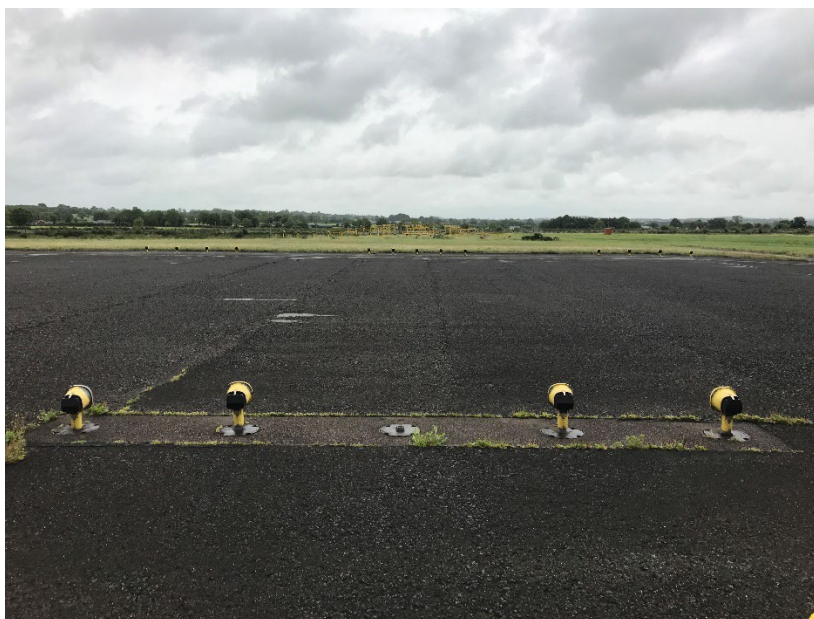
36 cm tall and 29 m beyond the end of the takeoff runway. Figure 3 contains an image of the damage which at first sight does not convey the seriousness of the event.

Damage to supplementary runway light 29 m from the end of the runway

There was no damage to the aircraft, which continued its flight to Corfu, Greece without further incident. However, it was only the benign nature of the runway clearway and terrain elevation beyond, and the lack of obstacles in the climb-out path which allowed the aircraft to climb away without further collision after it struck the runway light. Had an engine failed at a critical moment during the takeoff, the consequences could have been catastrophic.

The AAIB made six Safety Recommendations, which resulted in significant safety action.

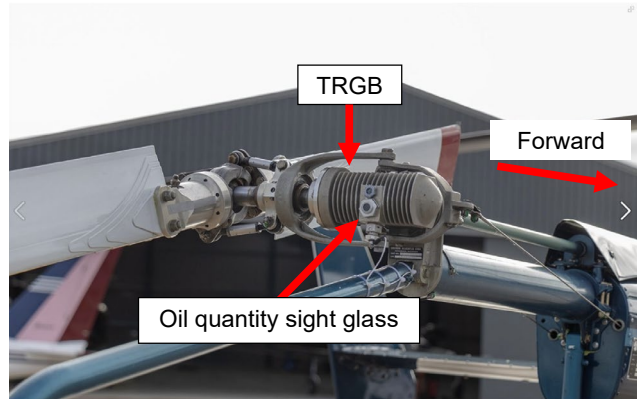
The helicopter suffered a loss of thrust from the tail rotor while hovering close to the ground near a mountain top, resulting in a loss of control and hard landing. Subsequent examination of the tail rotor gearbox (TRGB) revealed damage to the bevel gears and failure of a bearing, which was consistent with a lack of lubrication. The investigation found inconsistencies in the way maintenance was performed on the tail rotor gearbox, compared to the helicopter manufacturer's maintenance instructions. It is likely that insufficient oil was added to the TRGB when it was serviced 25 flying hours prior to the accident.

TRGB viewed from rear of 280FX helicopter

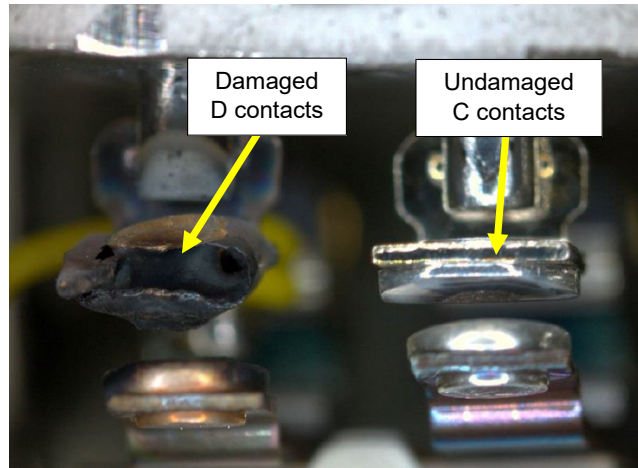
In the climb, after departing Farnborough Airport, D-AAAY had an uncommanded⁸ flap movement above the maximum flap extension speed during which the flaps moved to their fully extended position. The aircraft returned to Farnborough with the flaps extended where it landed without further incident. An uncommanded and unarrested flap movement requires the flaps to move without movement of the flap lever and then for a failure in the flap arrest system to stop this movement. The flap surfaces are moved by two drive motors that are commanded by the sequencing of four extend and retract relays. These four relays also form part of the system to arrest an uncommanded flap movement.

Damaged D contact (left) and undamaged C contact (right)

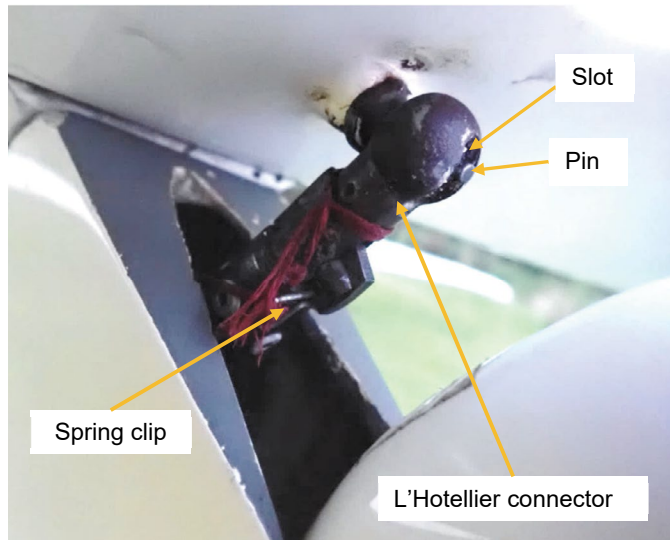
An on-site inspection of the aircraft revealed that the elevator was not connected to the elevator control rod. Two Safety Recommendations were made; the first to mandate Positive Control Checks and the second to amend the Flight and Operations Manual (FOM) to include relevant information on the limitations of pitch control using flaps.

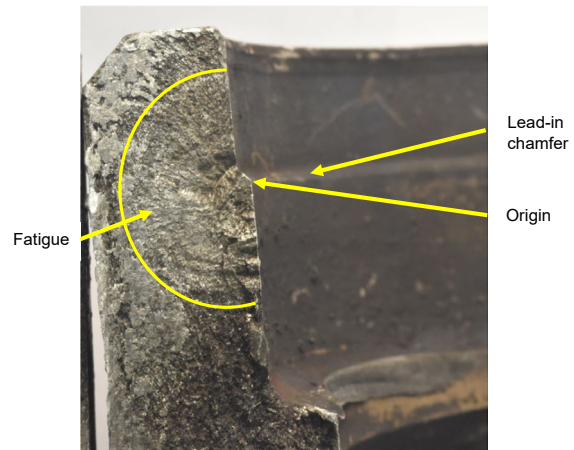
The fatigue crack originated from a corrosion pit in the wheel hub. Following this occurrence, the wheel manufacturer developed an ultrasonic inspection technique to identify cracks in this location on the hub and the operator has incorporated the new inspection into their maintenance programme.

Radial fracture surface with area of fatigue highlighted (reproduced with permission)

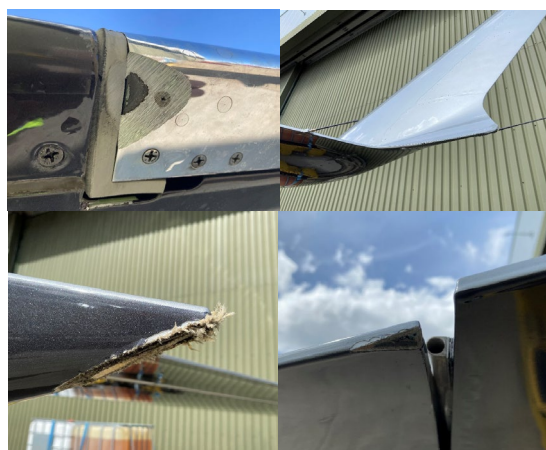
The risk of wingtip contact is well known in this aircraft type and has been the subject of numerous previous reports including by the AAIB. As a result of this known risk, the manufacturer has taken a number of actions including improving training and publishing new guidance for pilots on techniques for wingtip strike avoidance. Before this Serious Incident, the manufacturer applied to Transport Canada for approval to make crosswind training a Training Area of Special Emphasis (TASE) for the Global Fleet. This would ensure that all training providers have a standardised approach to crosswind techniques and training, for both initial and recurrent training programs. At the time of publication, the manufacturer was in the midst of ongoing discussions with Transport Canada regarding the details of the proposed TASE.

Damage to LX-NST. Clockwise from top left – slat, winglet, aileron, flap fairing

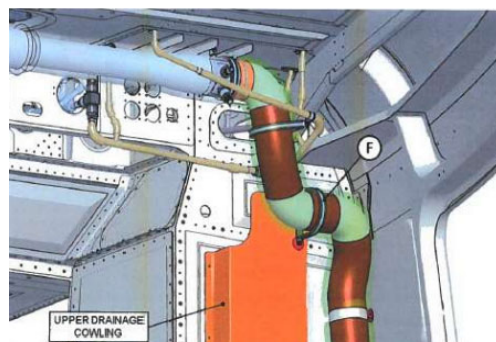
A heating duct failed in flight releasing fragments of duct insulation material into the cabin and cockpit, causing respiratory irritation to the occupants. The aircraft landed safely. Similar heating duct failures had previously occurred in several of the operator's other AW189 aircraft and were investigated by the AAIB (AAIB Bulletin 4/2022 report AAIB-27128 refers). As a result of those failures the aircraft manufacturer had published a Service Bulletin (SB) to inspect and modify the installation of the heating duct and this had been embodied on G-MCGV.

Heating duct on AW189 showing flexible sections in brown and rigid sections in green (Circle 'F' indicates a securing 'P-clamp')

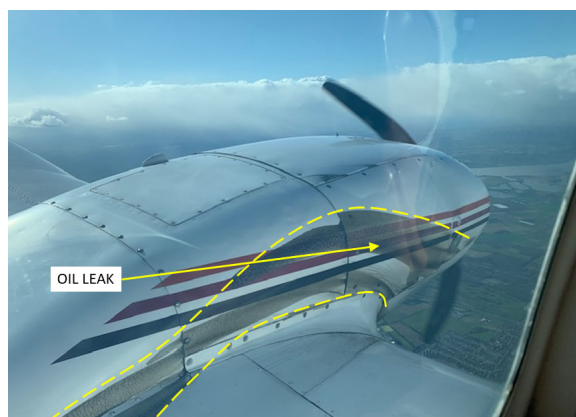
During an IFR flight from Le Touquet to Wellesbourne, the pilot observed oil leaking from the left engine followed by engine vibration. He shut the engine down and descended but elected to continue the flight toward Wellesbourne. On reaching 2,000 ft he found he was unable to maintain level flight on one engine and decided to land in a field.

Photograph taken in-flight of the oil leak from the left engine

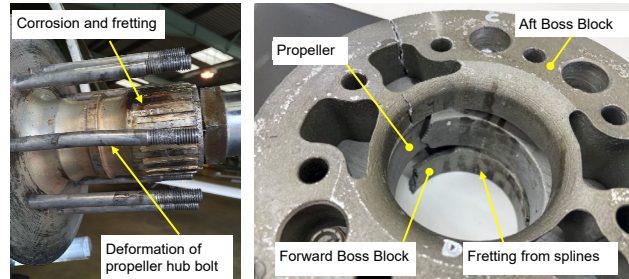
During the flight the aircraft developed severe vibration requiring the pilot to return to the airfield where fatigue cracks were found in the propeller and its two mounting blocks. The cracks originated from fretting between the propeller assembly and splines on the engine hub.

Engine hub corrosion and fretting, and fretting of inner surfaces of blocks and propeller

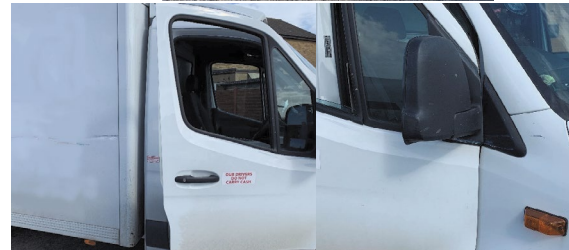
Having flown into Sandtoft Airfield earlier in the day the pilot was preparing for his return flight to Gloucester. Having started the engine, he proceeded to taxi from his parking position (Stand 7) across the runway and along Taxiway A to uplift fuel. There was a vehicle parked on Taxiway A completing a delivery to the cafe. Having judged the gap to be sufficient for the aircraft wingspan, the pilot proceeded at a slow walking pace but clipped the port wingtip of G-EKIR on the side and wing mirror of the vehicle. The port wing navigation light and casing were damaged and there was paintwork scuffing to the wing tip area. The vehicle had damage to the right panel and below the right wing mirror. There were no injuries. The vehicle did not have permission to enter or park on the taxiway.

Damage to the aircraft wingtip (top) and to the vehicle panel side panel (left) and below the wing mirror (right). (Images used with permission)

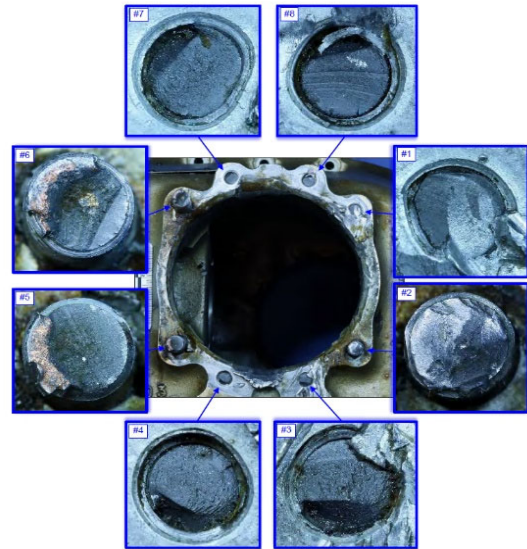
A closer view of the in-situ stud fracture surfaces

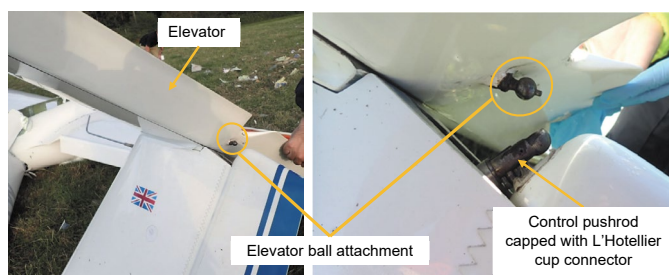
Images at the accident site showing that the L'Hotellier ball and cup were not connected

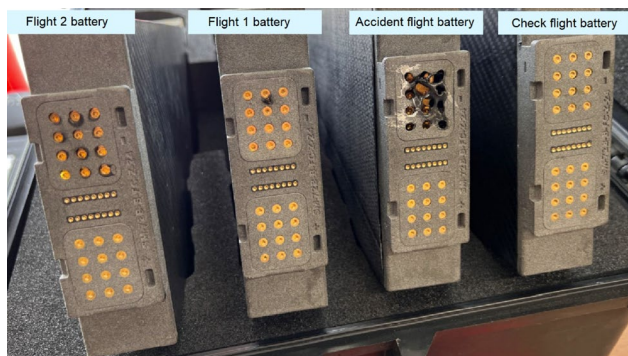
Damage to battery connectors
