Rail Accident Investigation Branch

Rail Accident Report

Runaway wagon at Kineton, Warwickshire 25 May 2023

Report 04/2024
May 2024

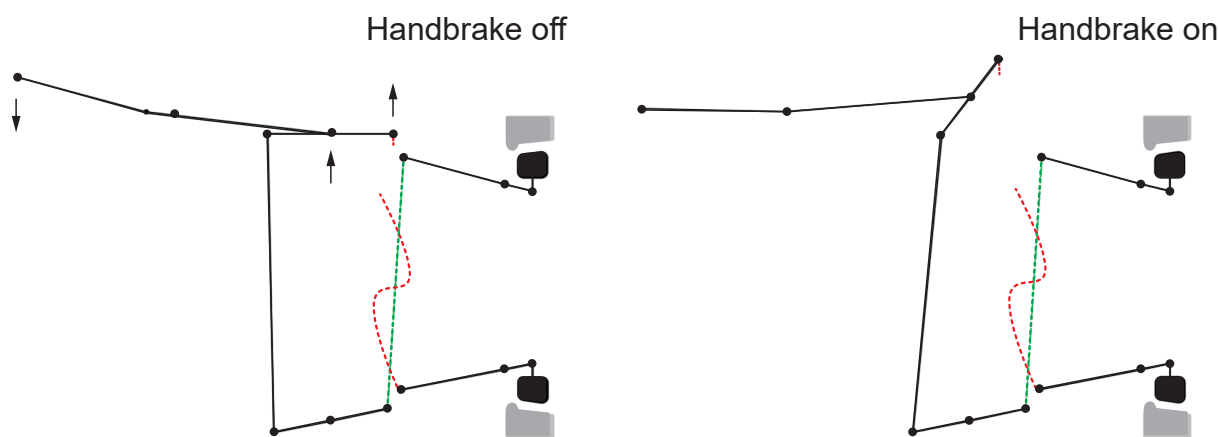
86 Because the cables need to work together, if one of the cables fails or becomes disconnected then the handbrake will cease to apply any force to either of the brake blocks. In this condition, however, the handbrake indicator will still show that the handbrake has been applied (figure 9).

Figure 9: Handbrake moving from a 'brake off' to 'brake on' position with the handbrake cable snapped.

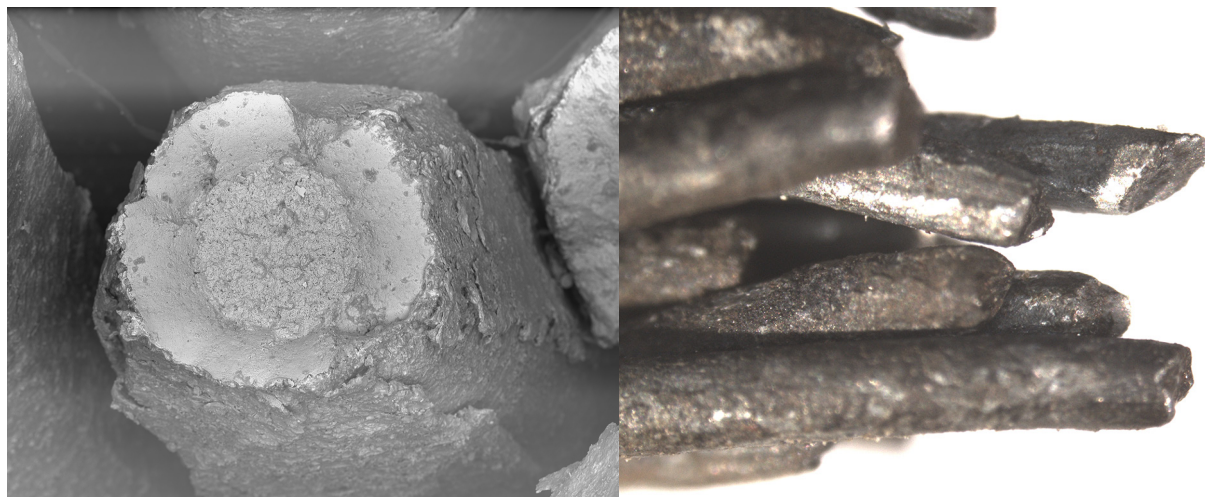
89 When the wagon was inspected after the runaway, one of its handbrake cables was found to have snapped, rendering the handbrake system ineffective. RAIB commissioned a metallurgical examination of the snapped cable. This found that the fracture faces of the wire strands demonstrated characteristic cup and cone shapes, indicative of an overload failure (figure 10). The examination concluded that the cable had failed due to repeated mechanical overload, rather than through fatigue.

Figure 10: Fracture faces on the snapped handbrake cable.

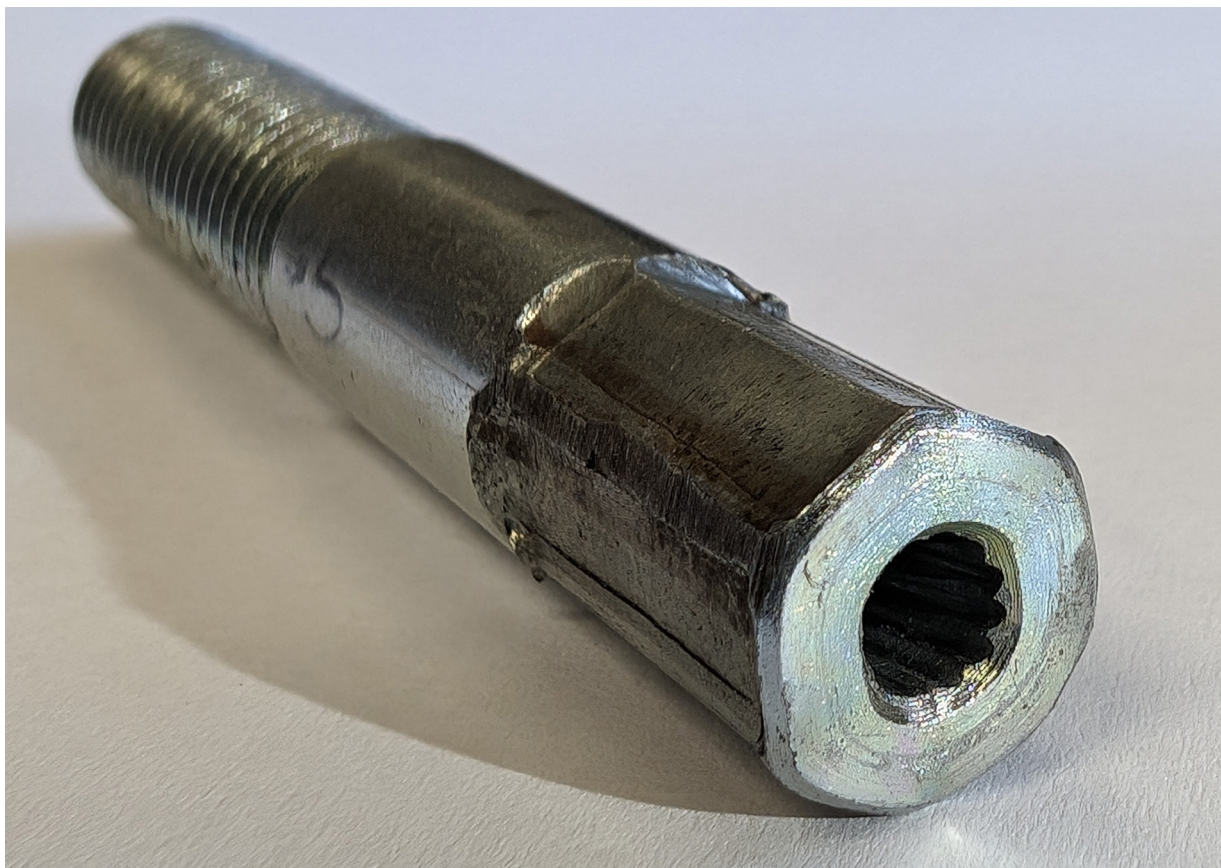
- 95 To maximise the strength offered by a cable at its termination point, it should be looped back on itself at the ends and then either secured by using U-bolts or spliced back into itself. On the FAA wagons, however, the handbrake cable was crimped into a termination piece that has helical internal fluting (figure 11).

- 96 This termination arrangement introduces stress concentration factors into the cable. Close to the termination, the tensile force carried by the cable needs to pass through the outer strands into the termination piece, leaving an uneven distribution of stresses through the cross-section. RAIB has calculated that, close to the termination, the outer strands of the cable experienced up to three times the amount of stress than they would experience if the force was uniformly distributed through the cross-section.

Figure 11: Termination piece which was crimped onto the handbrake cable to allow it to connect to the pivots.

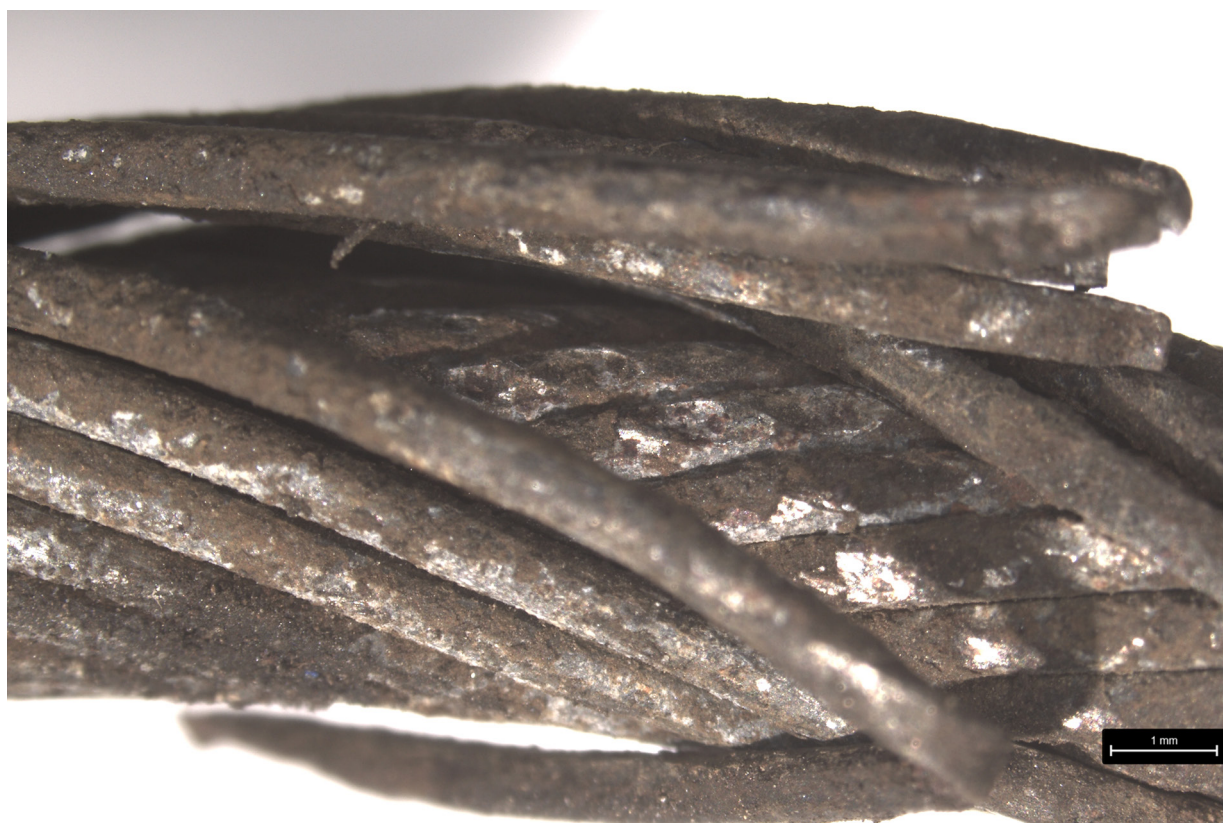
- 106 The detailed examination of the snapped cable by the metallurgist identified areas of wear damage to the strands, including areas remote from the location of failure, which in their opinion, are indicative that the service life of the cable had been exceeded (figure 12). These areas of wear took the form of indentations on the steel core strands where they had been pressing against one another over the repeated application of high tensile force in the cable. RAIB calculated that these indentations could increase the localised stresses in the affected strands by up to 100% (dependent on the depth of the indentation).

Figure 12: Deformation of the individual cable strands caused by the cable crushing itself due to high tensile loads.

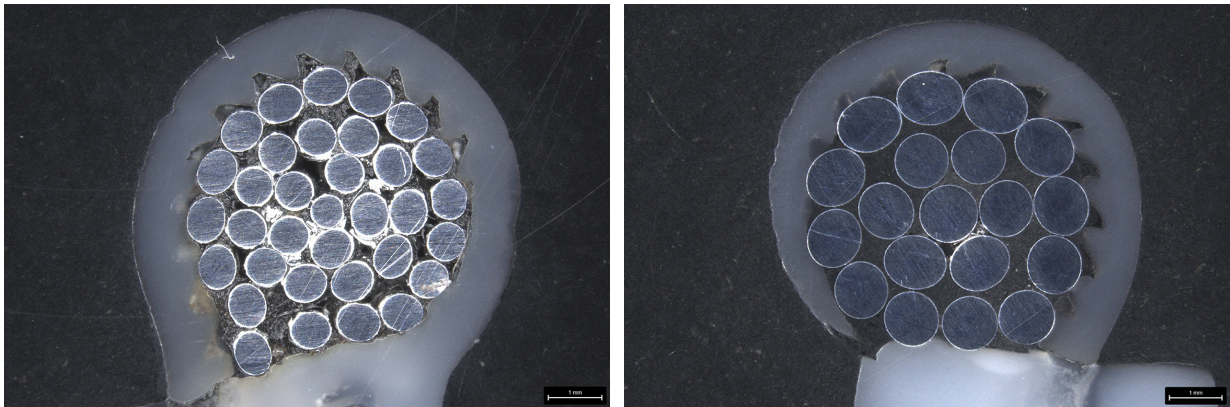
- 110 Had the cable been replaced during the wagon's service life, it is likely that a more modern cable design would have been used in its place. This is because the original cable make-up (5x11x17) is not available to purchase in the UK, leading to DB Cargo specifying a replacement design of cable. Although the cable to the new design has the same nominal diameter as the original cable (5 mm), it is manufactured to a diameter of 5.12 mm, whereas the original cable was manufactured to a diameter of 4.75 mm. Overall, this means that a modern cable has a 19% larger cross-sectional area than an original cable (16.77 mm² for a modern cable compared to 14.09 mm² for the original cable, figure 13). As well as having a larger cross-sectional area, a modern cable is manufactured of a higher strength steel than the original cable (approximately 55% stronger than the original cable).

Figure 13: Original equipment manufacturer's cable (left), compared to a cable of more modern design (right).

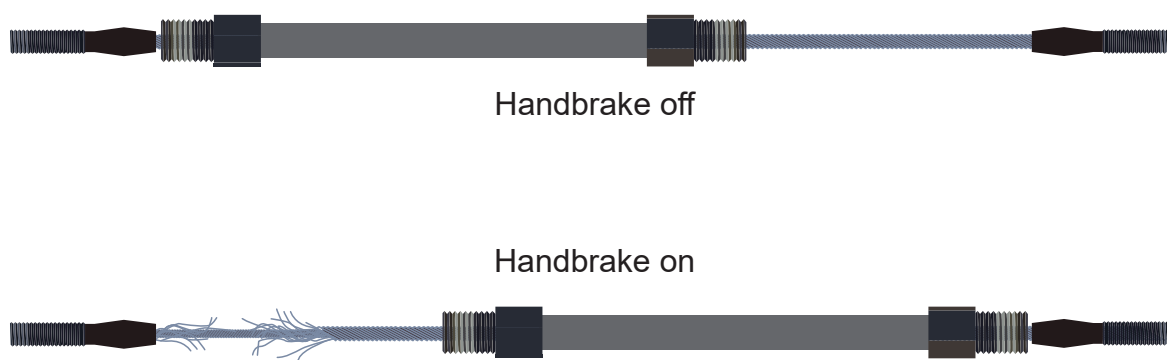
- 115 Witnesses working for DB Cargo who were responsible for the maintenance of the FAA wagons leased by K+N told RAIB that, during a VIBT examination, they always inspect the handbrake cable with the handbrake in the 'off' position. The inner part of the handbrake cable (the part which frayed and then snapped) is designed to move within a fixed housing (figure 14). With the handbrake in the off position, the fixed housing hides this part of the cable and thus renders the inspection ineffective.

Figure 14: Diagram showing how the part of the cable which was damaged was within the housing during the inspection.

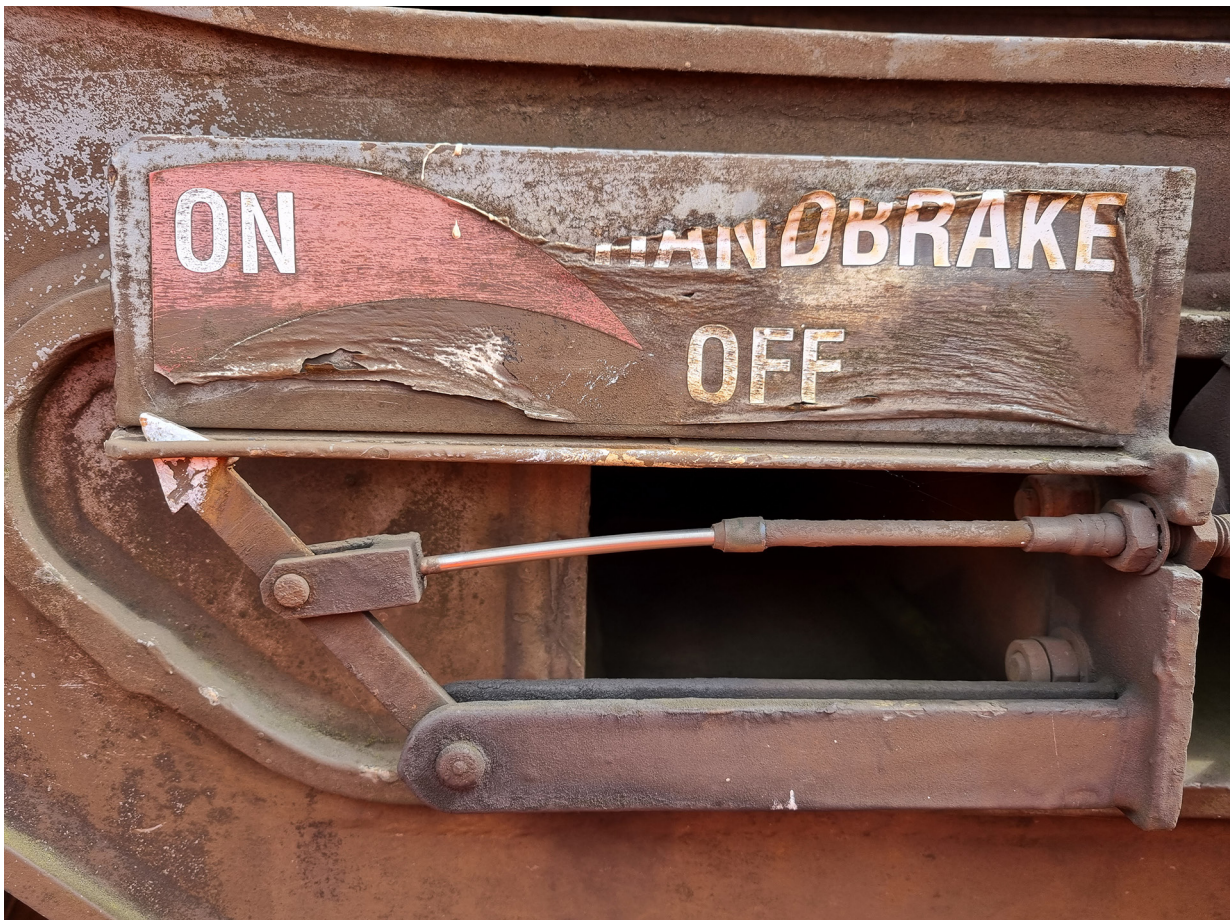
- 120 RAIB also considered whether a shunter could notice a change in the number of turns required to fully apply the handbrake. During the reconstruction, the wagon handbrake was turned from the fully off position to the fully on position in $10\frac{3}{4}$ turns. The top handbrake cable was then disconnected, to simulate it snapping, and only another half turn was able to be achieved before the handbrake indicator bottomed out on the housing, preventing further movement (figure 15). DB Cargo's maintenance standard would pass a handbrake as fit for service if it fully applies using between 8 and 12 turns, indicating that this test would still pass a handbrake as fit even where the cable had snapped.

Figure 15: Handbrake indicator from an FAA wagon.
