SAFETY FLYER TO THE SHIPPING INDUSTRY

Loss of propulsion control identified following the collision between the fishing vessel *Kirkella* and harbour tug *Shovette* at King George Dock, Hull, England on 24 June 2022

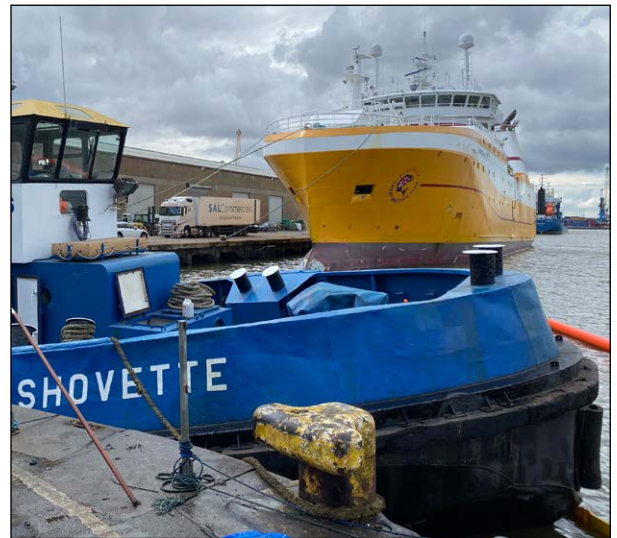
On 24 June 2022, the UK registered fishing vessel *Kirkella* lost control of its propulsion system while berthing and collided with the harbour tug *Shovette* in King George Dock, Hull, England. *Kirkella*'s bulbous bow breached *Shovette*'s hull and starboard fuel tank during the collision, causing the tug to partially sink and resulting in approximately 7,000 litres of marine diesel oil spilling into the dock. *Kirkella* was not damaged during the accident.

Kirkella and *Shovette*
