# Track worker struck by a road-rail vehicle at Braybrooke, 6 February 2024

## Summary of the accident

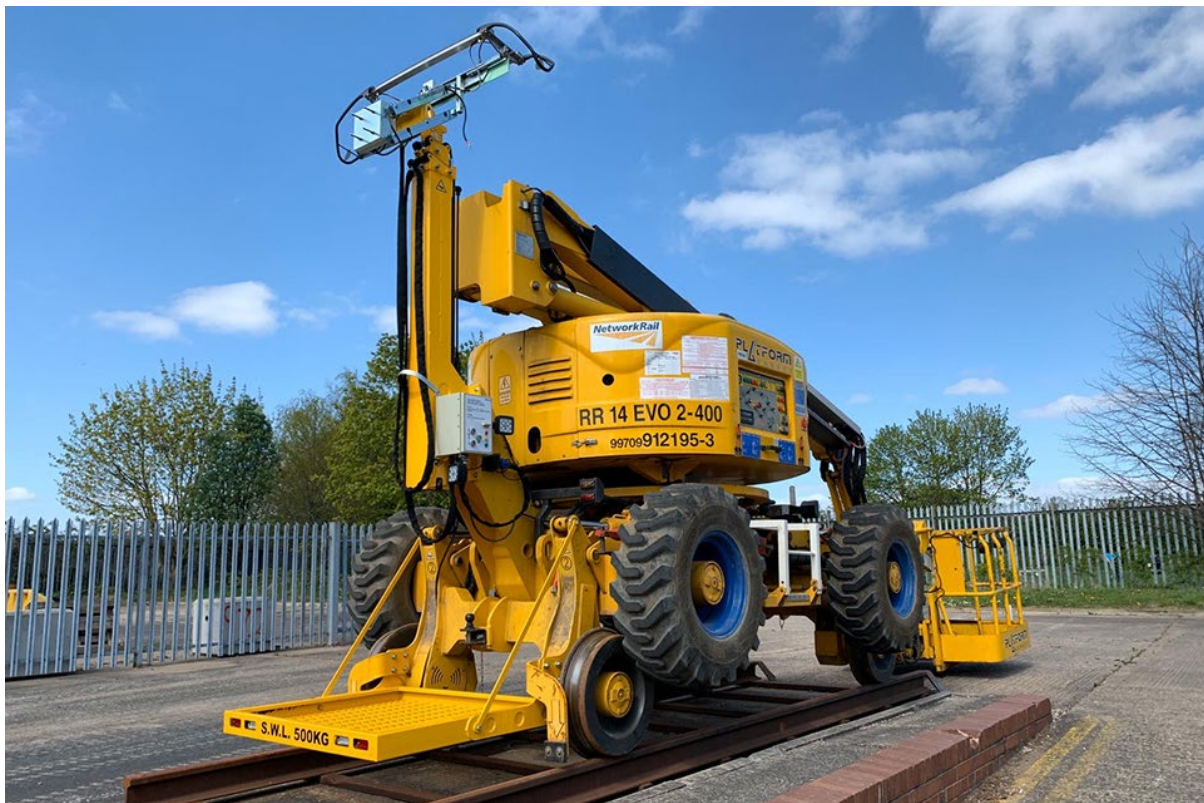
**An RRV of the same type as the machine involved in the accident, with deployed carry deck nearest the photographer and operator's basket at the opposite ('trailing') end. (Courtesy of SPL Powerlines UK Ltd.)**

When driving the RRV with the basket in the trailing position, the machine operator, situated in the basket, has a restricted view of the track ahead. This is because the boom and body of the machine obscure their view. When a machine operator's view ahead is restricted, it is a requirement of the Rule Book (GERT 8000 Handbook 15 'Duties of the machine controller (MC) and on-track plant operator', Issue 6 September 2022) that the movement is controlled by a machine controller on the ground. It is also a specific requirement for this type of RRV that any movements made with the basket trailing be controlled by staff on the ground.

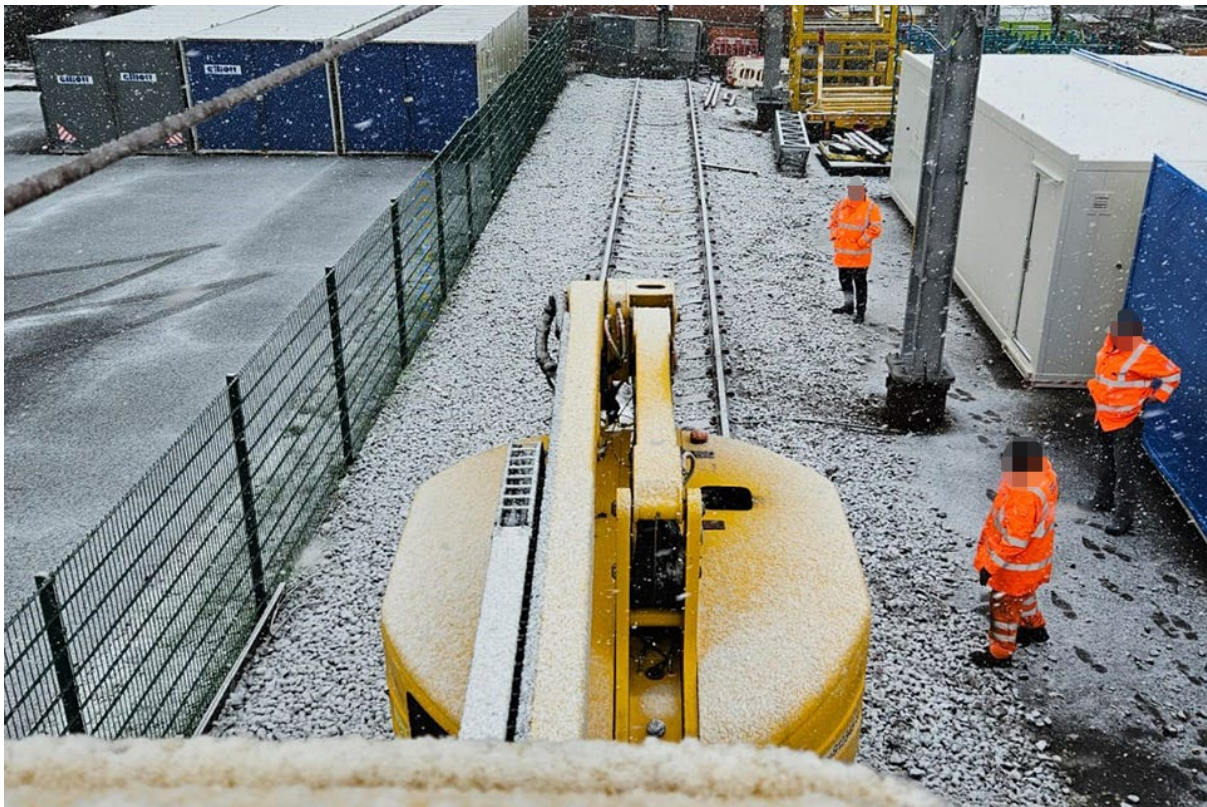
The accident occurred because the person responsible for directing the movements of the RRV involved (the machine controller) had not seen the track worker walking along the track ahead when they instructed the machine operator to move the machine. The machine operator had a restricted view of the track ahead from their control position.

**View from the raised operator's basket showing the restricted view of the track immediately ahead of the machine. (Courtesy of SPL Powerlines UK Ltd.)**

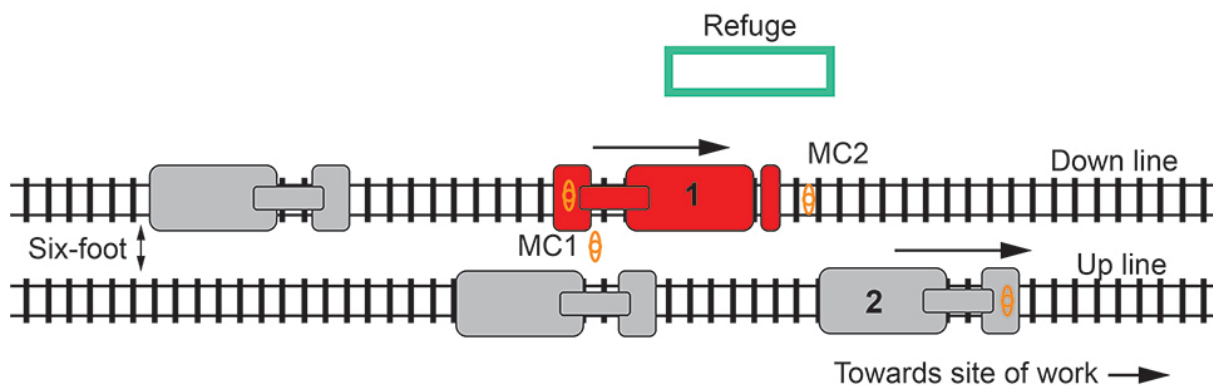
Sometime after machine controller 1 had checked the cess side of their machine, machine controller 2 left the refuge and walked towards RRV2, which was on the Up Main line. Machine controller 2 took a position in between the rails of the Down Main line (the 'four-foot') and started to walk ahead of RRV1, with their back to it.

Immediately before the accident, the operator of one of the RRVs on the Up Main line saw machine controller 2 walking in the four-foot of the Down Main line. They realised that RRV1 was about to strike machine controller 2, so they shouted a warning. This was heard by machine operator 1, who responded by stopping RRV1. Machine controller 2 tried to move out of the way of RRV1, towards the six-foot. However, they reported being struck on the back of one of their legs by the carry deck of RRV1 as they did so, and they fell to the ground in the six-foot. Only after RRV1 had stopped did machine operator 1 see machine controller 2 lying on the ballast and realise why a warning had been shouted.

**Approximate positions of the four RRVs and the position of machine controller 1 and machine controller 2 immediately before the accident.**

This accident occurred because machine controller 2 was walking in the area directly ahead of RRV1 and because the movement of the machine brought them within its exclusion zone and then into contact with the carry deck. The area directly ahead of RRV1 was outside the vision of machine operator 1, who had a restricted view of the line ahead, and also of machine controller 1, who was to the rear of the machine. Although machine controller 1 had checked the line ahead before authorising RRV1 to move, machine controller 2 had in the intervening period left the refuge and walked ahead of the machine.
