Accident

Aircraft Type and Registration:	Aerosport Scamp, G-BOOW	
No & Type of Engines:	1 Volkswagen 1834 piston engine	
Year of Manufacture:	1988 (Serial no: PFA 117-10709)	
Date & Time (UTC):	10 February 2024 at 1344 hrs	
Location:	Near RAF Mona, Anglesey	
Type of Flight:	Private	
Persons on Board:	Crew - 1	Passengers - None
Injuries:	Crew - Serious	Passengers - N/A
Nature of Damage:	Aircraft destroyed	
Commander's Licence:	Airline Transport Pilot's Licence	
Commander's Age:	50 years	
Commander's Flying Experience:	4,876 hours (of which 2 were on type) Last 90 days - 2 hours Last 28 days - 1 hour	
Information Source:	Aircraft Accident Report Form submitted by the pilot

Synopsis

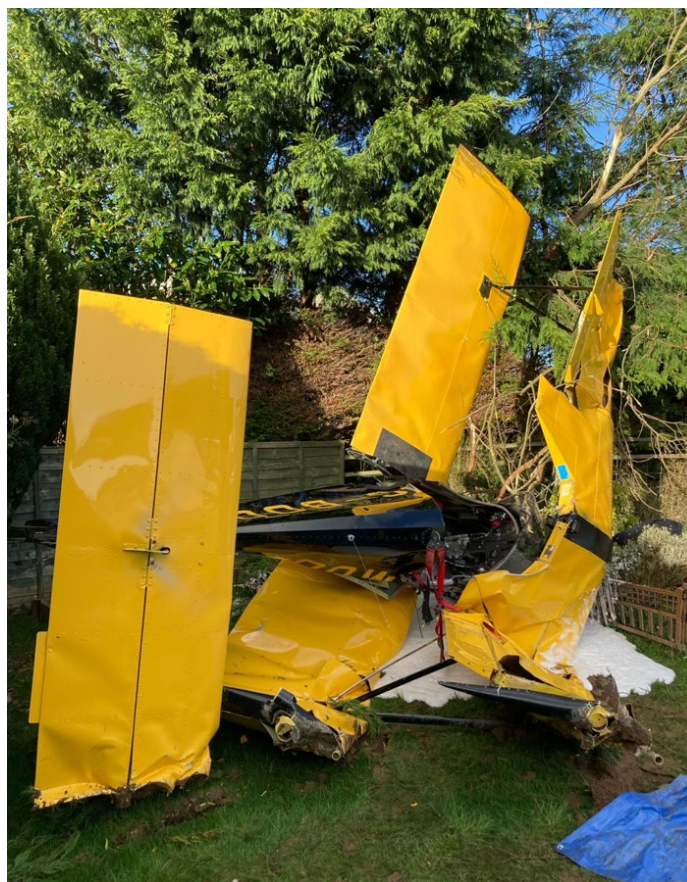
Figure 1

With the engine now producing power, the pilot decided to fly a tight right-hand circuit which he considered would also provide the opportunity to land downwind on Runway 22 if necessary. As the aircraft entered the downwind leg, at 600 ft agl, the engine power decreased to idle with significant rough running. The pilot lowered the nose below the horizon and, being too low to reach the airfield, selected a field to land in. He felt the aircraft stall with a right wing drop and he pitched the aircraft further nose down to recover, however he was now too low to reach his selected field. The engine then stopped. With a residential area ahead and a high rate of descent, he picked an open area of gardens with a line of trees to land in and intentionally stalled the aircraft into the tree line. The aircraft slid sideways from the trees, coming to rest on its right side (Figure 1). The pilot sustained a fractured wrist and some minor injuries. While he was wearing a helmet which provided some protection, the pilot sustained a minor head injury

G-BOOW accident site (used with permission)
