Accident

Aircraft Type and Registration:	De Havilland Canada DHC-6-300 Twin Otter, VP-FBC	
No & Type of Engines:	2 Pratt & Whitney PT6A-27 engines	
Year of Manufacture:	1982 (Serial no: MSN787)	
Date & Time (UTC):	23 January 2023 at 1600 hrs	
Location:	E322, Mount Lymburner field location at the north-west end of the Ellsworth Mountains, Antarctica	
Type of Flight:	Private	
Persons on Board:	Crew - 2	Passengers - None
Injuries:	Crew - None	Passengers - N/A
Nature of Damage:	Damage to fairing around the landing gear, and upper and lower forward bulkhead	
Commander's Licence:	Commercial Pilot's Licence	
Commander's Age:	33 years	
Commander's Flying Experience:	5,438 hours (of which 3,223 were on type) Last 90 days - 174 hours Last 28 days - 58 hours	
Information Source:	Aircraft Accident Report Form submitted by the commander

Synopsis

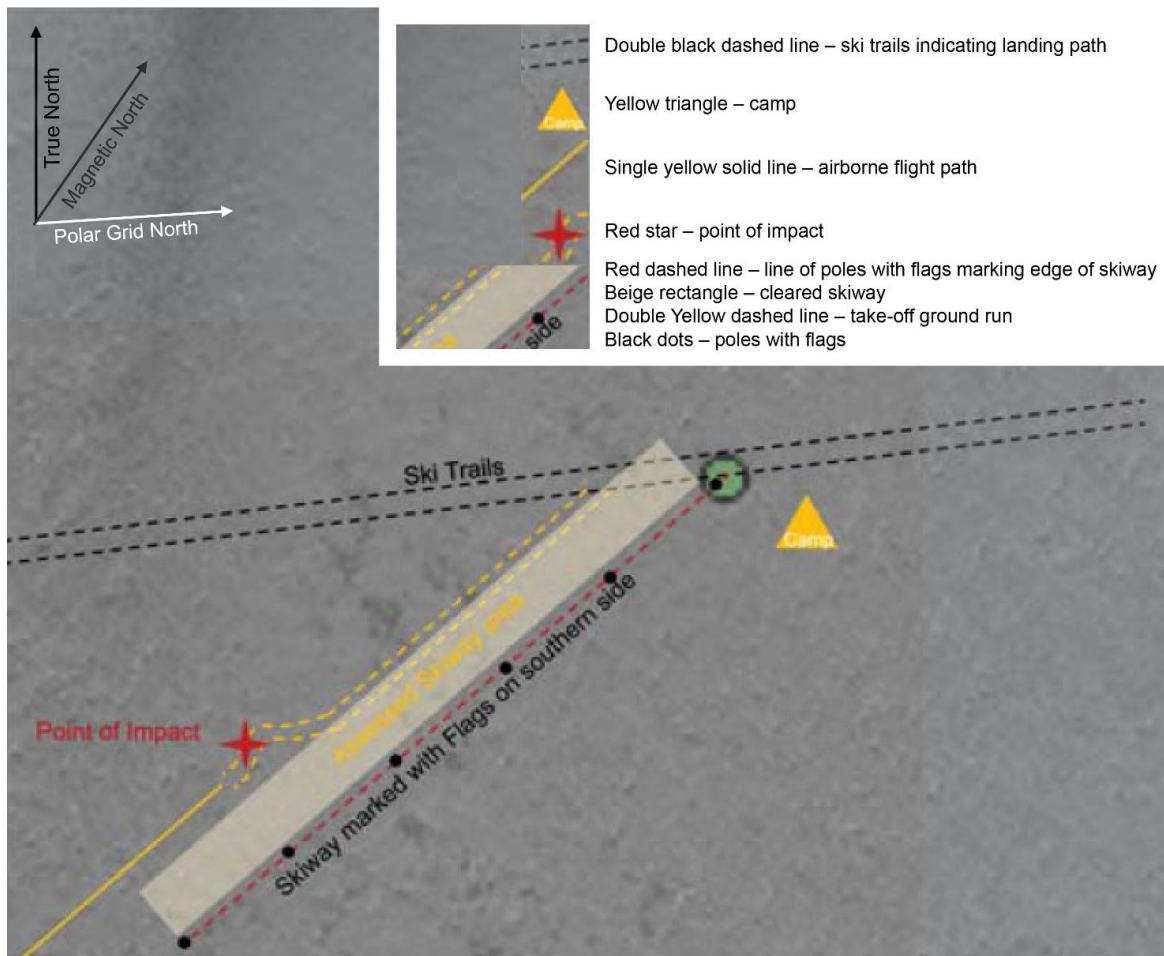
Figure 2

The direction of the ice ridges (also known as sastrugi²) was more apparent when on the ground. Consequently, the commander prepared a skiway³ of 800 m, about 20° off the direction in which he had landed but in line with the direction of the sastrugi (Figure 2), for the following aircraft to land. He marked the skiway with bamboo poles.

Station E322 landing site with ski trails and cleared skiway shown (© Google Earth)

The operator's own safety investigation found that the accident occurred because the aircraft's ground roll diverged from the cleared skiway and struck a sastrugi.

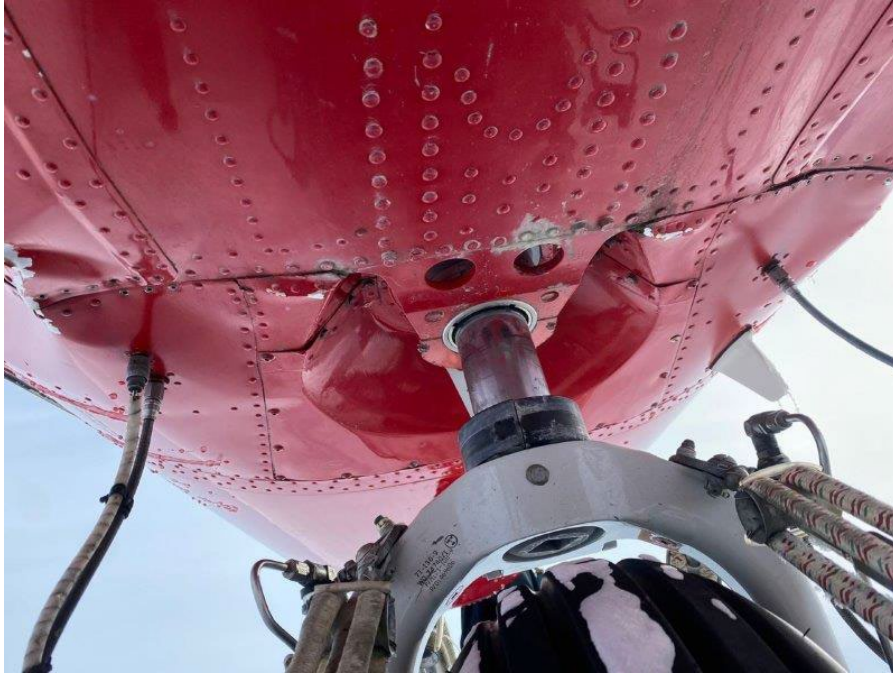
Figure 4

On landing at the field station, further damage was found to have occurred to the nose fairing around the landing gear and the lower bulkhead forward of the cockpit.

On landing at Castle, the commander inspected the aircraft and assessed the damage to the external nose gear and surrounding aircraft skin (Figure 4), nose baggage bay, avionics and hydraulic bays. He checked the flying controls, including the rudder and elevator, of which the pulleys are attached to the forward bulkhead at station 60. While he determined that this bulkhead looked torn and buckled, he determined all the flying controls were undamaged and there were no control restrictions. The engine nacelles and main landing gear also appeared undamaged.

Damage to aircraft skin around the nose gear (photo taken after landing at Sky Blu)

The type certificate holder issued a Repair Engineering Order for a temporary repair to the nose and bulkhead structure, allowing a ferry flight with a maximum of two cycles and eight flying hours.

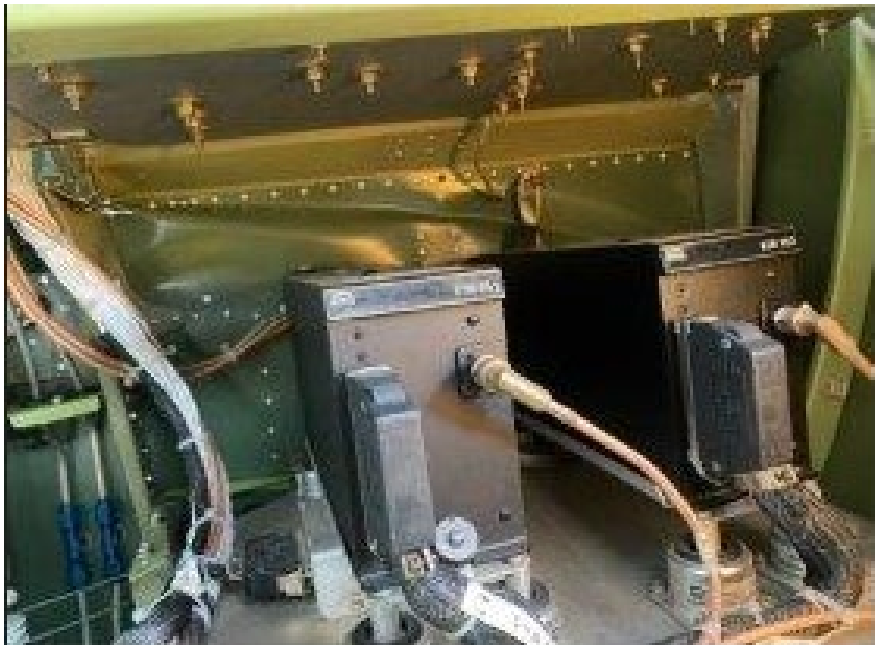
Figure 5

On landing at Sky Blu, the aircraft was inspected by a licensed engineer who confirmed damage to the upper and lower forward bulkhead at station 60 (Figure 5). The commander noted that the damage appeared to be worse than he had observed at Castle.

Station 60 upper bulkhead damage (photo taken after landing at Sky Blu)

The forward bulkhead at station 60, to which the nosewheel landing gear is connected, separates the nose compartment from the flight compartment. The operator and commander stated that this area is known to be liable to damage in the event of an impact on the nosewheel landing gear.
