Accident

Aircraft Type and Registration:	Extra EA 300/L, G-OLAD	
No & Type of Engines:	1 Lycoming AEIO-540-L1B5 piston engine	
Year of Manufacture:	2007 (Serial no: 1270)	
Date & Time (UTC):	17 January 2024 at 1145 hrs	
Location:	Northrepps Aerodrome, Norfolk	
Type of Flight:	Private	
Persons on Board:	Crew - 1	Passengers - 1
Injuries:	Crew - None	Passengers - None
Nature of Damage:	Both mainwheels detached on landing leading to landing gear detachment, lower fuselage, engine and propeller damaged	
Commander's Licence:	Airline Transport Pilot's Licence	
Commander's Age:	71 years	
Commander's Flying Experience:	21,404 hours (of which 64 were on type) Last 90 days - 3 hours Last 28 days - 1 hour	
Information Source:	Aircraft Accident Report Form submitted by the pilot and follow-up enquiries by the AAIB

Synopsis

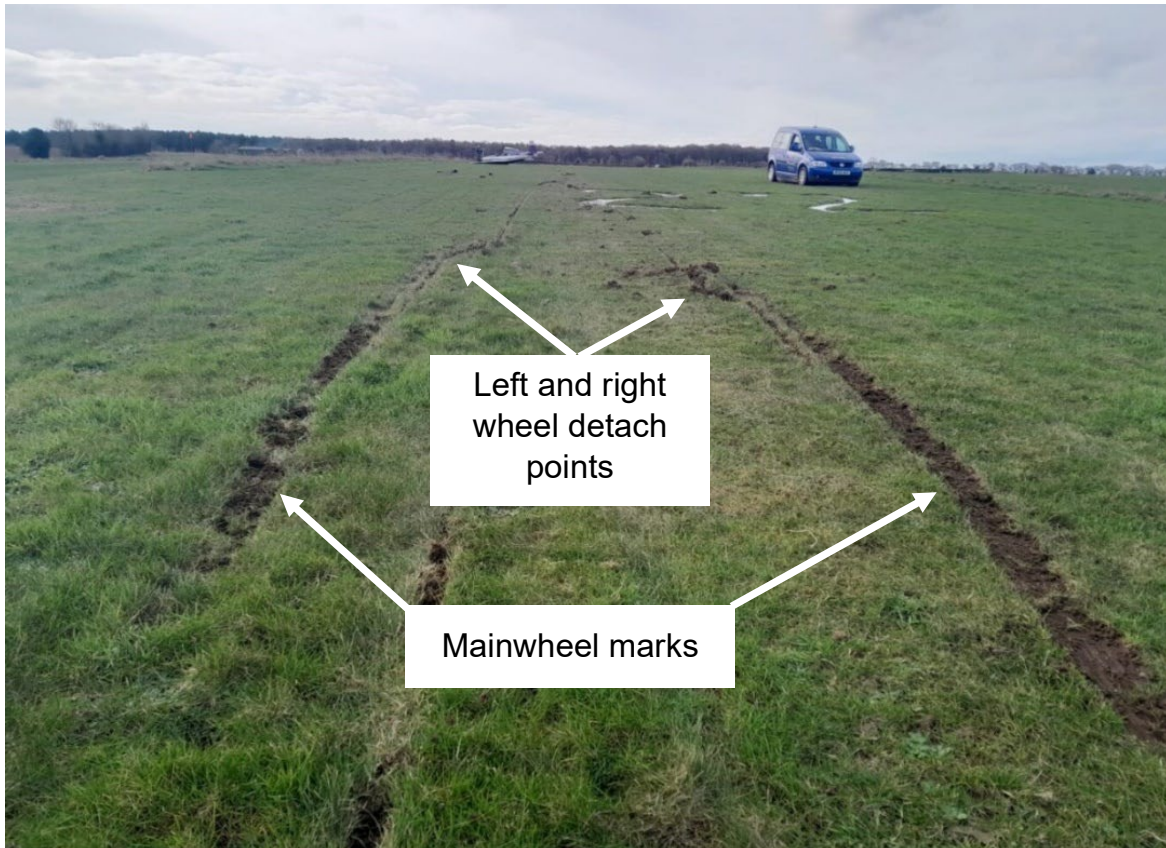
Figure 1
Runway witness marks

Witness marks in the grass surface appeared to show that the right tyre was initially not turning upon touchdown and that the right mainwheel assembly detached before the left mainwheel assembly (Figure 1).

Witness marks on the runway show it is likely that the surface in the displaced threshold was soft. This can increase both the landing gear leg flex and the tendency for the aircraft to dig in upon touchdown, introducing higher loads into the main landing gear assembly that may not be felt by the passengers. It was not possible to determine the cause of failure of the fasteners, but it is possible that if there was pre-existing damage to the bolt threads it could lead to failure of the fasteners under normal landing loads.

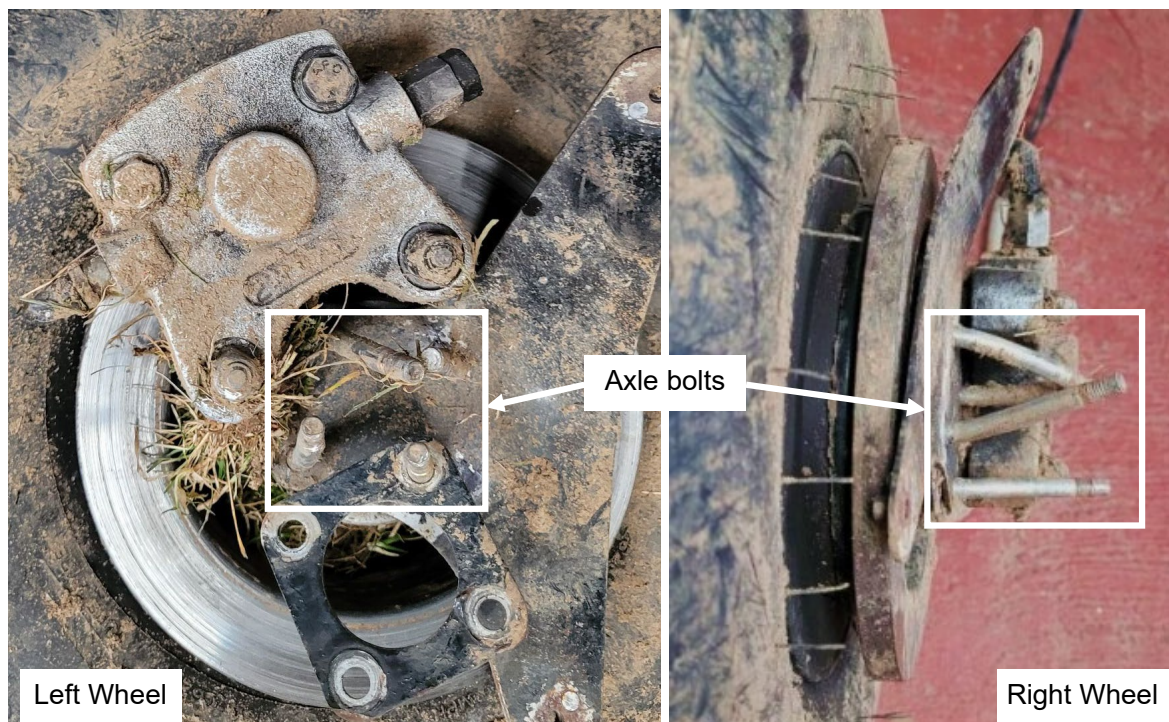
Figure 2

Both mainwheel assemblies detached from the landing gear leg, which then bent back underneath the fuselage. The maintenance organisation tasked with recovering the aircraft found that both main wheels turned freely. The four axle attachment bolts on each wheel were bent and the threads were stripped (Figure 2). None of the eight axle bolt nuts were recovered.

Damaged axle attachment bolts

The damage to the axle attachment bolts is consistent with side forces having been applied to the tyres, and the nuts being pulled from the bolt threads under load. The pilot noted that this aircraft routinely experiences firm landings and heavy braking at Northrepps due to the 615 m runway length. However, neither the pilot or passenger felt this landing was heavier than normal, and both confirmed their feet were clear of the brakes.

The axle attachment fasteners of both wheels failed due to the nuts being pulled from the bolts under load. It is possible the bolt threads had been damaged during the axle removal and refitting process when the bolts were re-used. The version of the manufacturer's maintenance manual used for the process specified to use new axle attachment bolts.

Extra Aircraft is taking safety action to add the prominent instruction to Chapter 32-10-00 of the maintenance manual for all related models at their next revision.
