Serious Incident

Aircraft Type and Registration:	UAS Prion Mk3	
No & Type of Engines:	1 Parallel-twin-120cc engine	
Year of Manufacture:	2023 (Serial no: 3-0021)	
Date & Time (UTC):	6 March 2023 at 1352 hrs	
Location:	West Wales Airfield	
Type of Flight:	Private - Test & Evaluation	
Persons on Board:	Crew - None	Passengers - None
Injuries:	Crew - None	Passengers - N/A
Nature of Damage:	Damage to nose gear, boom, fuselage and right wingtip	
Commander's Licence:	N/A	
Commander's Age:	26 years	
Commander's Flying Experience:	166 hours (of which 166 were on type) Last 90 days - 7 hours Last 28 days - 2 hours	
Information Source:	Aircraft Accident Report Form submitted by the operator.

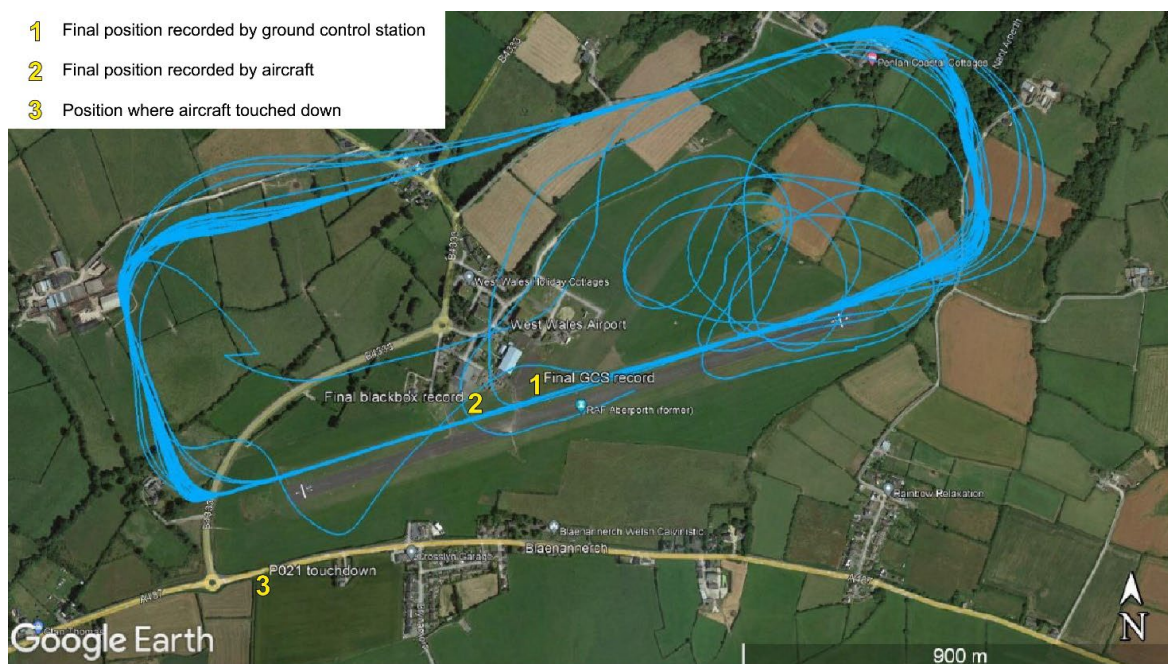
Figure 1

Track of UAS Prion during accident flight

The RPSO advised ATC of the situation. Meanwhile, the aircraft continued further along the direction of Runway 25 for about 30 seconds before turning right and circling, then disappearing from the RP’s sight beyond a hedge (Figure 1).

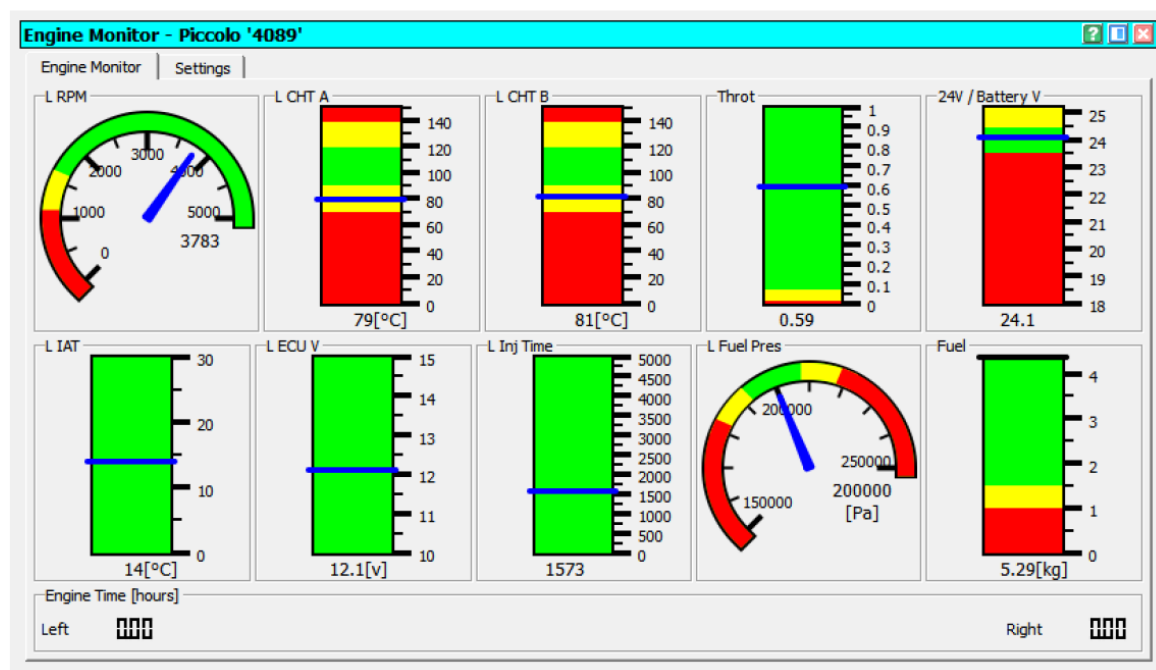
Figure 2

The operator identified that the after-flight check list was missing a check of the emergency battery status prior to the aircraft being connected to the ground power. It also improved the engine monitoring graphical interface flight telemetry system (Figure 2) to include voltage indication of the emergency battery to allow its charge status to be monitored in flight. This would indicate if the alternator generator system was faulty.

Engine monitor with emergency battery voltage (top right) indication

- The operator has standardised the wiring and schematics across the fleet.
- The operator has amended their after-flight check list to establish the charge status of the emergency battery, prior to the connecting of ground power to the aircraft, as a means to verify the functionality of the power generation and charging system.
- The operator has included voltage indication of the emergency battery in the engine monitoring graphical interface to indicate alternator generator system performance.
