AAIB Bulletin

6/2024

Aircraft Type and Registration:	Airbus A321-253NX, G-OATW	
No & Type of Engines:	2 CFM International SA LEAP-1A33 turbofan engines	
Year of Manufacture:	2020 (Serial no: 10238)	
Date & Time (UTC):	4 October 2023 at 1151 hrs	
Location:	London Stansted Airport	
Type of Flight:	Commercial Air Transport (Passenger)	
Persons on Board:	Crew - 11	Passengers - 9
Injuries:	Crew - None	Passengers - None
Nature of Damage:	Damage to several cabin windows and impact damage to the left horizontal stabiliser	
Commander's Licence:	Airline Transport Pilot's Licence	
Commander's Age:	54 years	
Commander's Flying Experience:	4,905 hours (of which 2,300 were on type) Last 90 days - 128 hours Last 28 days - 27 hours	
Information Source:	AAIB Field Investigation

A cabin window was seen to be loose shortly after takeoff and several windowpanes were missing after the aircraft landed. The windowpanes fell out because they had been damaged by infrared energy emitted by high-intensity lights during a filming event the previous day.

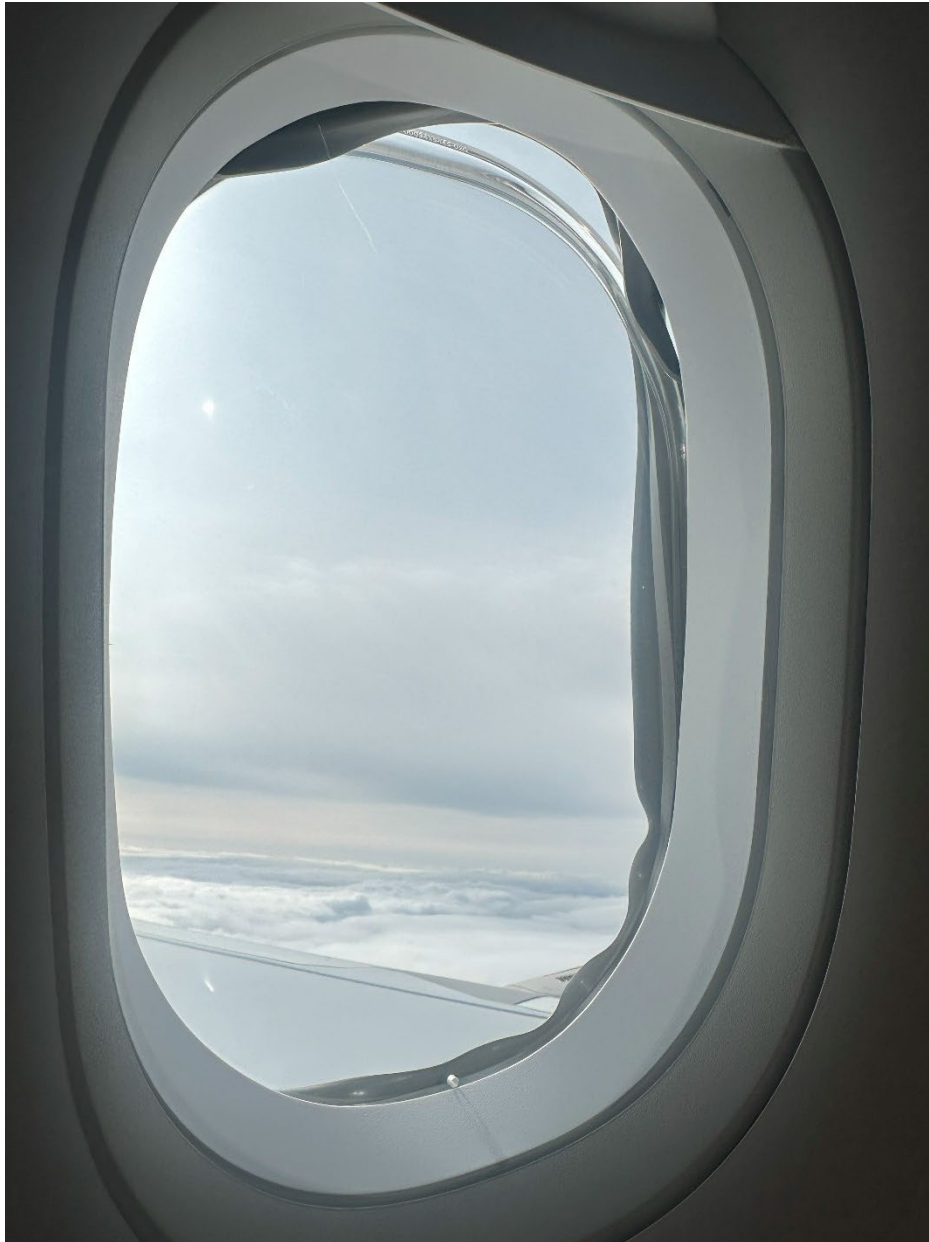
The aircraft departed a few minutes ahead of schedule and took off from Runway 22. Several passengers recalled that after takeoff the aircraft cabin seemed noisier and colder than they were used to. As the aircraft climbed through FL100, and the seatbelt signs were switched off, the loadmaster, who had been seated just in front of the other passengers, walked towards the rear of the aircraft. He noticed the increased cabin noise as he approached the overwing exits and his attention was drawn to a cabin window on the left of the aircraft. He observed that the window seal was flapping in the airflow and the windowpane appeared to have slipped down². He described the cabin noise as 'loud enough to damage your hearing'. Figure 1 shows the window in flight.

View of the left side cabin window aft of the overwing exit

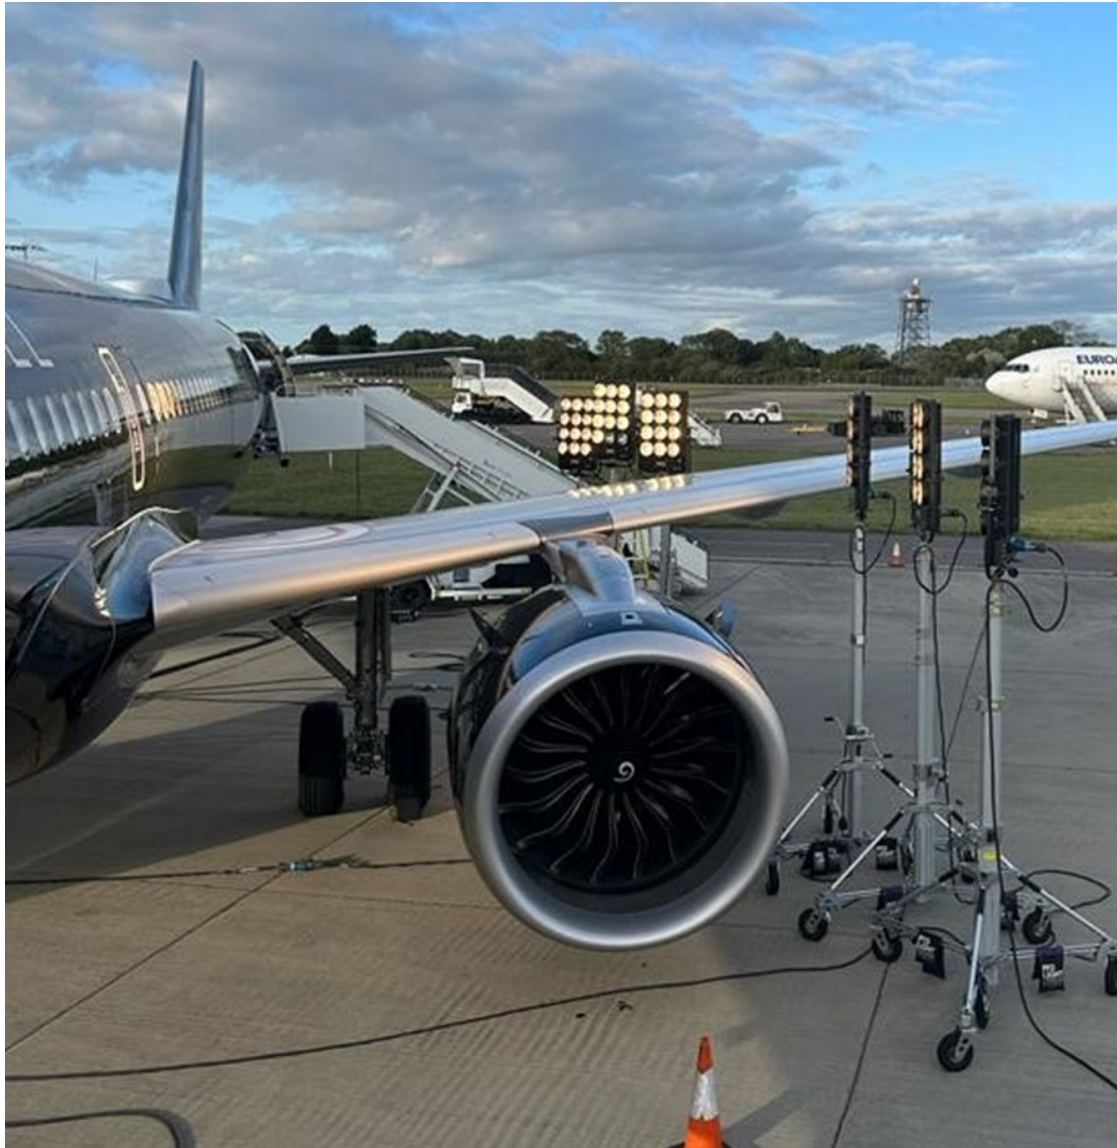
The day before the occurrence flight the aircraft had been used for filming on the ground, during which external lights had been shone through the cabin windows to give the illusion of a sunrise. The lights were first shone on the right side of the aircraft for approximately five and a half hours, with the light focused on the cabin windows just aft of the overwing exits. The lights were then moved to the left side of the aircraft where they illuminated a similar area on the left side for approximately four hours. Photographs taken during filming showed six sets of flood lights on both sides of the aircraft. Figure 2 shows the lights positioned on the left of the aircraft.

Flood lighting on the left side of the aircraft

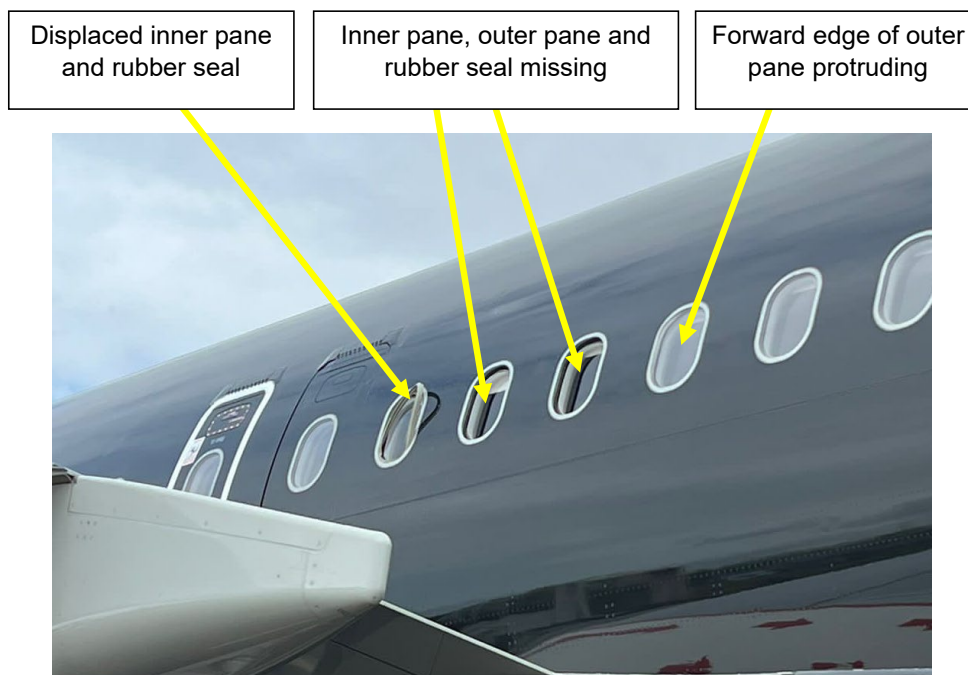
**Figure 5**

Two cabin window assemblies were missing in their entirety, and the inner pane and seal from a third were displaced but partially retained (Figure 5). The forward edge of a fourth window protruded from the left side of the fuselage (Figure 6). The four windows were adjacent to each other, just aft of the left overwing exit. All the scratch panes remained in place, so there was no direct, unrestricted aperture into the passenger cabin.

Displaced and missing windowpanes on the left side of the aircraft

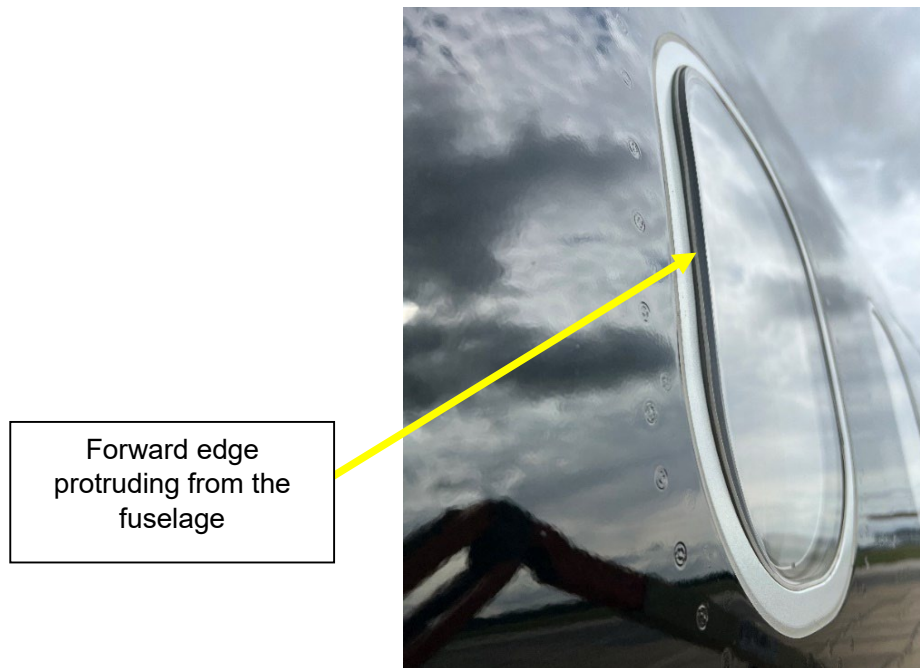
Figure 6

Forward edge
protruding from the
fuselage

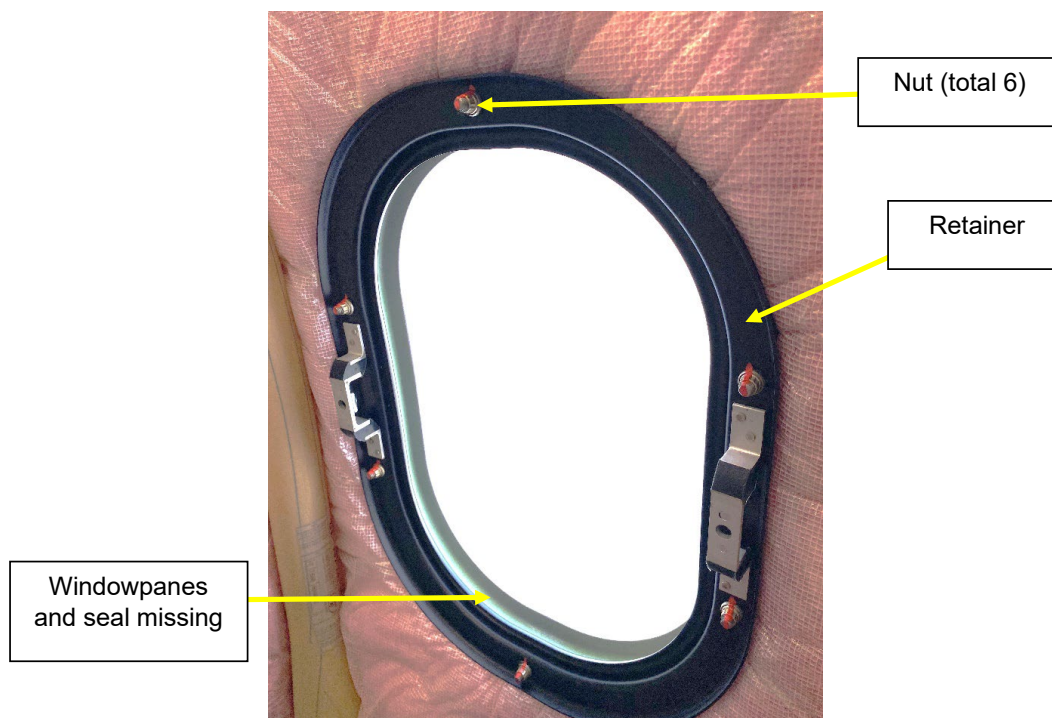
Removal of the cabin lining inside the passenger cabin revealed that, despite the missing and dislodged windowpanes, the window retainers were in good condition and correctly installed (Figure 7).

Correct installation of the retainer but the window assembly is missing

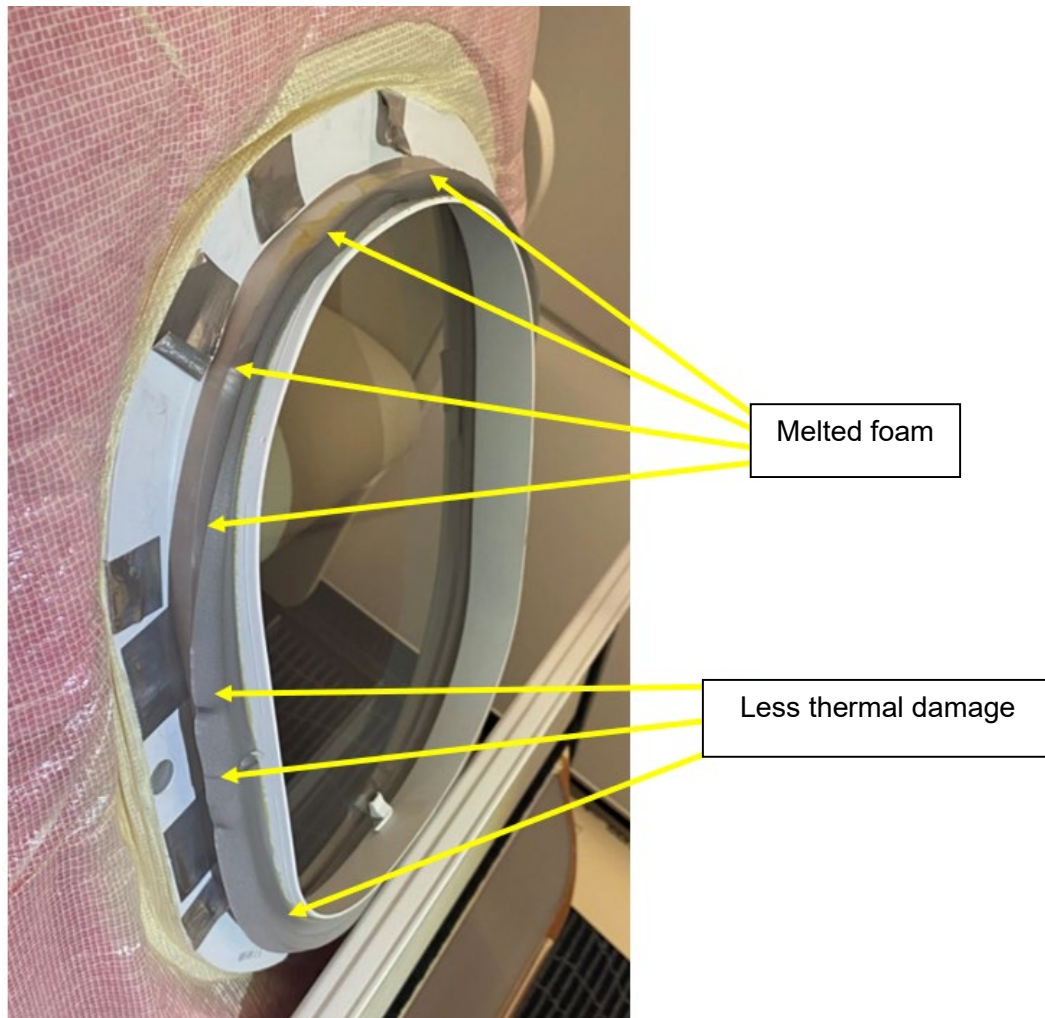
Figure 8

The foam ring material on the back of the cabin liners was found to be melted in the areas adjacent to the windows that were damaged or missing (Figure 8).

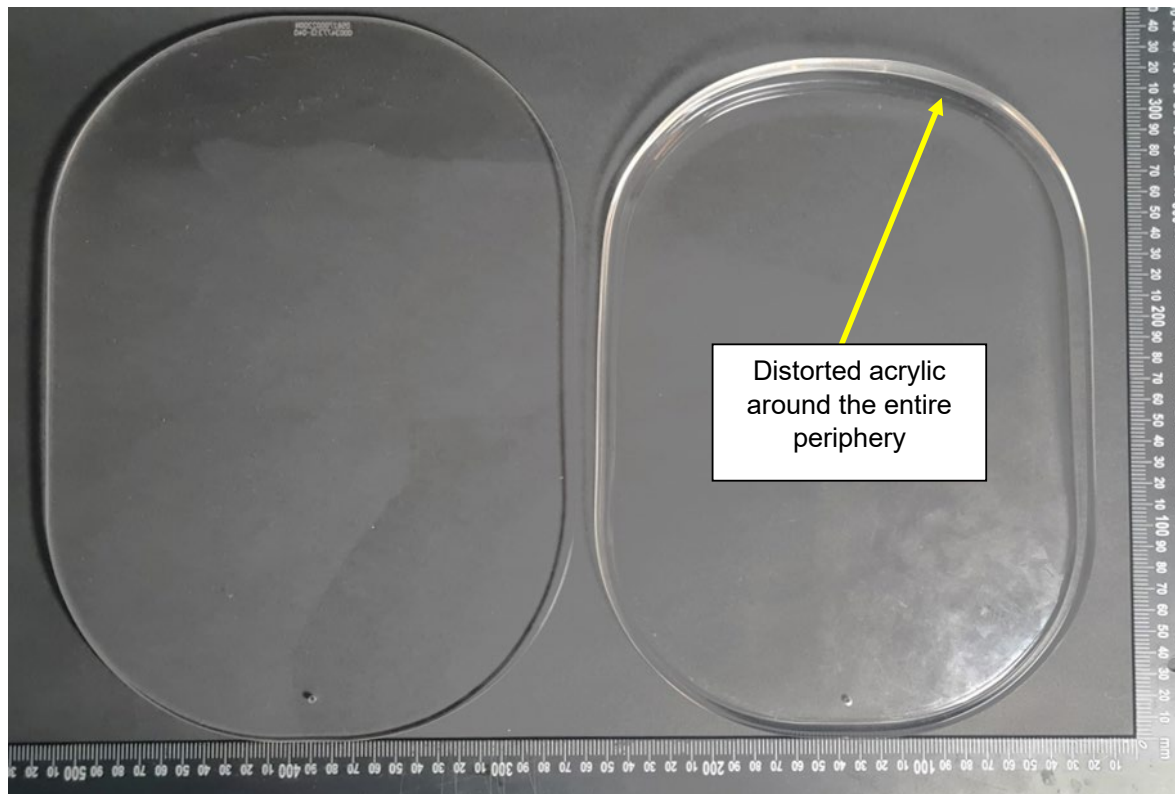
Figure 9

The inner windowpane that was loosely retained after the aircraft landed was found to be shrunk and deformed around its periphery (Figure 9). The corresponding rubber seal was undamaged, but the deformed windowpane no longer formed an effective interface with it.

A serviceable inner windowpane (left) and the damaged inner windowpane (right)

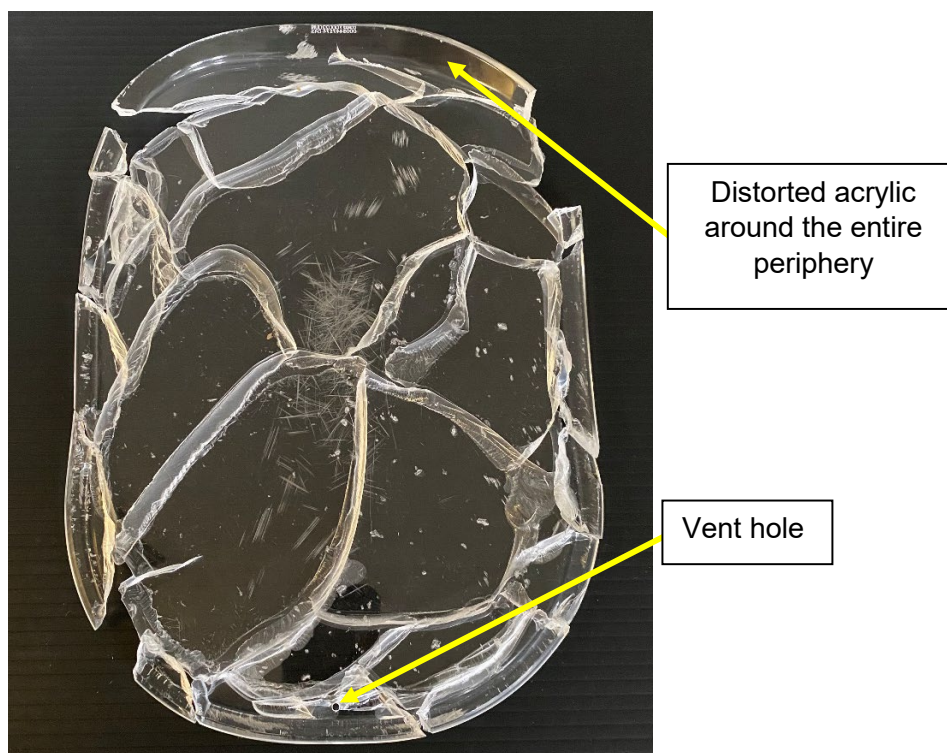
**Figure 11**

A vent hole in one of the broken parts showed that the shattered remains were from an inner windowpane⁵ (Figure 11). The window was distorted around its periphery and had shrunk.

A shattered inner windowpane was recovered from the entrance to a rapid-exit taxiway. The broken remains showed thermal distortion around its periphery, and it was apparent that the windowpane had shrunk. The distortion and shrinkage meant that the windowpane no longer formed an effective interface with the slot in the rubber seal. This made it more likely to fall out due to vibration or the differential air pressure between the passenger cabin and the outside environment.

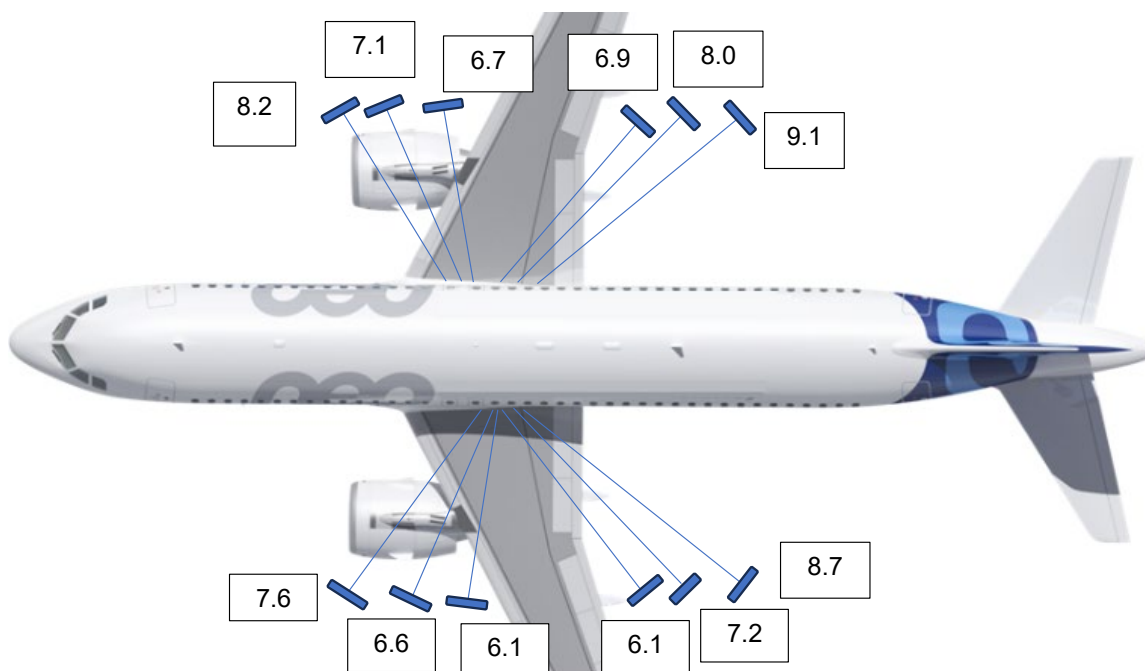
Photographs of the filming showed that the lights were approximately 6 to 9 m from the window areas where damage occurred (Figure 12).

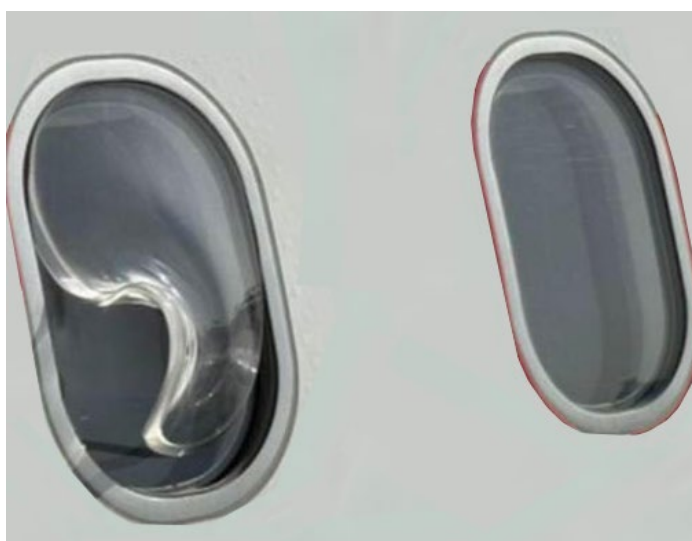
Figure 15

The AAIB does not know the specifications of the lights or how long they were turned on. The window damage was readily visible after the filming (Figure 15).

Thermal damage sustained by an outer windowpane on an Airbus A321
(image used with permission)

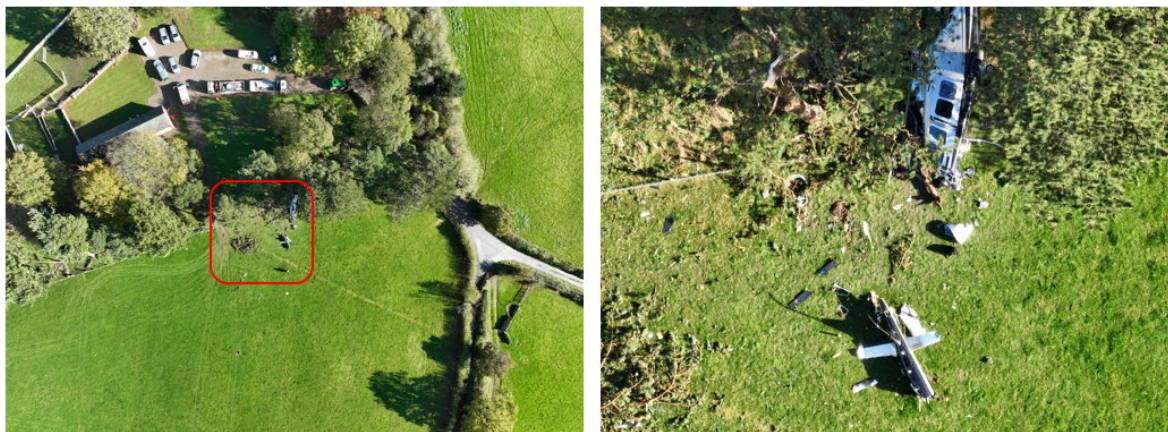
Figure 2

The helicopter came to rest at the base of a tree approximately 30 m from the shooting lodge. The main fuselage of the helicopter was intact but the tail boom had separated and been thrown forward of the point of ground impact (Figure 2).

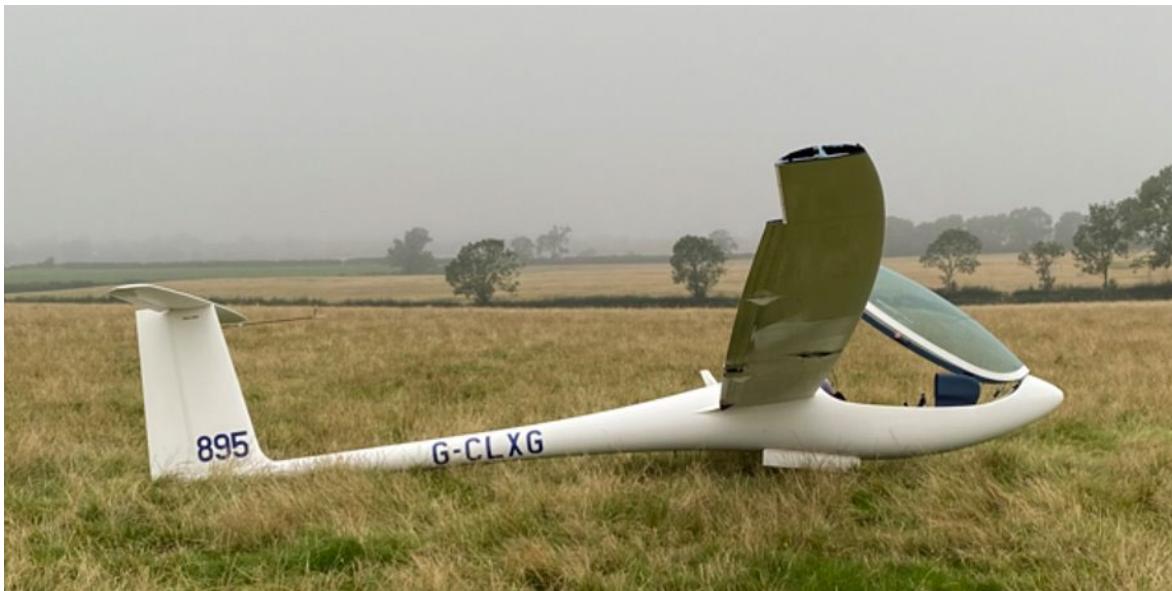
Figure 3

G-CLXG landed in a grass field 1.4 nm southeast of the G-KADS accident site. The glider was mostly intact apart from the right winglet and outermost section of right flaperon which were missing and not subsequently recovered (Figure 3).

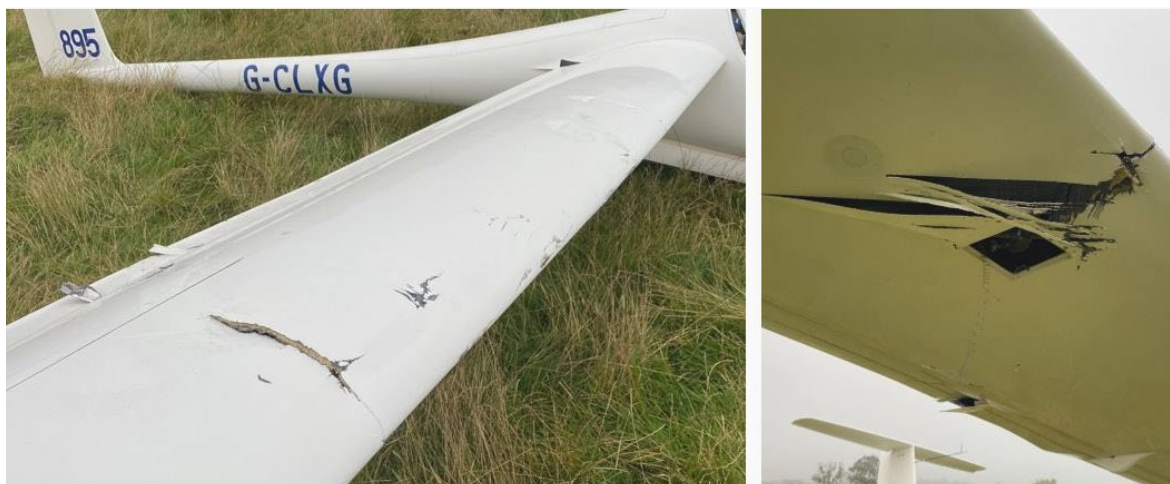
Figure 4

G-CLXG's right wing was damaged between 1.6 m and 3.5 m outboard from the wing root due to the impact with G-KADS' rear fuselage. The upper and lower wing skins were torn and delaminated, and the flaperon control surface at the trailing edge had split open due to rearward deflection of the wing (Figure 4). The right flaperon moved in response to movement of the control column through the flaperon inboard and outboard drive arms, which were undamaged. The battery compartment access panel in the lower wing skin was missing, the battery pack was not damaged and the powerplant battery management system did not indicate that any faults were present.

Damage to G-CLXG's right wing

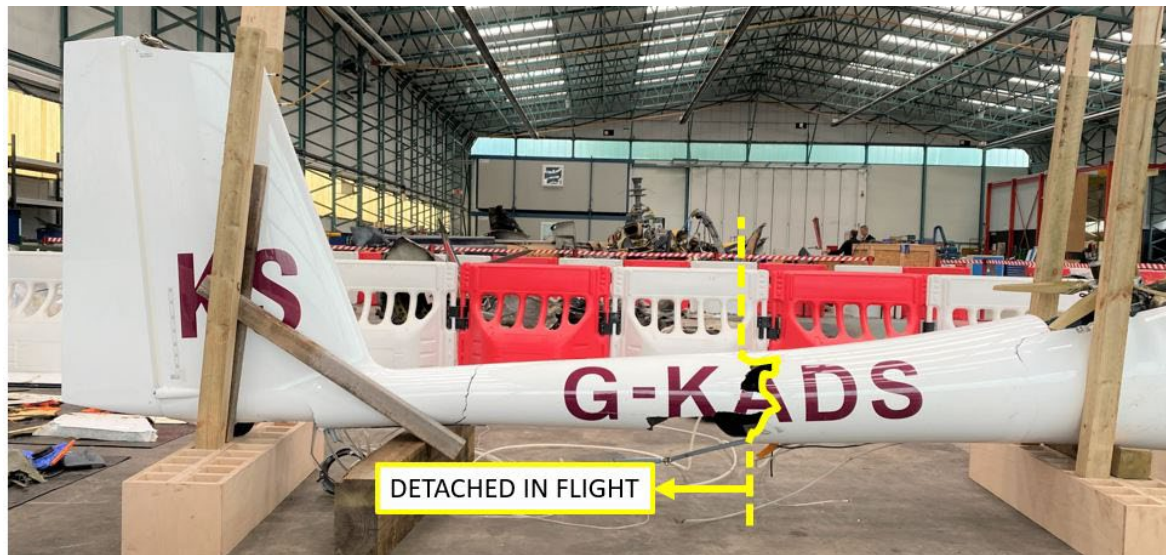
Figure 6

The recovered parts of G-KADS' fuselage were reassembled (Figure 6). This showed that G-CLXG's right wing had struck the fuselage from below, in an upwards direction. The rudder cables, fin ballast tank dump cable and elevator pushrod had failed in overload and the pitot-static system tubes were severed.

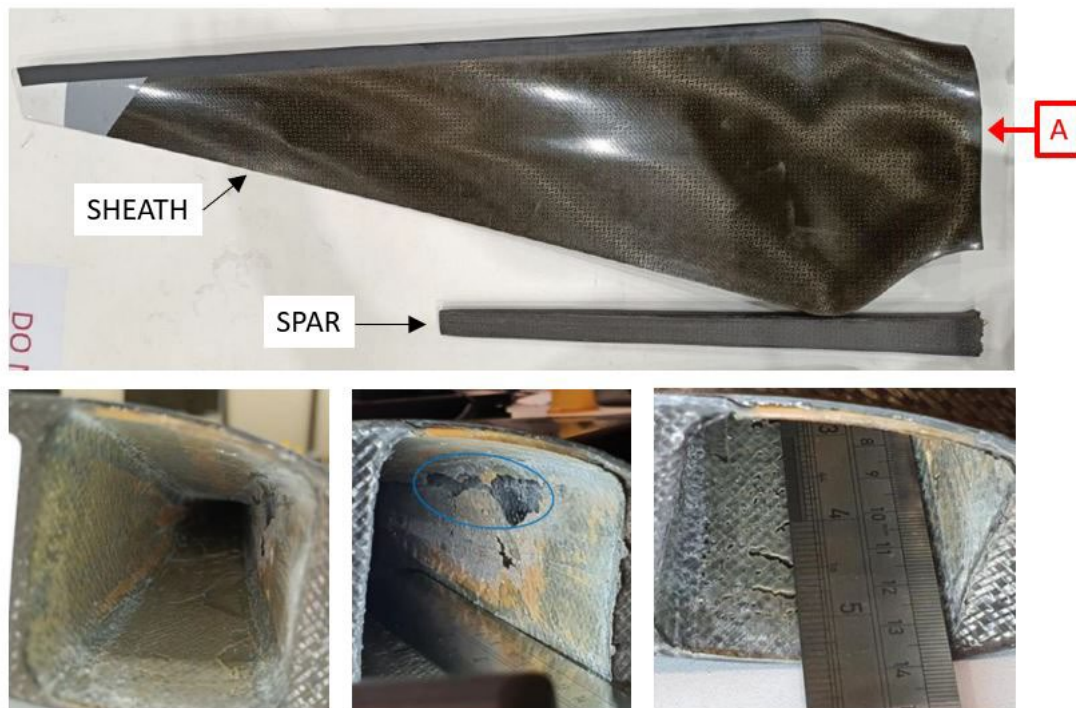
Figure 3

The blade sheath that released during flight showed evidence of poor bonding between the sheath and the blade spar (Figure 3). Most of the adhesive remained attached to the internal sheath surface with very little present on the blade spar.

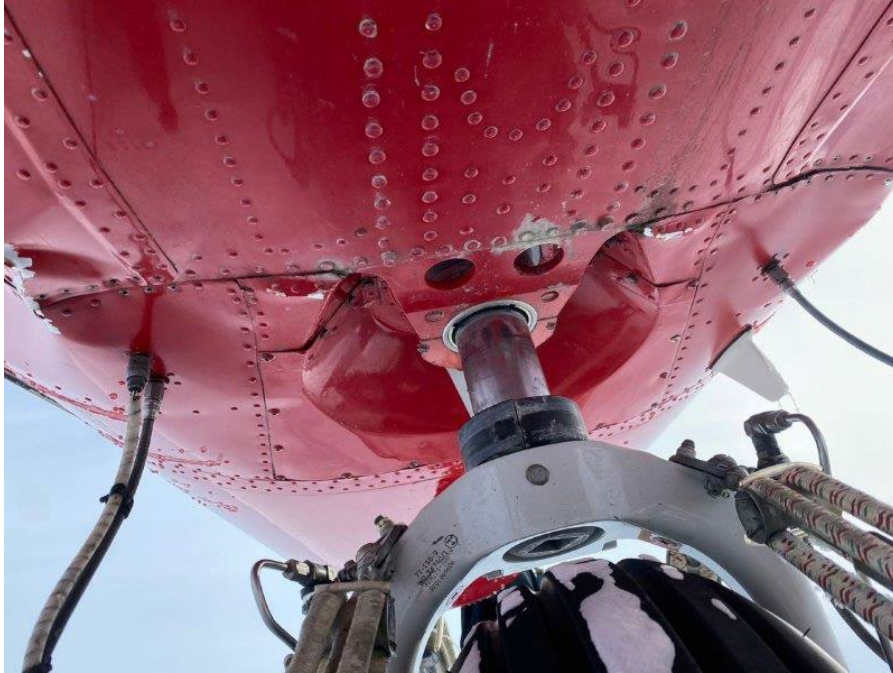
Figure 4

On landing at Castle, the commander inspected the aircraft and assessed the damage to the external nose gear and surrounding aircraft skin (Figure 4), nose baggage bay, avionics and hydraulic bays. He checked the flying controls, including the rudder and elevator, of which the pulleys are attached to the forward bulkhead at station 60. While he determined that this bulkhead looked torn and buckled, he determined all the flying controls were undamaged and there were no control restrictions. The engine nacelles and main landing gear also appeared undamaged.

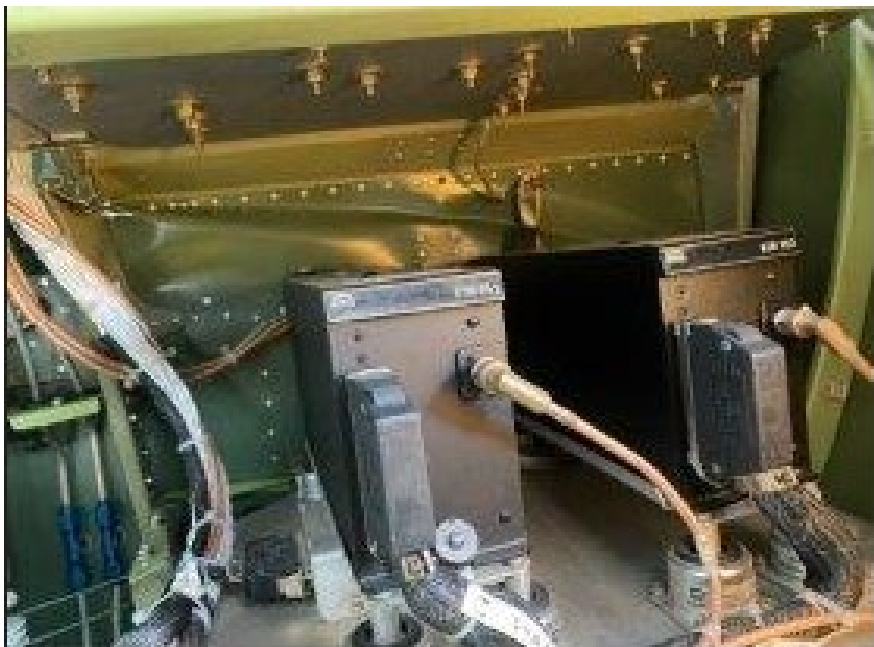
Figure 5

On landing at Sky Blu, the aircraft was inspected by a licensed engineer who confirmed damage to the upper and lower forward bulkhead at station 60 (Figure 5). The commander noted that the damage appeared to be worse than he had observed at Castle.
