Rail Accident Investigation Branch

# Rail Accident Report

## Signal passed at danger at Stafford Trent Valley Junction No. 1 22 August 2023

Report 05/2024  
June 2024

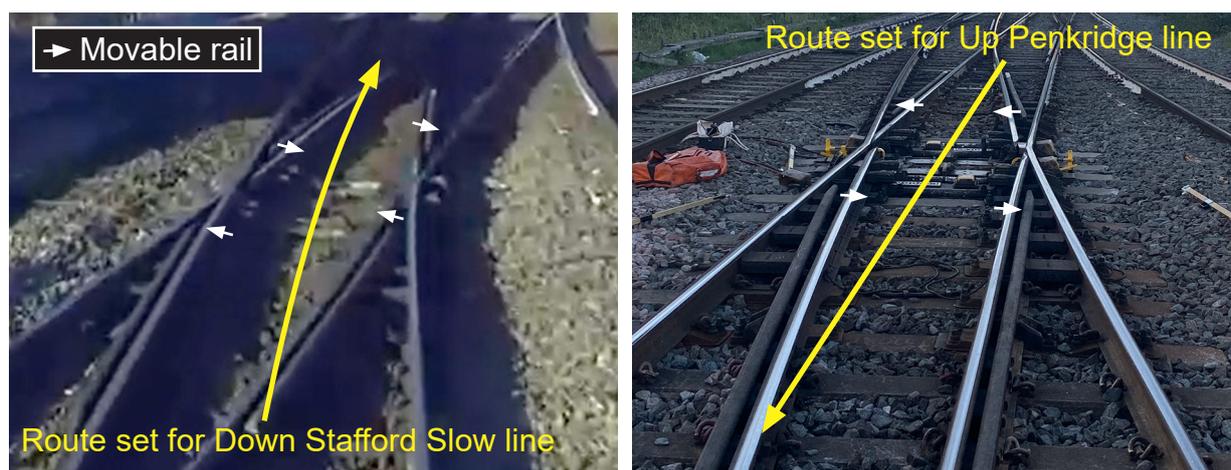
Figure 4: Switch diamond at Stafford Trent Valley Junction No. 1, showing possible set routes (courtesy of Network Rail with RAIB annotations).

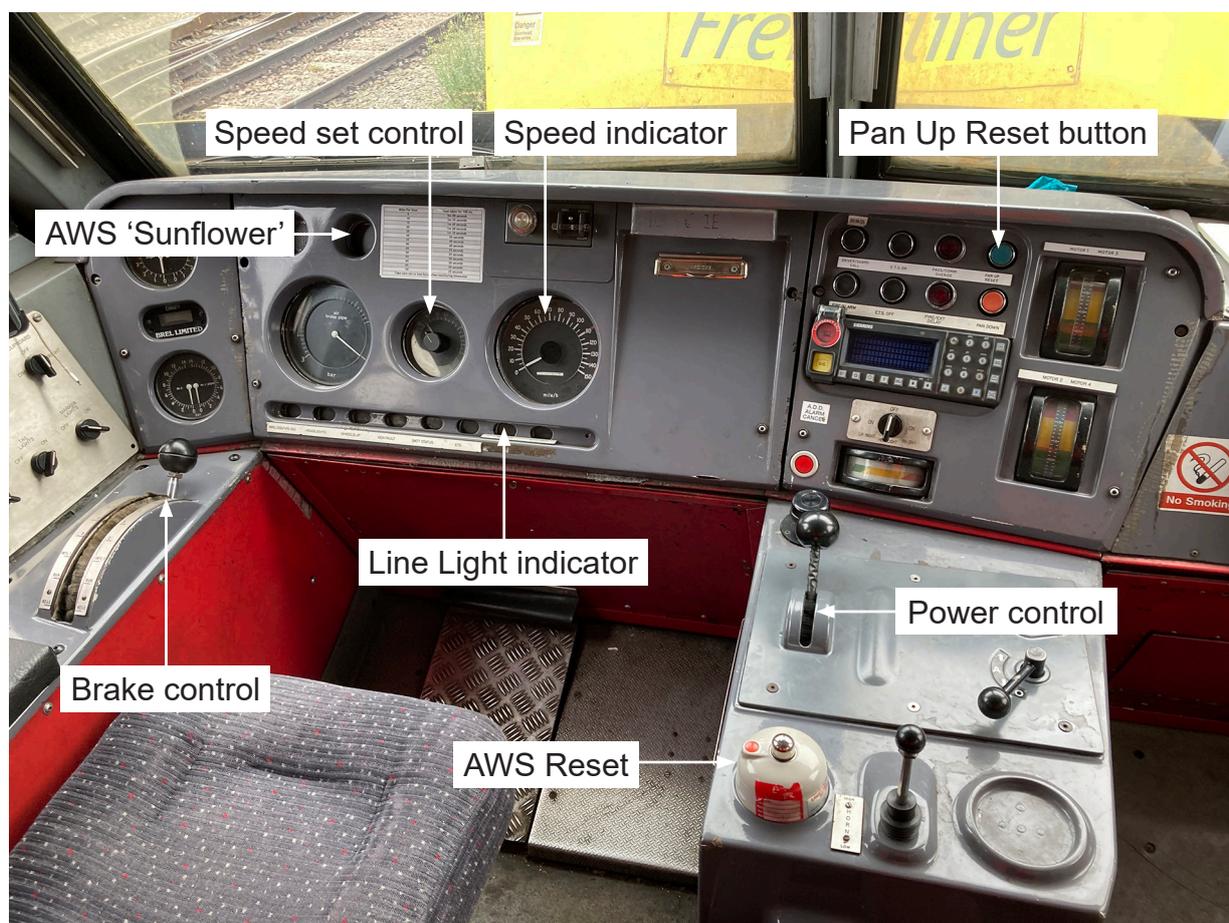
- 18 The class 90 locomotive is equipped with a 'speed set' system, used by the driver to define a target speed for the locomotive. This system consists of a rotary dial in the cab (figure 6) that the driver uses to select the target speed. The locomotive then responds to the power controller as normal, but when the target speed is reached the power is automatically reduced and controlled so that the target speed is not exceeded. The acceleration to reach the target speed is determined by the position of the power controller chosen by the driver. If the speed exceeds the target speed, such as when descending a gradient, the rheostatic brake is automatically applied to reduce the speed back to the target speed. If additional braking is required, then this must be manually applied by the driver using the train brake control handle.

Figure 6: Class 90 locomotive driver controls (courtesy of Freightliner with RAIB annotations).

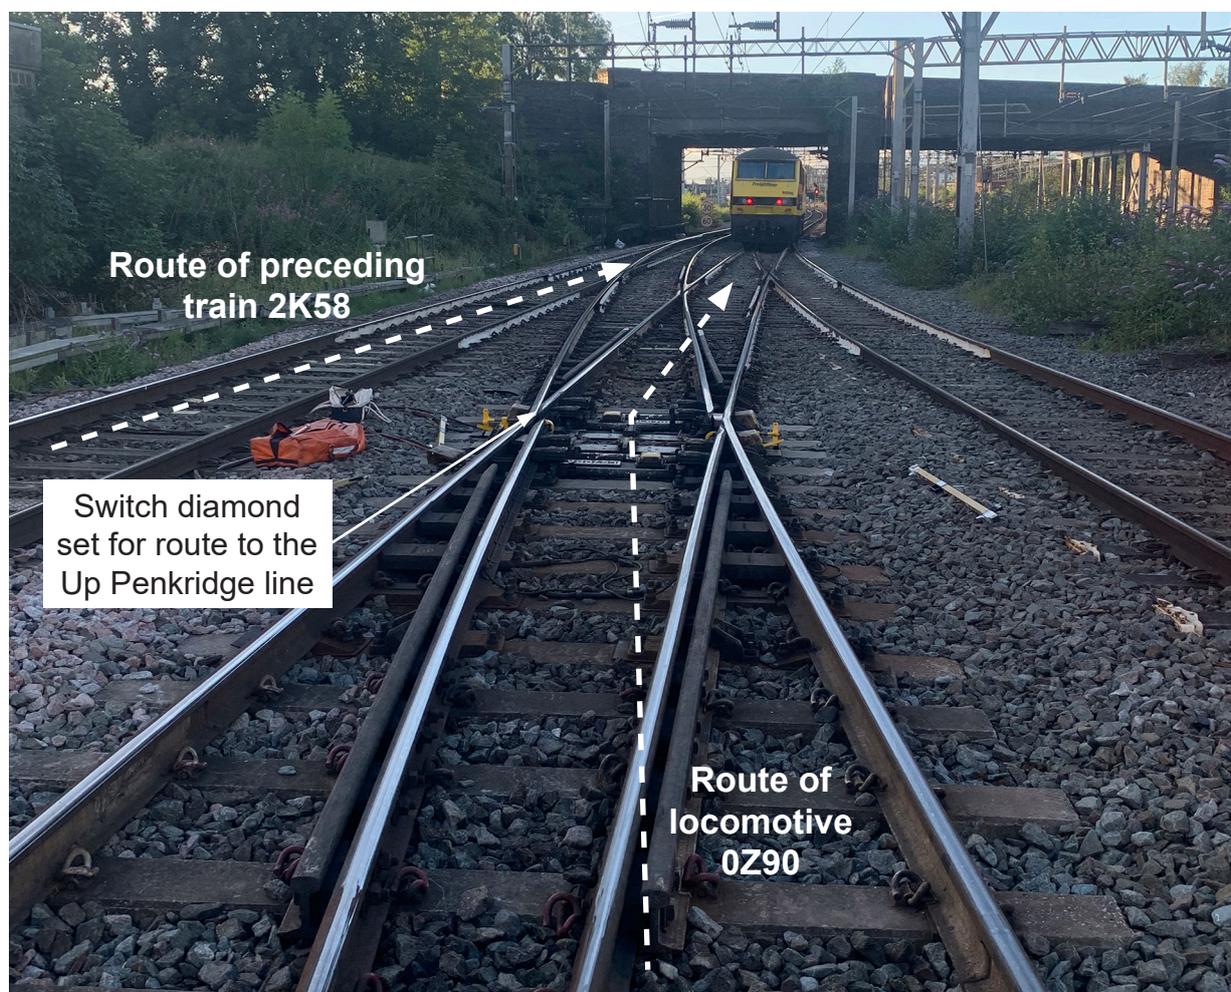
Figure 8: The final stopping position of the locomotive (courtesy of Network Rail with RAIB annotations).

- 48 At 16:41:48 hrs, the locomotive came to a stop on the Up Penkrigde line, between the switch diamond and the switch tips at Stafford Trent Valley Junction No. 1. The locomotive did not derail as it passed through the switch diamond.

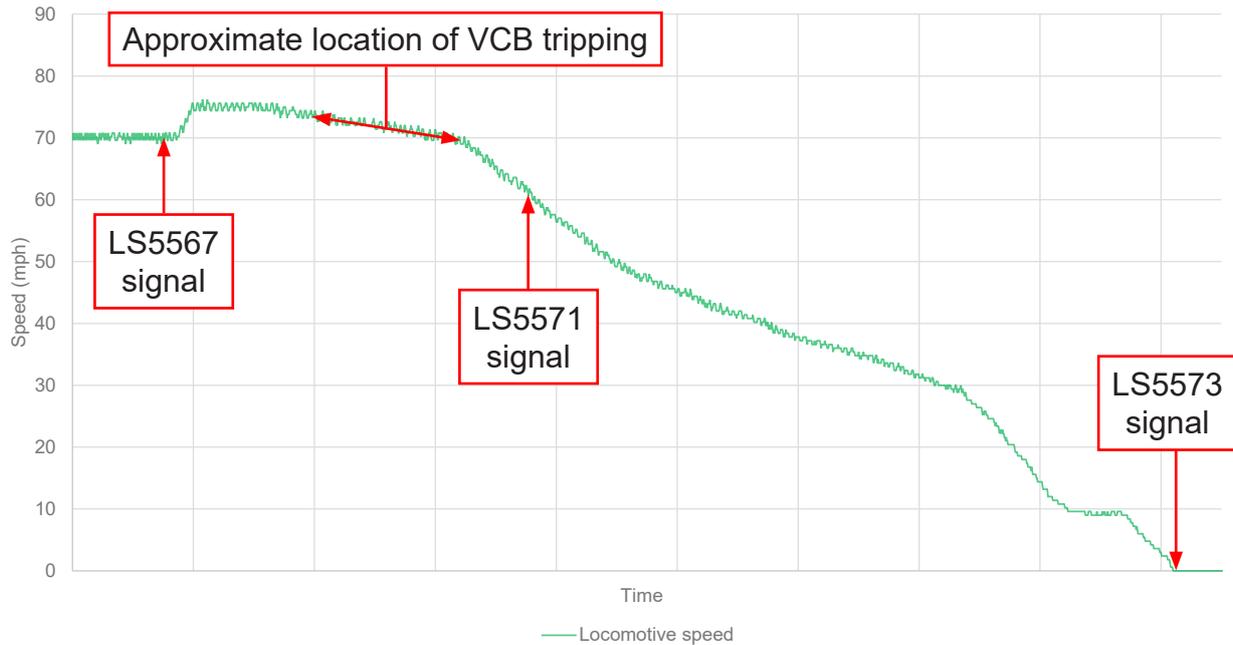
- 59 Figure 9 shows the speed profile of the locomotive as it entered the cautionary sequence of signals. As the locomotive passed the green aspect at LS5567 signal, the driver increased the speed to the maximum permitted line speed of 75 mph (121 km/h). This was in excess of the maximum permitted speed at that location for light locomotives of 60 mph (96 km/h) (see paragraph 99). The driver then allowed the locomotive to coast and slow gently as it approached the double yellow aspect at LS5571 signal.

Figure 9: Speed profile of the locomotive between the VCB tripping and coming to a stop close to LS5573 signal.

- 60 At some point before the locomotive reached LS5571 signal, the VCB tripped and the locomotive lost power. Once the driver had recognised this they applied the brakes. After acknowledging the AWS for the double yellow signal at LS5571, the driver continued to brake towards the single yellow signal at LS5573, while trying to remember what actions to take in the event of the VCB tripping. Shortly before LS5573 signal, the driver released the brakes and allowed the locomotive to coast towards it, before applying the brakes again to come to a stop, very close to the signal. RAIB has calculated from the OTDR data that the front of the stopped locomotive was probably less than 5 metres from the signal.

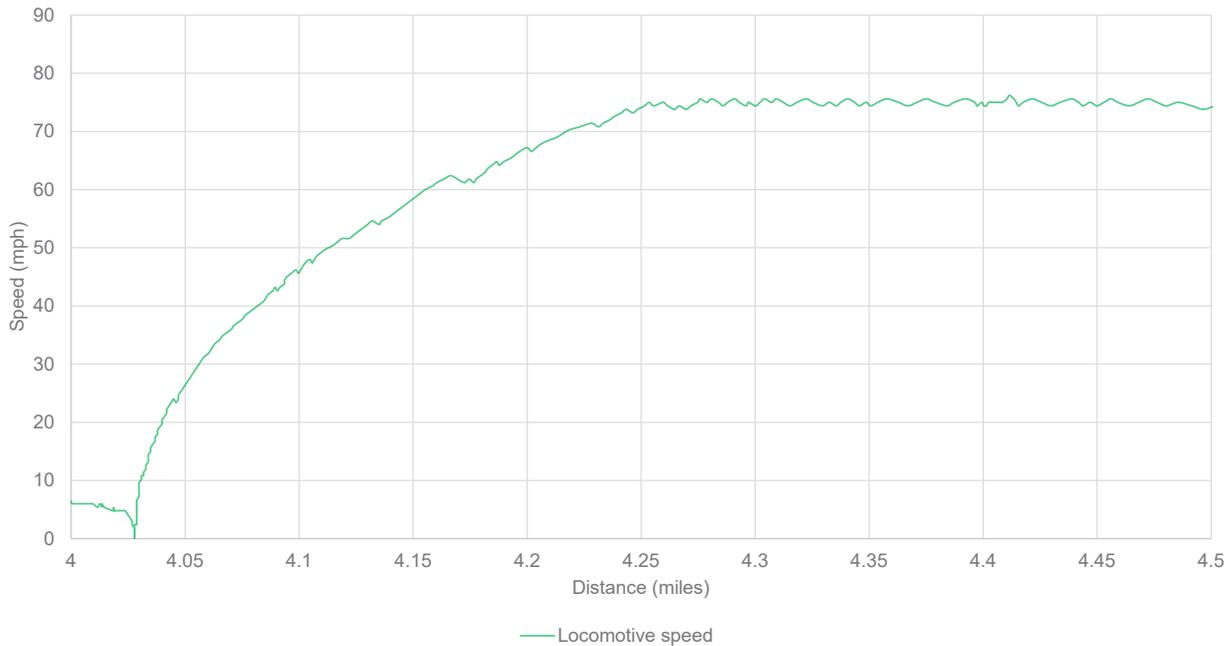
- 92 The driver accelerated the locomotive rapidly to 75 mph (121 km/h) after resetting the fault on the VCB (paragraph 42) by using the speed set control and applying maximum power. The accelerating performance of the light class 90 locomotive (paragraph 55) meant that it was able to reach 75 mph (121 km/h) in only 20 seconds before the speed set control limited the accelerating power, to maintain that speed.

- 93 This driving style was consistent with how the driver had been driving on the rest of the journey from Crewe to Nuneaton and return (figures 11, 12 and 13). The flat spots on the speed profile indicate that speed set was used to control the speed at locations where the train was not being cautioned by signals. Similarly, the driver had been using full power when accelerating earlier in the journey. During braking, the driver was correctly removing power and manually applying the brake rather than adjusting the speed set control down to reduce the speed.

Figure 11: Speed profile showing use of speed set control at 75 mph (121 km/h).

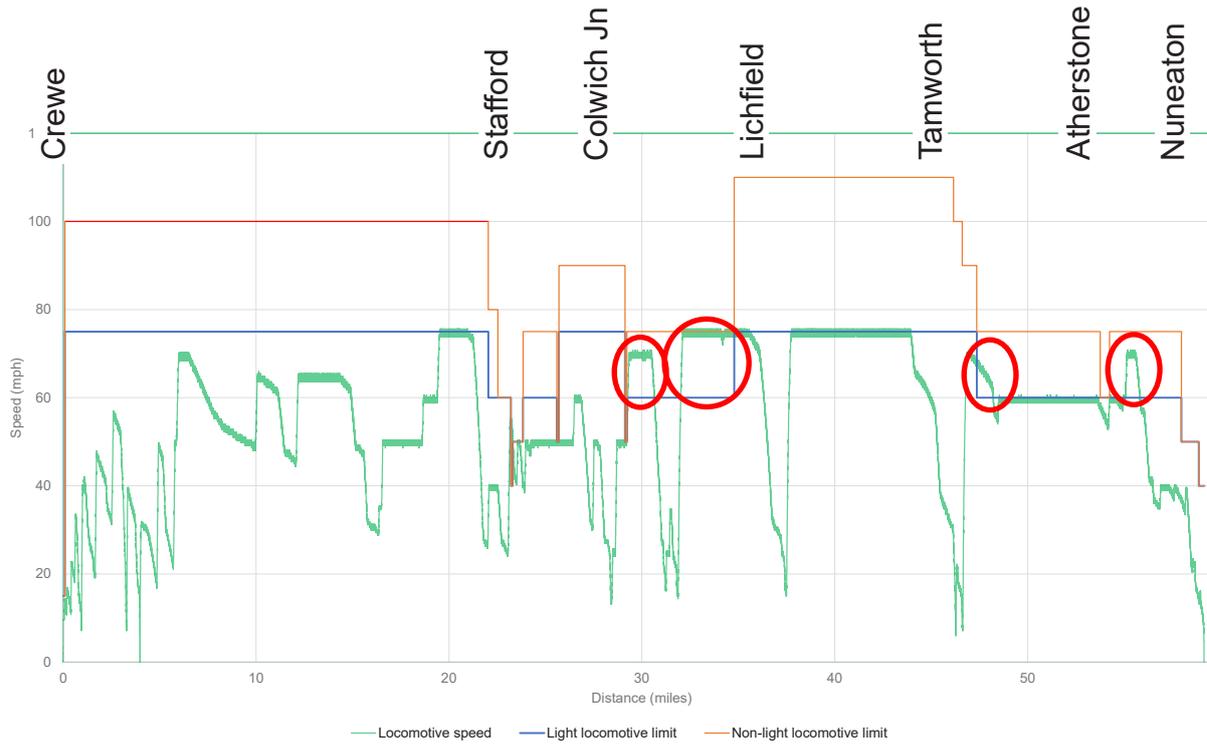
- 101 Examination of the data from the locomotive's OTDR showed multiple instances of the driver exceeding the maximum permissible speeds for light locomotives on the day of the SPAD (circled in figures 12 and 13). The driver was largely compliant with the signposted maximum permitted speeds for trains not operating as light locomotives, suggesting that they were not applying the additional speed restrictions required when running light throughout the day.

Figure 12: Locomotive speeds on the southbound journey from Crewe to Nuneaton.

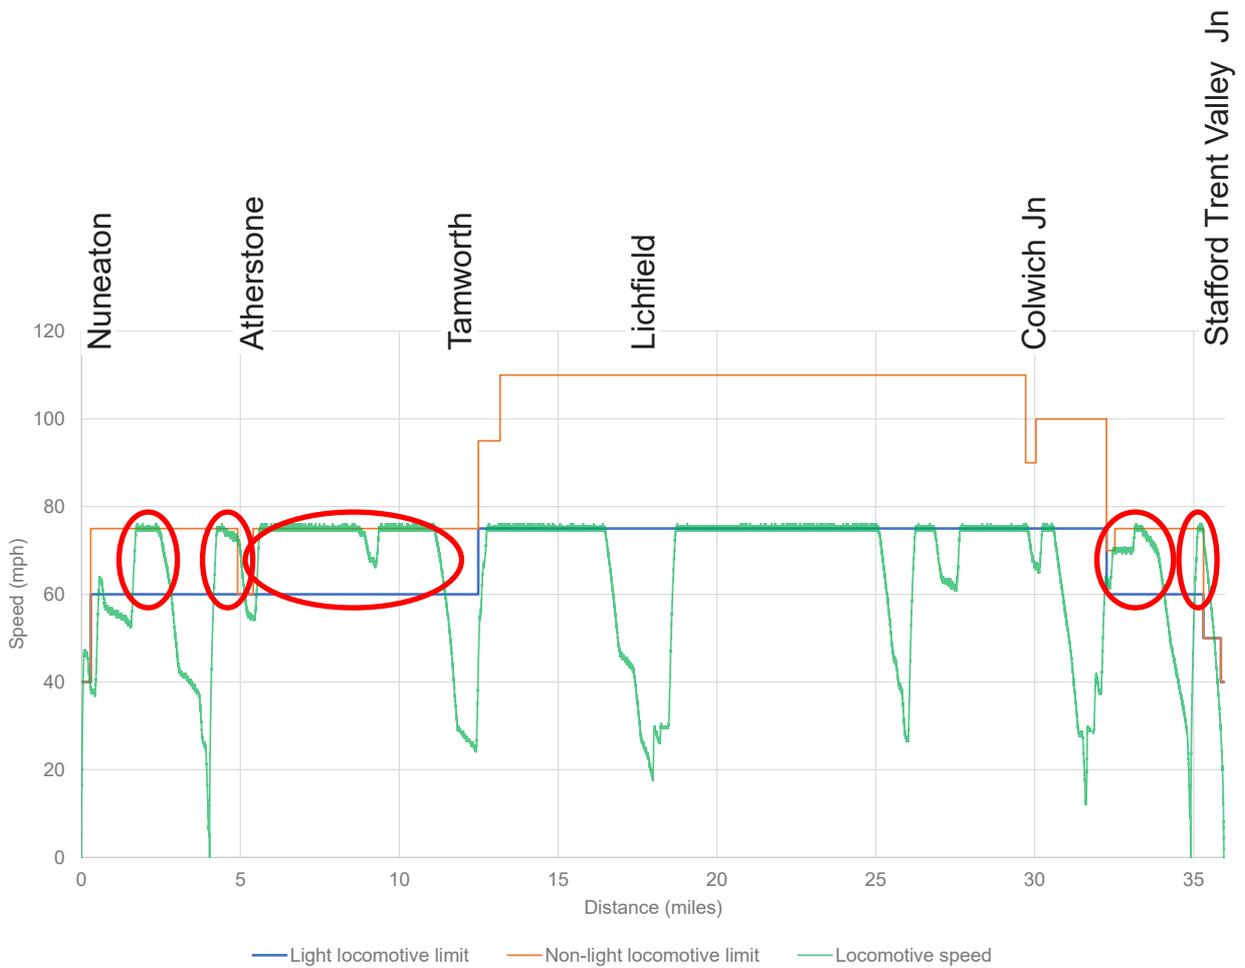
Figure 13: Locomotive speeds on the northbound journey from Nuneaton to Stafford Trent Valley Junction No. 1.

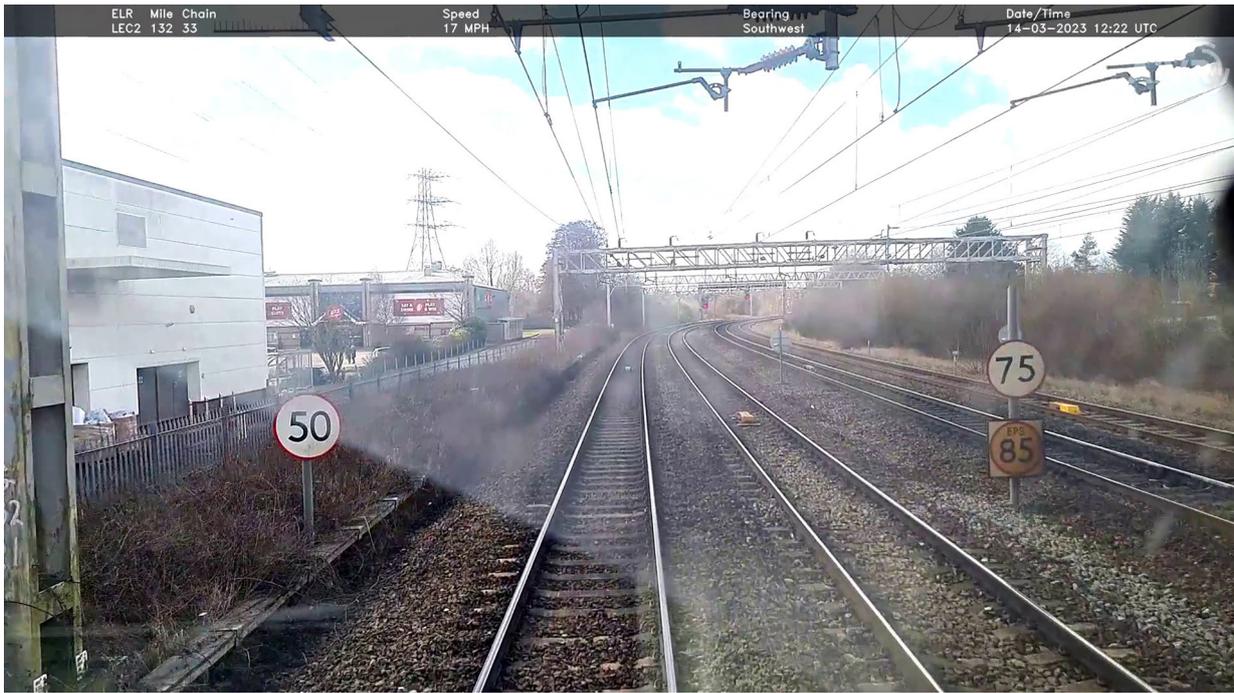
- 108 Approximately 670 metres after setting off from LS5573 signal, the locomotive passed a sign indicating the start of a 50 mph (80 km/h) maximum permitted speed limit (figure 14). By this point, the locomotive's speed was 70 mph (113 km/h) with the emergency brake applied (paragraph 45).

Figure 14: Speed restriction between LS5573 and LS5575 signals (courtesy of Network Rail).

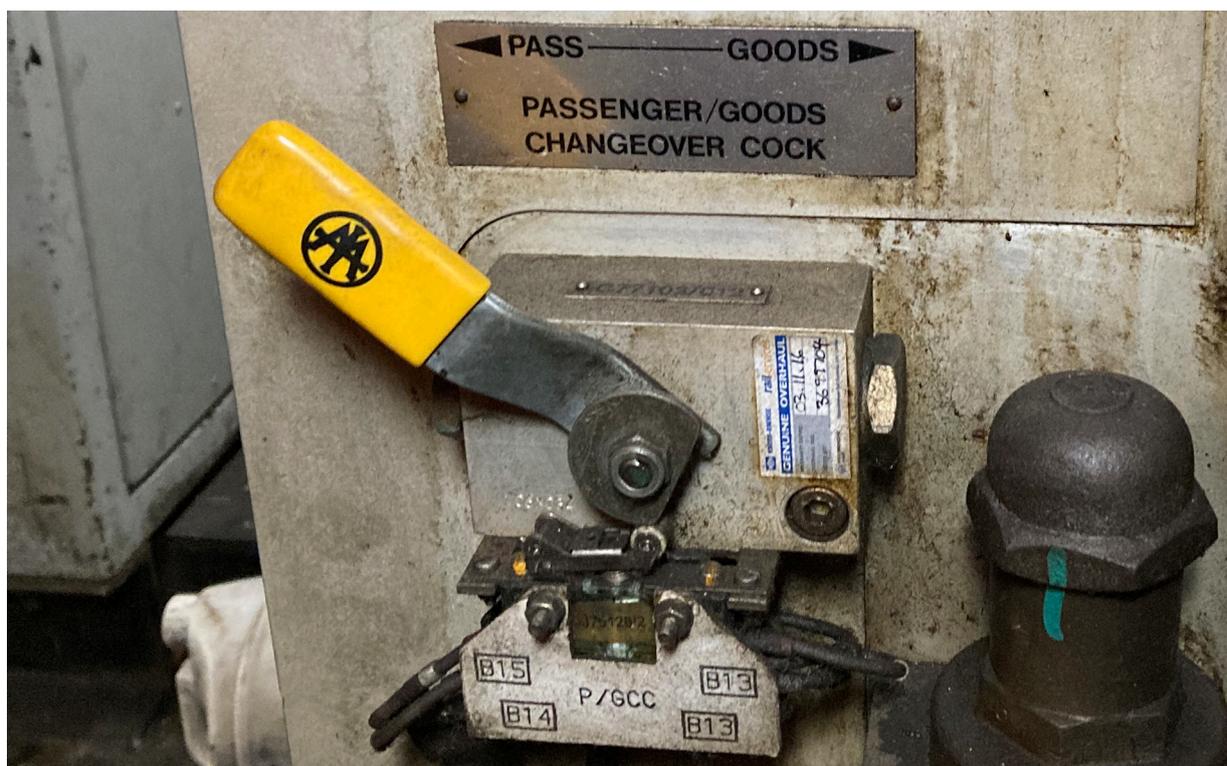
123 The class 90 locomotive, like many freight locomotives, is equipped with a 'Passenger/Goods changeover switch' (figure 16). This is intended to alter the flow rate of air in the braking system, with slower apply and release rates in the freight setting. Application and release rates are generally faster on passenger trains compared to freight trains, which can be much longer. This changeover switch ensures that the braking rate of the locomotive is approximately matched to that of the type of train which it is hauling. The operation instructions for the class 90 state that this switch should be set to passenger mode when operating as a light locomotive, and this was found to be the setting on locomotive 90006 at the time of the incident.

Figure 16: Passenger/Goods changeover switch on the class 90 immediately after the incident (courtesy of Freightliner).
