Report on the investigation of
the collision between the fishing vessel **Kirkella (H7)**
and harbour tug **Shovette**
resulting in pollution at King George Dock, Hull, England
on 24 June 2022

SYNOPSIS

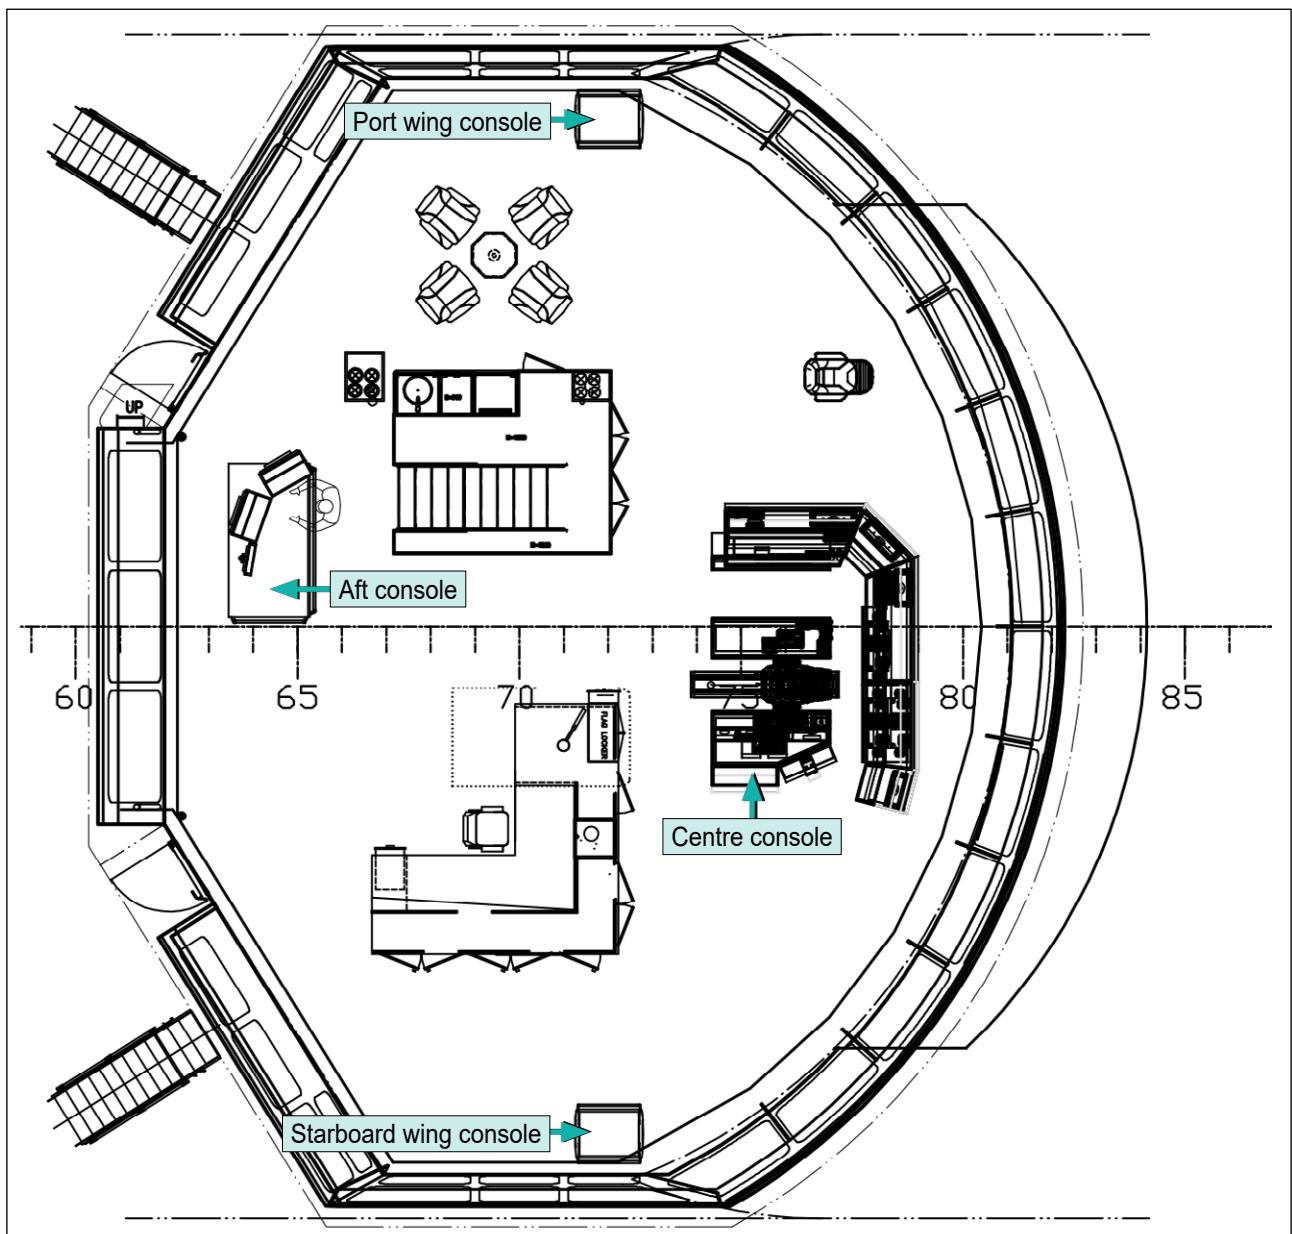
Figure 2: Bridge manoeuvring control consoles

At 0611, *Kirkella's* master passed control of the vessel's propulsion system from the starboard wing control station to the centre console position (**Figure 2**). At the same time, the crew deployed the vessel's gangway to the quayside. Once the master was content that the vessel was secured in position control of the propulsion system was passed to the ECR (**Figure 3**) so that the main engine could be shut down.

Kirkella's propulsion and bow thruster were controlled by a Rolls-Royce Helicon-X3 system (**Figure 9**). There were four control stations on the bridge (see **Figure 2**) and one in the ECR. The bridge control positions were frequently used during fishing and navigation and the crew had adopted a process whereby controls at the console in use were set to stop/zero before changing to a different console.

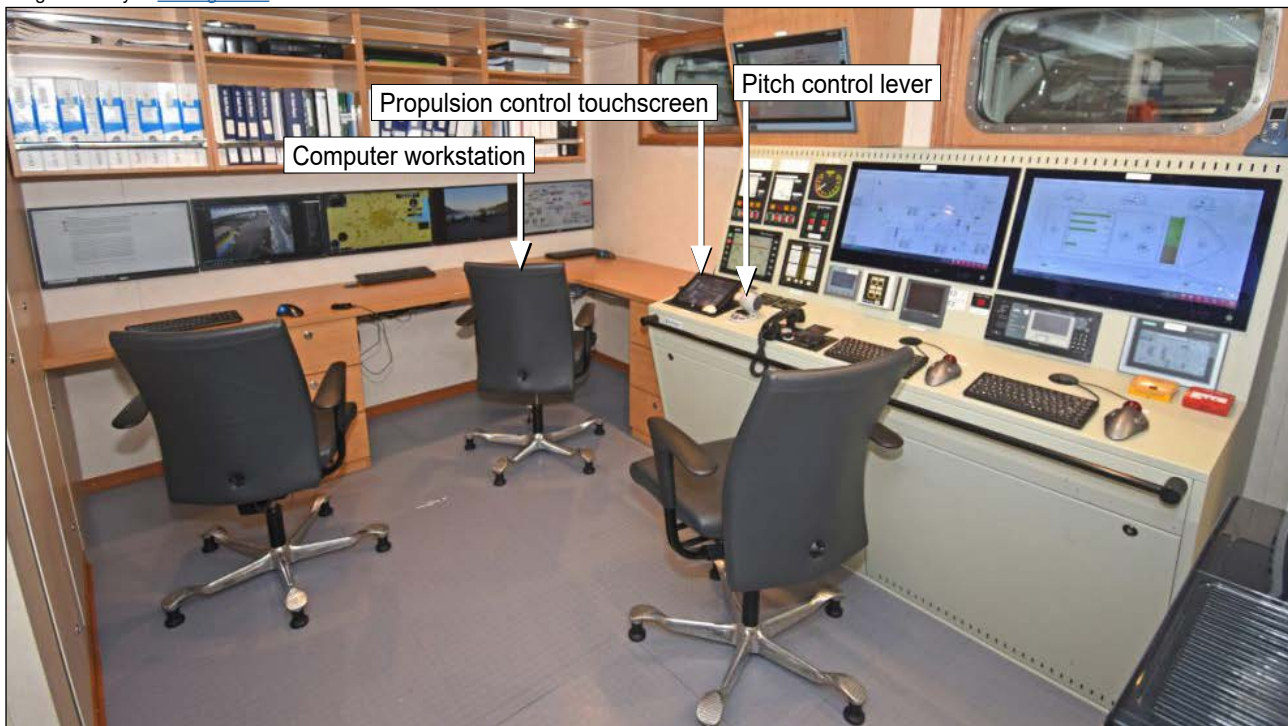
Figure 3: The engine control room

The first engineer (1/E) was sitting in the ECR working at a computer. The 1/E heard the propulsion command change alarm and reached across from their chair and pressed the 'ECR' then 'Accept' buttons on the touchscreen to accept control (**Figure 4**). Eighteen seconds later, *Kirkella* started to move ahead.

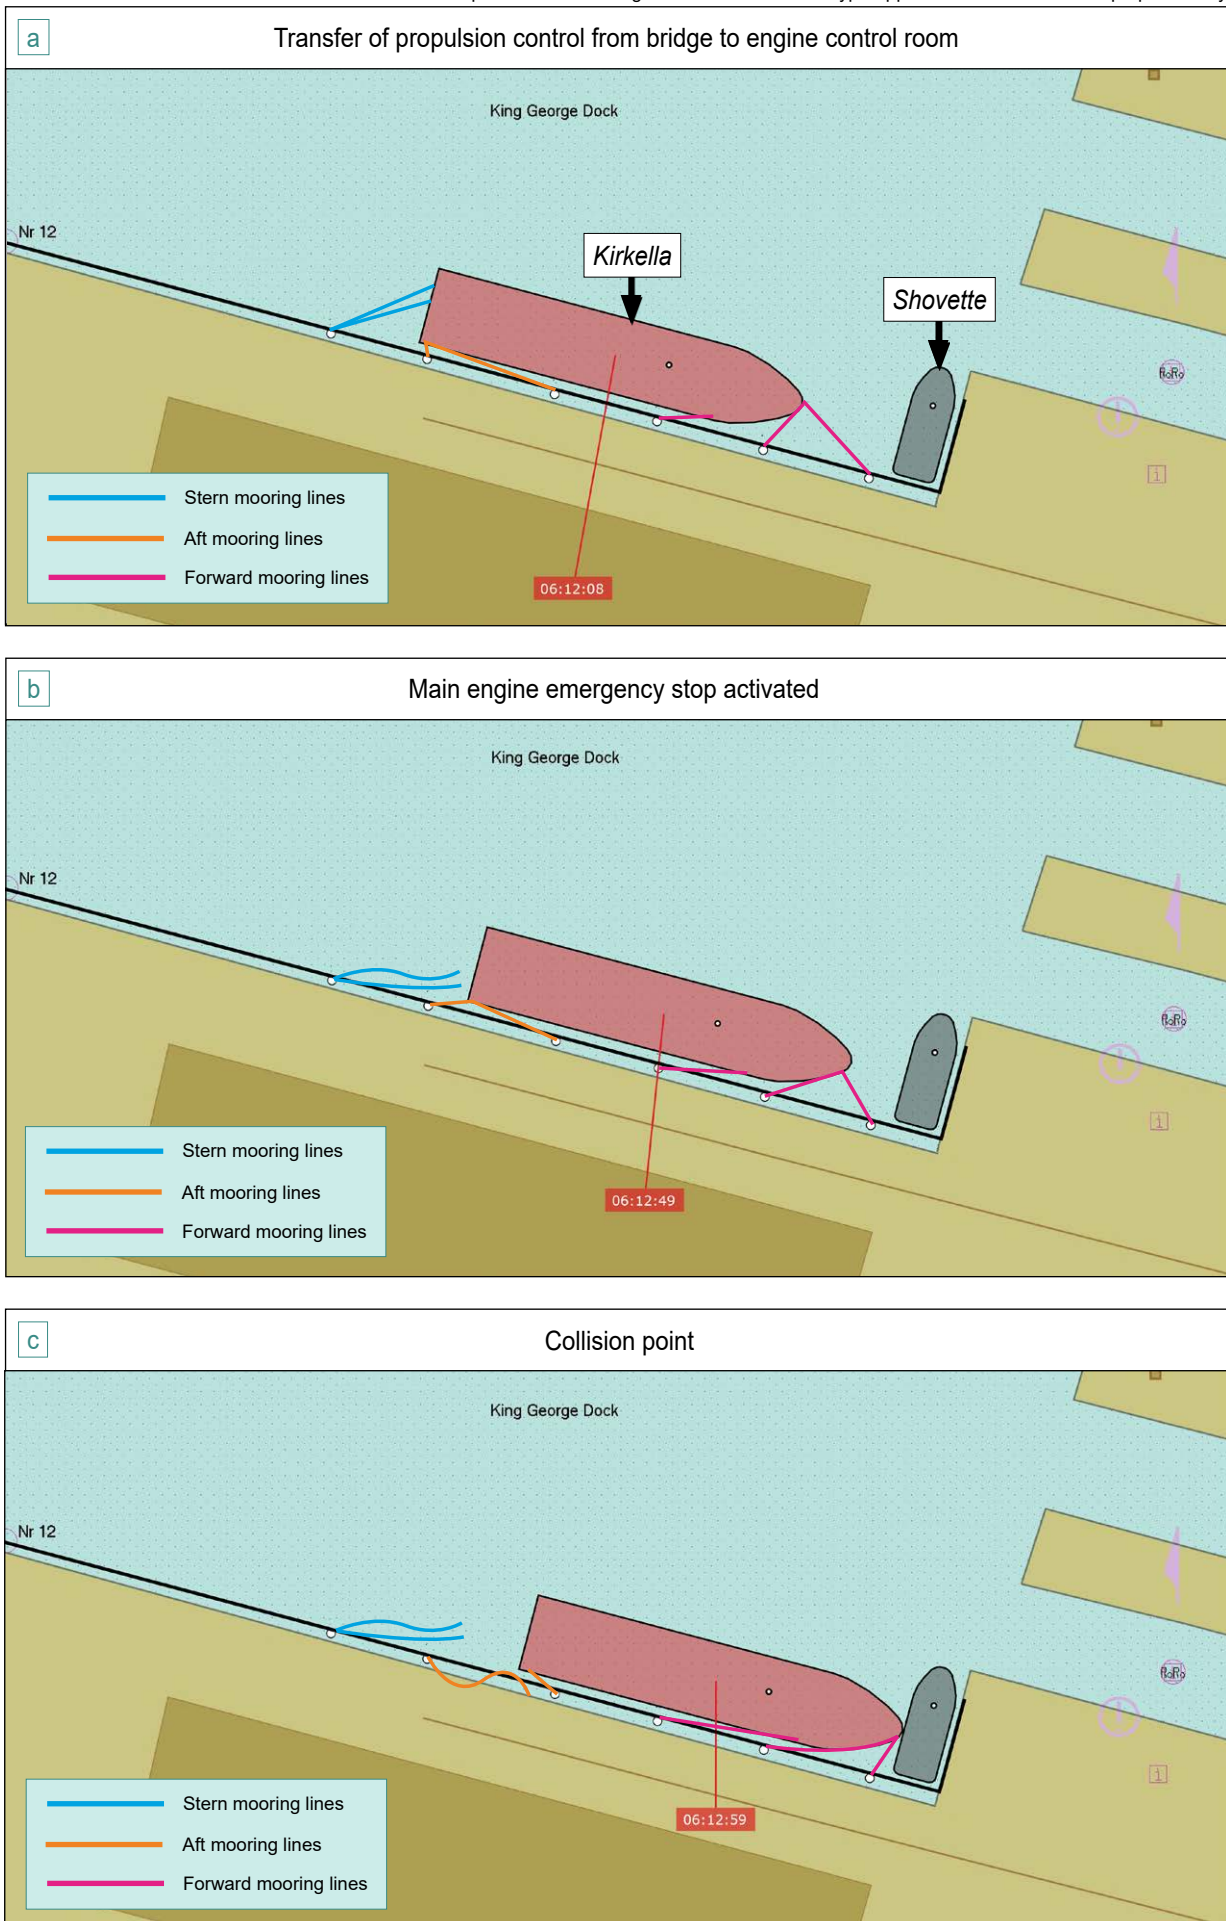
Figure 5: Sequence of *Kirkella's* loss of control

On the bridge, the 1/O was shutting down the bridge equipment when they noticed the vessel moving ahead and raised the alarm. The master reacted to the 1/O's exclamation and saw that the vessel was moving ahead. Shortly afterwards, the two stern lines parted and the forward spring lines surged on the mooring bits.

The master went to the centre console and telephoned the ECR, instructing the 1/E to stop the engine. At about the same time, the master pushed the emergency stop button on the centre console, which declutched the engine. Moments before the master's telephone call, having sensed a change in the main engine load, the 1/E had checked the engine control console and observed that the pitch was 85%.

As *Kirkella* continued to move forward, two further mooring lines parted and the gangway was dragged until it fell from the quayside. Ten seconds after the master had declutched the engine, *Kirkella* collided with the moored and unmanned harbour tug *Shovette* (Figures 5a to 5c), which was berthed adjacent to the all-weather terminal at the end of the King George Dock (Figure 1). *Kirkella* bounced off the tug and came to rest with three forward mooring lines and one aft mooring line still intact.

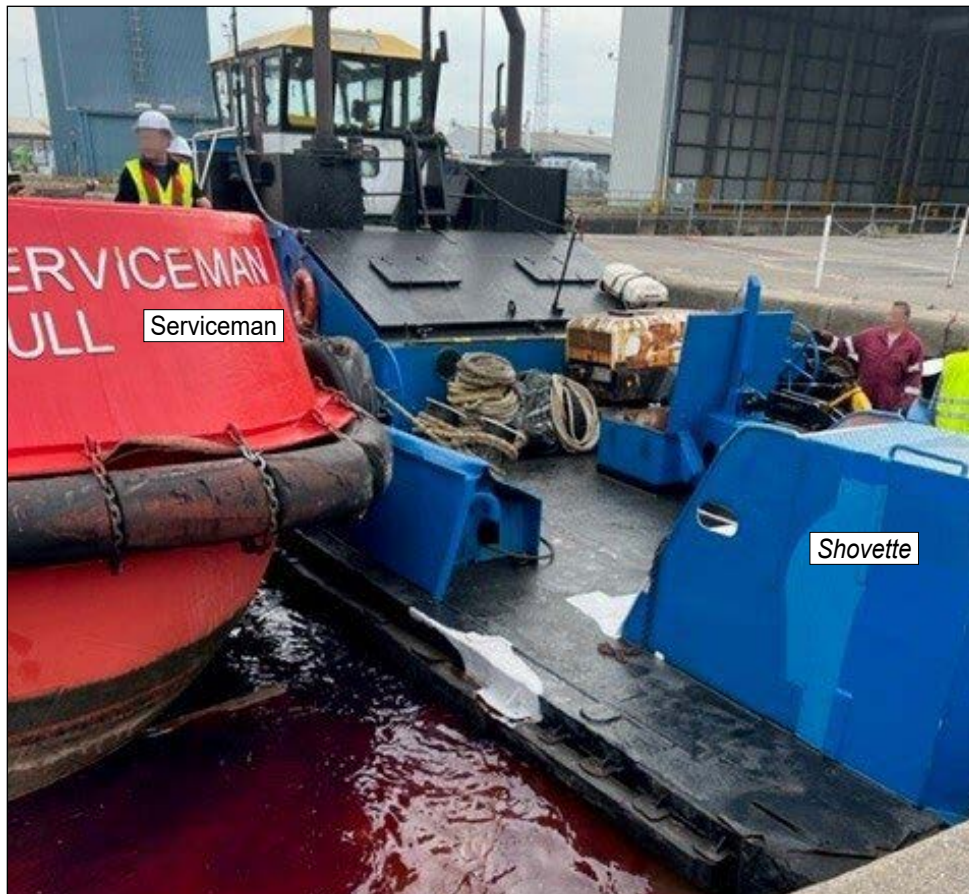
Figure 6: *Shovette* low in polluted dock water after the collision

Shovette's port side hull had been holed below the waterline; the fuel tank had been breached and the engine room flooded. The tug settled low in the water and marine diesel oil spilled from the ruptured fuel tank into the dock (**Figure 6**).

Shovette was repaired locally and returned to service on 2 September 2022.

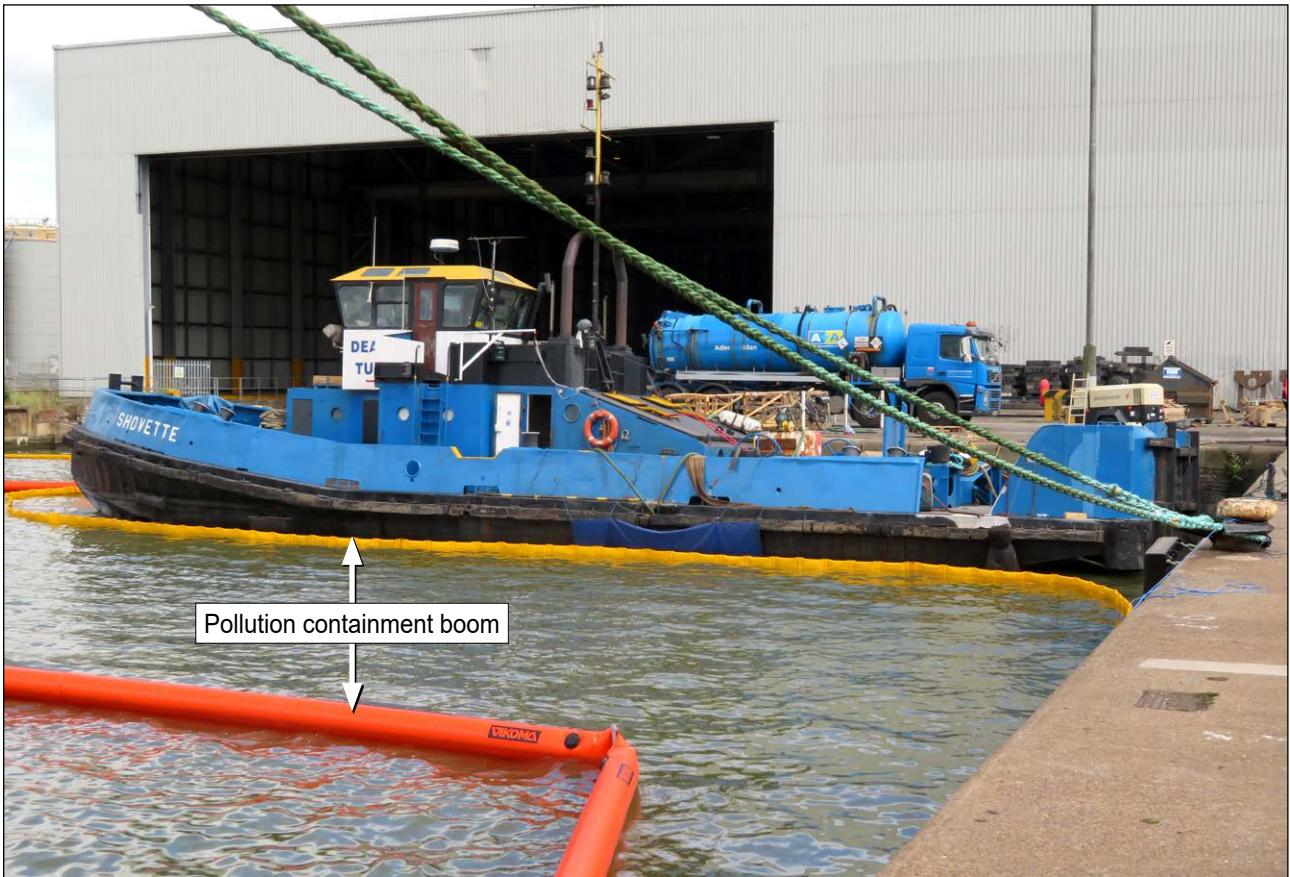
Figure 7: Pollution booms deployed

The dockmaster telephoned the port's oil spill response contractor whose team, once on site, deployed containment booms and absorbent materials to limit the extent of the pollution (**Figure 7**). The contractor used a variety of methods, including an oil recovery boat (**Figure 8**), to remove most of the oil within 3 weeks; the clean-up operation was completed after a further 8 weeks. The pollution response operation cost around £250,000, with unknown additional costs incurred for loss of business continuity and port personnel involvement.

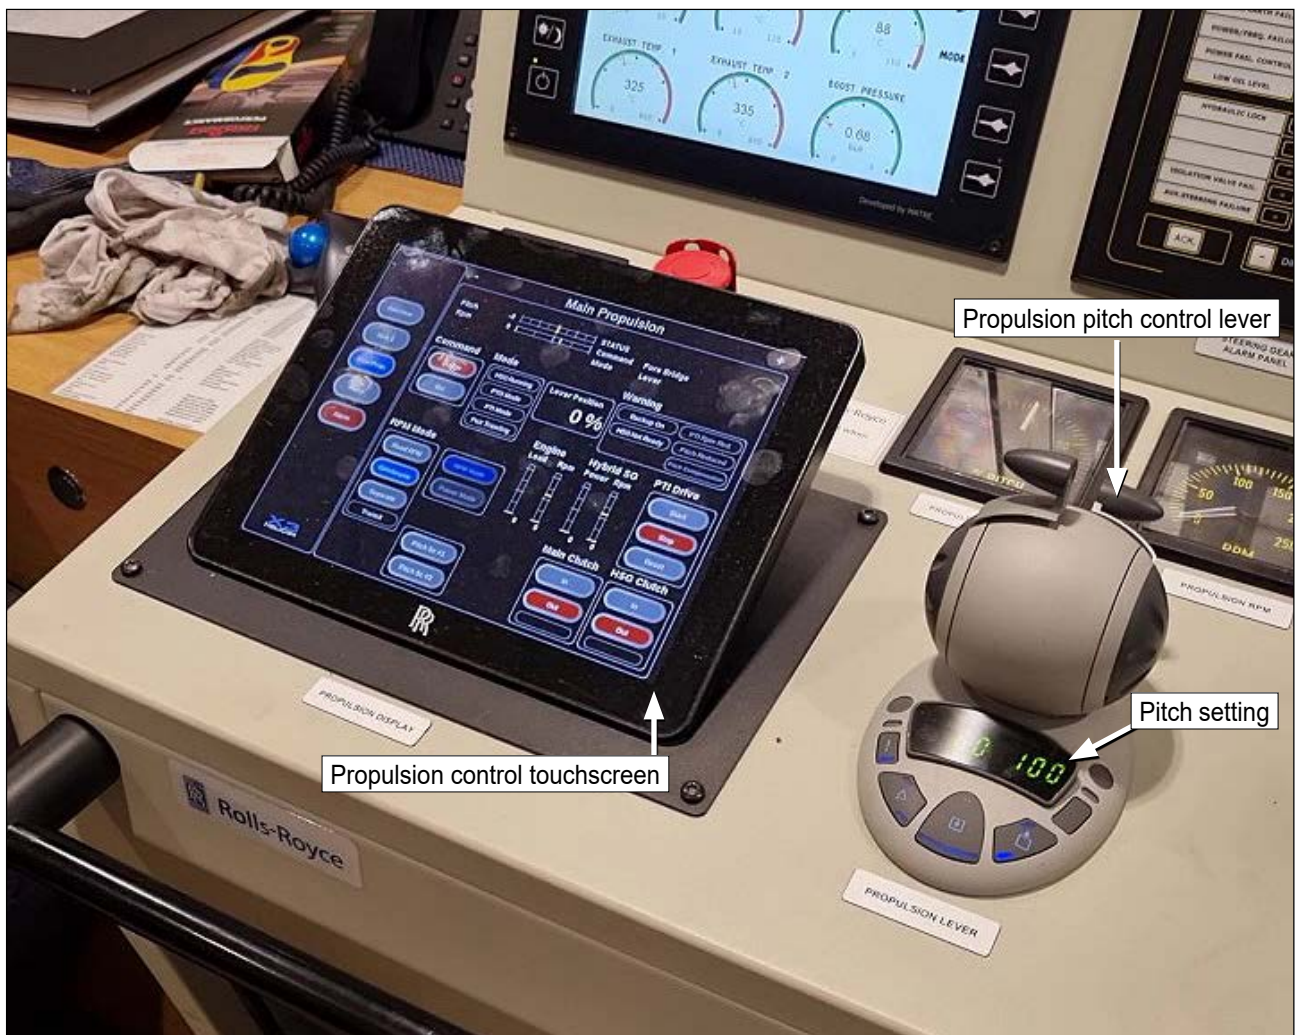
Figure 9: Engine control room propulsion control system

In the ECR, the control transfer alarm would sound and the operator was required to press the accept button within 10 seconds to complete the transfer of control from the bridge to the ECR. The operator manual noted that, *There is normally no command transfer interlock because of discrepancy between the lever position at the present station in command and the lever position at the new station to be in command.*

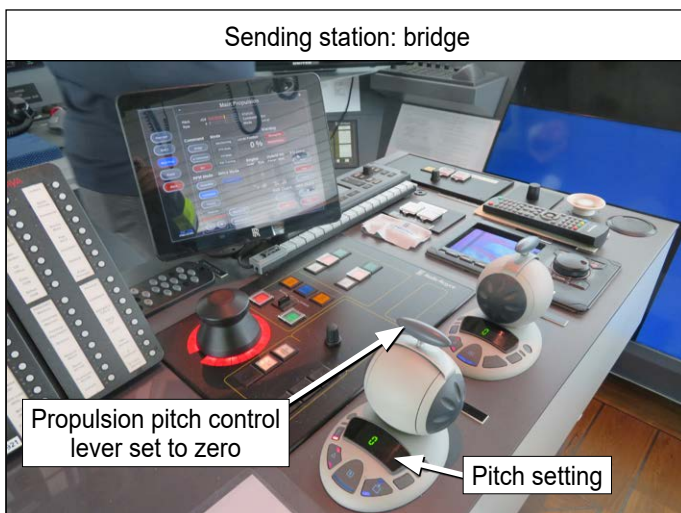
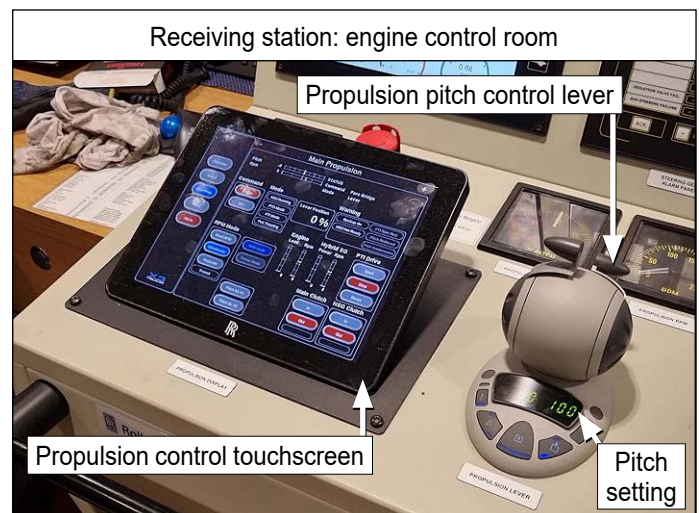
The status of *Kirkella*'s propulsion control system at handover of control

Kirkella's propulsion system comprised a single main engine driving a controllable pitch propeller via a clutch and gearbox. The vessel's propulsion was controlled by a Rolls-Royce Helicon-X3 integrated propulsion control system, supported by Kongsberg Maritime. The propulsion system could be operated from several stations located in the wheelhouse and from the engine control room (ECR). The loss of control occurred when the propulsion control was passed from the bridge to the ECR with the clutch engaged. At the time of the handover, the bridge propeller pitch lever was set at zero, while the ECR's propeller pitch lever was set at 100% ahead (see figure). The propeller pitch automatically advanced when control was accepted in the ECR, causing *Kirkella* to move forward on the berth.
