Report on the investigation of the
foundering of the fishing vessel

Piedras

78 nautical miles south-west of Mizen Head, Ireland
on 1 June 2022

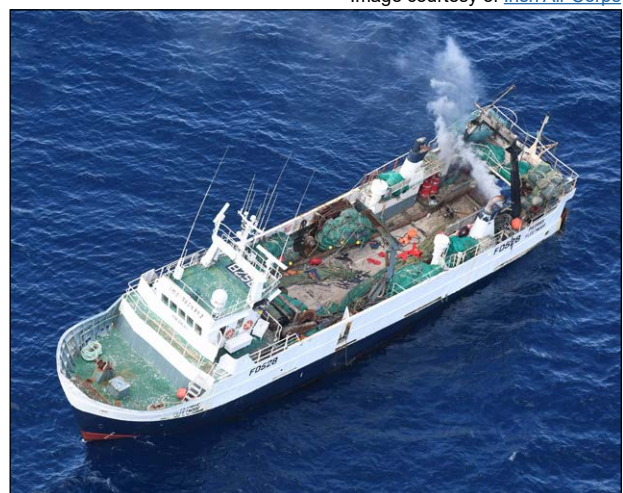
At 1018, *Piedras* was listing heavily to port with smoke or steam visible at the stern (**Figure 2**). The partially inflated port liferaft had by this time drifted away and was not recovered. Other helicopter assets were stood down by the Valentia Island coastguard as the crew had been safely recovered. By 1047, the fire on board *Piedras* was reported as out and the port list was described as worsening. By 1111, all air search and rescue assets had departed the scene to return to their bases. At 1234, *Piedras* sank and *Armaven Uno* started its passage to Castletownbere. By 1247, a ship of the Irish Naval Service L.É. *Samuel Beckett* had arrived on scene and recovered floating debris for the next 3 hours; there was no significant pollution on the sea surface. At approximately 2000, *Armaven Uno* arrived at Castletownbere and the crew of *Piedras* disembarked.

Figure 2: *Piedras* listing to port with smoke or steam visible at the stern

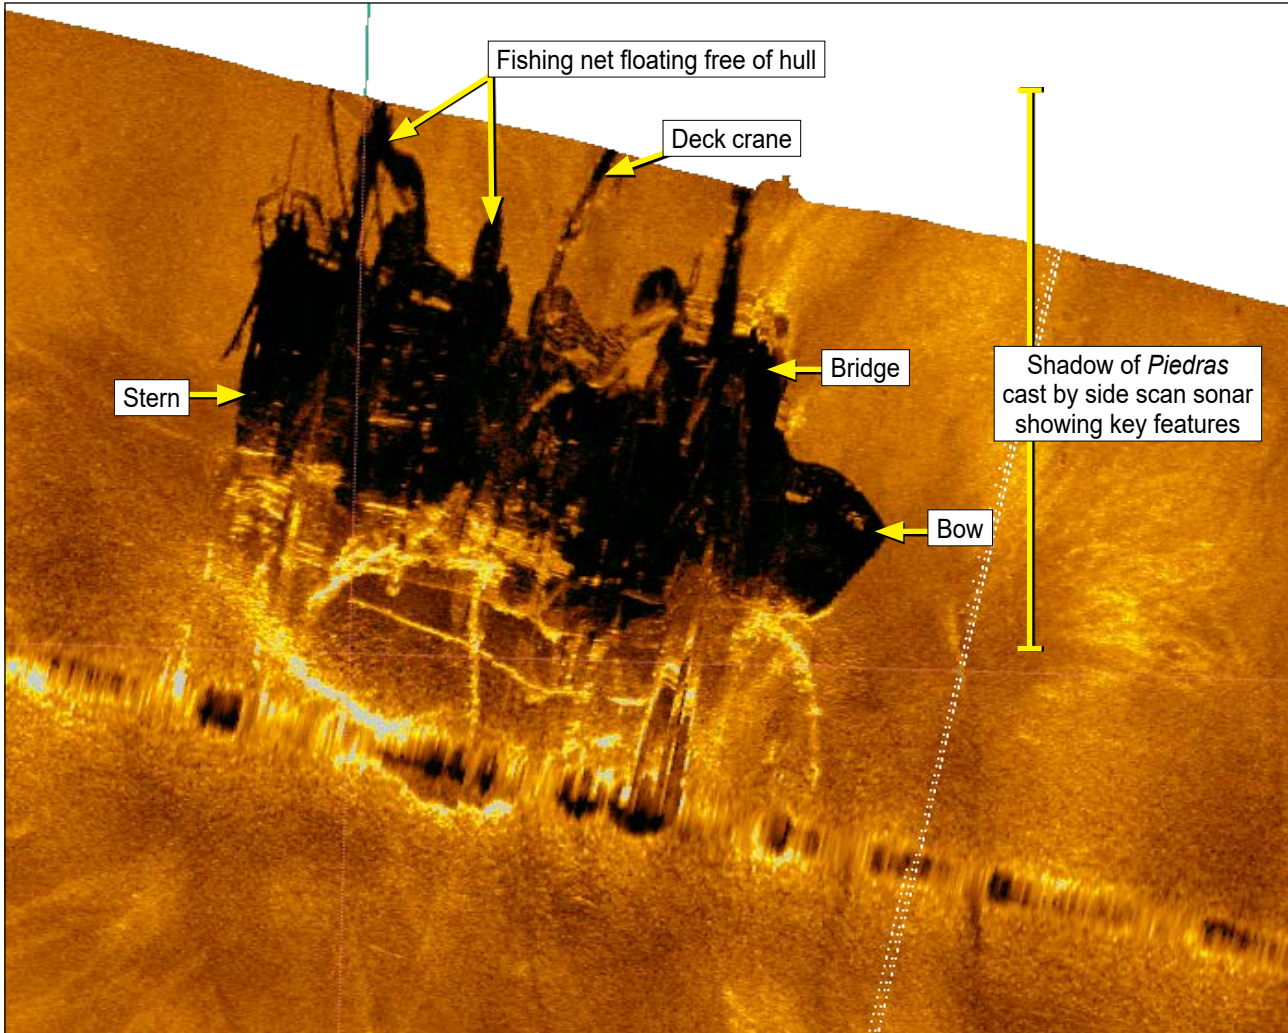
On 11 August 2022, RV *Belgica* was conducting a research cruise on behalf of the Flanders Marine Institute (VLIZ) and positively identified the position of the wreck of *Piedras* at 50° 43.61'N 011° 11.15'W in a depth of 850m below mean sea level. The vessel was aligned on an east-south-east heading, seemingly intact and upright with a slight list to port (**Figure 3**).

Figure 3: Side scan sonar image of *Piedras* sitting upright on the seabed at 850m depth

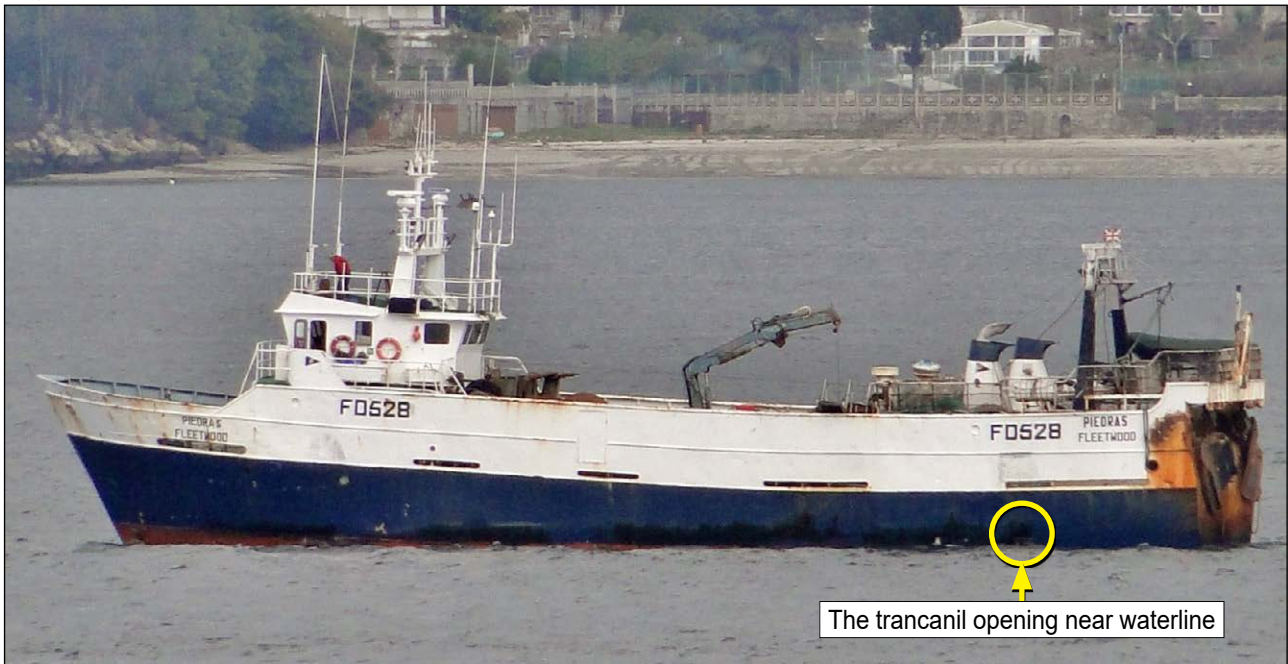
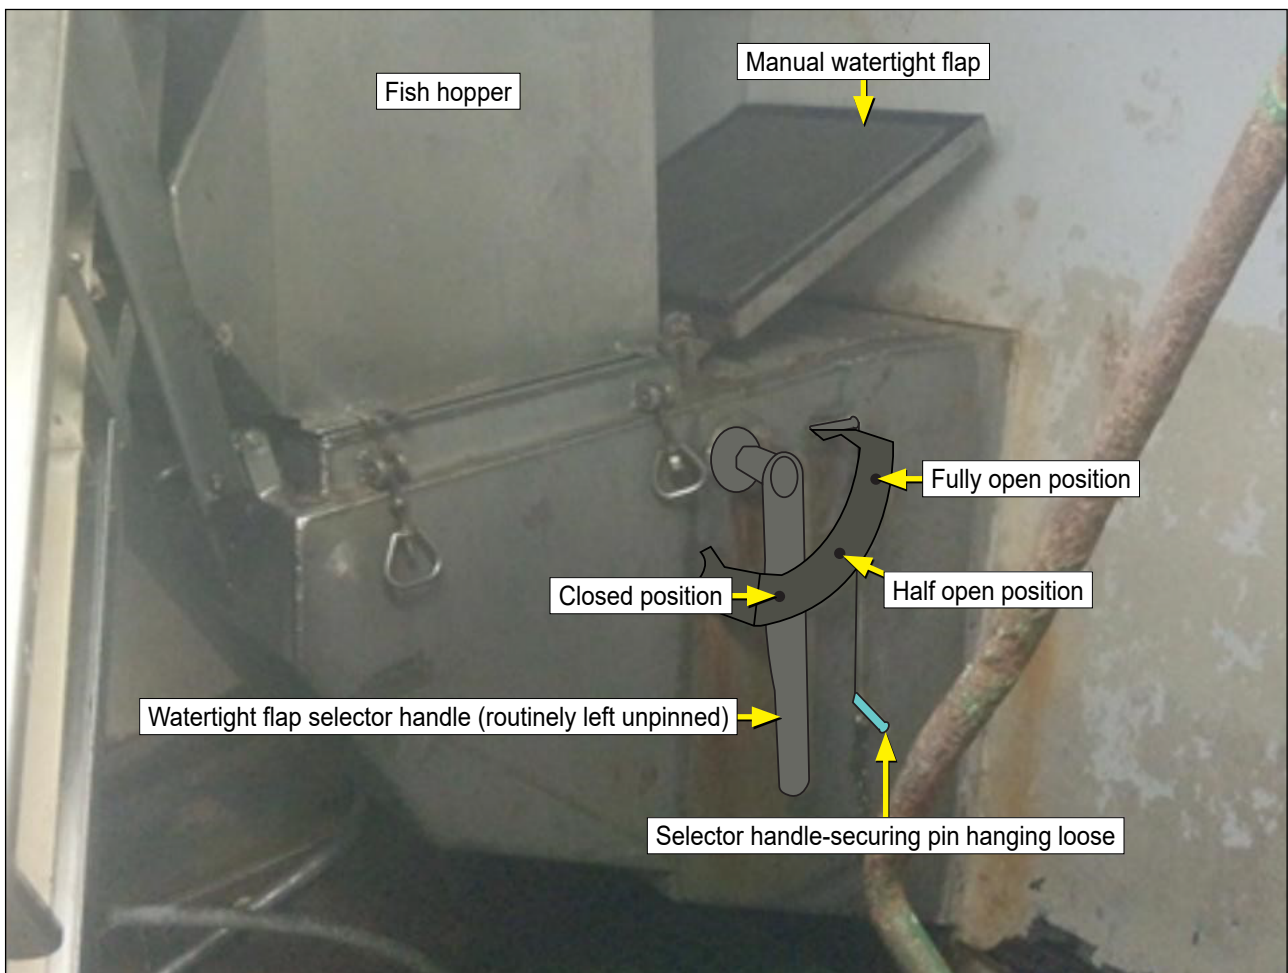
Figure 8: *Piedras* trancanil

A fish gut sluice, known as a trancanil, was located port side aft of the fish processing room. The trancanil (**Figure 8**) was fitted with a manual watertight flap that could be pinned into three separate positions: closed, half open and fully open. At the inboard end of the trancanil was a further watertight flap, which could be fitted to a hopper when in the open position. During the processing stage the crew used the hopper as a receptacle for fish offal, which was then discharged back into the sea via the trancanil. Seawater was pumped into the trancanil to prevent it becoming blocked by the discharging fish offal. The wheelhouse was fitted with a remote trancanil indicator to allow crew to see whether the trancanil was in the open or closed position. The trancanil remained rigged to the hopper during fishing trips and was only secured in poor weather.

Piedras started to list to port when the engine room flooded, which fully submerged the trancanil. During the abandonment, floodwaters were seen on the deck above the engine room. It was not possible to determine if this water was coming directly from the engine room accessways or via the trancanil, or both. In the cases of both *Riempda* and *Dorneda* the fish waste chute was found to be the source of the floodwater; it is therefore possible that, with the hopper still in place and the watertight flap pinned open, the trancanil in *Piedras* was a significant source of secondary flooding that deluged the fish processing room and spread through the vessel.

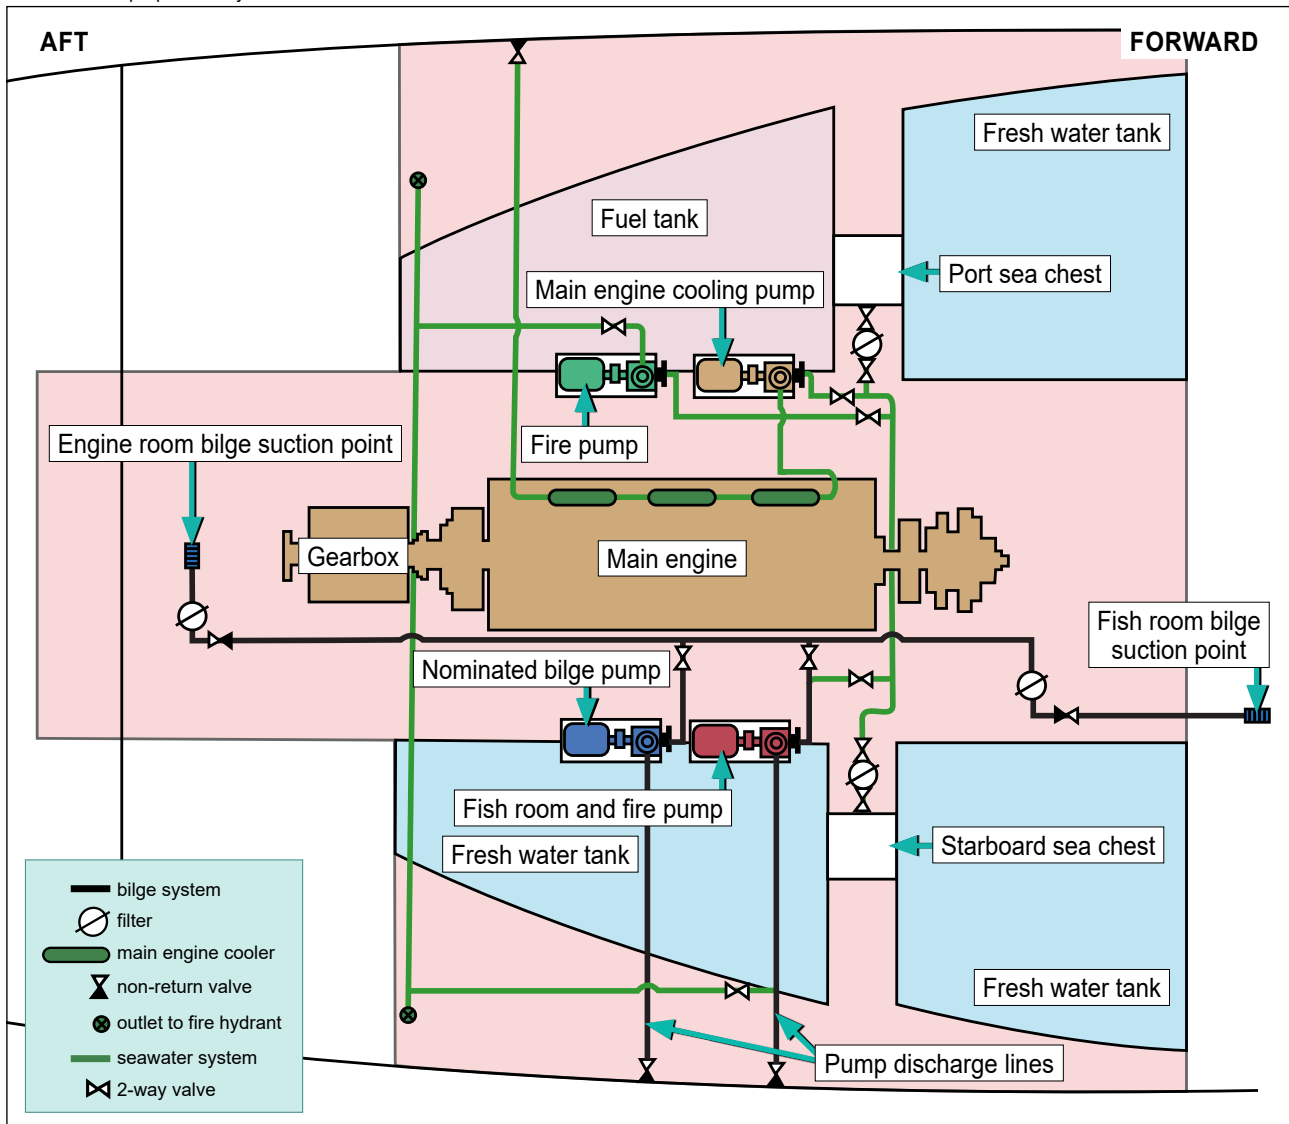
Figure 9: Simplified diagram of the engine room seawater and bilge system

Piedras was equipped with two electrically-driven self-priming centrifugal pumps⁷ that could be connected to the bilge system (**Figure 9**) and could be operated from independent power supplies. Each pump was capable of pumping around 40 cubic metres per hour with a 25m head⁸. Only one pump at a time could be selected to remove water from the bilges. The forward pump was normally used for fish room duties and as a fire pump, while the aft pump served as the nominated bilge pump. *Piedras* had one engine room bilge suction point at the aft end of the engine room. The engine room main bilge suction pipe and discharge pipes were 5 inches (127mm) in diameter.

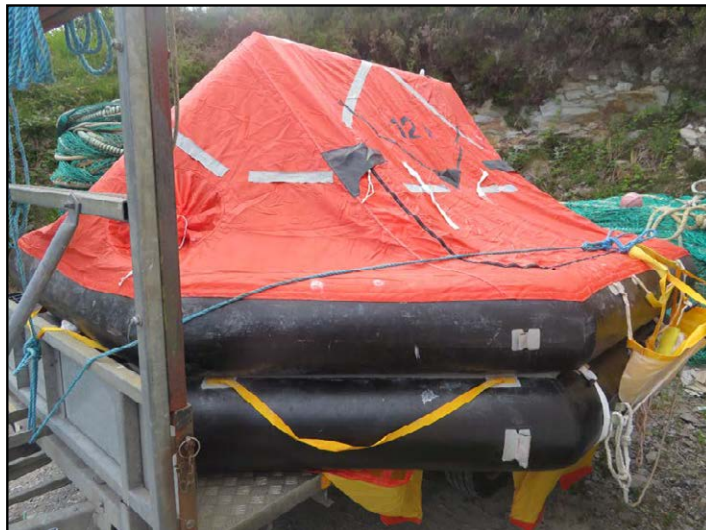
The port liferaft was not recovered following the accident. An inspection of the starboard liferaft found an expired SOLAS⁹ pack. Items with a one-year life expectancy were found to have expired in 2008. Items with a five-year life expectancy were found to have expired in 2012. The certificates provided following the December 2021 inspection had recorded March 2023 expiry dates.

Recovered *Piedras* starboard liferaft

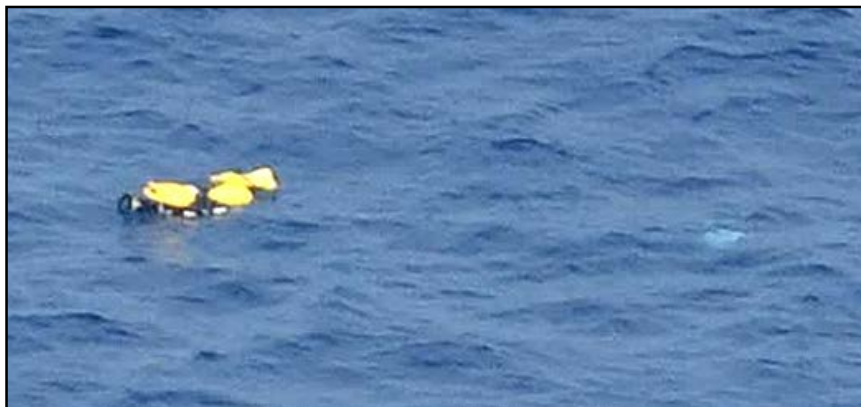
It was not possible to determine the cause of the port liferaft's failure to deploy correctly, as it was not recovered after the accident. It was last observed drifting in an inverted orientation, having apparently released from its canister and partially inflated (**Figure 1**).

Figure 1: The port liferaft, floating inverted and partially inflated

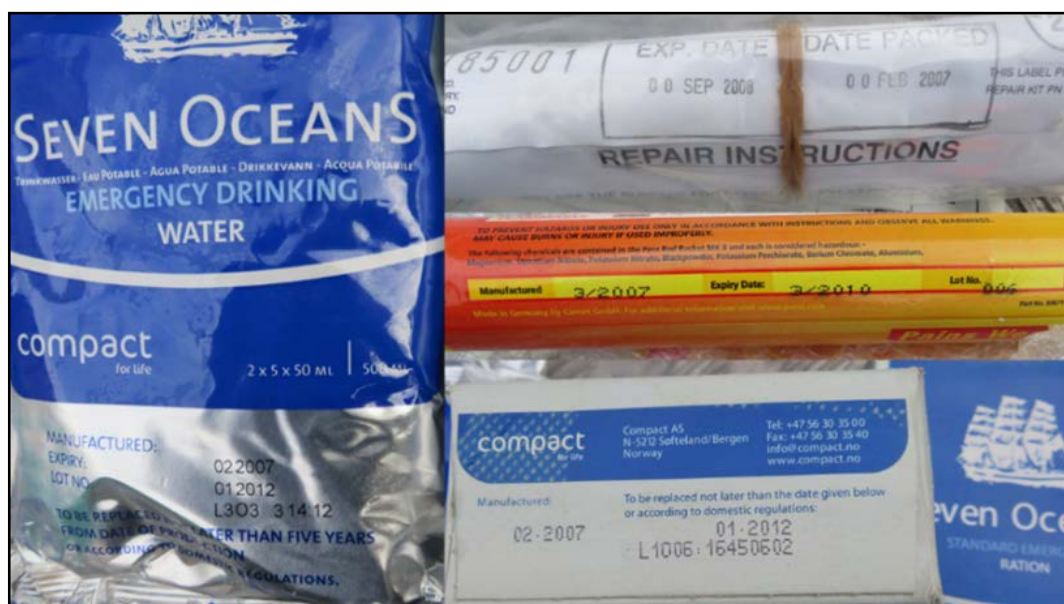
- the torch batteries had expired in January 2010;
- all of the pyrotechnics had expired in March 2010; and
- all of the food and water supplies had expired in January 2012.

Figure 2: Examples of the expired consumable items in *Piedras's* starboard liferaft

The starboard liferaft had not been correctly serviced since its manufacture in March 2007, despite having been routinely certified by Comfer Marin SL.
