MAIB Safety Bulletin SB2/2023, issued 24 August 2023

**Potential failure of
Deutsche Schlauchboot GmbH (DSB) liferafts
serviced by Comfer Marin SL, Marin, Spain
identified following the foundering of the fishing vessel
Piedras (FD 528)
south-west of Mizen Head, the Republic of Ireland
on 1 June 2022**

MAIB SAFETY BULLETIN 2/2023

The Marine Accident Investigation Branch is carrying out an investigation into the foundering of the fishing vessel *Piedras* (FD 528), 78 nautical miles south-west of Mizen Head, the Republic of Ireland, on 1 June 2022.

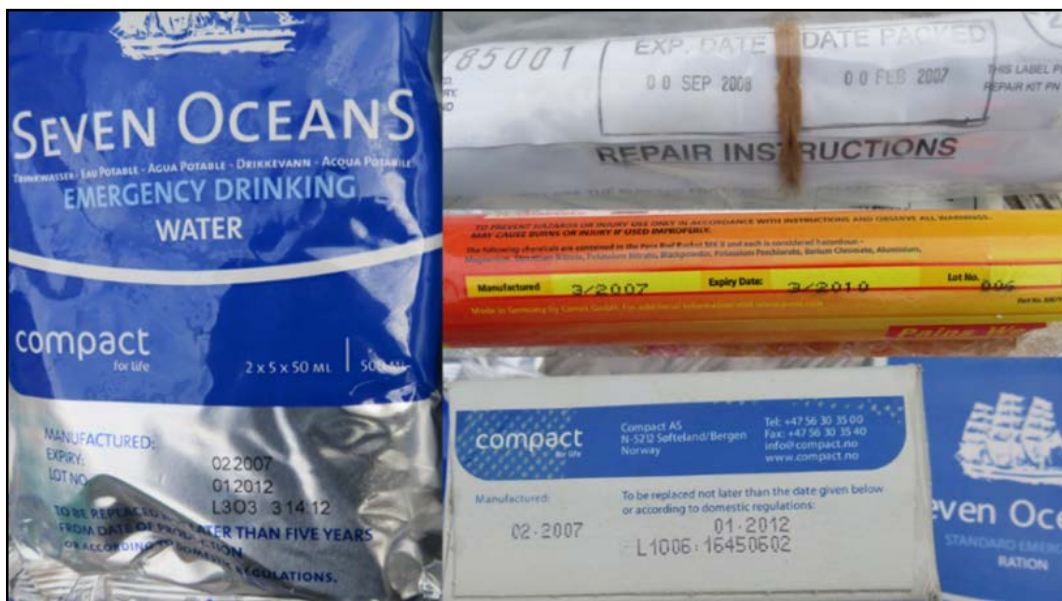
Subsequent examination by the MAIB of the SOLAS A³ pack in the recovered starboard liferaft (**Figure 2**) found that:

- the first aid kit had not been replaced since it was supplied in 2007;
- the liferaft repair kit had expired in September 2008;

- the torch batteries had expired in January 2010;
- all of the pyrotechnics had expired in March 2010; and
- all of the food and water supplies had expired in January 2012.

Figure 2: Examples of the expired consumable items in *Piedras's* starboard liferaft

The starboard liferaft had not been correctly serviced since its manufacture in March 2007, despite having been routinely certified by Comfer Marin SL.

S2023/104M Immediately contact their nearest approved Survitec liferaft service station to arrange for the liferafts to be urgently reinspected and serviced to ensure they are fully functional and comply with statutory requirements.
