Accident

Aircraft Type and Registration:	Spitfire Mk 26B, G-CLHJ	
No & Type of Engines:	1 Isuzu V6 Piston Engine	
Year of Manufacture:	2019 (Serial no: LAA 324-15249)	
Date & Time (UTC):	22 August 2023 at 1403 hrs	
Location:	Near Enstone, Oxfordshire	
Type of Flight:	Private	
Persons on Board:	Crew - 1	Passengers - None
Injuries:	Crew - 1 (Fatal)	Passengers - N/A
Nature of Damage:	Aircraft destroyed	
Commander's Licence:	Private Pilot's Licence	
Commander's Age:	68 years	
Commander's Flying Experience:	1,164 hours (of which 26 were on type) Last 90 days - 18 hours Last 28 days - 8 hours	
Information Source:	AAIB Field Investigation

Synopsis

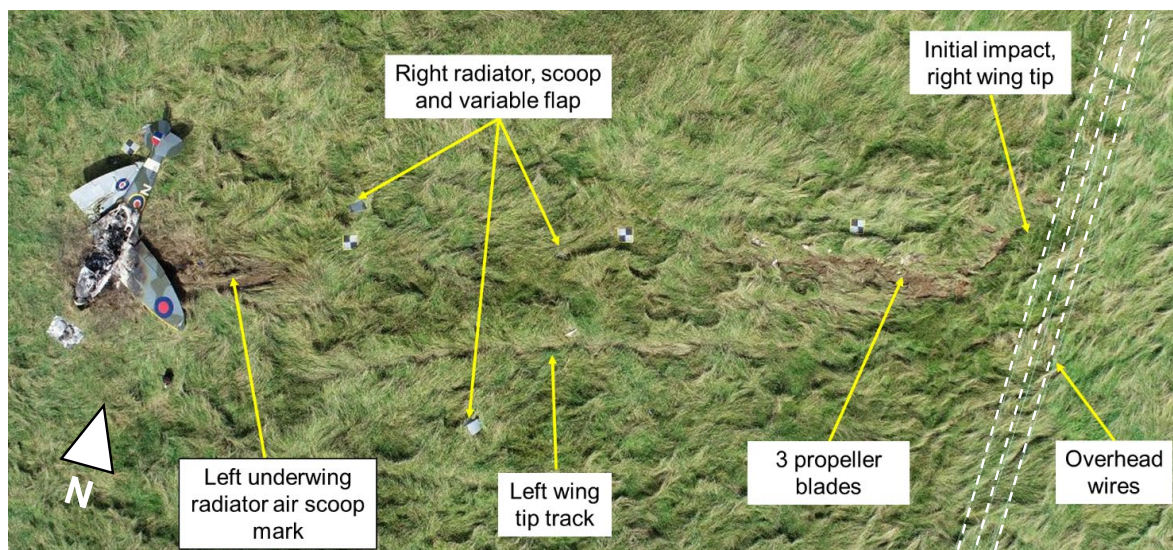
Figure 1

The aircraft came to rest in a field approximately 100 m from a road opposite houses. The initial impact point was directly below 11kV power lines that crossed the field in a north/south direction; there was no evidence the aircraft touched any of the power lines during the accident (Figure 1). The ground marks showed the right wingtip hit the ground first with significant force. The impact mark and trail of debris suggested the aircraft was travelling in a westerly direction. Three propeller blades and a substantial part of the spinner were found together a short distance from the first impact point. Gouging and disruption to the soil from there on showed the aircraft to have carried on forwards until the left radiator fairing on the underside of the left wing ploughed into the soil causing the aircraft to rotate to the left before coming to a stop. The aircraft remained upright throughout the accident sequence. A fire, centred on the cockpit area, caused extensive damage to the centre of the aircraft.

Accident site overview

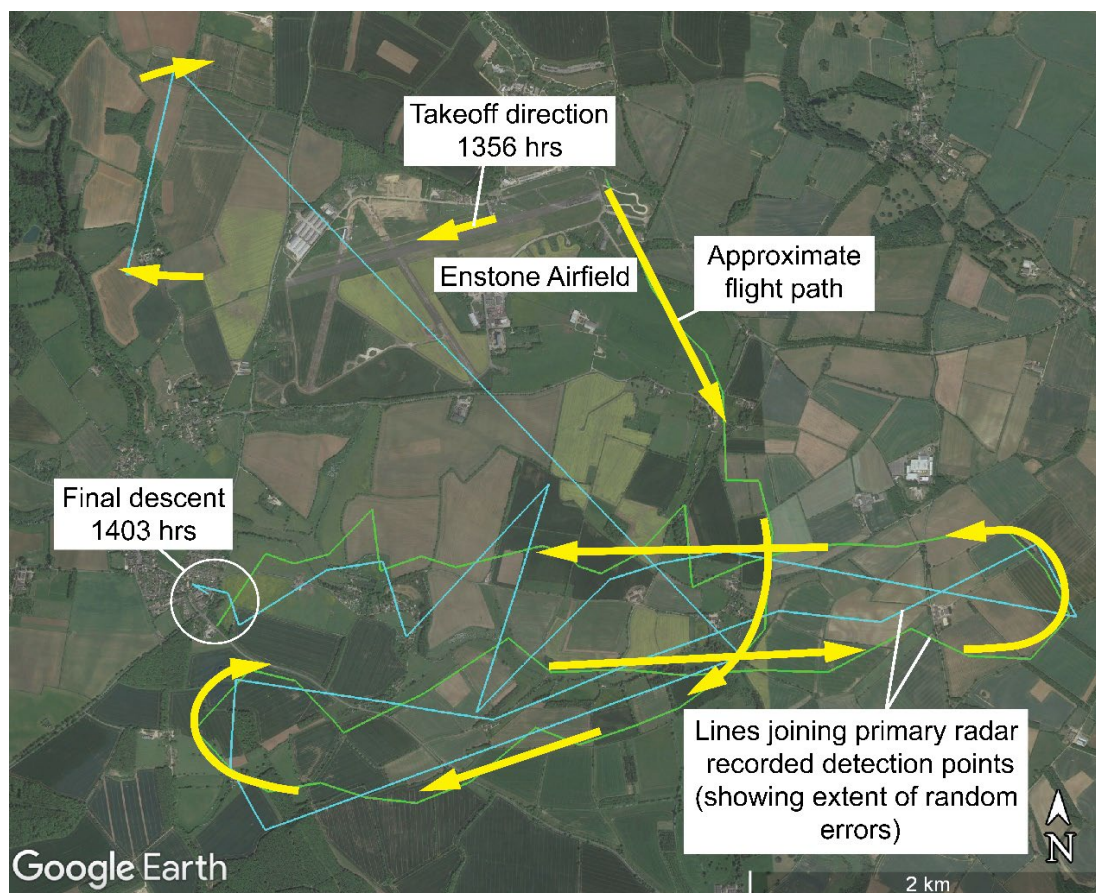
Figure 2
Approximate flight path

The aircraft was fitted with a transponder but there was no secondary radar detection of the aircraft. There was also no track recorded by the ground network associated with the electronic conspicuity device. The flight was detected and recorded by NATS primary radar. This provided the approximate flight path over ground when the aircraft was high enough to be in view of the radar installations but does not provide altitude information (Figure 2).

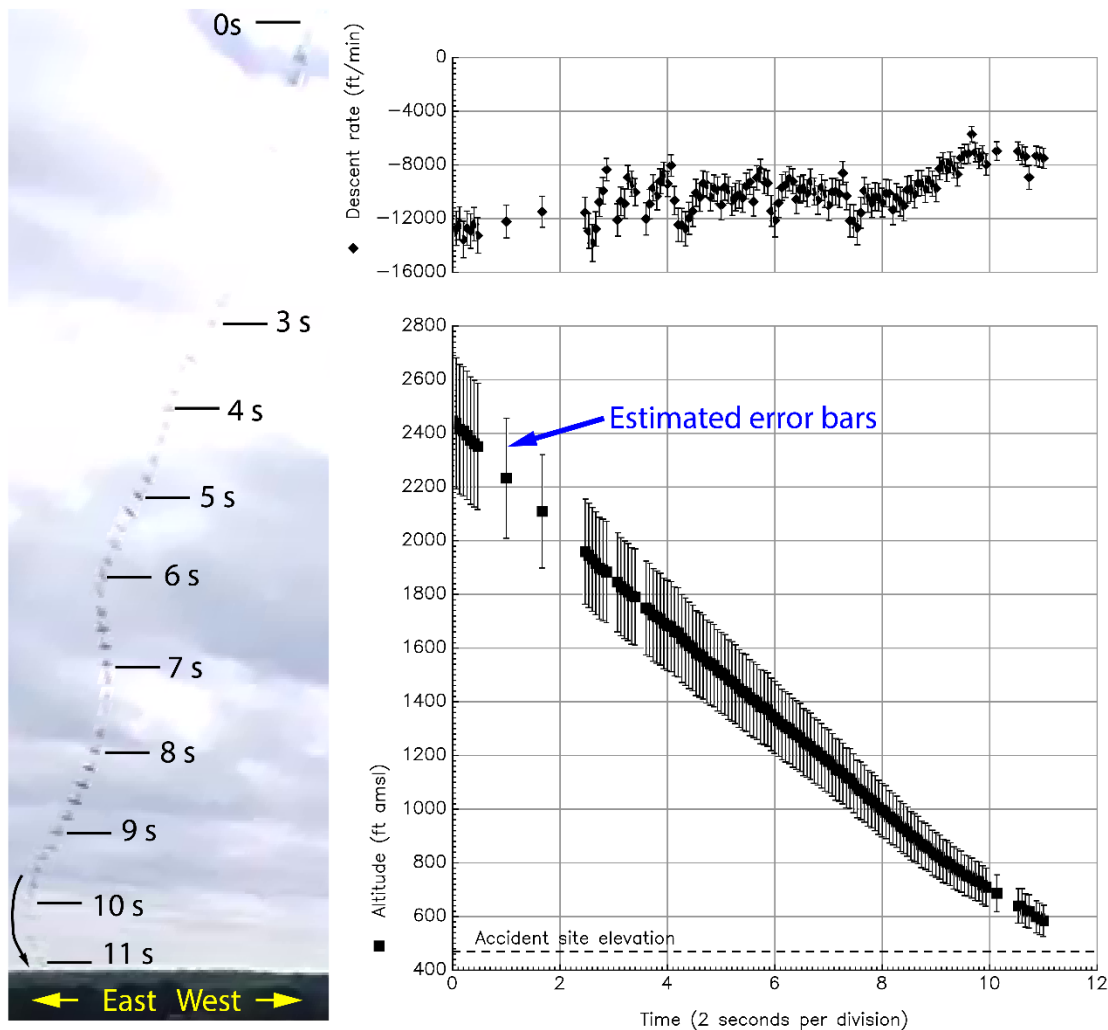
Figure 3

Compound undistorted CCTV image and analysis of the final descent

The aircraft was not visible in the CCTV recording when it was in front of a relatively bright area of the sky during the initial part of the captured portion of the descent. However, the available data points indicate that the flight path appears relatively consistent for approximately the first five seconds of the captured part of the descent. The shape of the descent during the final three seconds indicates a reduced descent rate. The final second of the captured descent indicated an increasingly westerly component to the direction of travel. The aircraft was not in view of the camera for approximately the last 100 ft of the descent.

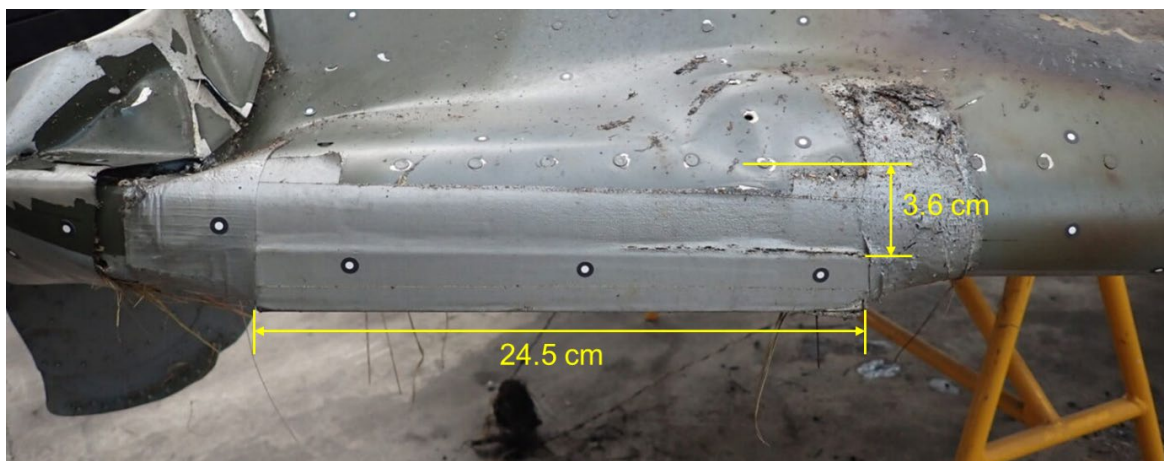
Figure 6

The stall strip fitted to the leading edge of the right wing was still in place (Figure 6) although there was distortion on its surrounding structure. The stall strip that had been fitted to the left wing was found lying beneath the wing at the accident site. The leading edge section to which it had been attached was melted and burnt through and there was no duct tape present. Therefore, the left wing stall strip position on the wing could not be accurately determined. Both stall strips were 24.5 cm in length.

Stall strip fitted to the right wing leading edge

Pictures taken of the aircraft when the stall strips were initially fitted were compared to the current location of the remaining stall strip. Despite the damage to the wing around the stall strip, reference points were established between the before and after pictures which showed that the stall strip had been moved down a few millimetres as requested by the pilot.

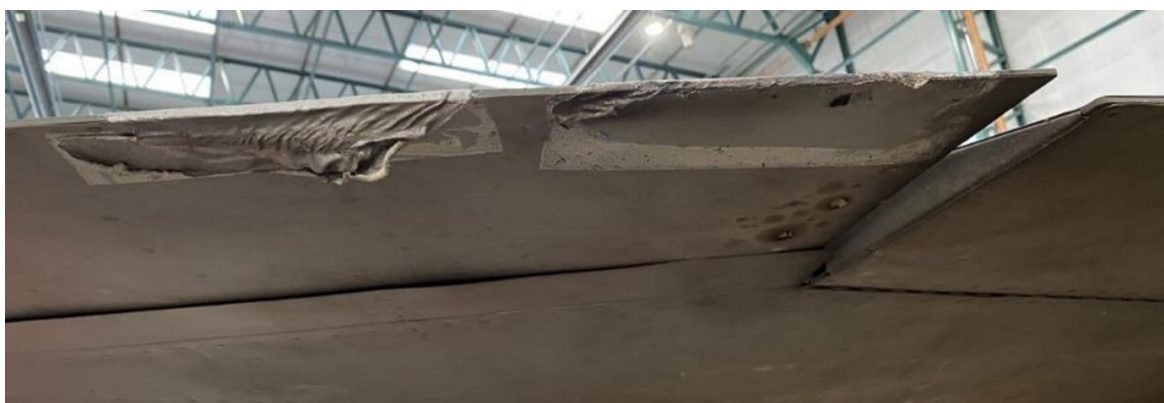
Figure 7

Remains of the duct tape attached to the left aileron trailing edge were present with signs of heat degradation of the tape surface. The foam wedge piece or remains of any material identified as such were not found. (Figure 7)

Remains of duct tape on the lower surface of the left aileron

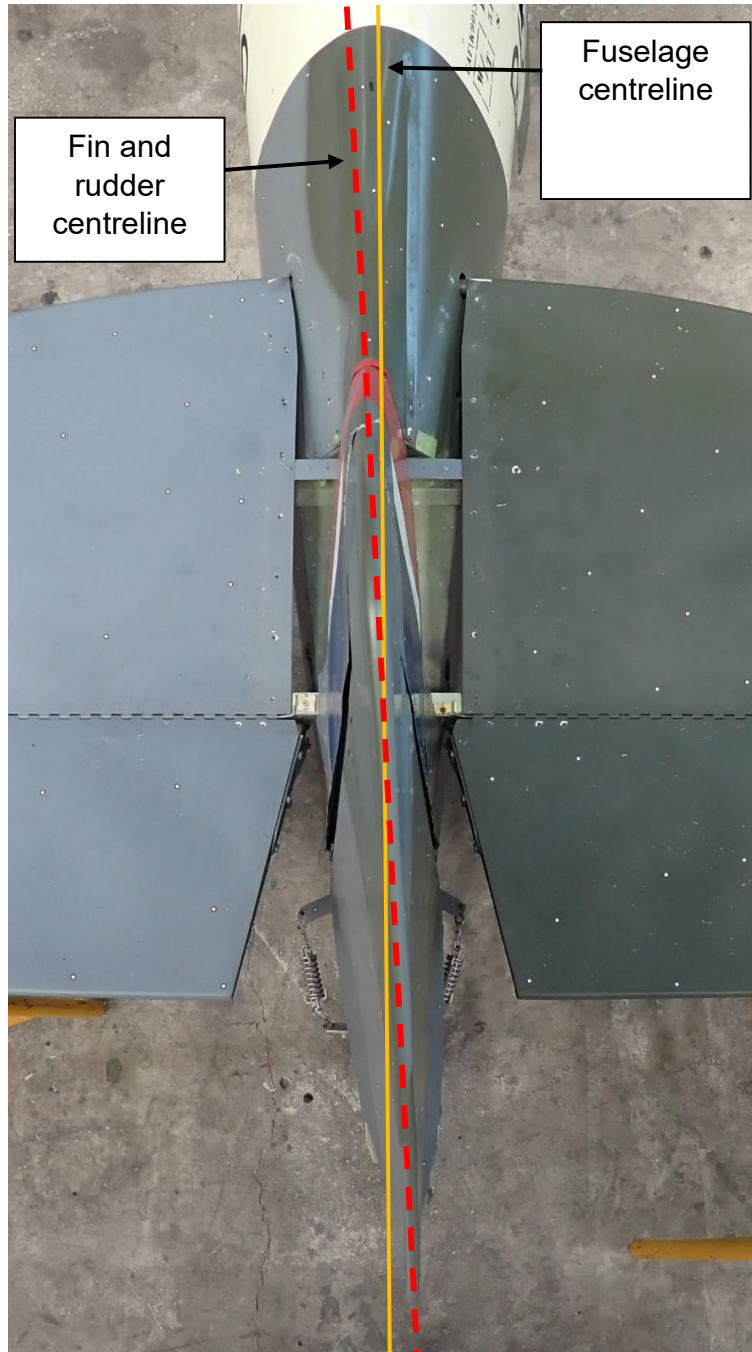
Figure 8

A visual examination of the fin and tailplane found the leading edge of the fin appeared to have a significant misalignment to the left. Precision measurements along with laser alignment checks found the fin and rudder were misaligned 4.4° to the left of the aircraft

centre line (Figure 8). Removal of the left and right fin root fairings confirmed this and revealed the position of the fin relative to the centre line of its support frame. The left and right tailplane inboard rib measurements show the base of the fin, where it attaches to the fuselage, was misaligned 5 mm to the left of the centre line. Detailed examination of the structure around this area and the fin root fairings found no evidence that the misalignment was because of the impact sequence.

Fin and rudder misalignment from above with the rudder horn aligned with the fin leading edge

The aircraft should not have had a fin misalignment. There is no mention of it in the kit construction manual and the fin is shown symmetrically on the fuselage centre line on the manufacturers drawing. Other Spitfire Mk 26 and Mk 26B aircraft do not have the fin misalignment and during the testing of those aircraft, there was no marked tendency for them to roll.

Despite the adjustments made to correct the roll, when the aircraft is approaching the stall and the effect of the ailerons is reduced, the fin misalignment may have had an effect by inducing a constant yaw causing the right wing to stall first and drop as reported by the pilot. In effect the misalignment fin and rudder created a pro-spin condition.

The LAA issued Mandatory Technical Directive MTD-01-2024 on 13 February 2024 applicable to all Spitfire Mk 26 and Mk26b aircraft. The MTD required geometry and symmetry checks to be carried out to ensure correct alignment of fin assembly and rigging of rudder with comprehensive illustrated instructions how to achieve the checks.
