## Accident

<b>Aircraft Type and Registration:</b>	Jabiru UL-450, G-CDFK	
<b>No &amp; Type of Engines:</b>	1 Jabiru 2200A piston engine	
<b>Year of Manufacture:</b>	2006 (Serial no: PFA 274A-14144)	
<b>Date &amp; Time (UTC):</b>	4 April 2023 at 1107 hrs	
<b>Location:</b>	Damyns Hall Aerodrome, Upminster, Essex	
<b>Type of Flight:</b>	Private	
<b>Persons on Board:</b>	Crew - 1	Passengers - 1
<b>Injuries:</b>	Crew - 1 (Serious)	Passengers - 1 (Serious)
<b>Nature of Damage:</b>	Extensive	
<b>Commander's Licence:</b>	National Private Pilot's Licence	
<b>Commander's Age:</b>	57 years	
<b>Commander's Flying Experience:</b>	230 hours (of which 173 were on type) Last 90 days - 1.5 hours Last 28 days - 0.5 hours	
<b>Information Source:</b>	AAIB Field Investigation

## Synopsis

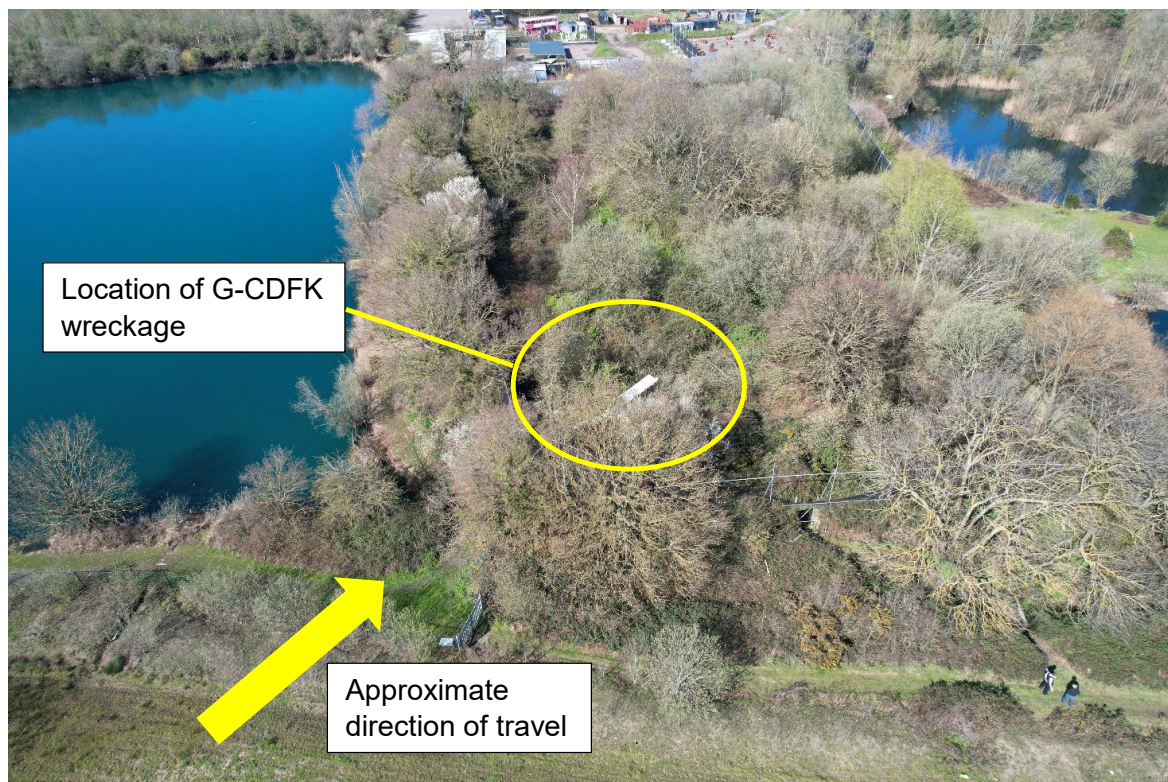
**Figure 1**

The accident site was in a wooded area (Figure 1) approximately 900 m from the start of the aircraft’s takeoff roll and 390 m from the upwind threshold of Runway 21 at Damyns Hall Aerodrome. Damage to the trees indicated that it had entered them nearly vertically, striking the trunk of a mature tree before coming to the ground.

Area of woodland in which G-CDFK came to rest (courtesy of London Fire Brigade)

The aircraft came to rest upright with its right wing supported by foliage and the left wing on the ground. The cockpit floor had crumpled, as had the engine mounts.

One of the propeller blades was mainly intact with its tip missing, however the other blade had fractured at the hub. Fragments of propeller blade material remained close to the accident location. The condition of the propeller indicated that the propeller was not rotating, or was rotating slowly, when it struck the trees.

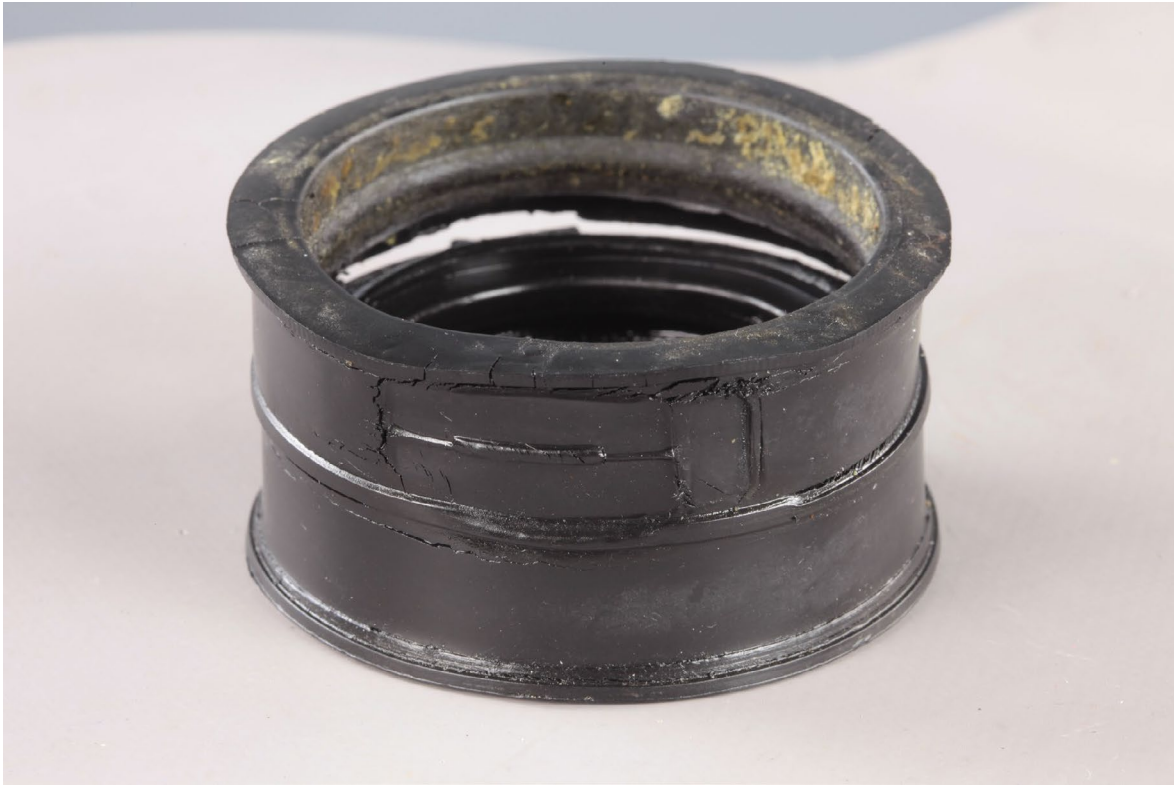
**Figure 2**

The nitrile rubber coupling (Figure 2), part number 4691084, removed from the engine was examined in a laboratory. A 360° crack radiating from the inner diameter outward through most of the coupling was found. Additionally, cracks were present radiating inboard from the outer diameter that met the 360° crack. The coupling had a through crack around 65% of the circumference.

Split carburettor coupling from G-CDFK

The laboratory examination identified that the rubber showed signs of age-related degradation and embrittlement.

There was no record within G-CDFK's aircraft or engine logbook of the carburettor coupling having been replaced during the life of the aircraft. It is therefore assumed that the coupling was over 16 years old at the time of the accident and some 11 years over the 5-year life limit set by the manufacturer.

It is recommended that the UK Civil Aviation Authority mandate a suitable life limit for the carburettor to plenum chamber coupling, Jabiru part number 4691084 (or equivalent parts), to ensure the couplings are removed from use before a crack can propagate.

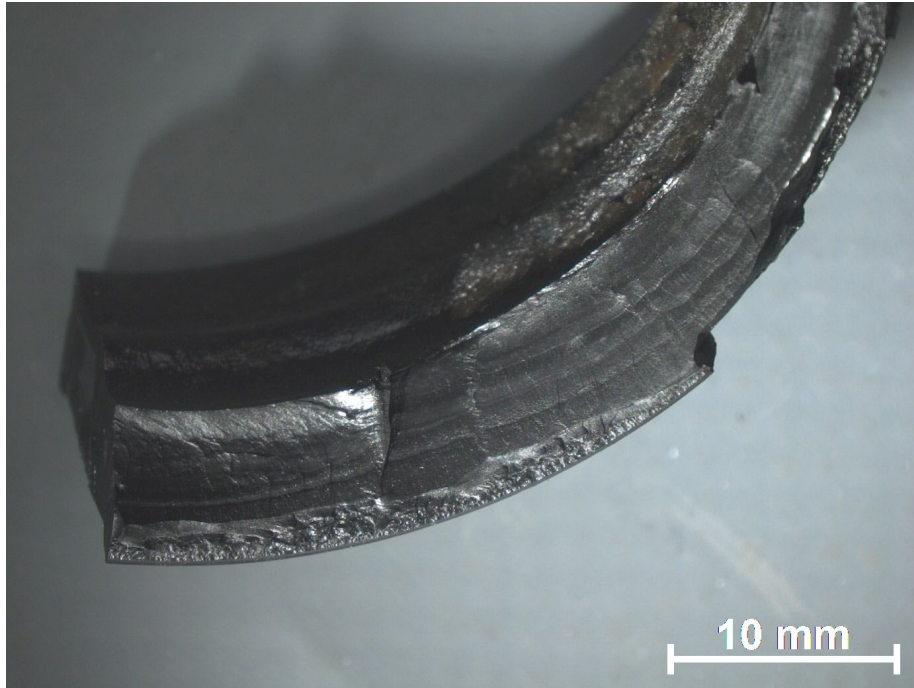
**Figure 3**

Assessment of the fracture surfaces indicated that the main crack from the inner diameter had been present for some time and exhibited fatigue striations (Figure 3). It could not be determined for certain whether the external cracks were present during the accident flight, as a result of the impact or during later manipulation when the coupling was removed, but there were five distinct areas of different external crack morphology, two of which exhibited fracture surfaces consistent with overload, leaving the remaining three areas likely to have been present during the accident flight. This suggests that at least 30% of the circumference was fractured during the flight. External cracks were also present in the coupling that had not joined with the main inner crack.

Cracks in coupling wall, showing fatigue propagation from inner diameter

The coupling from the accident engine was assessed in a laboratory and confirmed that it showed signs of age-related degradation and embrittlement, and that there were pre-existing through-cracks present at the time of the accident. The main crack had initiated on the internal surface around 360° propagating outwards before it combined with smaller cracks propagating inwards from the outer surfaces. The location of the main crack means that its presence cannot be detected without the coupling being removed from the engine.

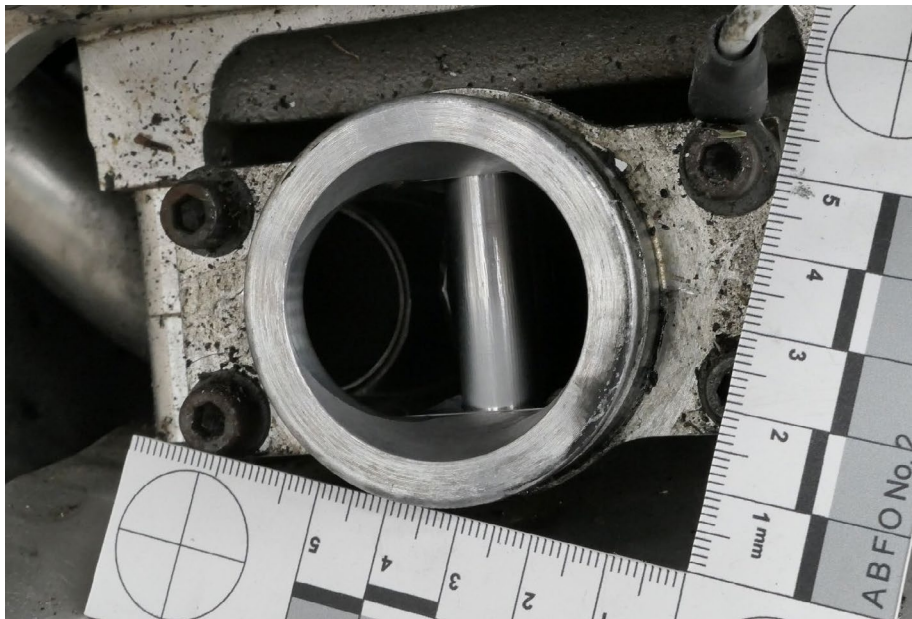
**Figure 4**

The rear face of the inlet to the plenum chamber showed staining (Figure 4), possibly indicating the location of the split in the coupling,

Inlet to plenum chamber showing marking indicating leak in coupling

Evidence of staining in an arc on the rear face of the plenum chamber union indicates that there was disrupted airflow in that location. This suggests a split in the coupling had been present for some time.

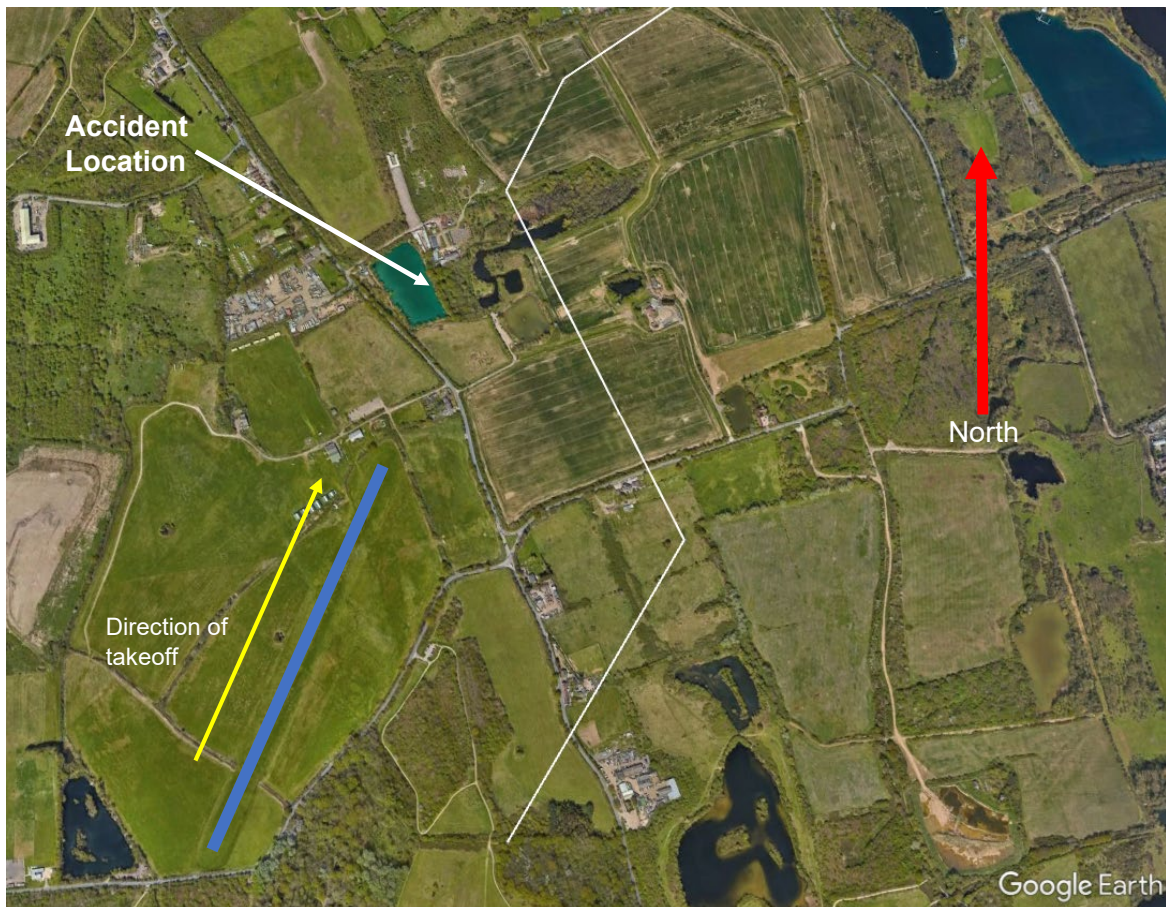
**Figure 5**

Damyns Hall is an unlicensed airfield with a main grass runway orientated 030°/210° and 650 m long (Figure 5 runway highlighted in blue). The runway slopes down towards the threshold on Runway 03. Pylon power cables run 0.7 nm to the north-east of the airfield as shown in Figure 5.

Aerial view of Damyns Hall Aerodrome highlighting the power cables to the northeast (highlighted in white). Runway 03/21 is marked in blue
