## Accident

<b>Aircraft Type and Registration:</b>	Piper PA-28-180, G-AYUH	
<b>No &amp; Type of Engines:</b>	1 Lycoming O-360-A4A piston engine	
<b>Year of Manufacture:</b>	1970 (Serial no: 28-7105042)	
<b>Date &amp; Time (UTC):</b>	21 August 2023 at 0820 hrs	
<b>Location:</b>	Near Stanley Hall, Halstead Hall, Essex	
<b>Type of Flight:</b>	Private	
<b>Persons on Board:</b>	Crew - 1	Passengers - None
<b>Injuries:</b>	Crew - 1 (Fatal)	Passengers - N/A
<b>Nature of Damage:</b>	Aircraft destroyed	
<b>Commander's Licence:</b>	Private Pilot's Licence	
<b>Commander's Age:</b>	72 years	
<b>Commander's Flying Experience:</b>	407 hours Last 90 days - 7 hours Last 28 days - 1 hour	
<b>Information Source:</b>	AAIB Field Investigation

## Synopsis

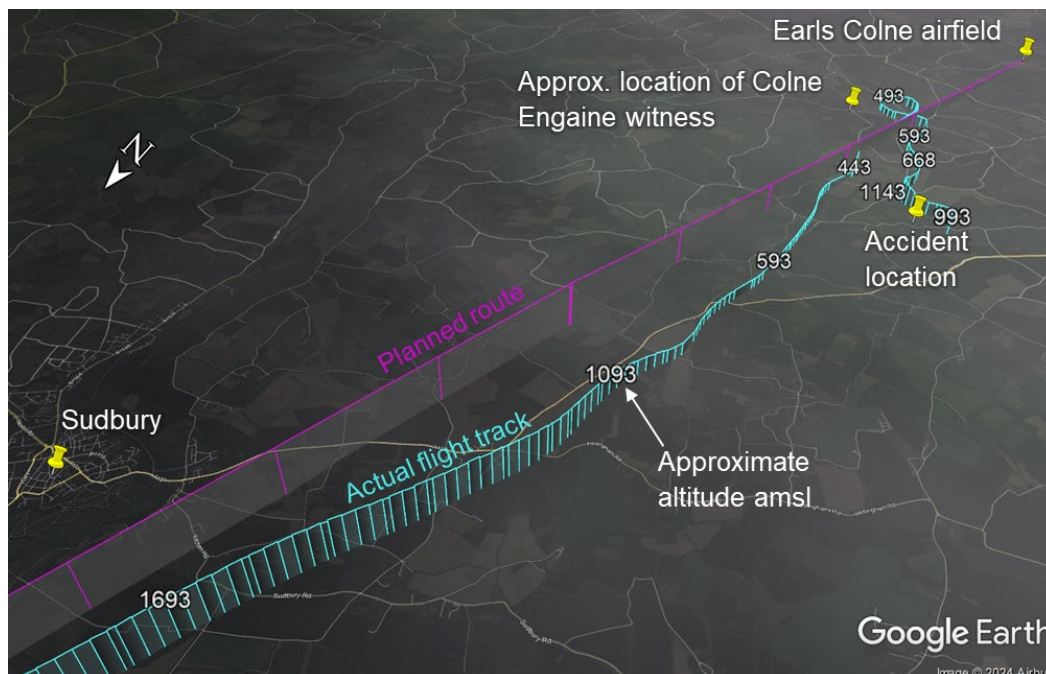
**Figure 2**

As G-AYUH approached Earls Colne, it began to descend at a location consistent with the edge of the band of low cloud / fog captured by the Met Office satellite image. The aircraft continued at an altitude of around 500 ft amsl (approximately 250 ft aal for Earls Colne).

At approximately 0815 hrs the radio operator, now joined by a colleague in the radio room, noted that G-AYUH had disappeared from the screen of an electronic conspicuity tracking website which was used by the radio operators to aid the monitoring of aircraft in the vicinity. The pilot then transmitted that he was at 500 ft, entering ‘*thick cloud or fog*’ and was returning to Old Buckenham. A witness working on a roof in the area, who is a private pilot, reported seeing an aircraft approaching from the north, “trying to stay below the cloud”, which was “low at around 500 ft above the ground”. The witness lost sight of the aircraft as it passed between Colne Engine and Halstead (2 km to the west), but a short time later saw it again briefly heading in a northerly direction having apparently turned around. The witness reported that the sound of the aircraft’s engine appeared constant and normal. Recorded data shows the aircraft making a 270° left turn over the village of Colne Engine (Figure 2) then continuing in a north-westerly direction and climbing to approximately 1,100 ft amsl (860 ft agl), before continuing to the west.

View from the north-west showing the planned route and actual flight track for the final part of the flight, with fog/cloud overlaid.

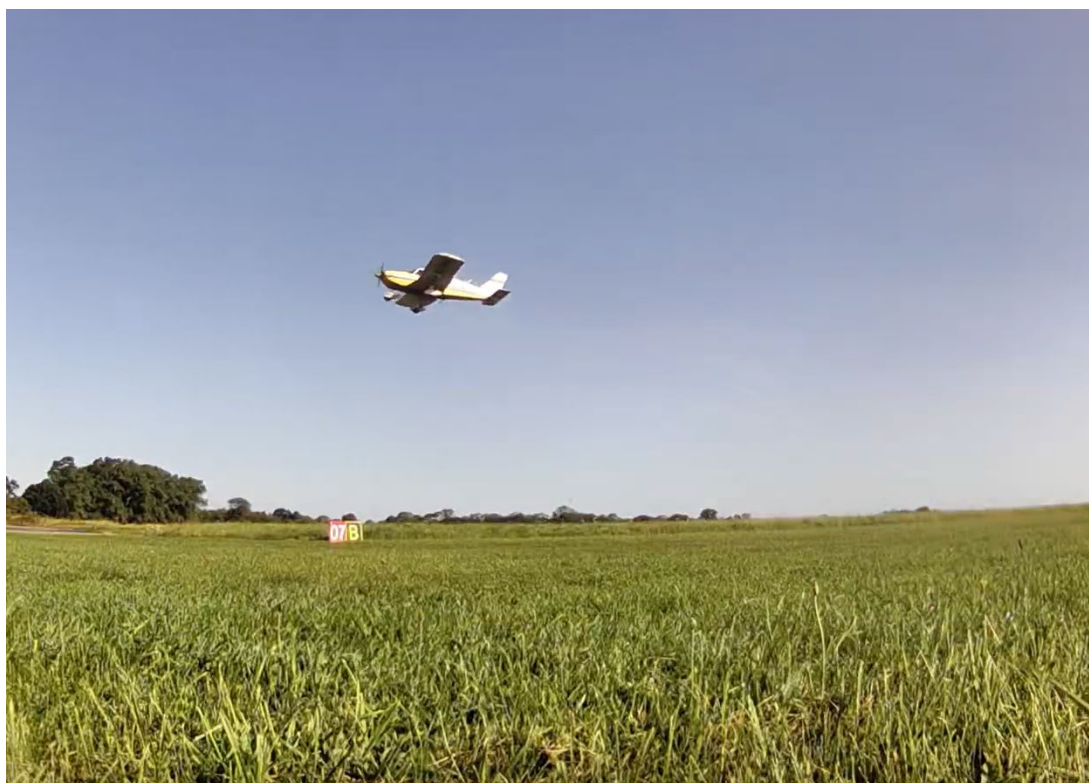
**Figure 7**

Both Old Buckenham and Earls Colne airfields had CCTV which was recorded. The CCTV at Old Buckenham Airfield showed the aircraft taking off in clear sky conditions at 0753 hrs (Figure 7). The departure appeared normal.

CCTV of G-AYUH departing from Old Buckenham (used with permission).

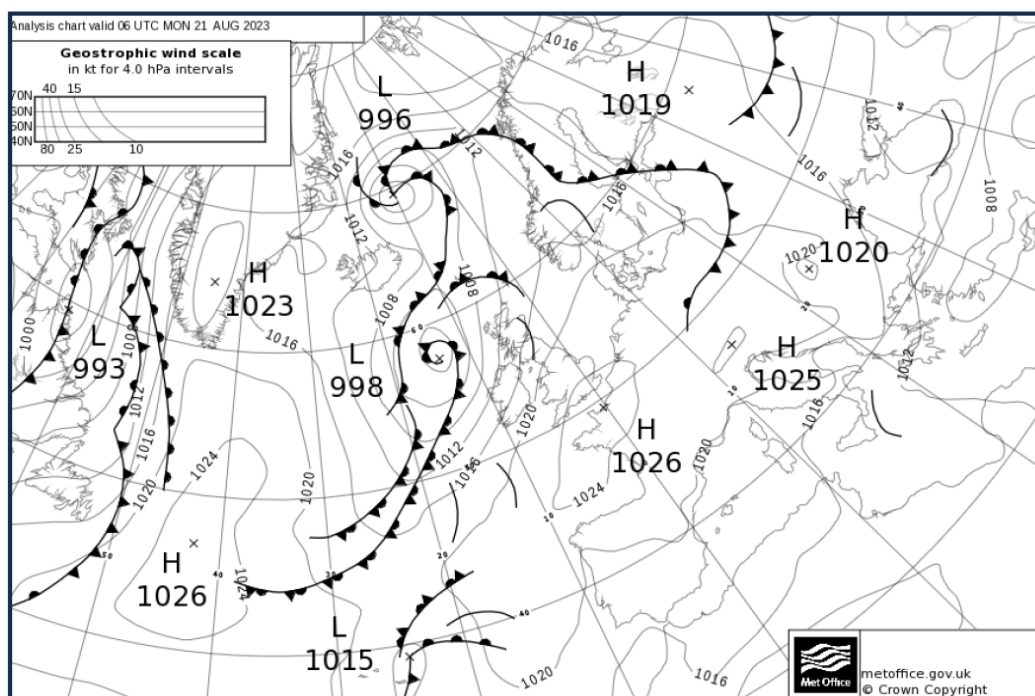
**Figure 9**

The Surface Analysis Chart published by the Met Office (Figure 9), valid for 0600 hrs on Monday 21 August 2023, shows an area of high pressure over southern UK and northern France. The south-east of the UK was therefore experiencing settled conditions with slack south-westerly winds.

Surface Analysis Chart valid 0600 hrs Monday 21 August 2023

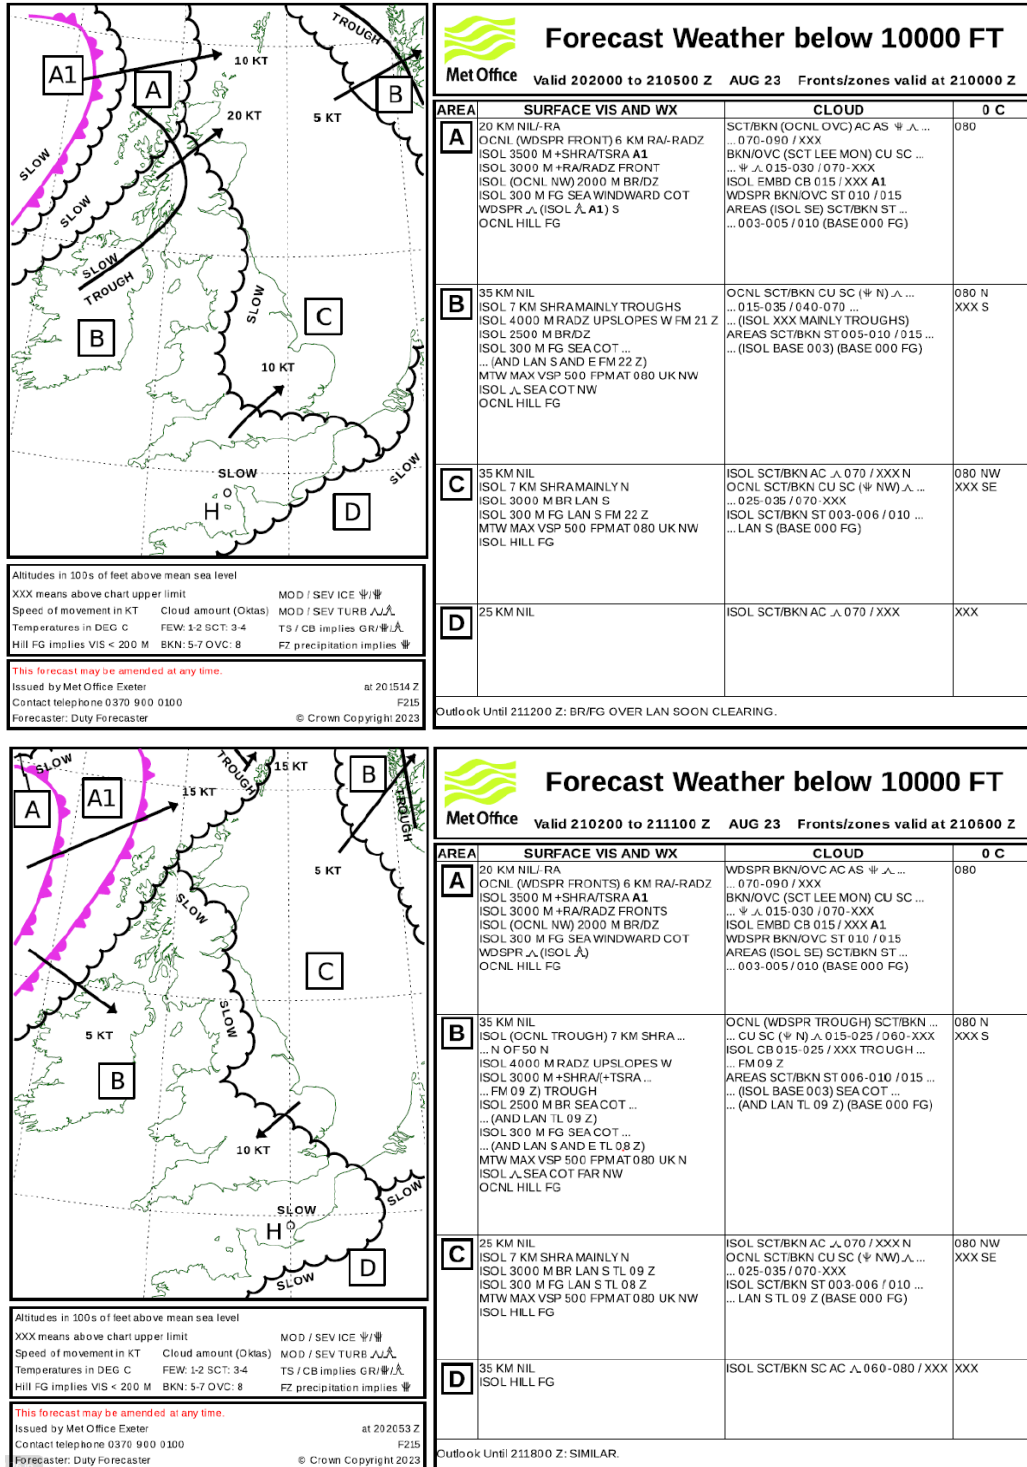
Figure 10

The Met Office published Low Level Significant Weather Charts (Form 215 – Figure 10) at 1514 hrs and 2053 hrs on Sunday 20 August 2023 (valid for 0000 hrs and 0600 hrs on Monday 21 August 2023). The flight was planned to be conducted within Area C, however the boundary of Area B would slowly approach the area of the planned flight overnight before retreating back to the south-west. The conditions within Area C were expected to be generally good with 35 km visibility, although this was forecast to reduce to 3,000 m in mist (BR) or 300 m in fog (FG)<sup>4</sup> over land (LAN) after 2200 hrs on 20 August, before clearing by 0800 hrs or 0900 hrs (0900 or 1000hrs local time) on 21 August. Occasional (OCNL)<sup>5</sup> scattered or broken (SCT/BKN) amounts of cloud between 2,500 and 3,500 ft were expected, however isolated (ISOL)<sup>6</sup> scattered or broken cloud between 300 and 600 ft was expected to develop at times in the south of Area C, lowering to the surface in the presence of fog.

F215 Low Level Significant Weather Charts for 0000 hrs and 0600 hrs 21 August 2023

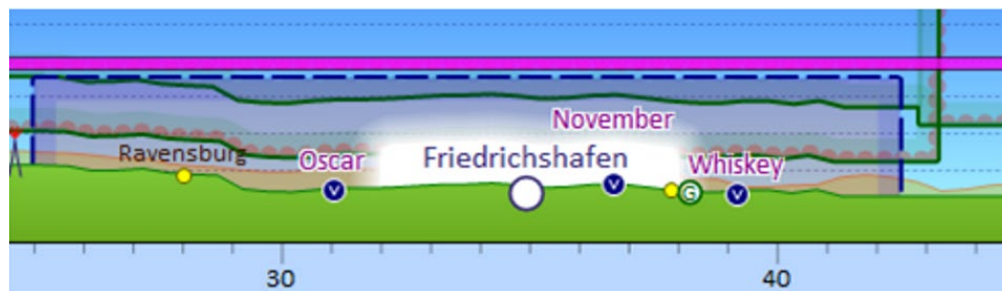
**Figure 13**

SkyDemon can show a Virtual Radar display which graphically depicts some conditions in a TAF or METAR published for an aerodrome. SkyDemon provided the AAIB with an example (Figure 13) for an aerodrome reporting fog in a METAR.

Example of the SkyDemon Virtual Radar display depicting fog (used with permission)

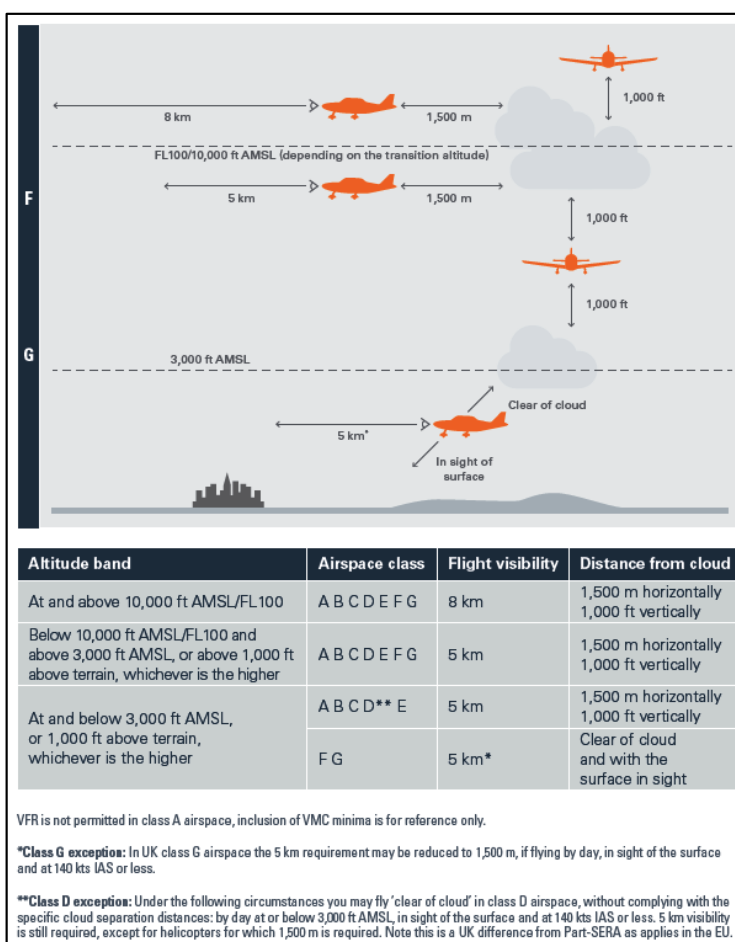
**Figure 14**

Graphical representation of Visual Flight Rules
