Rail Accident Investigation Branch

# Rail Accident Report

## Uncontrolled evacuation of a partially platformed train at Clapham Common London Underground station, 5 May 2023

Report 03/2024  
May 2024

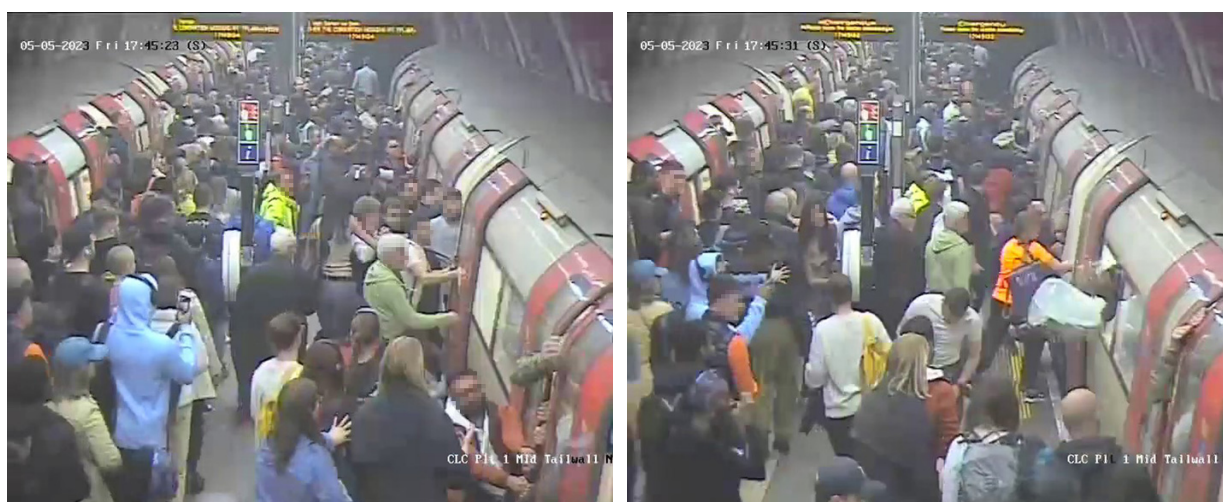
- 4 Passengers in the train became aware of smoke and a burning smell, and unsuccessfully attempted to force open the train's bodyside doors. Around 2 minutes and 23 seconds after the train had stopped, the station's automated station evacuation alarm sounded and, at around the same time, passengers began exiting the train through the interconnecting doors which lead between the train's cars. Twenty seconds after this alarm sounded, passengers on the station platform began to break the train's bodyside windows and passengers inside the train also began to break these windows and evacuate through the openings onto the platform (figure 1).

Figure 1: Closed-circuit television (CCTV) footage from Clapham Common station platform at 17:45 hrs; the camera is facing towards the steps leading to the platform. Left-hand image shows a passenger breaking a bodyside window on car 5 of train 065 and right-hand image shows passengers beginning to evacuate from the train via the broken window (courtesy of LUL).

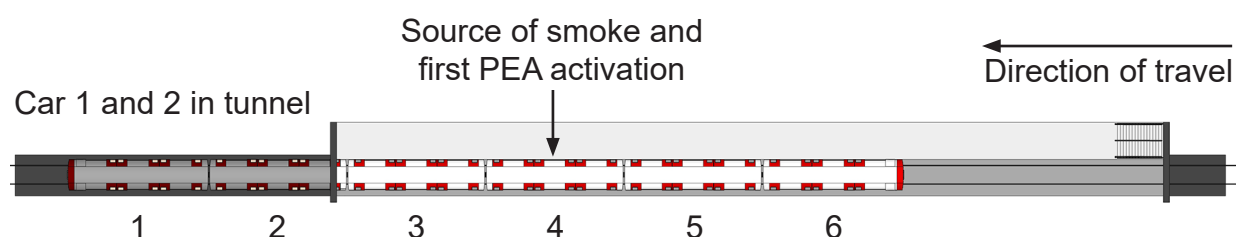
Figure 9: Detailed view of train 065 and its position on the northbound platform after coming to a halt (following a PEA activation).

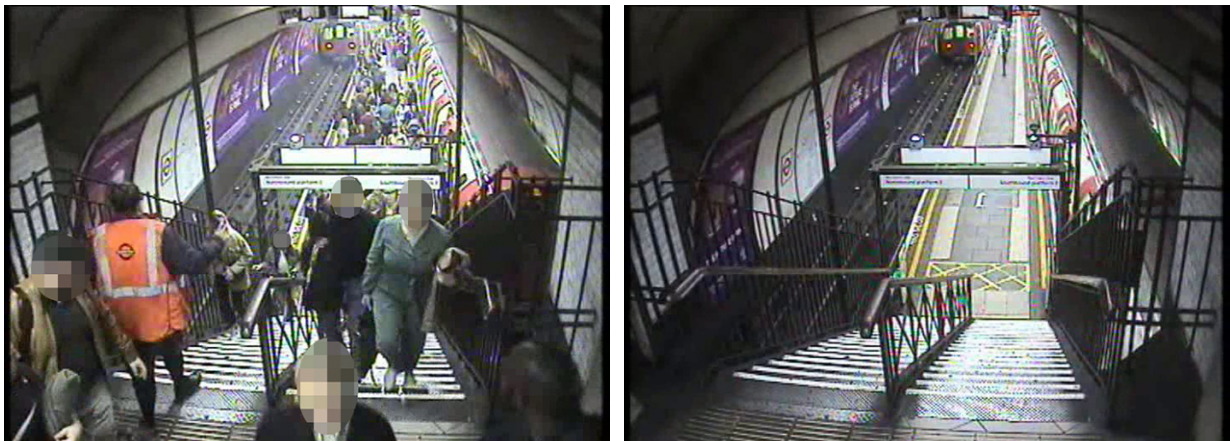
Figure 10: CCTV footage from the top of the stairs leading to the platform. Left-hand image shows CSA(A) moving down the stairs to access the platform during the incident with smoke visible. Right-hand image shows the platform after the incident and after smoke had cleared. Courtesy of LUL.

- 61 CCTV also shows the smoke had spread around the platform and was present when CSA(A) went to investigate the passenger's report of smoke (figure 10). Data from the train's on-train data recorder (OTDR) shows that seconds after the train departed the platform, a PEA was activated in car 4. This was followed by multiple PEA activations in other cars within the train.

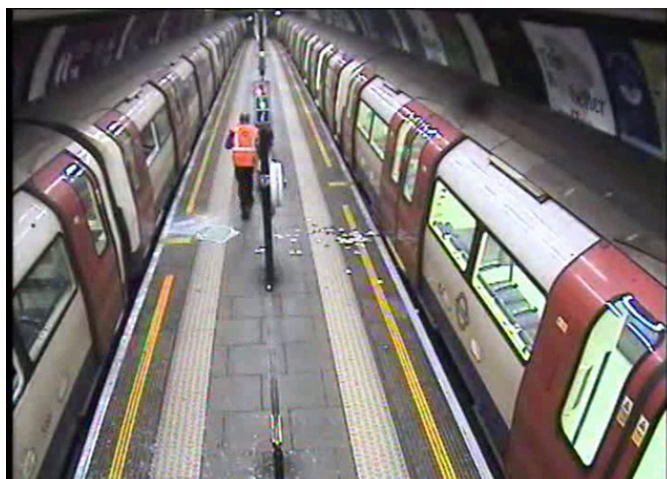
- 46 At 17:58 hrs (around 15 minutes after train 065 had been brought to a stand), the last passenger is seen on CCTV to have left the platform.

*Figure 11: Station CCTV footage showing the platform after the evacuation and after passengers had exited the platform. CCTV camera is pointing away from stairs (leading to the platform) with train 065 on left and train 241 on right side of the image. Courtesy of LUL.*

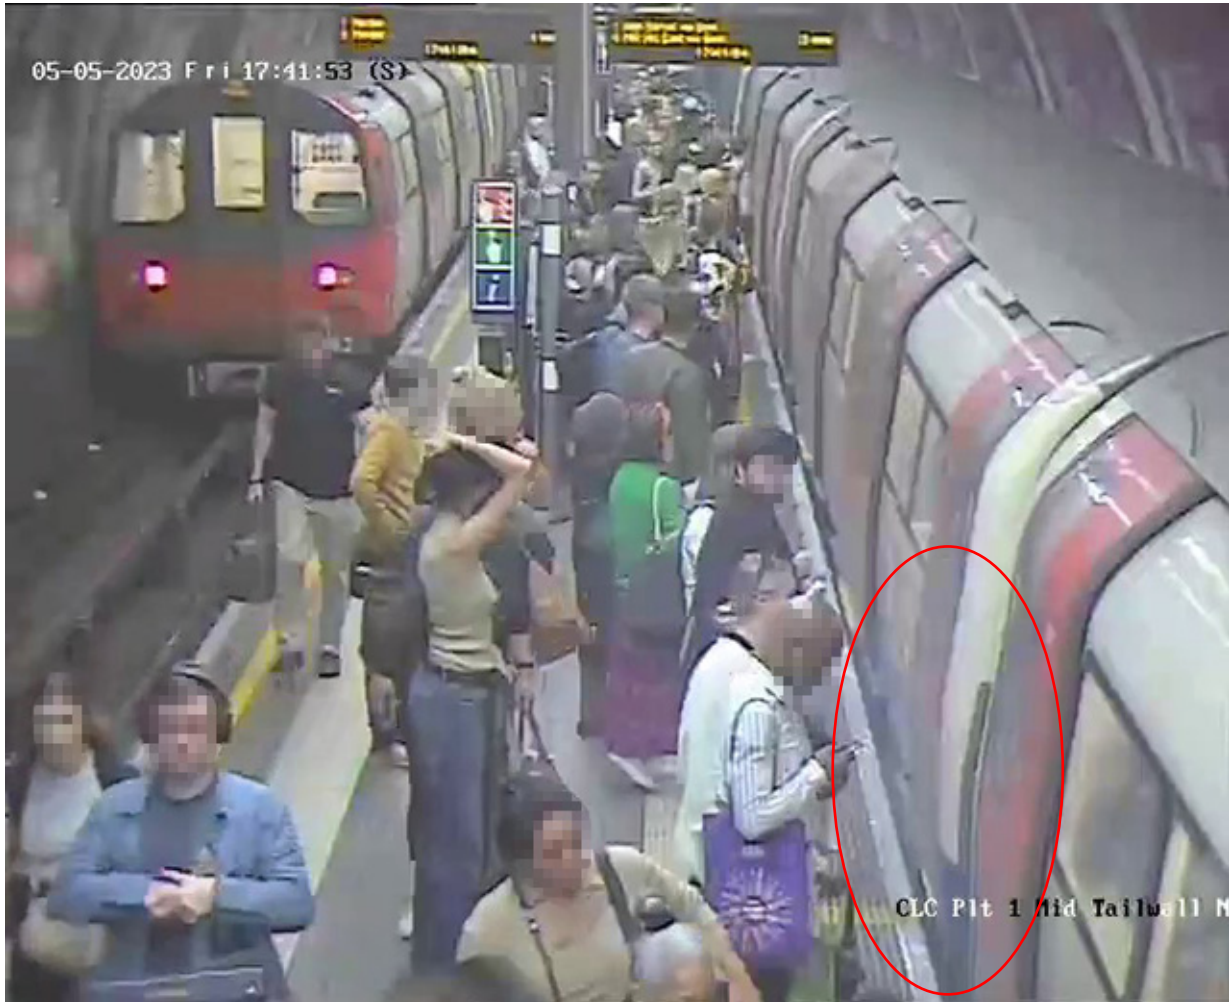
- 60 CCTV station footage shows that, as train 065 entered the platform and came to a stand, smoke was emanating from around the underneath of car 4 (figure 14, indicated by a red circle). As passengers began to board and alight, CCTV also shows several passengers reacting to the smoke and moving away from the immediate area. The proximity of the rising plume of smoke to the open bodyside doors makes it probable that the smoke had entered the passenger compartment of car 4 during this time. This is potentially supported by CCTV images which show that some passengers in car 4 and other cars of the train, having boarded the train, then alighted from it just before departure (see paragraph 63).

Figure 14: CCTV footage of the station platform immediately after train 065 comes to a stand initially; smoke (red circle) can be seen emanating from the underside of the leading end of car 4. A southbound train is in the process of departing the station (before train 241's arrival). The CCTV camera is facing towards the steps leading to the platform (figure 5). Courtesy of LUL.

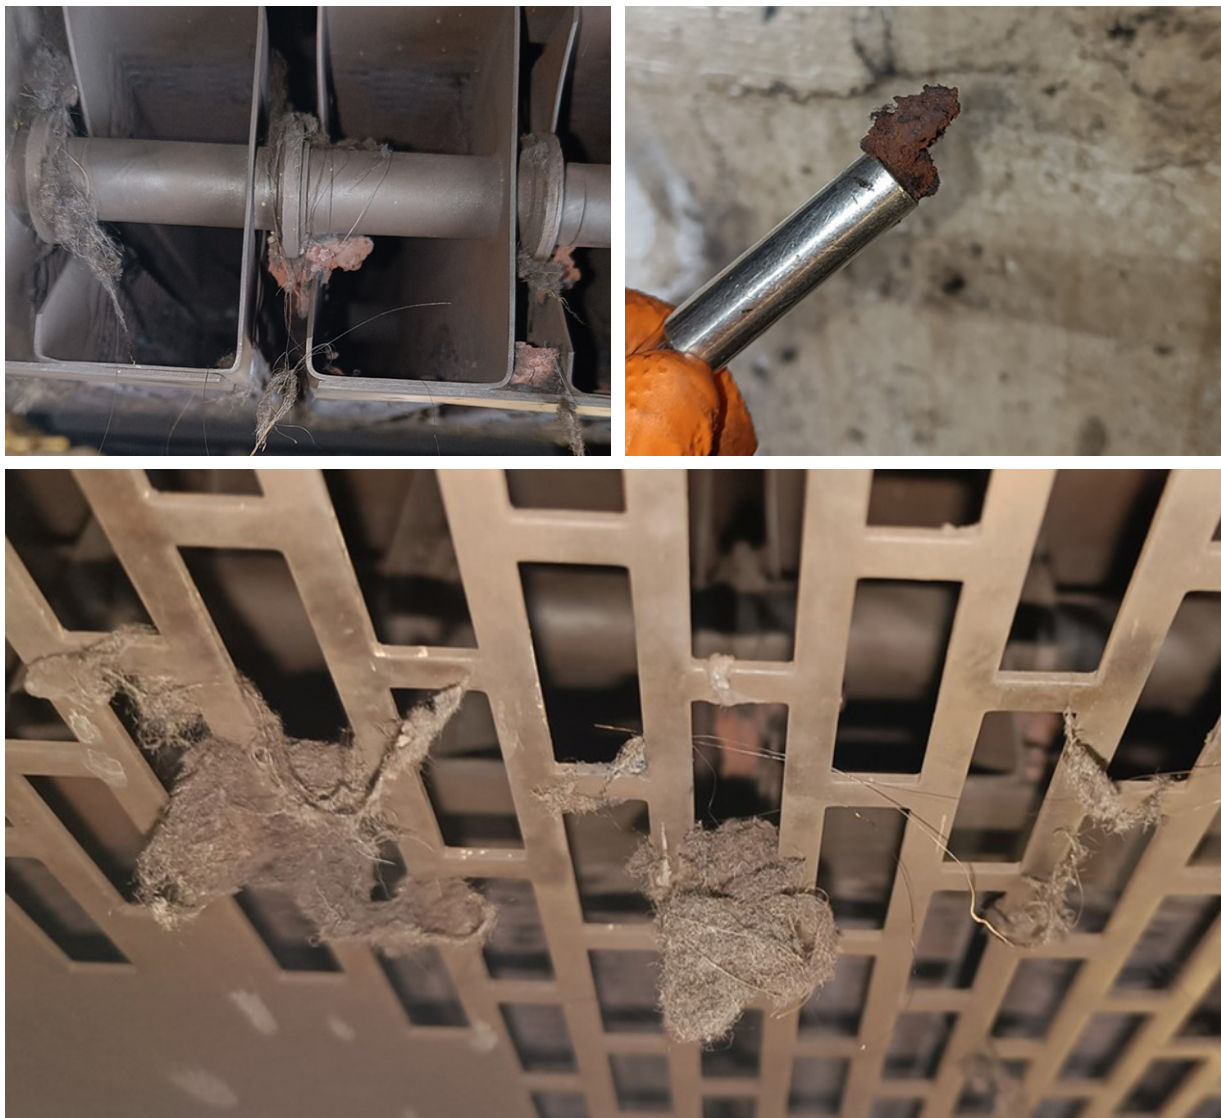
63 LUL and Alstom engineers inspected the train after the incident and confirmed that a strong burning smell was present within the passenger saloon of car 4. A subsequent inspection of the underframe of car 4 found burnt residue and a red clay-like substance on the brake resistor grid (figure 15). Independent analysis of the substances found showed that this was a mixture of organic material and a red magnetic clay substance. LUL confirmed the substance was grinding paste which is used for rail grinding activities on LUL infrastructure.

*Figure 15: Remaining material found on brake resistor of car 4 of train 065 following the incident. Top left-hand image shows red magnetic clay on inlet to the resistor, bottom image shows organic material on the resistor grid and top right-hand side image shows red magnetic clay material (before material testing). Courtesy of LUL.*

- 64 A review of signalling data from the time of the incident showed operational conditions where the conductor rail would not have been receptive to regenerated brake energy. This suggests that a high level of rheostatic braking would have been used by train 065 as it approached Clapham Common station.
- 65 Following the inspection of train 065, LUL engineers concluded that the likely source of the smell (and possibly the smoke) was the heating of the red clay and the organic debris on the surface of the brake resistor grid of car 4.

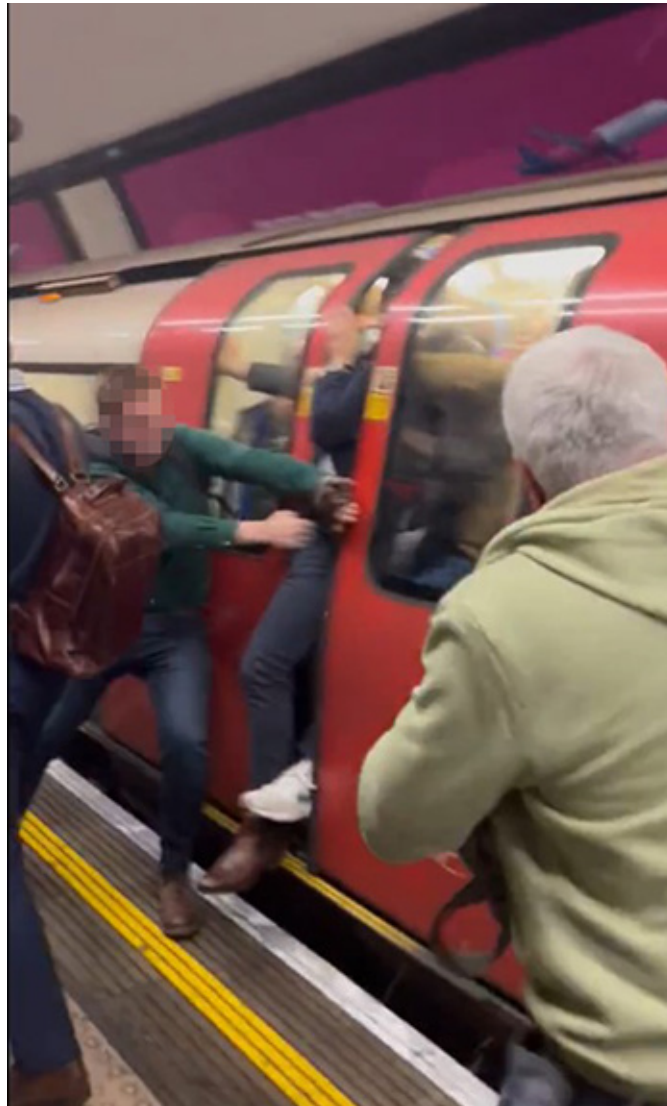
- 78** Passengers became increasingly alarmed, and their behaviour escalated, as the train's doors remained closed and they could not see any effective action from LUL staff.
- 79 Video evidence, recorded by passengers inside train 065 and on the platform, shows passengers initially reacting to the smell of burning and the sight of smoke. The behaviour of passengers within the train appears to escalate as other passengers also became aware of the situation, with some passengers attempting to force the train's bodyside doors. Passengers on board the train can be heard expressing an immediate fear for their safety and calling to passengers on the platform to break the train's bodyside windows.

*Figure 16: Still image from a video recorded by a passenger standing on the station platform. The image shows the leading double doors of car 6 during the initial stages of the incident.*
