Rail Accident Investigation Branch

Rail Accident Report

Trap and drag accidents at Archway and Chalk Farm stations 18 February and 20 April 2023

Report 06/2024
June 2024

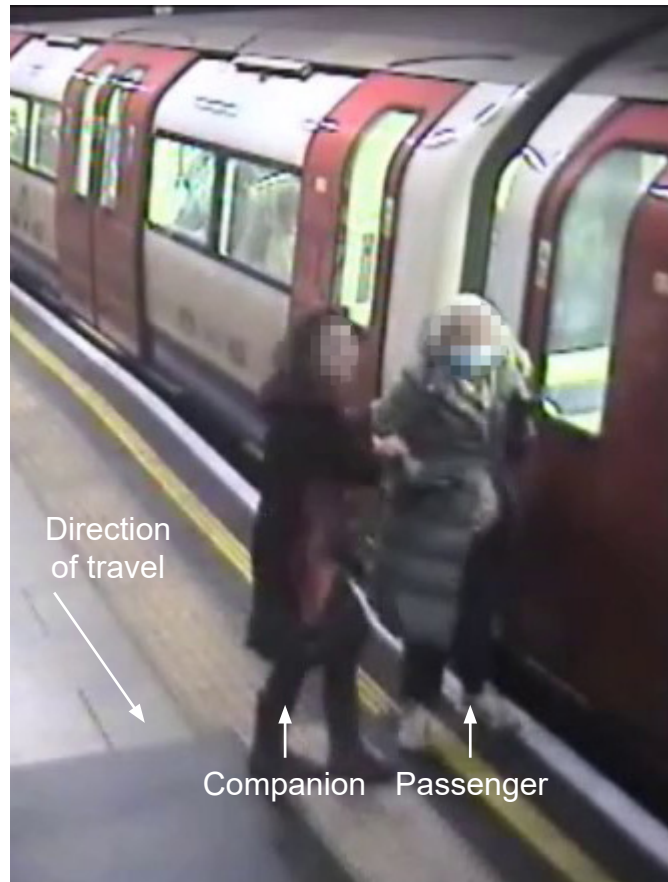
93 Approximately four seconds after the train started to move the train operator applied the emergency brake. The train operator stated that in carrying out a check of the platform as the train departed the station, they realised that there had been an accident and stopped the train.

Figure 7: The passenger, with coat trapped in door, on the platform at Archway station facing the front of the train.
