Rail Accident Investigation Branch

Rail Accident Report

Unsafe movement of a train at Styal station 3 May 2023

Report 07/2024
July 2024

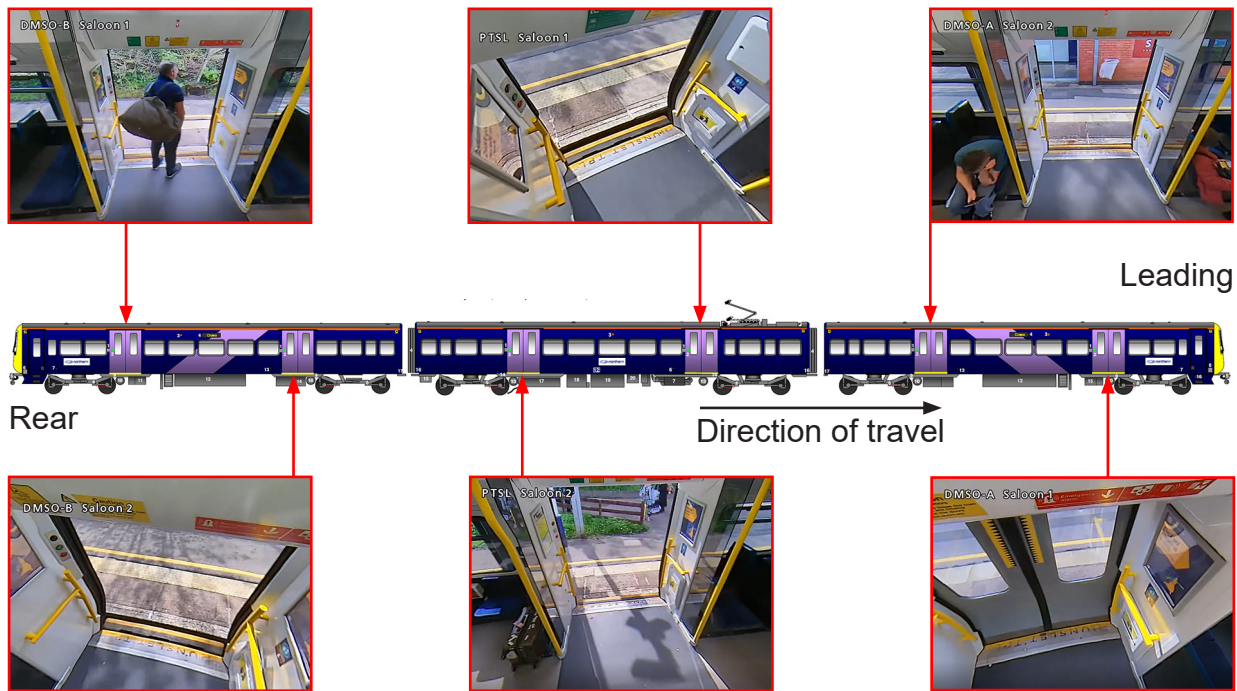
The train travelled for approximately 10 seconds with five doors open. Once the train reached 3.1 mph (5 km/h), a safety system caused the open doors to close automatically. No one was hurt in the incident, although people were moving towards the train and a passenger was standing in an open doorway when the train started to move.

Figure 2: Images from the internal CCTV showing the status of the train bodyside doors when the train started to move (courtesy of Northern Trains Ltd).

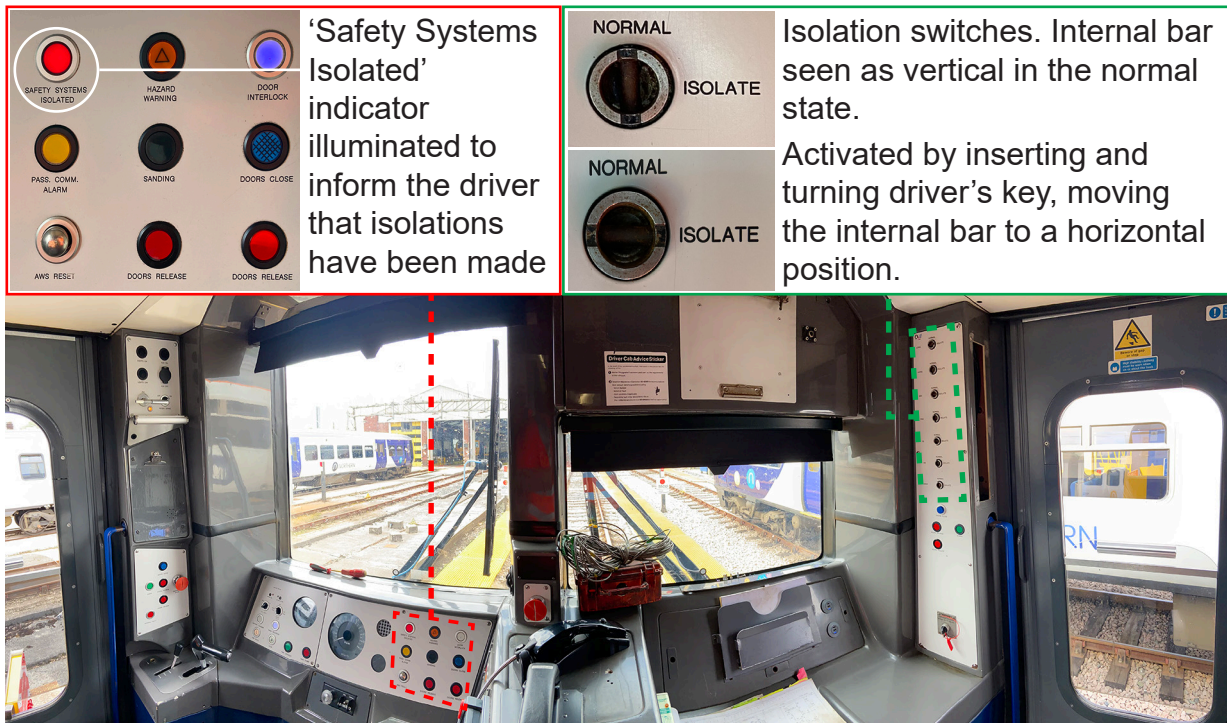
- 27 The emergency brake isolation switch (EBS) on class 323 units enables the train's braking safety systems to be bypassed (RIS-3437-TOM 'Defective On-Train Equipment', issue 3 dated 2022 uses the term 'emergency bypass switch' for the same piece of equipment).

- 28 The electrical supply for the train's brakes runs from the rear cab, through the train and its safety systems (such as the driver's safety device and emergency brake control) to the front cab. The electrical supply is sometimes known as a 'round train circuit' or 'safety loop'. The system also verifies that sufficient air pressure exists within the brake reservoirs. If these systems are in the correct configuration for safe operation, then the presence of this electrical supply will allow the train's brakes to be released. In contrast, a lack of electrical supply will ensure that the brakes cannot be released if a potentially unsafe condition exists. When activated, the EBS bypasses these functions, giving drivers the ability to move the train if defects exist which may have been preventing the train's brakes from being released.

Figure 4: The location of the 'safety systems isolated' light on the driver's desk and the safety isolation switches within the cab (left to right).

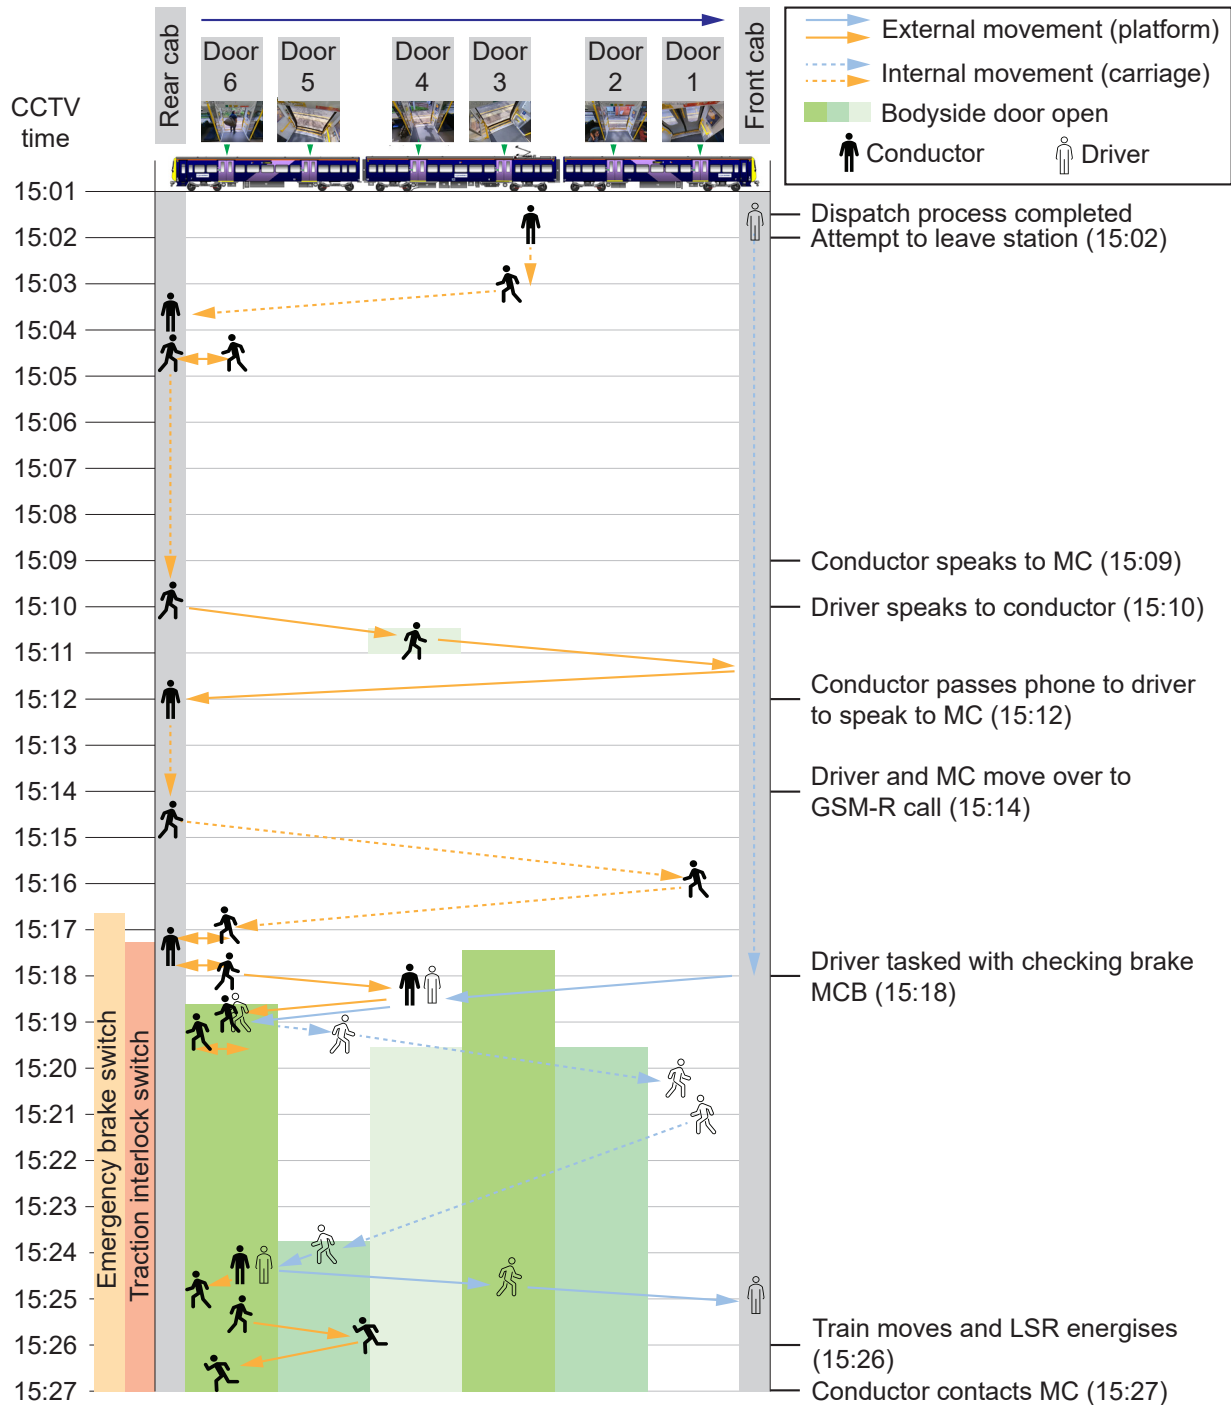
- 53 Meanwhile, the driver ran along the platform and returned to the front cab at 15:26 hrs. Within the next 30 seconds, the driver was able to get brake release and apply traction power. Although the conductor was stood on the platform and had not initiated the dispatch process, the driver sent an RTS acknowledgement to the conductor, normally the final step in the train dispatch sequence (see paragraph 105). The train then started to move with five bodyside doors open. The conductor, on the platform, shouted at the passengers on the platform to stand back from the moving train, while running towards the rear cab.

- 54 The passengers and conductor on the platform observed the five open bodyside doors automatically close as the train departed. This was due to the LSR being activated (paragraph 32) as the train accelerated to 3.1 mph (5 km/h).

Figure 5: The movements of the driver and conductor during the 25 minutes train 2A89 was at Styal station.

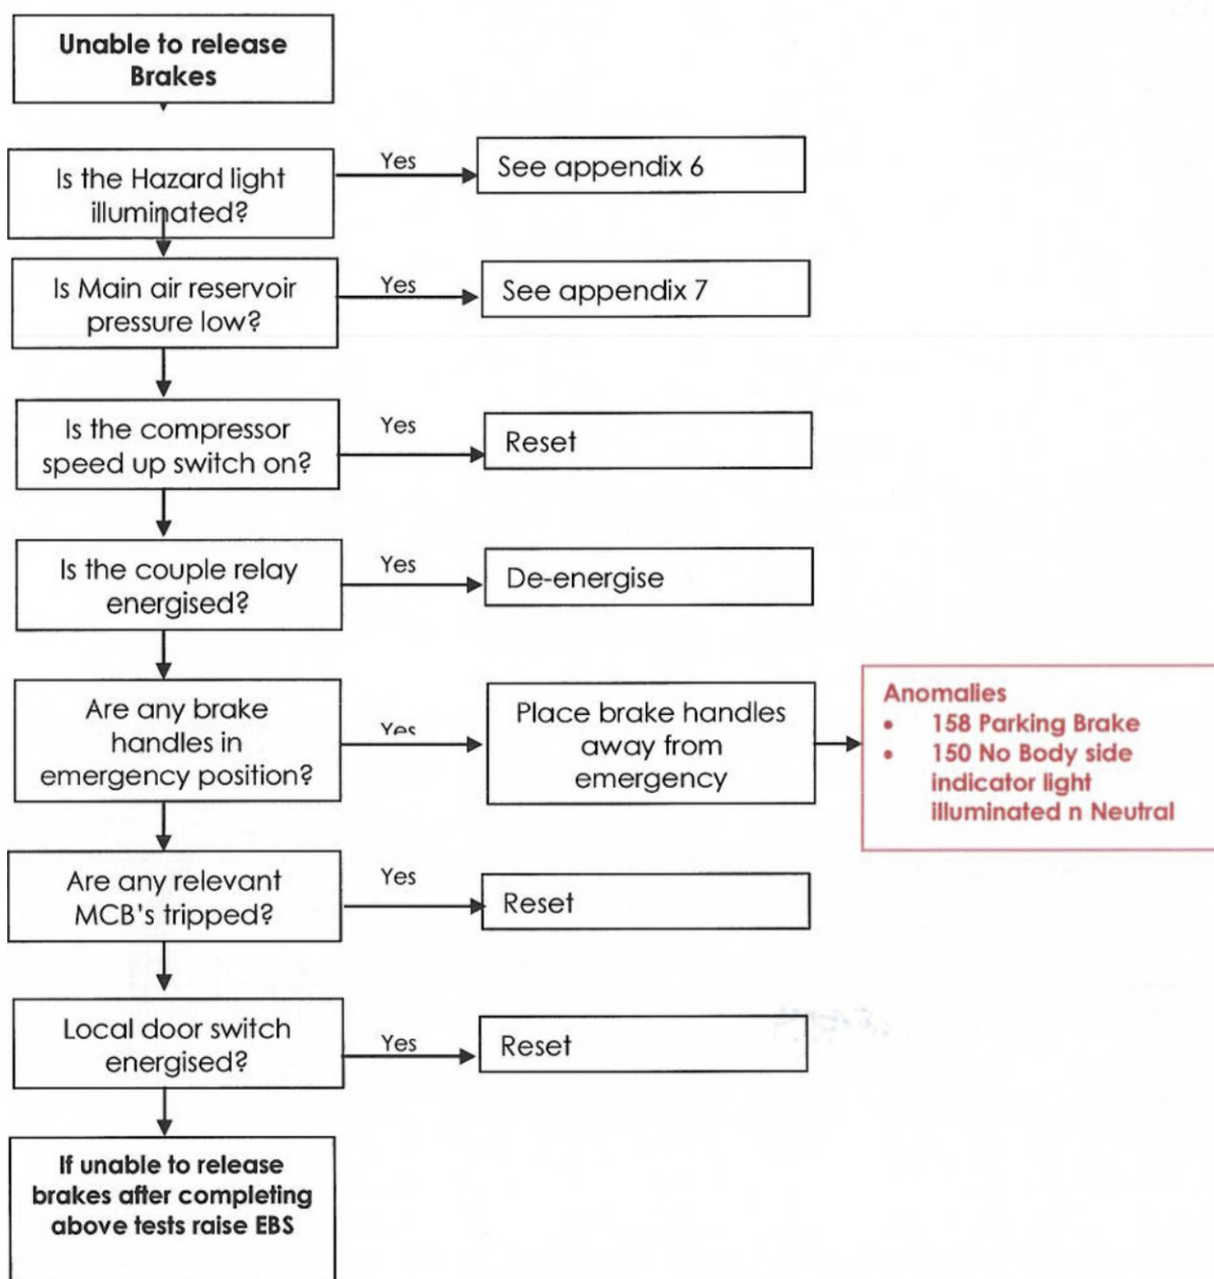
10.5. Appendix 5: Unable to Release Brakes Flowchart

- 119 The TIS is not referenced in the flow chart as an option, which also does not provide any support to the MC regarding the related Rule Book requirements (paragraph 85) following the activation of the EBS. This means that the flow chart does not guide the MC to seek authorisation or inform the DCM (paragraph 79), and it does not offer any further support or direction should the fault not be

rectified by the end of the flow chart.

Figure 6: 'Unable to Release Brakes Flowchart' issued to Northern MCs.
