Rail Accident Investigation Branch

Rail Accident Report

Unsafe movement of a train at Styal station 3 May 2023

Report 07/2024
July 2024

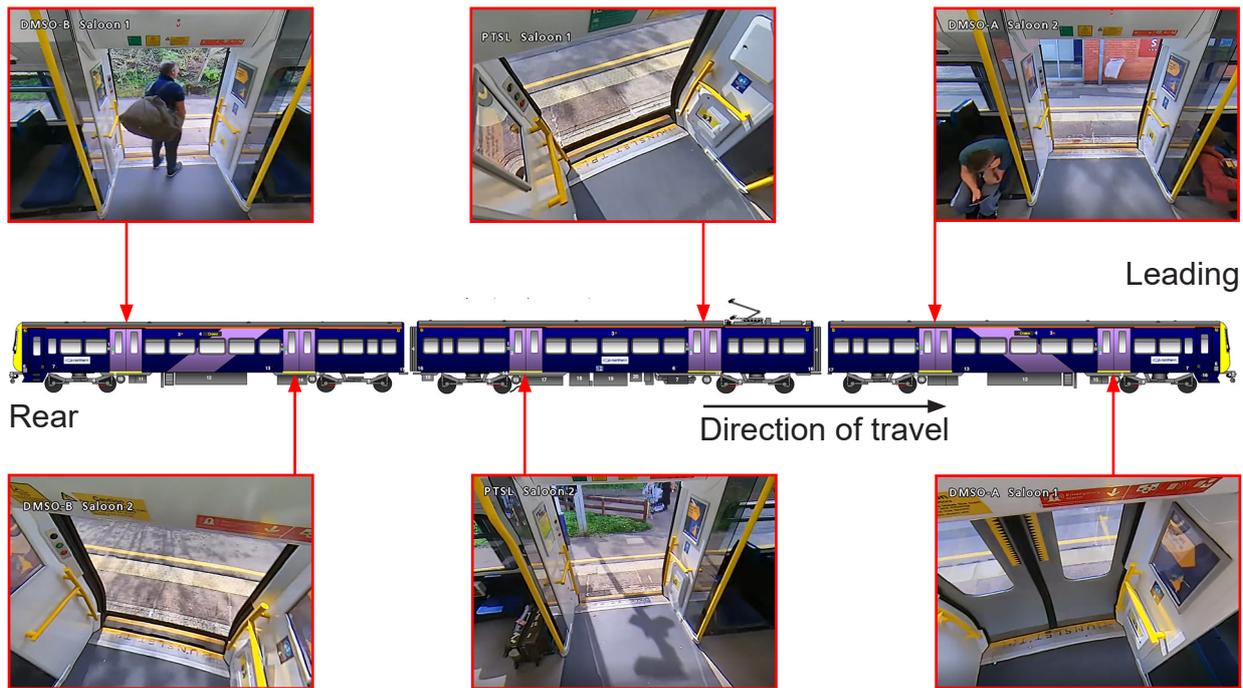
The train travelled for approximately 10 seconds with five doors open. Once the train reached 3.1 mph (5 km/h), a safety system caused the open doors to close automatically. No one was hurt in the incident, although people were moving towards the train and a passenger was standing in an open doorway when the train started to move.

Figure 2: Images from the internal CCTV showing the status of the train bodyside doors when the train started to move (courtesy of Northern Trains Ltd).

- 54 The passengers and conductor on the platform observed the five open bodyside doors automatically close as the train departed. This was due to the LSR being activated (paragraph 32) as the train accelerated to 3.1 mph (5 km/h).

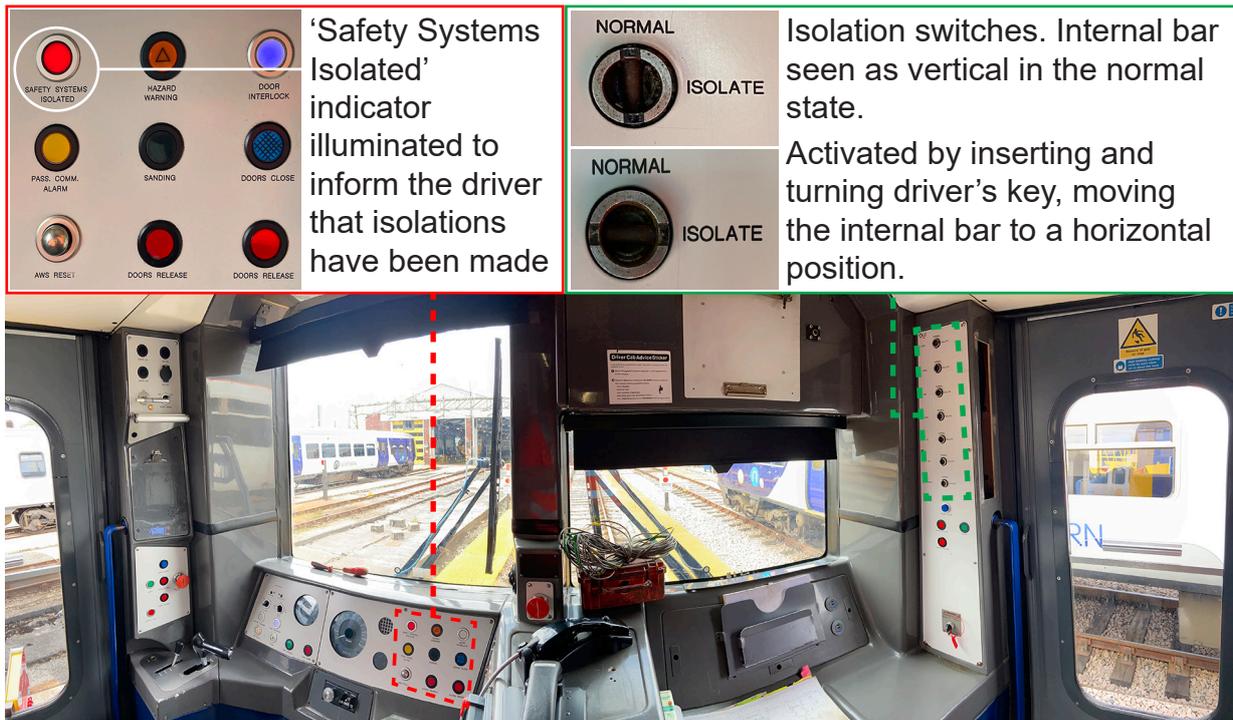
- 28 The electrical supply for the train's brakes runs from the rear cab, through the train and its safety systems (such as the driver's safety device and emergency brake control) to the front cab. The electrical supply is sometimes known as a 'round train circuit' or 'safety loop'. The system also verifies that sufficient air pressure exists within the brake reservoirs. If these systems are in the correct configuration for safe operation, then the presence of this electrical supply will allow the train's brakes to be released. In contrast, a lack of electrical supply will ensure that the brakes cannot be released if a potentially unsafe condition exists. When activated, the EBS bypasses these functions, giving drivers the ability to move the train if defects exist which may have been preventing the train's brakes from being released.

Figure 4: The location of the 'safety systems isolated' light on the driver's desk and the safety isolation switches within the cab (left to right).

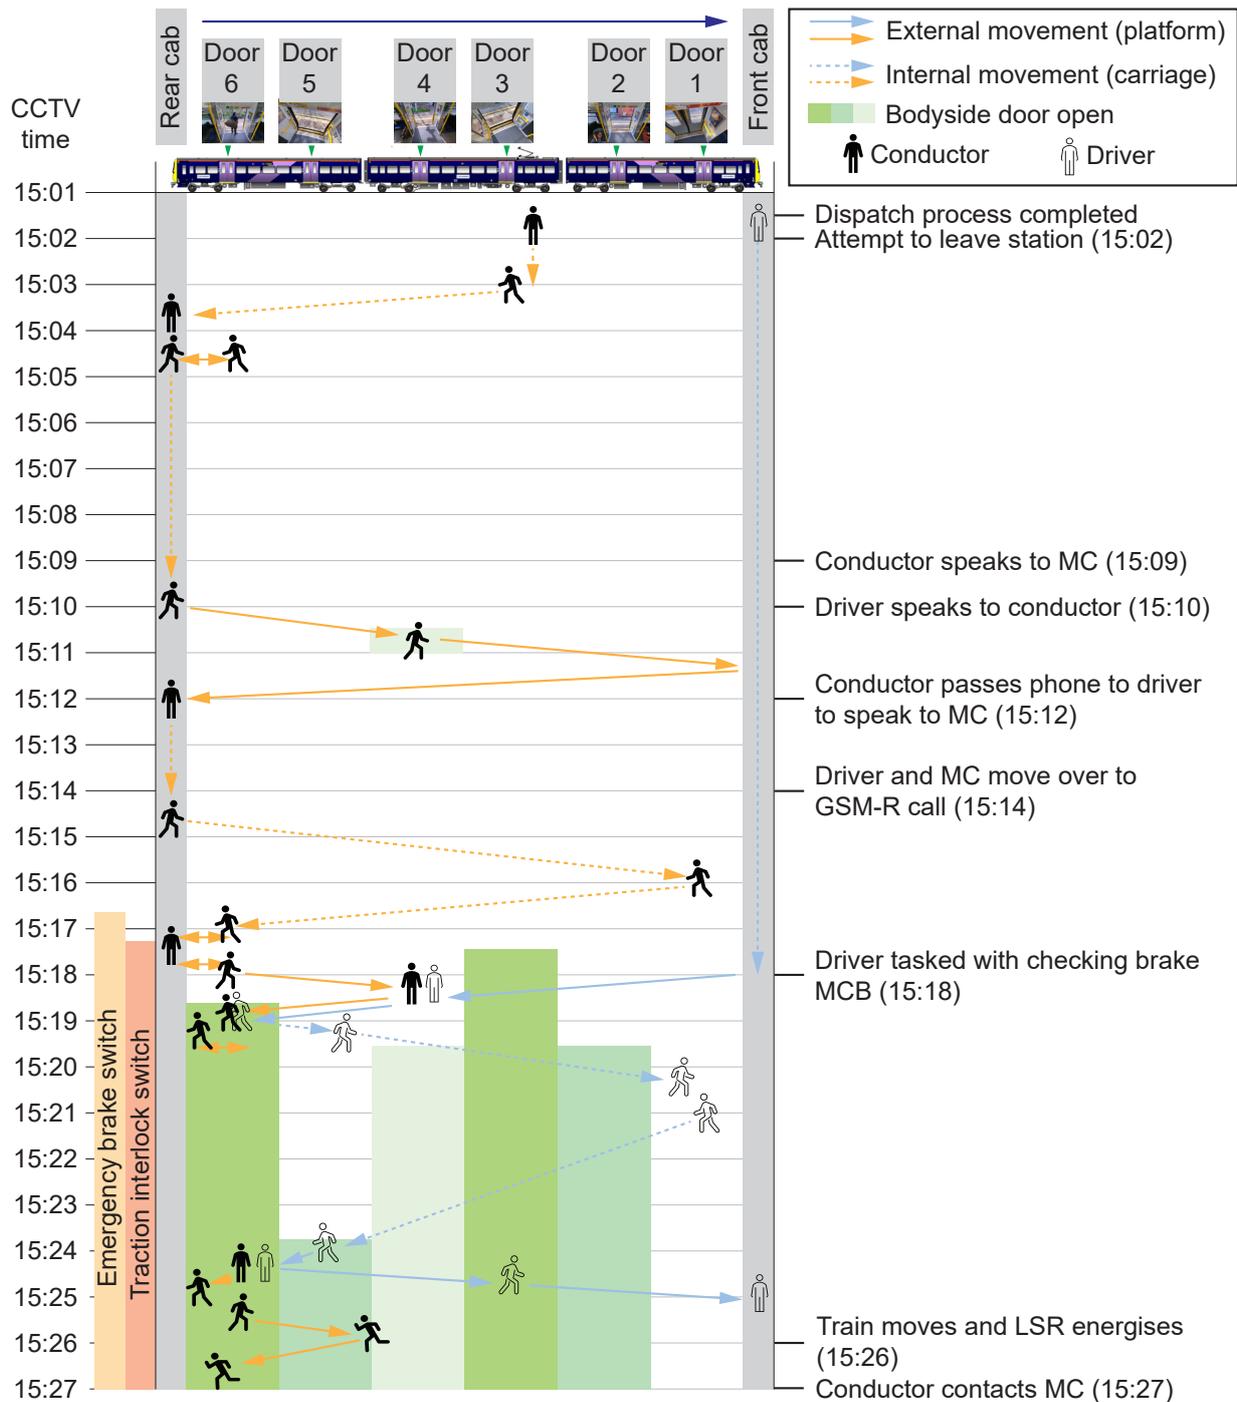
- 52 The driver met the conductor on the platform at 15:25 hrs. Together, they decided to make another attempt to overcome the defect. The conductor started to walk towards the rear cab, before being stopped by the passengers on the platform who had alighted the train. The conductor informed them that they were making a final attempt to overcome the defect and suggested that they boarded the train. The conductor did not expect the train to move at any point as they had not carried out the dispatch procedure.

- 53 Meanwhile, the driver ran along the platform and returned to the front cab at 15:26 hrs. Within the next 30 seconds, the driver was able to get brake release and apply traction power. Although the conductor was standing on the platform and had not initiated the dispatch process, the driver sent an RTS acknowledgement to the conductor, normally the final step in the train dispatch sequence (see paragraph 105). The train then started to move with five bodyside doors open. The conductor, on the platform, shouted at the passengers on the platform to stand back from the moving train, while running towards the rear cab.

Figure 5: The movements of the driver and conductor during the 25 minutes train 2A89 was at Styal station.

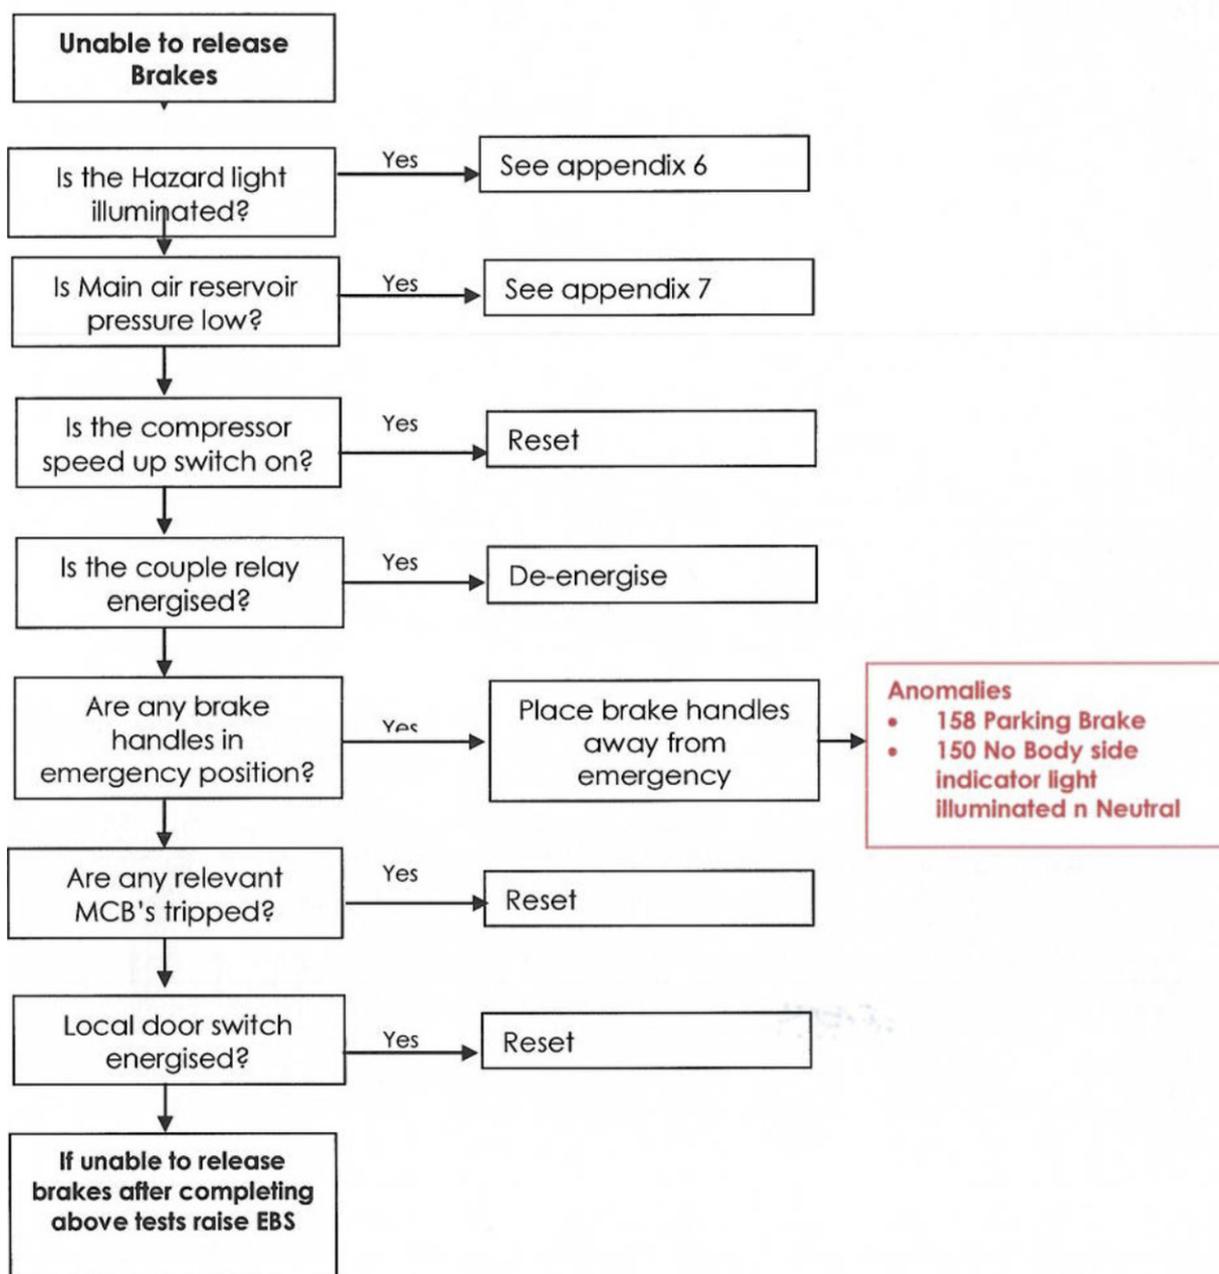
10.5. Appendix 5: Unable to Release Brakes Flowchart

- 119 The TIS is not referenced in the flow chart as an option, nor does the flowchart provide any support to the MC regarding the related Rule Book requirements (paragraph 85) following the activation of the EBS. This means that the flow chart does not guide the MC to seek authorisation or inform the DCM (paragraph 79), and it does not offer any further support or direction should the fault not be rectified by the end of the flow chart.

Figure 6: 'Unable to Release Brakes Flowchart' issued to Northern MCs.
