## Accident

<b>Aircraft Types and Registrations:</b>	1) Slingsby T.21B, WB 924 2) DJI Mini 2
<b>No &amp; Type of Engines:</b>	1) 0 engines 2) 4 electric motors
<b>Year of Manufacture:</b>	1) 1947 2) Unknown
<b>Date &amp; Time (UTC):</b>	7 October 2023 at 1657 hrs
<b>Location:</b>	Dunstable Airfield, Bedfordshire
<b>Type of Flight:</b>	1) Private 2) Private
<b>Persons on Board:</b>	1) Crew - 1                      Passengers - 1 2) Crew - 0                      Passengers - 0
<b>Injuries:</b>	1) Crew - None                  Passengers - None 2) Crew - N/A                  Passengers - N/A
<b>Nature of Damage:</b>	1) Superficial damage to the fabric surface of the leading edge of the glider's left wing. 2) The damage to the unmanned aircraft is unknown.
<b>Commander's Licence:</b>	1) BGA Gliding Certificate 2) Not known
<b>Commander's Age:</b>	1) 59 years 2) Not known
<b>Commander's Flying Experience:</b>	1) 864 hours (of which 3 were on type) Last 90 days - 14 hours Last 28 days - 8 hours 2) Unknown

<b>Information Source:</b>	Aircraft Accident Report Form submitted by the pilot and AAIB enquiries

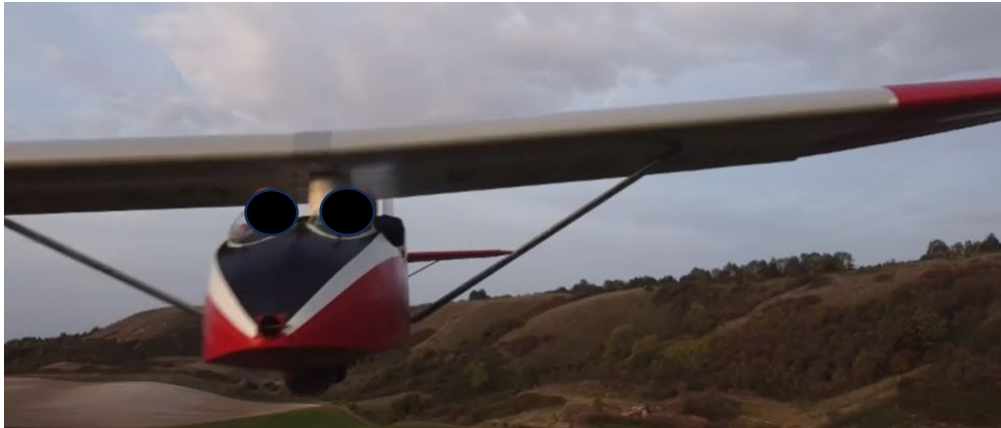
**Figure 1**

The UA fell to the ground and was retrieved by two young individuals who shared the UA log and video footage with a witness. The log and video show that the UA was flown on the direct approach path of the glider, and the glider was in view of the camera on the UA. Figure 1 is an image taken from the UA video just prior to impact. The video also shows that the UA was being flown from a public car park located on Dunstable Downs and that the young operator was accompanied by two adults.

View from the UA camera just before impact (used with permission)

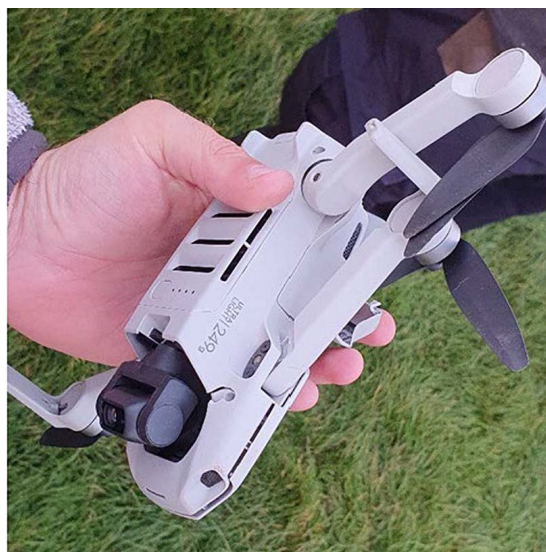
**Figure 2**

From a photograph of the UA, taken by a witness after the accident (Figure 2), it was identified as a DJI Mini 2, which is equipped with a camera and weighs 249 g. The images supplied to the AAIB did not display an Operator ID, nor was an ID reported to the AAIB.

UA after the collision (used with permission)
