Maritime &  
Coastguard  
Agency

# SS Richard Montgomery: Survey report 2023

April 2023

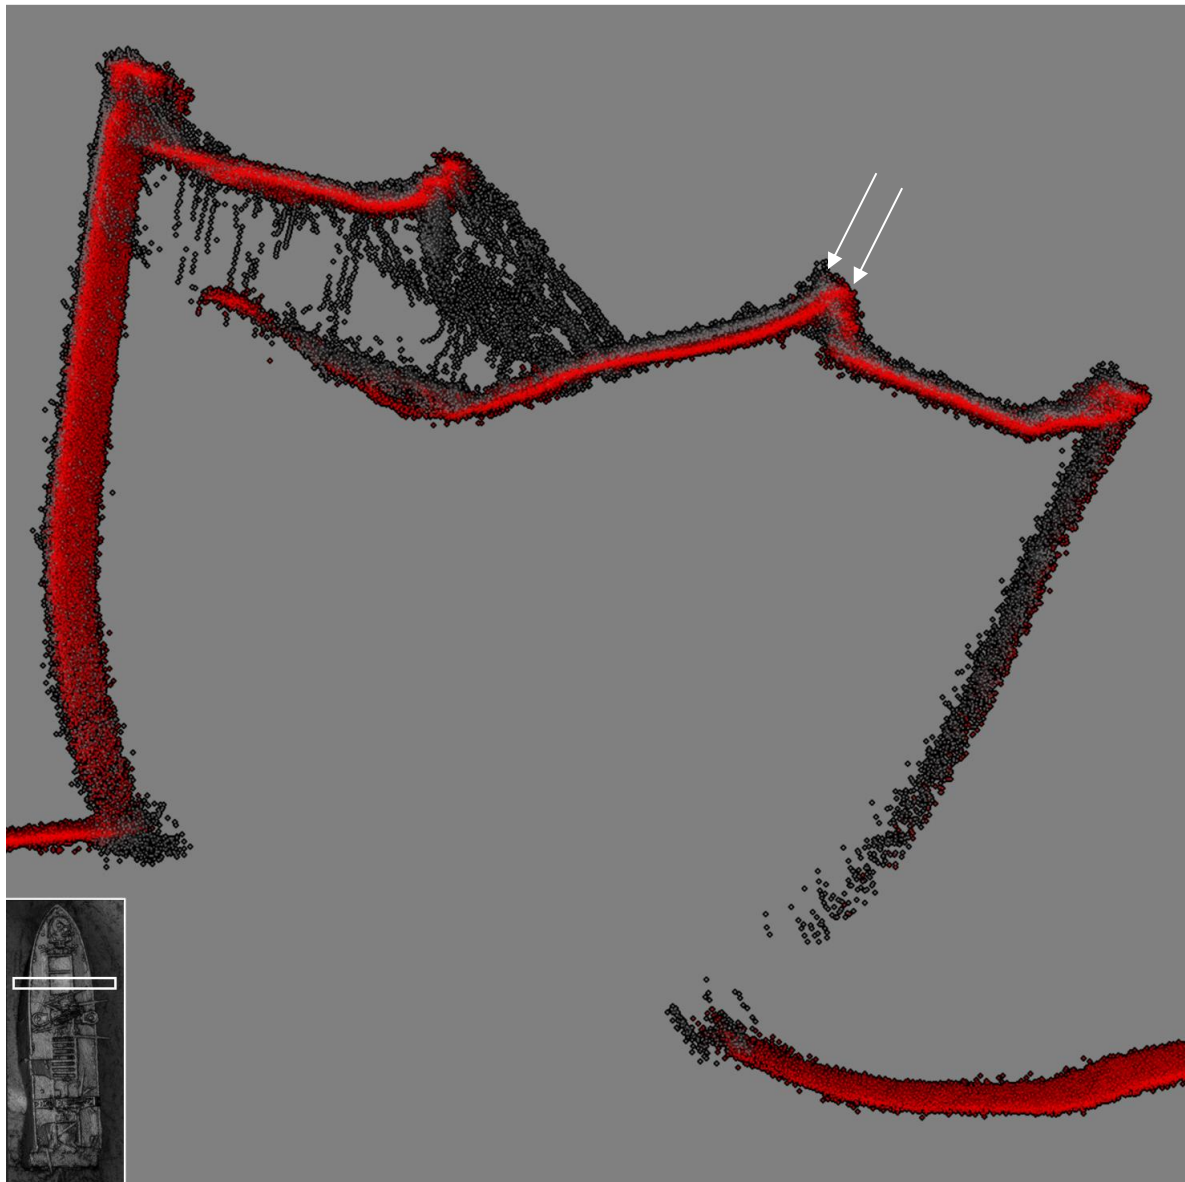
By comparing the full survey from 2023 with the full survey 2022, all the 2023 data is offset 10-15cm to the east (see examples in Figure 13 and Figure 14). The data has been verified to match very well on known structures on the stern section and objects on the sea floor. This increase in tilt might suggest that the northern part of SSRM has been undercut to the degree where it has started to lean more.

Figure 13. Cross section of point cloud data. Red is full survey 2023 and grey is 2022. Note the position of the coaming in both surveys and that the deck is lower in 2023 data.

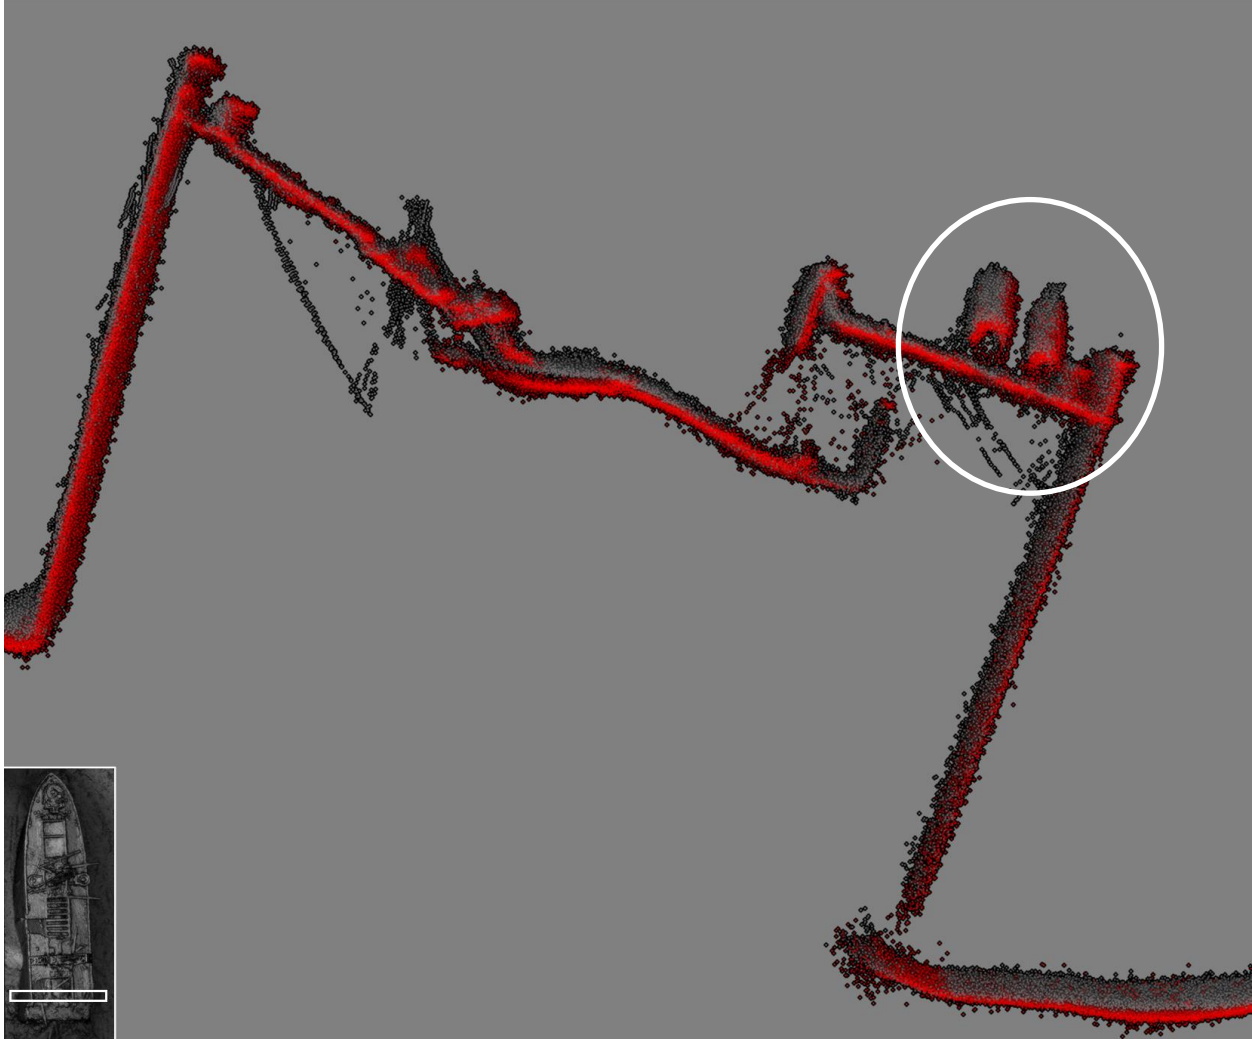
*Figure 14. Cross section of point cloud data. Red is full survey 2023 and grey is 2022. Note the two pipes in the circled section showing slight offset to the east.*

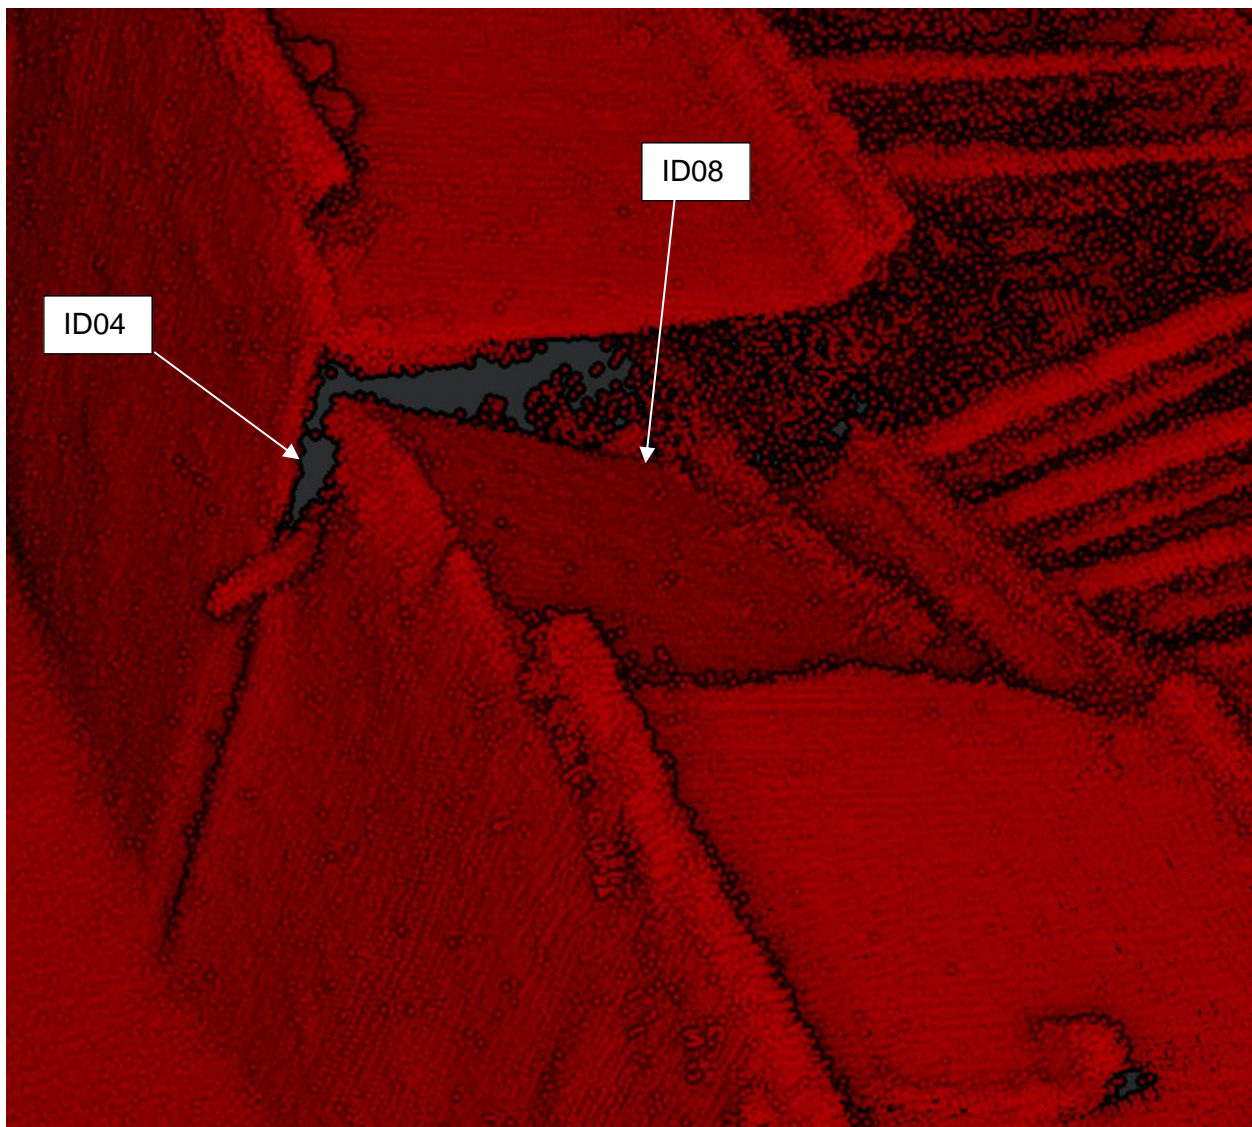
The forward section of the SSRM is seriously hogging almost exactly halfway along the no. 2 hold hatch. This hogging has resulted in a crack appearing on the upper part of the port side while the lower part of the starboard side is significantly buckled giving the appearance that the forward part of the wreck is splitting in two and pivoting about the starboard rim of hold 2. The flexing of the upper deck has caused a portion of the upper deck and half of the no. 2 hatch cover supports to collapse through into the 'tween deck space.

Figure 15. Crack in hull (ID04) and collapsed upper deck (ID 08) overview from the full survey in October 2023.

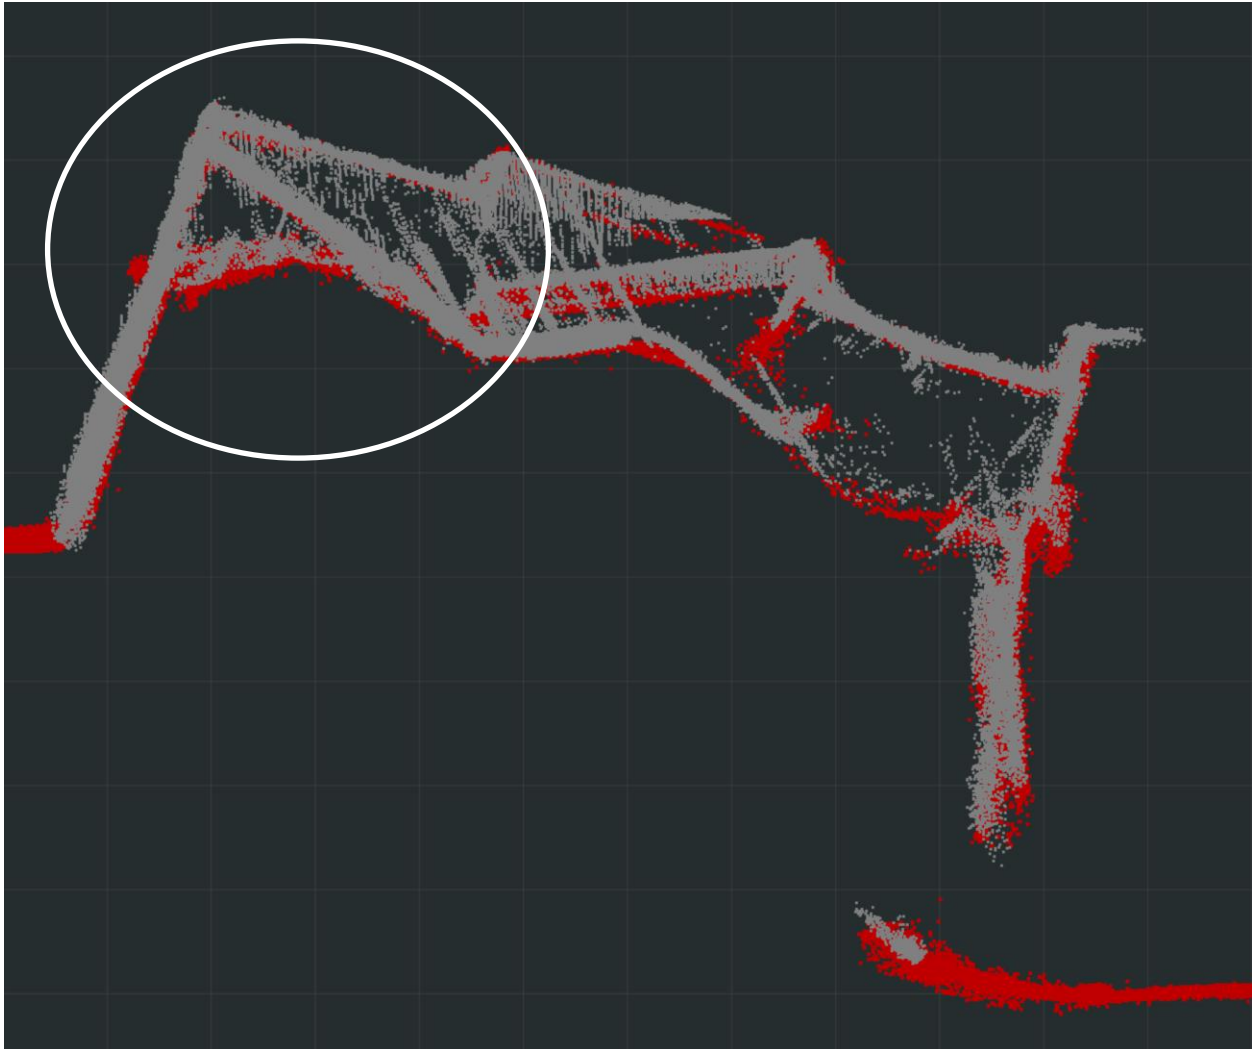
Overlaying the 2023 and 2022 survey data on a cross section shows the extent of the upper deck collapse (Figure 16). Between the two full surveys, it appears that the deck has collapsed further by approximately 17-20cm.

*Figure 16. Collapsed upper deck. October 2023 (red) and October 2022 (grey) in a cross section. Cross section is 1m thick.*

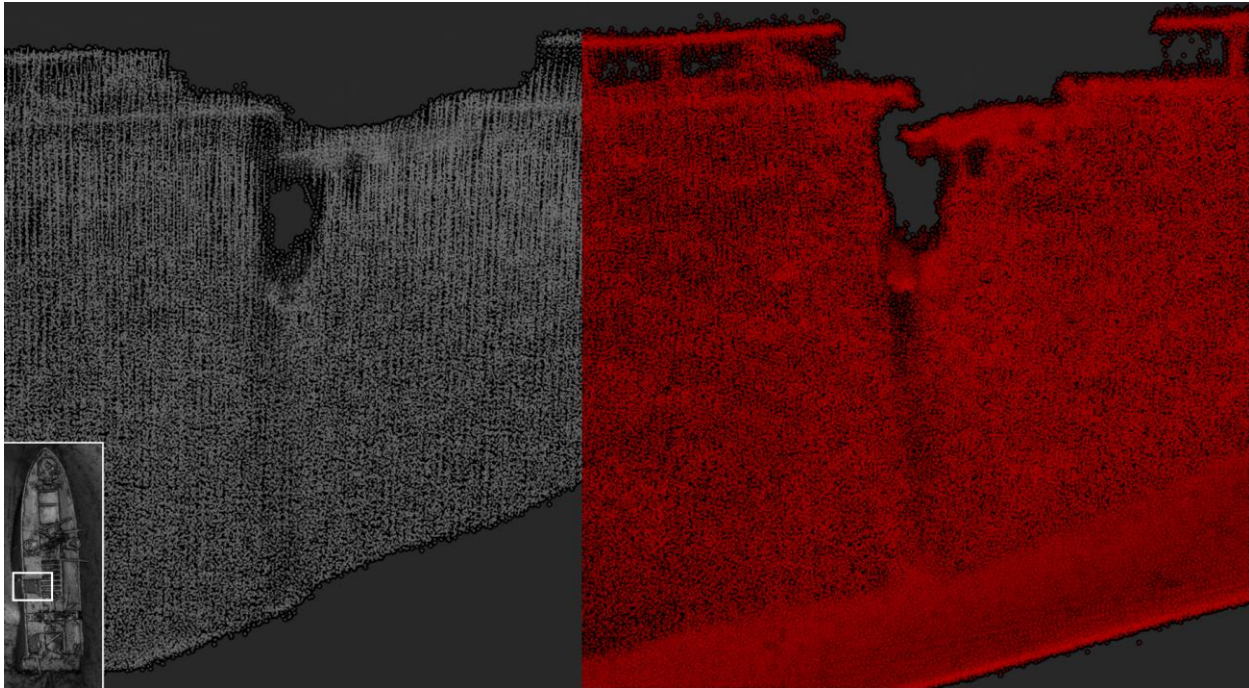
The crack in the hull is well defined in the 2023 full survey (Figure 17). Comparing the dimensions of the crack with the full survey from 2022 show that there has been an increase in the width by 5cm and 37cm in the length.

Figure 17. Side by side comparison of the crack in the hull (ID04). Left is 2022 full survey and right is 2023.

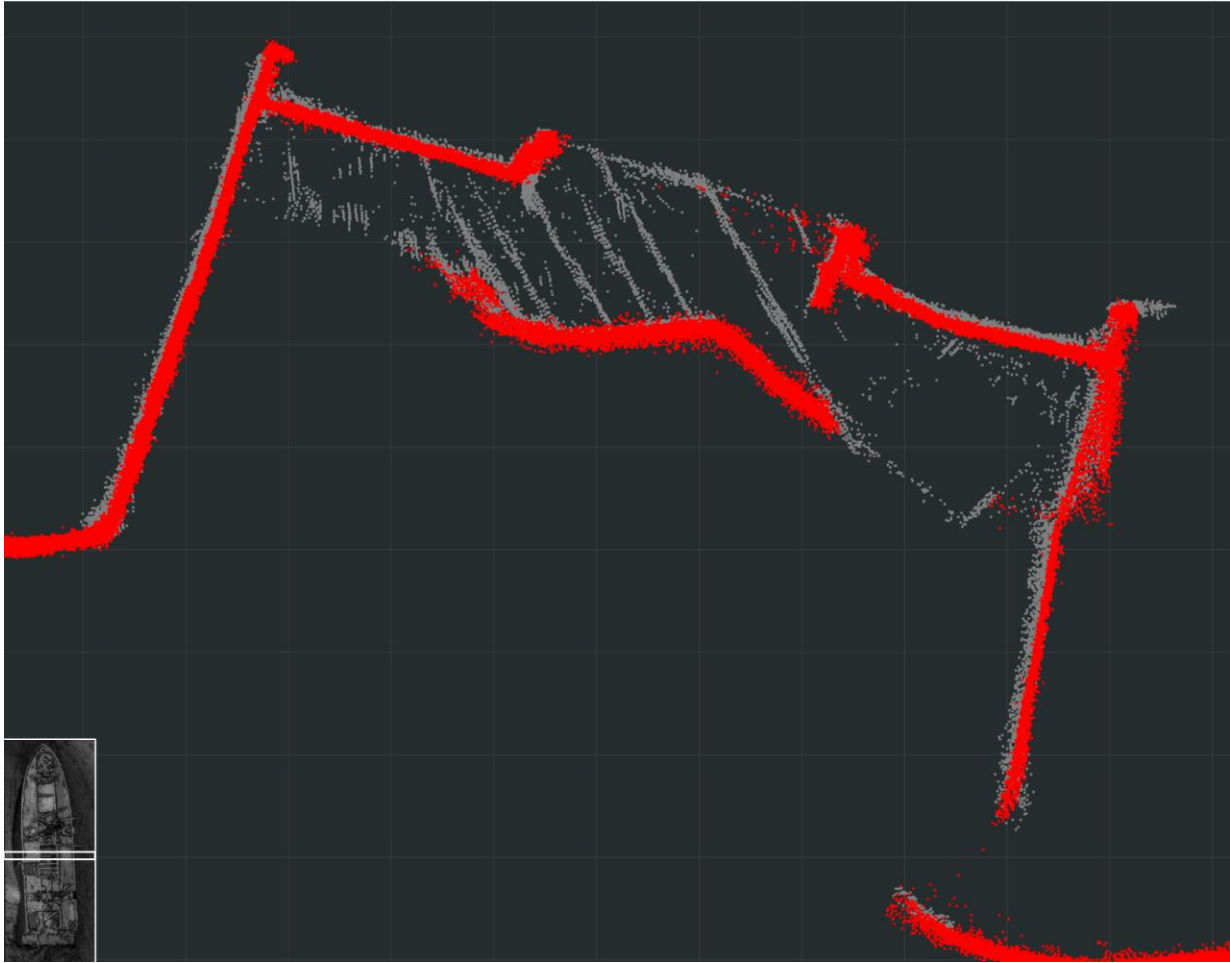
Agreeing with the result of the previous full survey 2022, there is no evidence showing sedimentation in the 'tween deck up to the coaming on the starboard side of the wreck in this area (Figure 18). It is possible that the sediments might wash out into an area that is internally collapsed and not visible in the multibeam data.

Figure 18. Comparison of a cross section in hold 2 between the 2022 full survey (grey) and 2023 full survey (red).

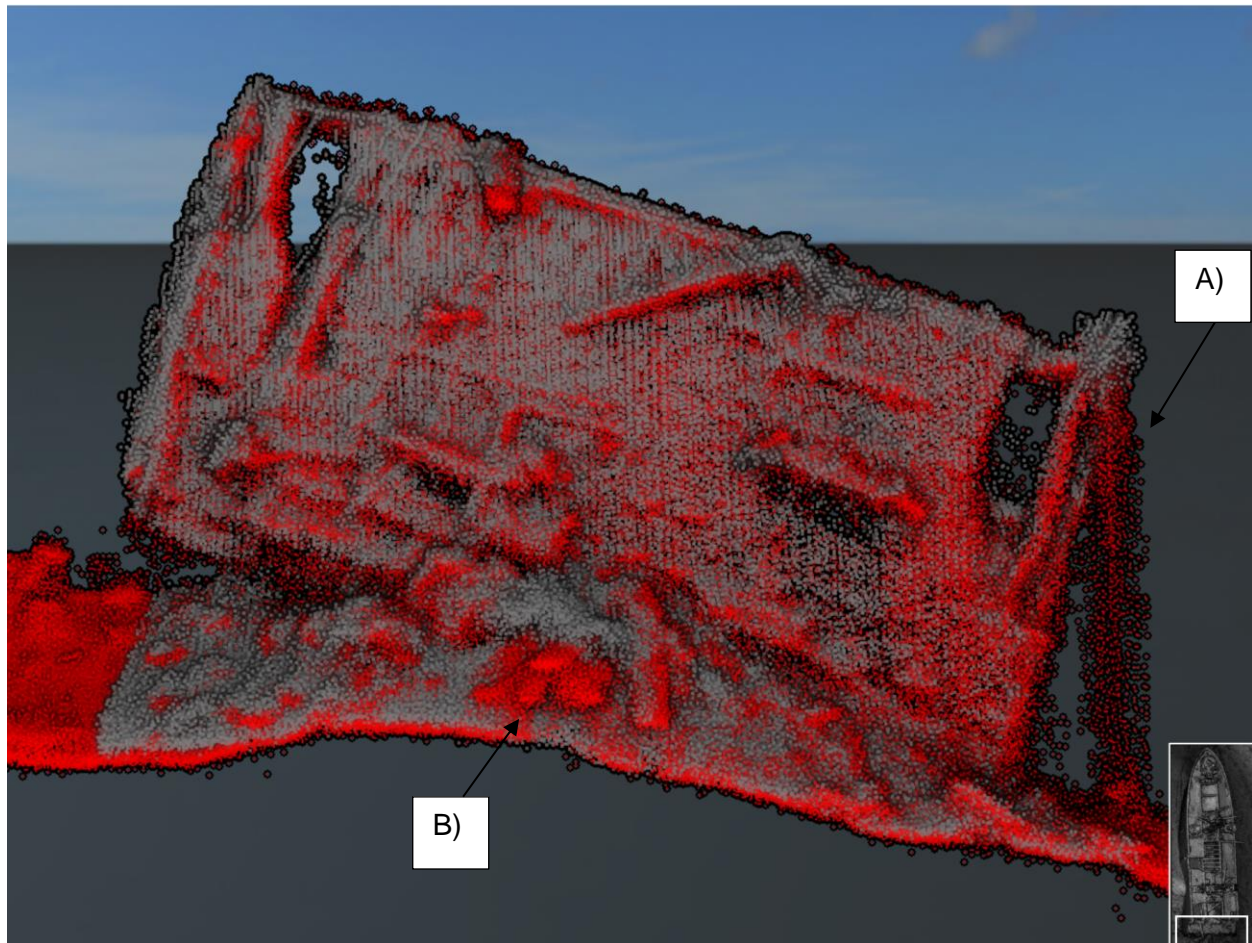
Figure 19 shows the apertures on the bulkhead at the aft end of the forward section, which are clearly visible in the 2023 data. Although no structural differences were found between the 2022 and 2023 survey, the 2023 survey identified an object that seems to hang from the railings (Figure 19, A). The high-resolution data also made more objects visible in the area between the forward section and the aft section (Figure 19, B).

Figure 19. Aperture in the bulkhead to rear of hold 3. Grey is 2022 data and red is 2023 data. Point A) shows the object hanging from the railing and point B) shows an example of an object only found in the 2023 dataset.

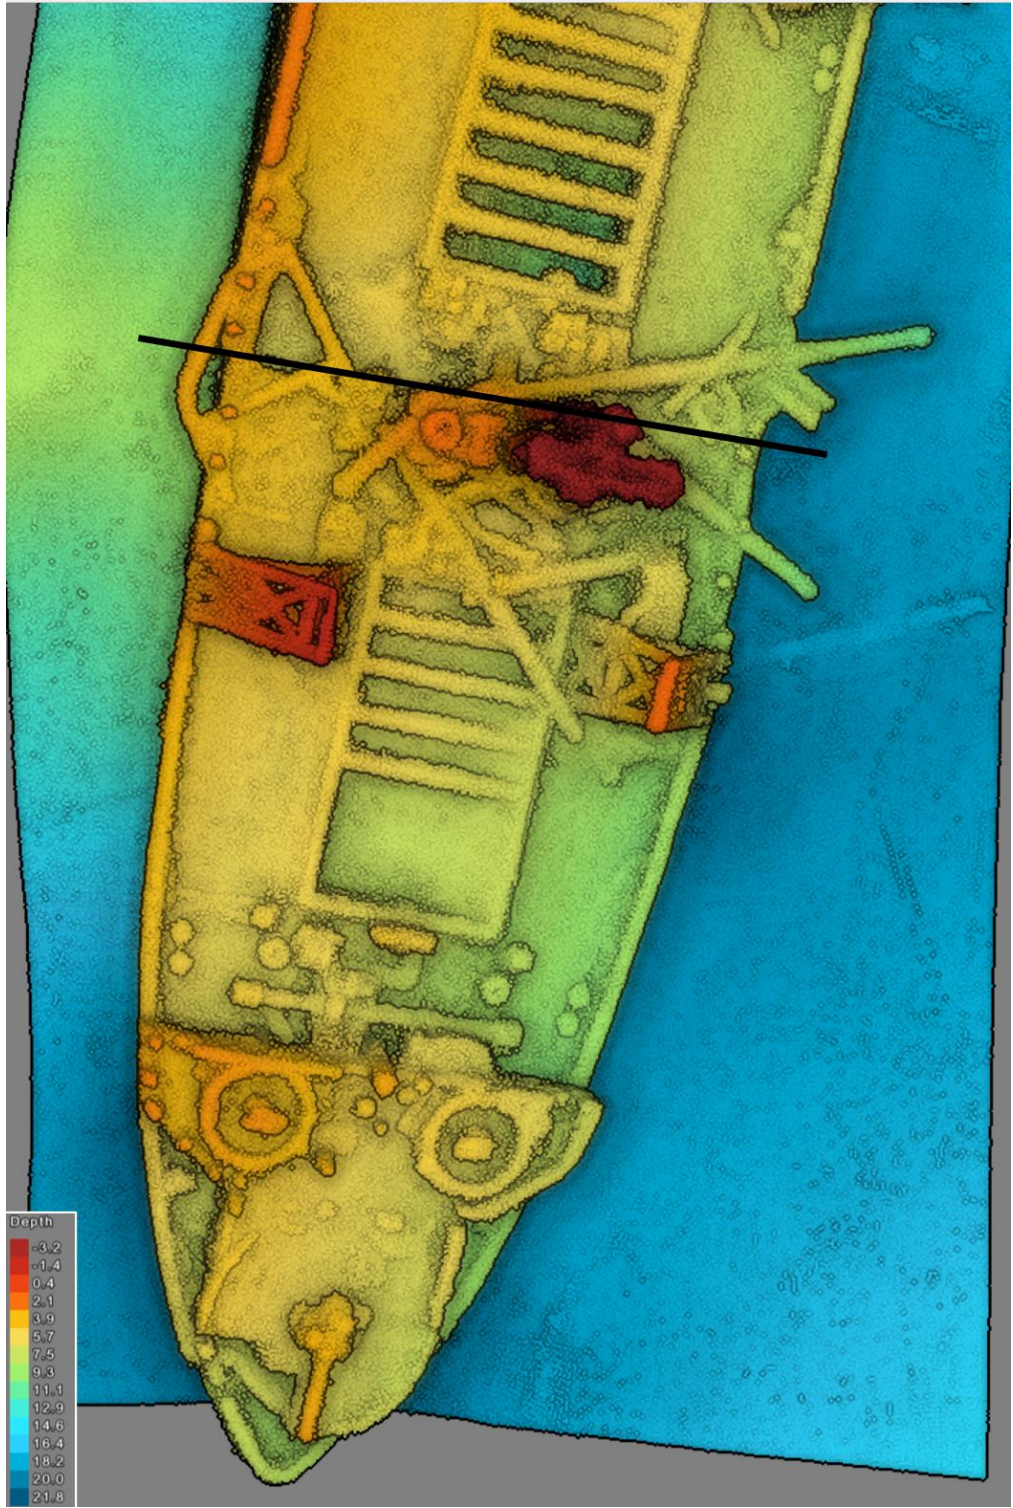
Key areas 4 and 5 represent the two ends of the same feature, namely a transverse crack across the rear hull section. Like the forward section, the rear section is hogging and potentially breaking in two about halfway along its length. The split appears to be occurring just forward of the mast with the mast remaining upright with respect to the stern part as it drops away from the forward part.

Figure 20. Top-down image of point cloud with line showing the probable split in the rear hull with ID25 and ID22 on port side and starboard side respectively.

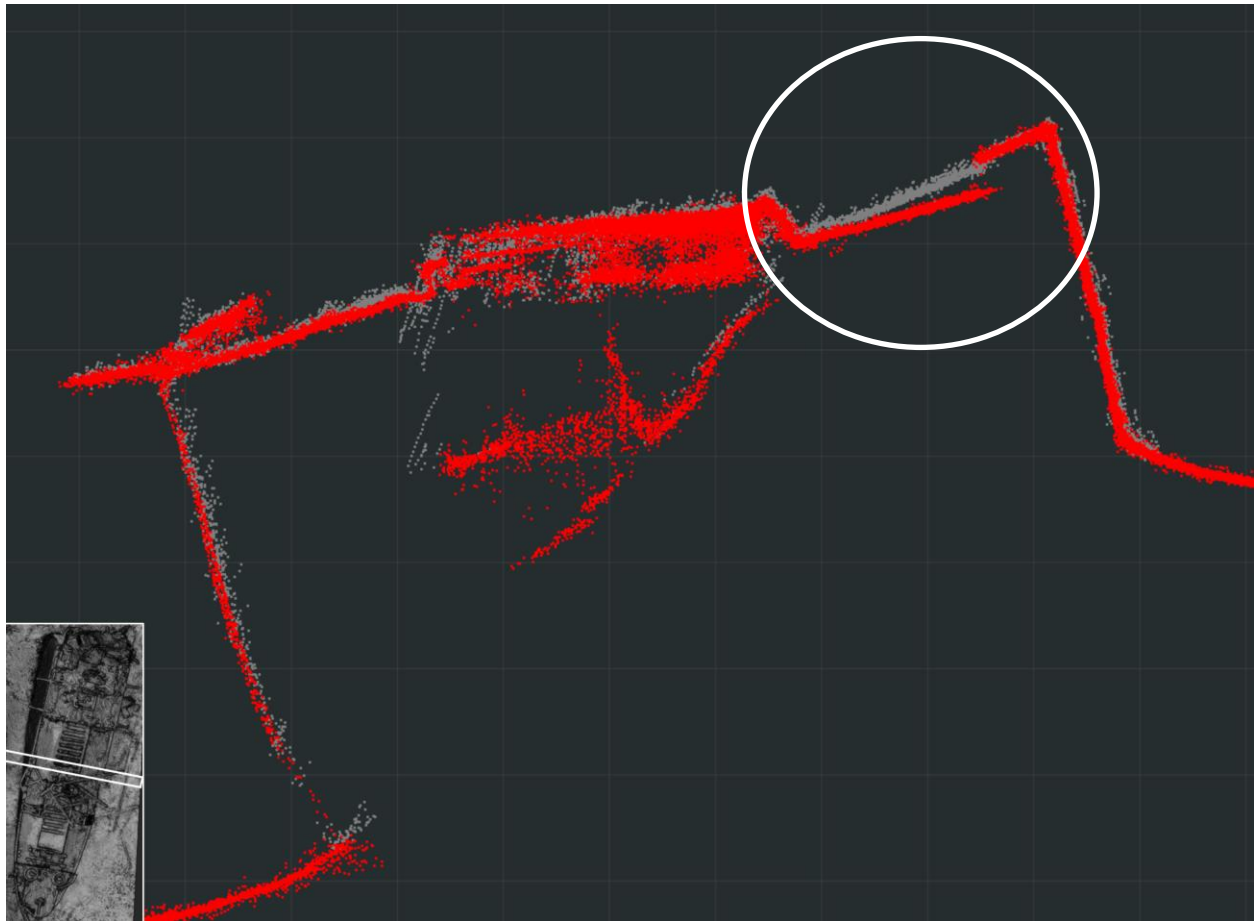
One notable change has been observed comparing the 2022 survey and the 2023 survey. The port side deck has collapsed between the 'tween deck hatch and the outer railings. A noticeable height difference of 0.55m has been observed (Figure 21). The total length of this collapse has been observed to exceed 6m (Figure 22) in north/south direction from the probable transversal split mentioned in section 4.2.6. This area has no ID, but because of the proximity to a key area it is proposed that an ID is assigned to it.

*Figure 21. Cross section showing collapse of deck area near key area 5. The difference is 0.55m. Red is 2023 full survey and grey is 2022 full survey.*

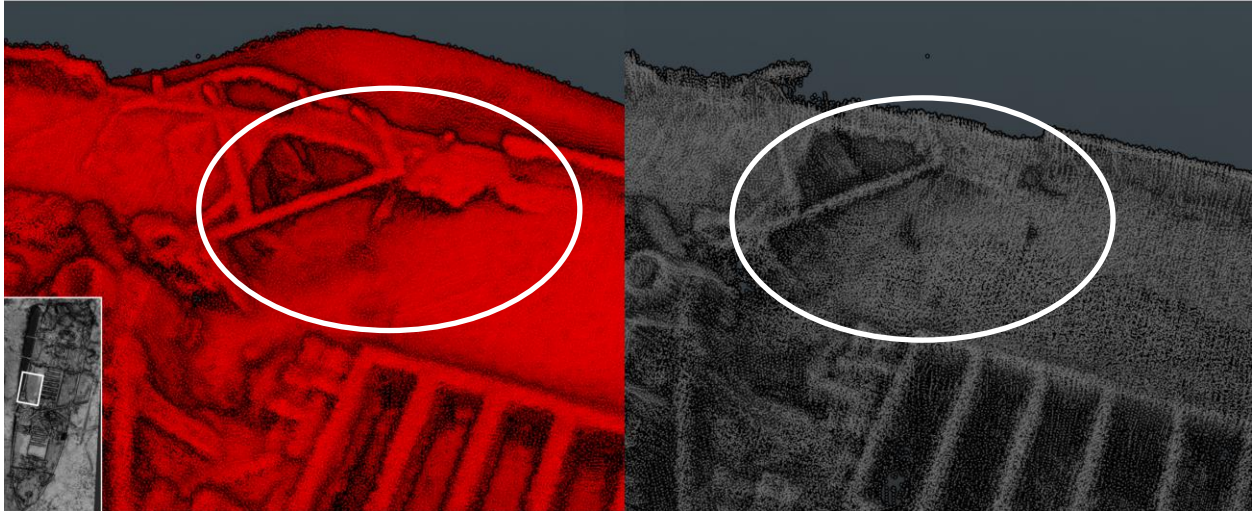
Figure 22. Comparison of point clouds on the newly discovered collapse. Measured distance of collapse is >6m. Red is 2023 full survey and grey is 2022.

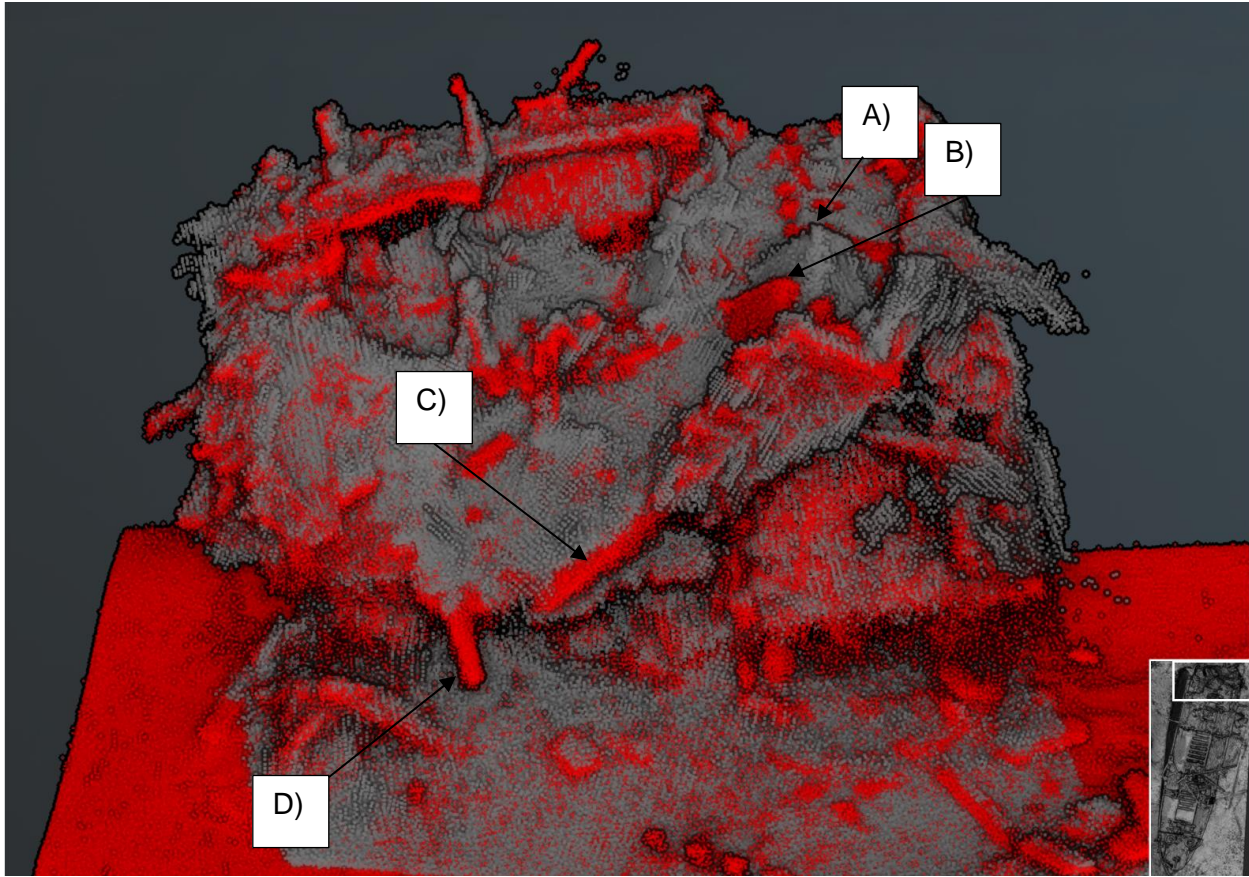
This area was left unsupported when the ship broke in two back in 1944. Consequently, it has been badly affected by wave and current action and is steadily collapsing and falling into the gap between the two halves of the vessel. This area has showed significant degradation in earlier surveys and continues to do so between the 2022 and 2023 surveys.

The further collapse of the area has been determined by comparing the box-like feature (ID46), which shows a difference of 1.5m between the 2022 (A) and 2023 survey (B). The deck does not seem to have collapsed any further between the two areas. However, there are two parts that are only visible in the 2023 survey (C and D) on the deck area, which might indicate that there has been some movement of objects.

Figure 23. Profile showing the bridge deck area. Red points are 2023 survey and grey are 2022. Points A) and B) show the movement of a well-defined object (ID46) in both surveys. Points C) and D) shows features only found in the 2023 dataset.

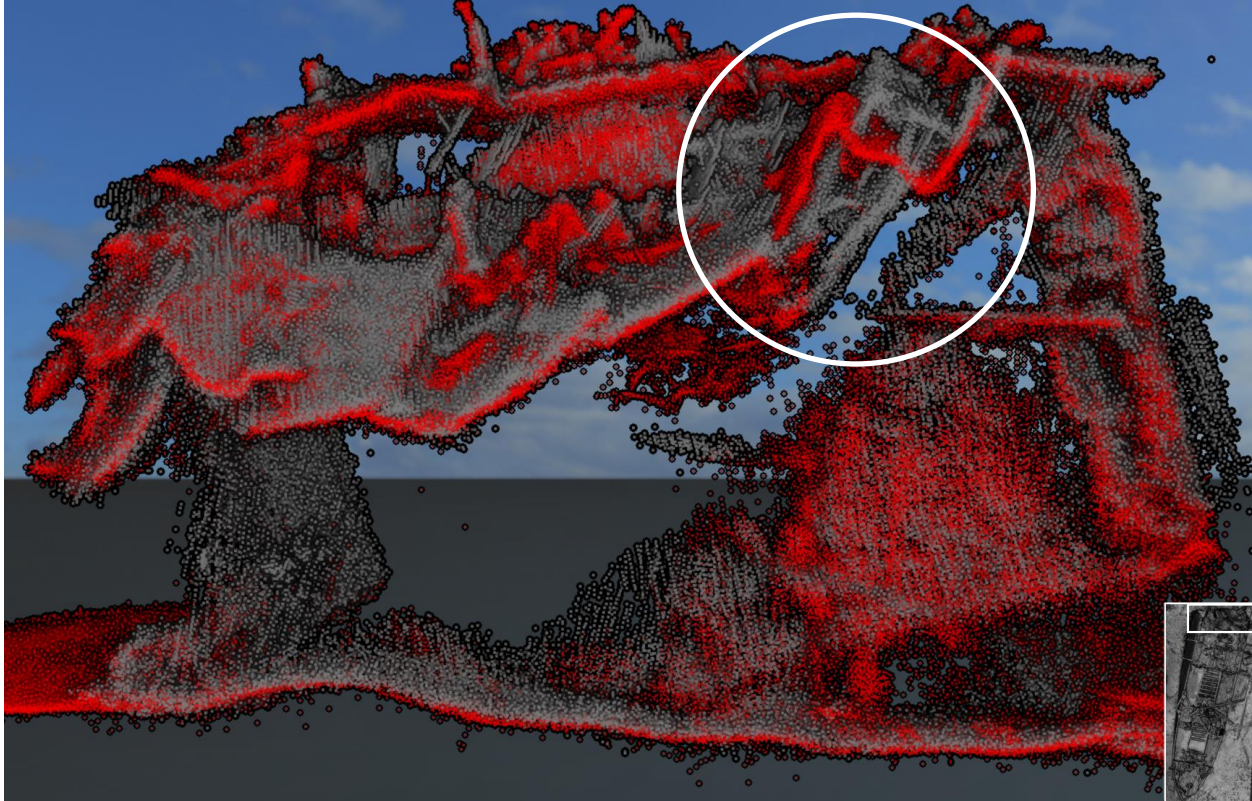
The collapse of the unsupported deck seems to be localized to the area around ID46 (Figure 24). Both the 2022 and 2023 survey matches well in the other parts of key area 6, except for more distinguishable objects found in the 2023 survey only.

Figure 24. Cross section at ID46 location, showing the difference in the deck area (circled). Red points are the 2023 full survey and grey points are the 2022 full survey.

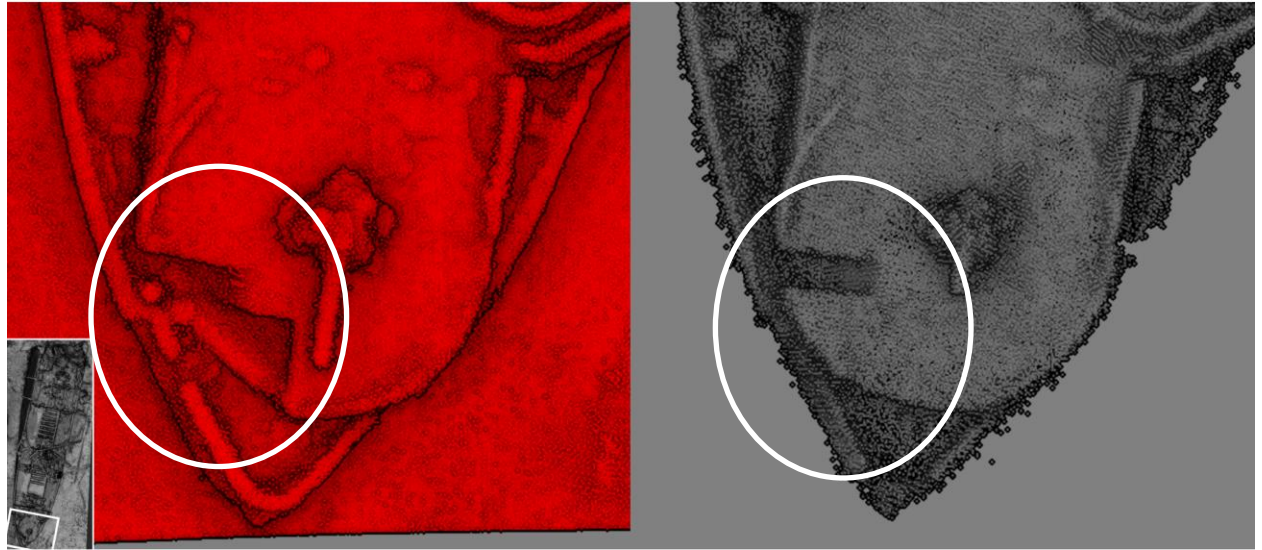
The two new suggested ID features are the collapsed deck (see section 4.2.6, Figure 21, Figure 22) and a collapsed deck underneath the turret on the stern section (Figure 25).

Figure 25. Top-down picture of the stern, showing the difference in the deck supporting the turret. Red points are the 2023 full survey and grey are the 2022 full survey.

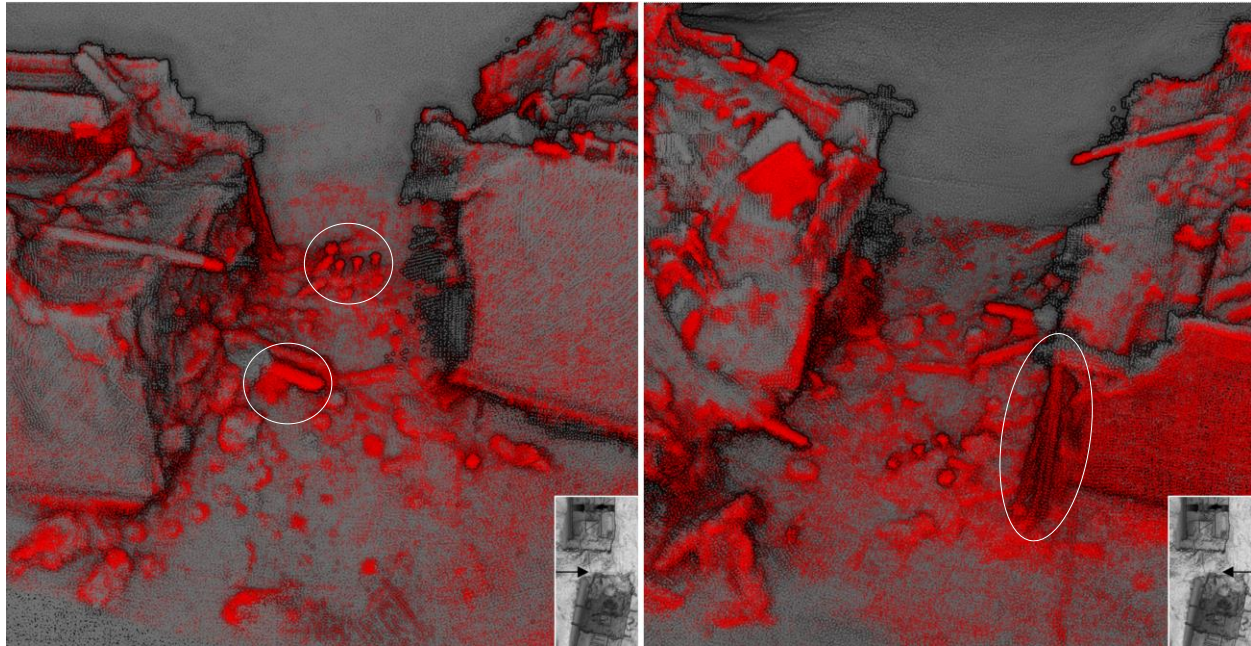
- 4.3.1** There have been differences between the two full surveys 2023 and 2022 in the area between the bow and stern section. Many new objects have been found and some objects have been better ensonified, resulting in higher resolution for those objects. Three larger new objects are visible between the two sections; one slightly elongated object (possibly a pipe or part of a mast), one triangular shaped frame with five cleat-like structures sticking up, and one suspected net-like object hanging from south east end on the bow section (Figure 26). Other than the three larger objects, there are numerous smaller objects clearly visible in the 2023 full survey.

Figure 26. Point cloud images of the area between the two bow and stern sections of SSRM from two directions. Red is the 2023 full survey and grey is the 2022 full survey. The arrows indicate which direction the camera is facing. Objects that are completely red are only found in the 2023 full survey.

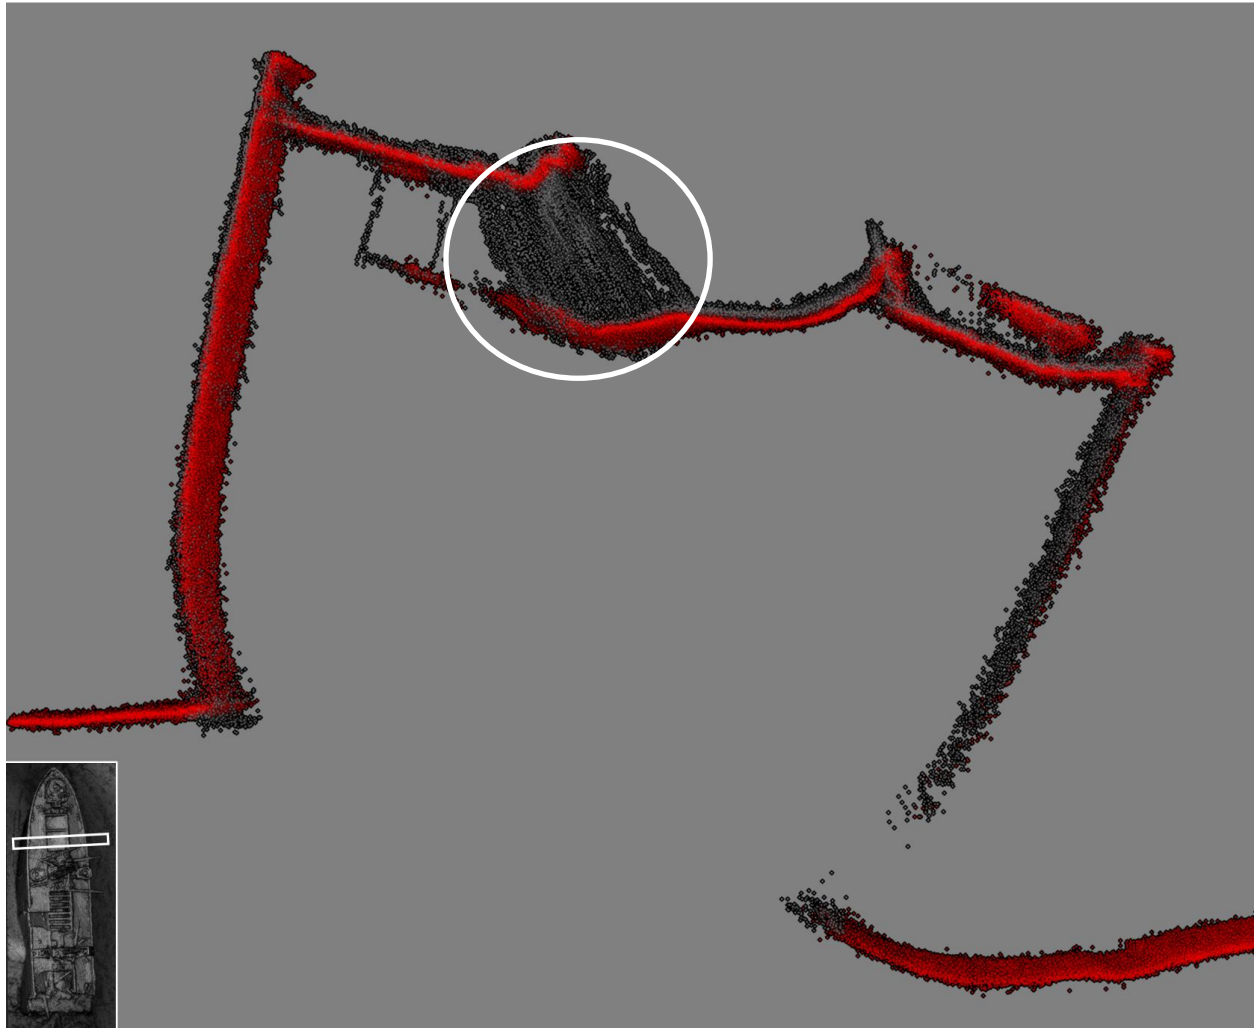
The hatch cover is missing as are all but one of the hatch cover supports. Sediment has settled in the 'tween deck space to a considerable depth, filling the starboard side to the top of the starboard side hatch coaming. The port side remains clear above the horizontal from the starboard hatch coaming. Apart from some undulations in the sediment surface there is no difference between the level identified by the 2022 full survey and the 2023 full survey (Figure 27, Figure 28). Comparisons between the 2022 and 2023 full surveys regarding sedimentation has been difficult in some areas as there has been a high level of noise in the 2022 survey. Because of this it has been difficult to determine what has been sediment or noise (see circle in Figure 28).

Figure 28. Cross section through the hull at the aft end of no. 1 hatch. Red full survey 2023, grey full survey 2022. Circled is an area where there is a large difference between the surveys, most likely noise in the 2022 survey.

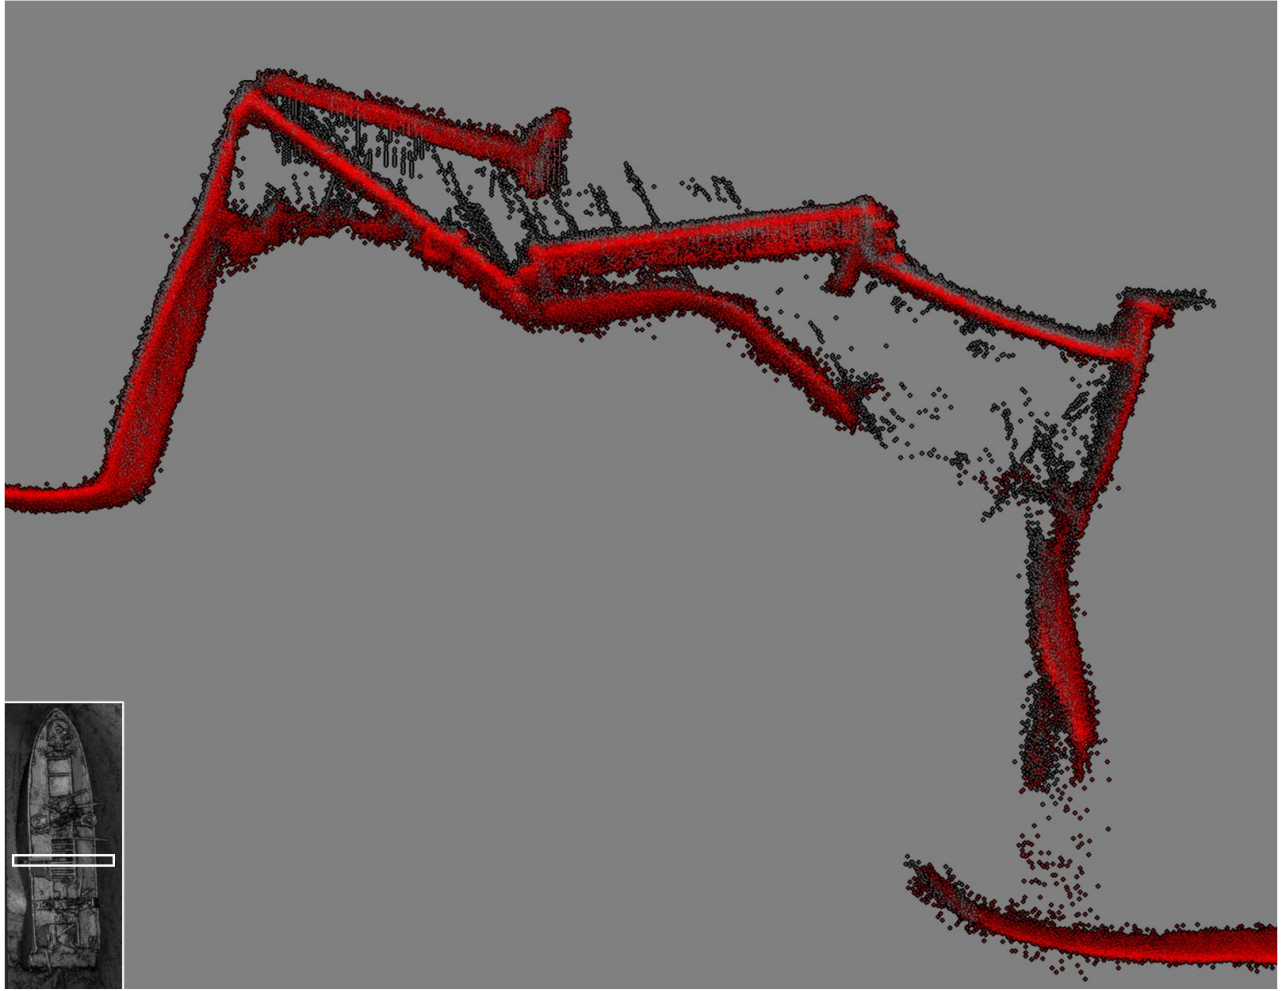
report (2022) suggested is also possible that the second deck has partially collapsed where it joins the port and starboard hull (Figure 30), but data collected in the full survey 2023 cannot confirm or deny that statement. However, there is evidence of a reduction in the amount of sediment in the aft end of hold 2 (Figure 31, white circle) of approximately 70cm, which might suggest that the hatch to the second deck may be compromised at this location.

*Figure 30. Cross section through the hull where the forward section is breaking in two. Red 2023 full survey, grey 2022 full survey.*

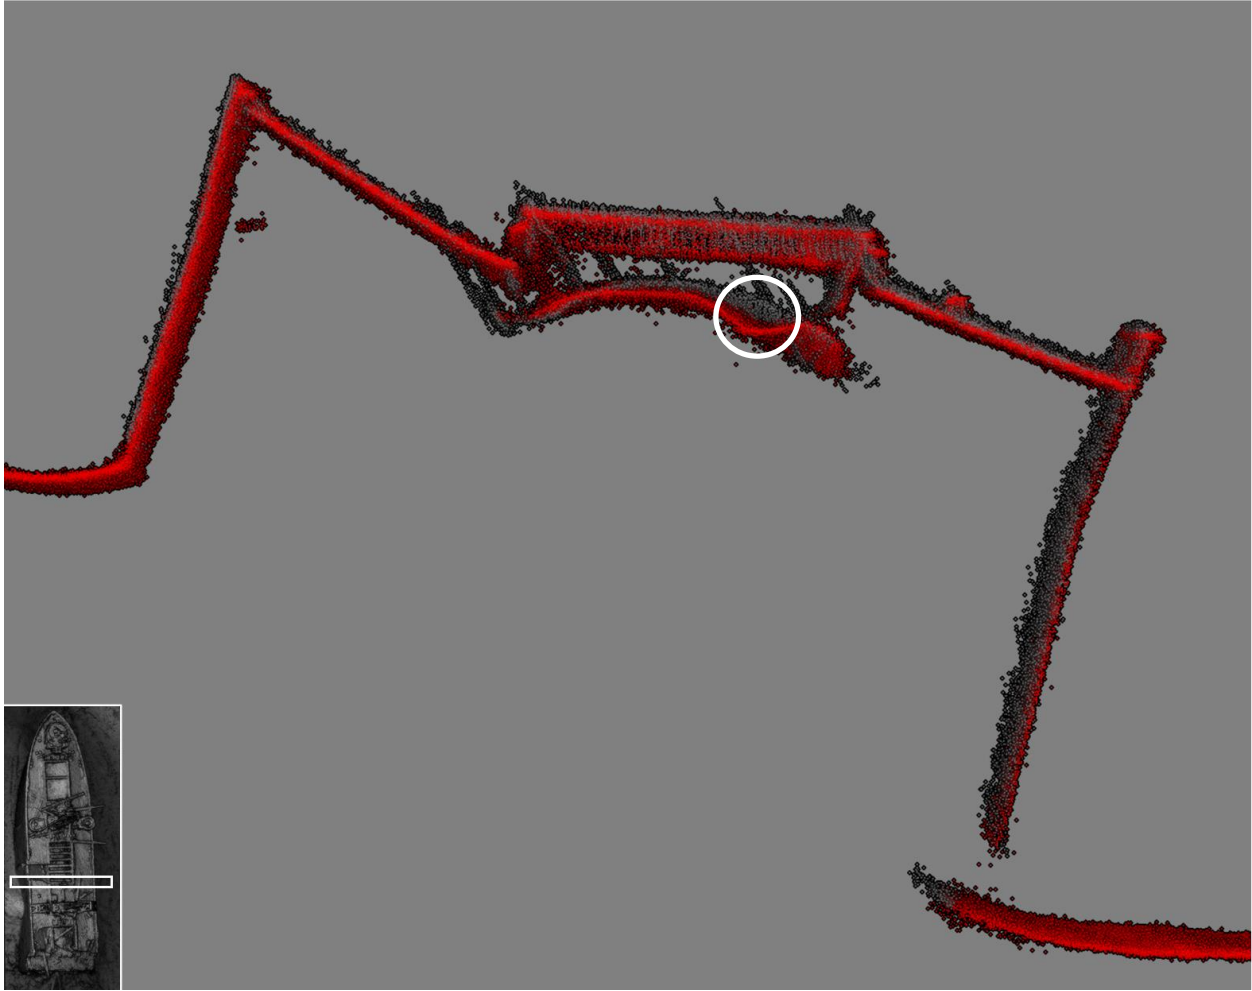
Sediments are visible in hold 2, but not to the same extent as in hold 1. The sediments have not filled the starboard side of the 'tween deck area up to the coaming seen in the no.1 hatch (Figure 29, Figure 30, Figure 31). This may be because of cracks in the hull sides at this location which could allow water to flush through and so remove the upper most sediment layers. A previous

Figure 31. Cross section through the hull at aft section, red full survey 2023, grey full survey 2022. Area of changed sedimentation circled.
