Maritime &  
Coastguard  
Agency

# SS Richard Montgomery: Survey report 2023

April 2023

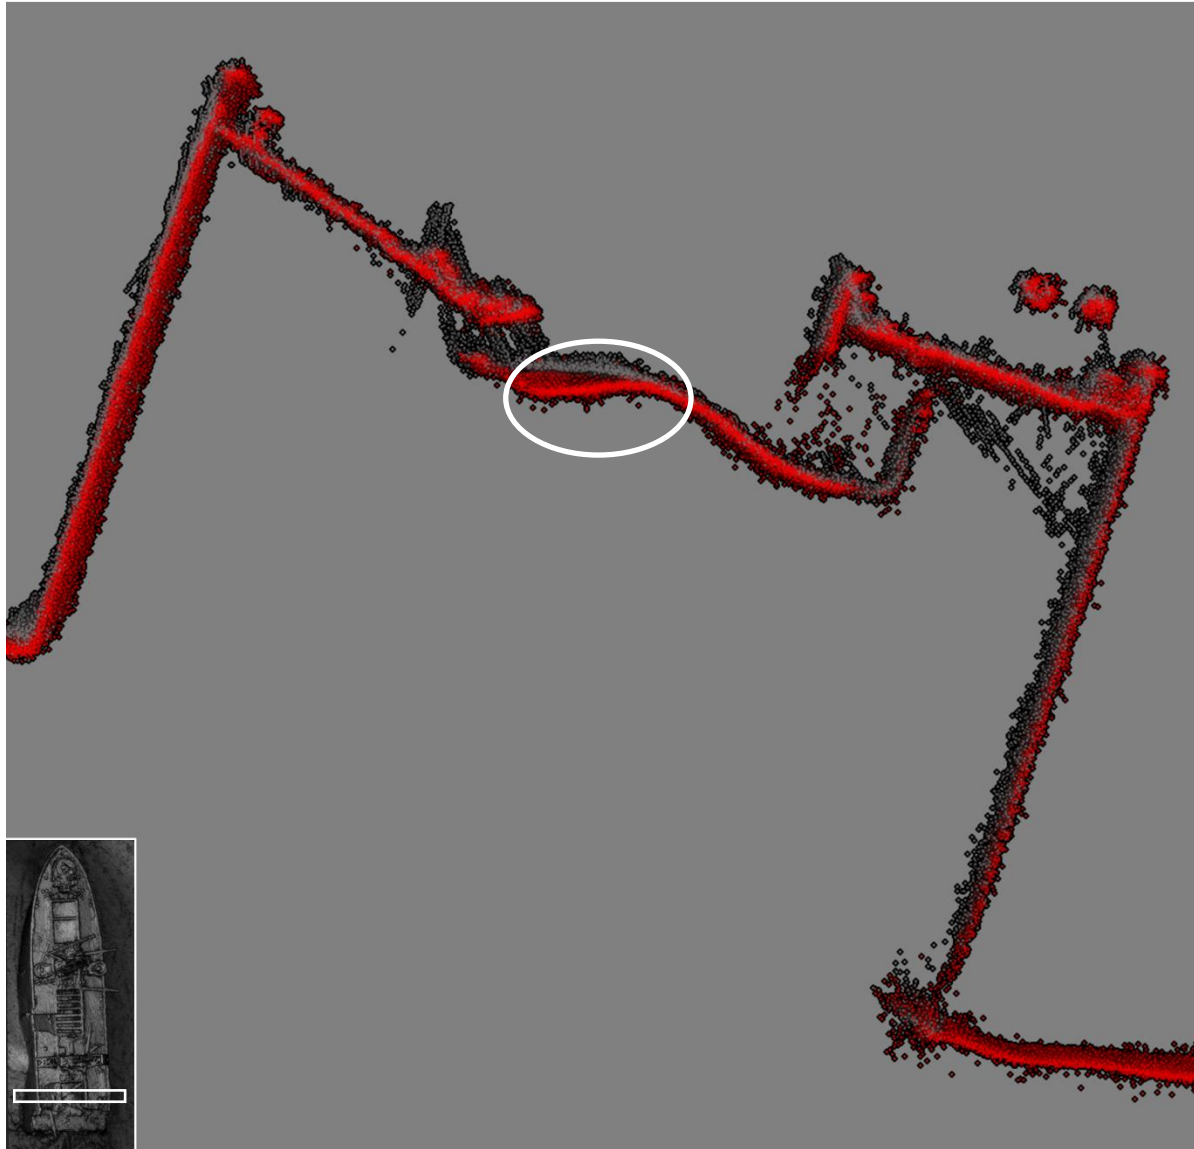
Sediment accumulation is largely limited to the forward part that still retains the protection of the upper deck. Similar to hold 1 and 2, there is no clear indication that the hatch leading to the second deck has collapsed. However, there is a change in the sediment level in the middle part of the hold where the 2023 full survey shows sediment level has dropped 45cm (Figure 33). It is possible that the sediment has washed of the broken aft end of the forward section of SSRM.

Figure 33. Cross section through the hull at the middle of no. 3 hatch. Red full survey 2023, grey full survey 2022. Difference in sediment level circled.

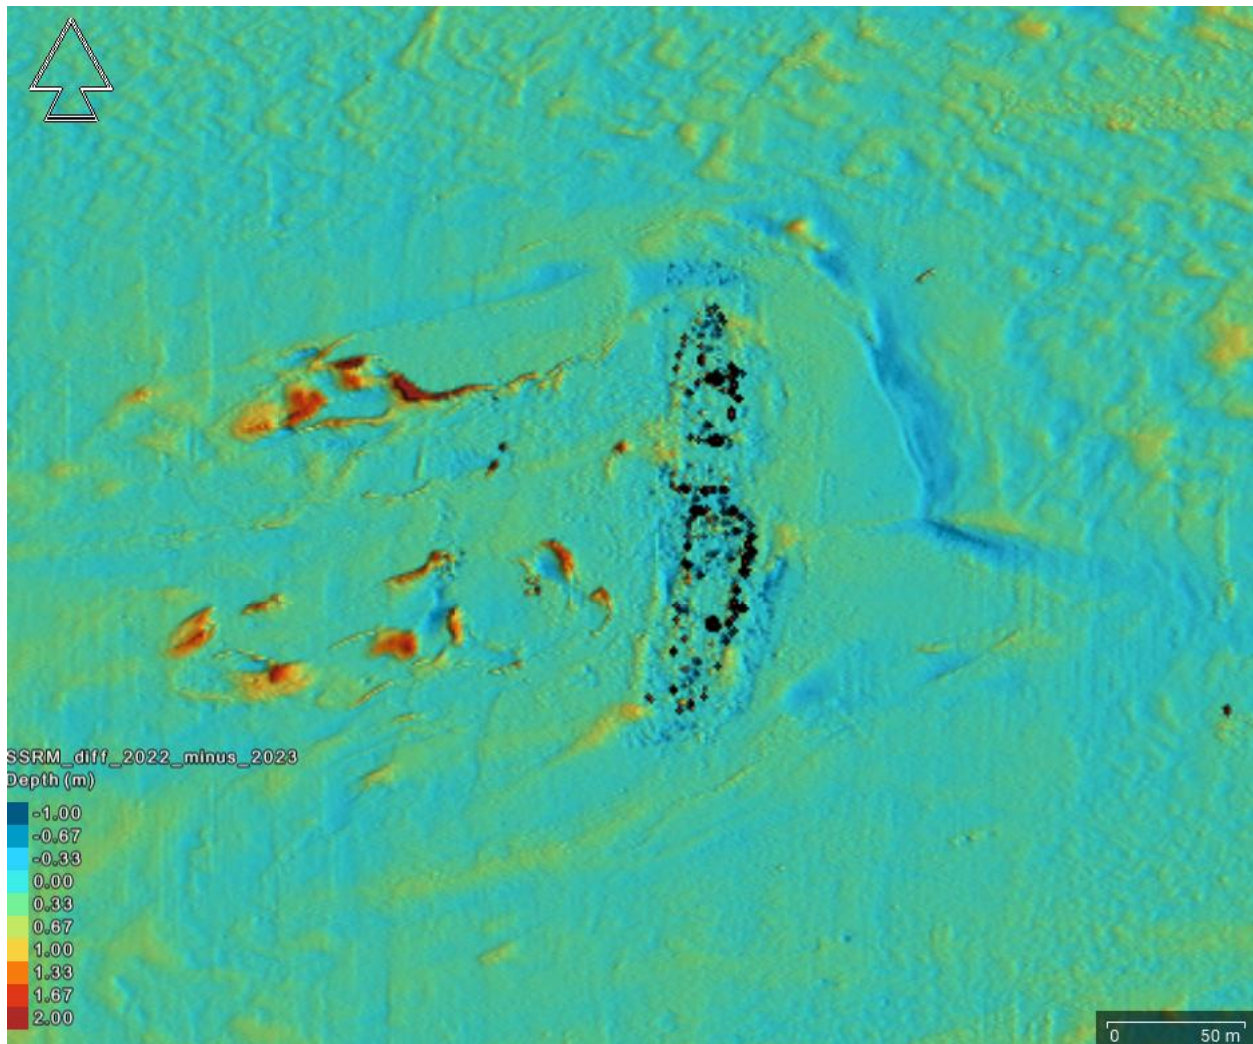
In the immediate area surrounding SSRM, a slight decrease in sediments has been observed east of the wreck in the range of 0-0.33m on the forward section. A larger decrease in sediments is visible by the bow section in the range of 0-0.6m. West of SSRM there has been an increase in sediments of 0.33-1m, suggesting eastward movement of the sediments in the immediate area of SSRM (Figure 39).

The difference model shows that the eastern part of the seabed near SSRM has decreased in depth by 0.3-0.5m, possibly indicating westward movement of the sand previously on the sand ridge. West of the SSRM, there has been some increase in the height of the scour ridges. Some of these ridges show an increase height up to and exceeding 2m.

Figure 39. Difference model with full surveys from 2022 and 2023, showing the immediate area around SSRM.

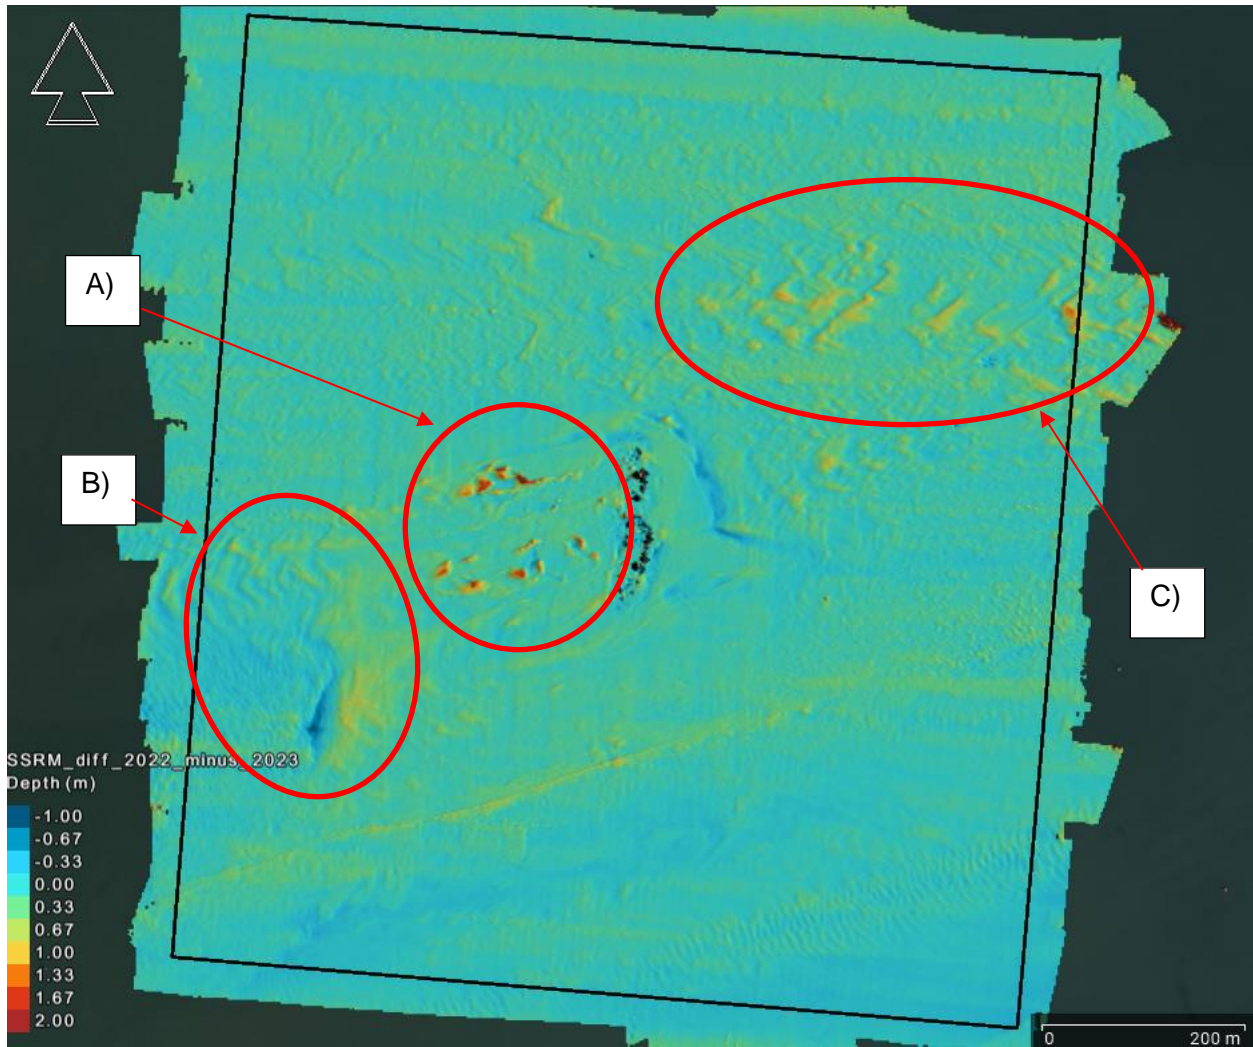
Changes to the wider seafloor around SSRM has occurred mainly directly west of the wreck and northeast of it (Figure 40). On the west side (A) there is a build-up of sediments in in the 2m range in the scour ridges. Further southwest (B) and northeast (C) there are some changes in the sand waves where accretion has occurred. In southwestern area (B) there are slight differences of sand waves increasing by 0.5-1m, but also some erosion of 0.5-1m. In the northwestern area (C) there is a larger increase of height by 0.5-1.5m.

Figure 40. Difference model between 2022 and 2023 full survey, showing the complete full survey area.
