Report on the investigation of
the contact of the chemical tanker

Ali Ka

with Oikos Jetty 2

on 25 October 2022

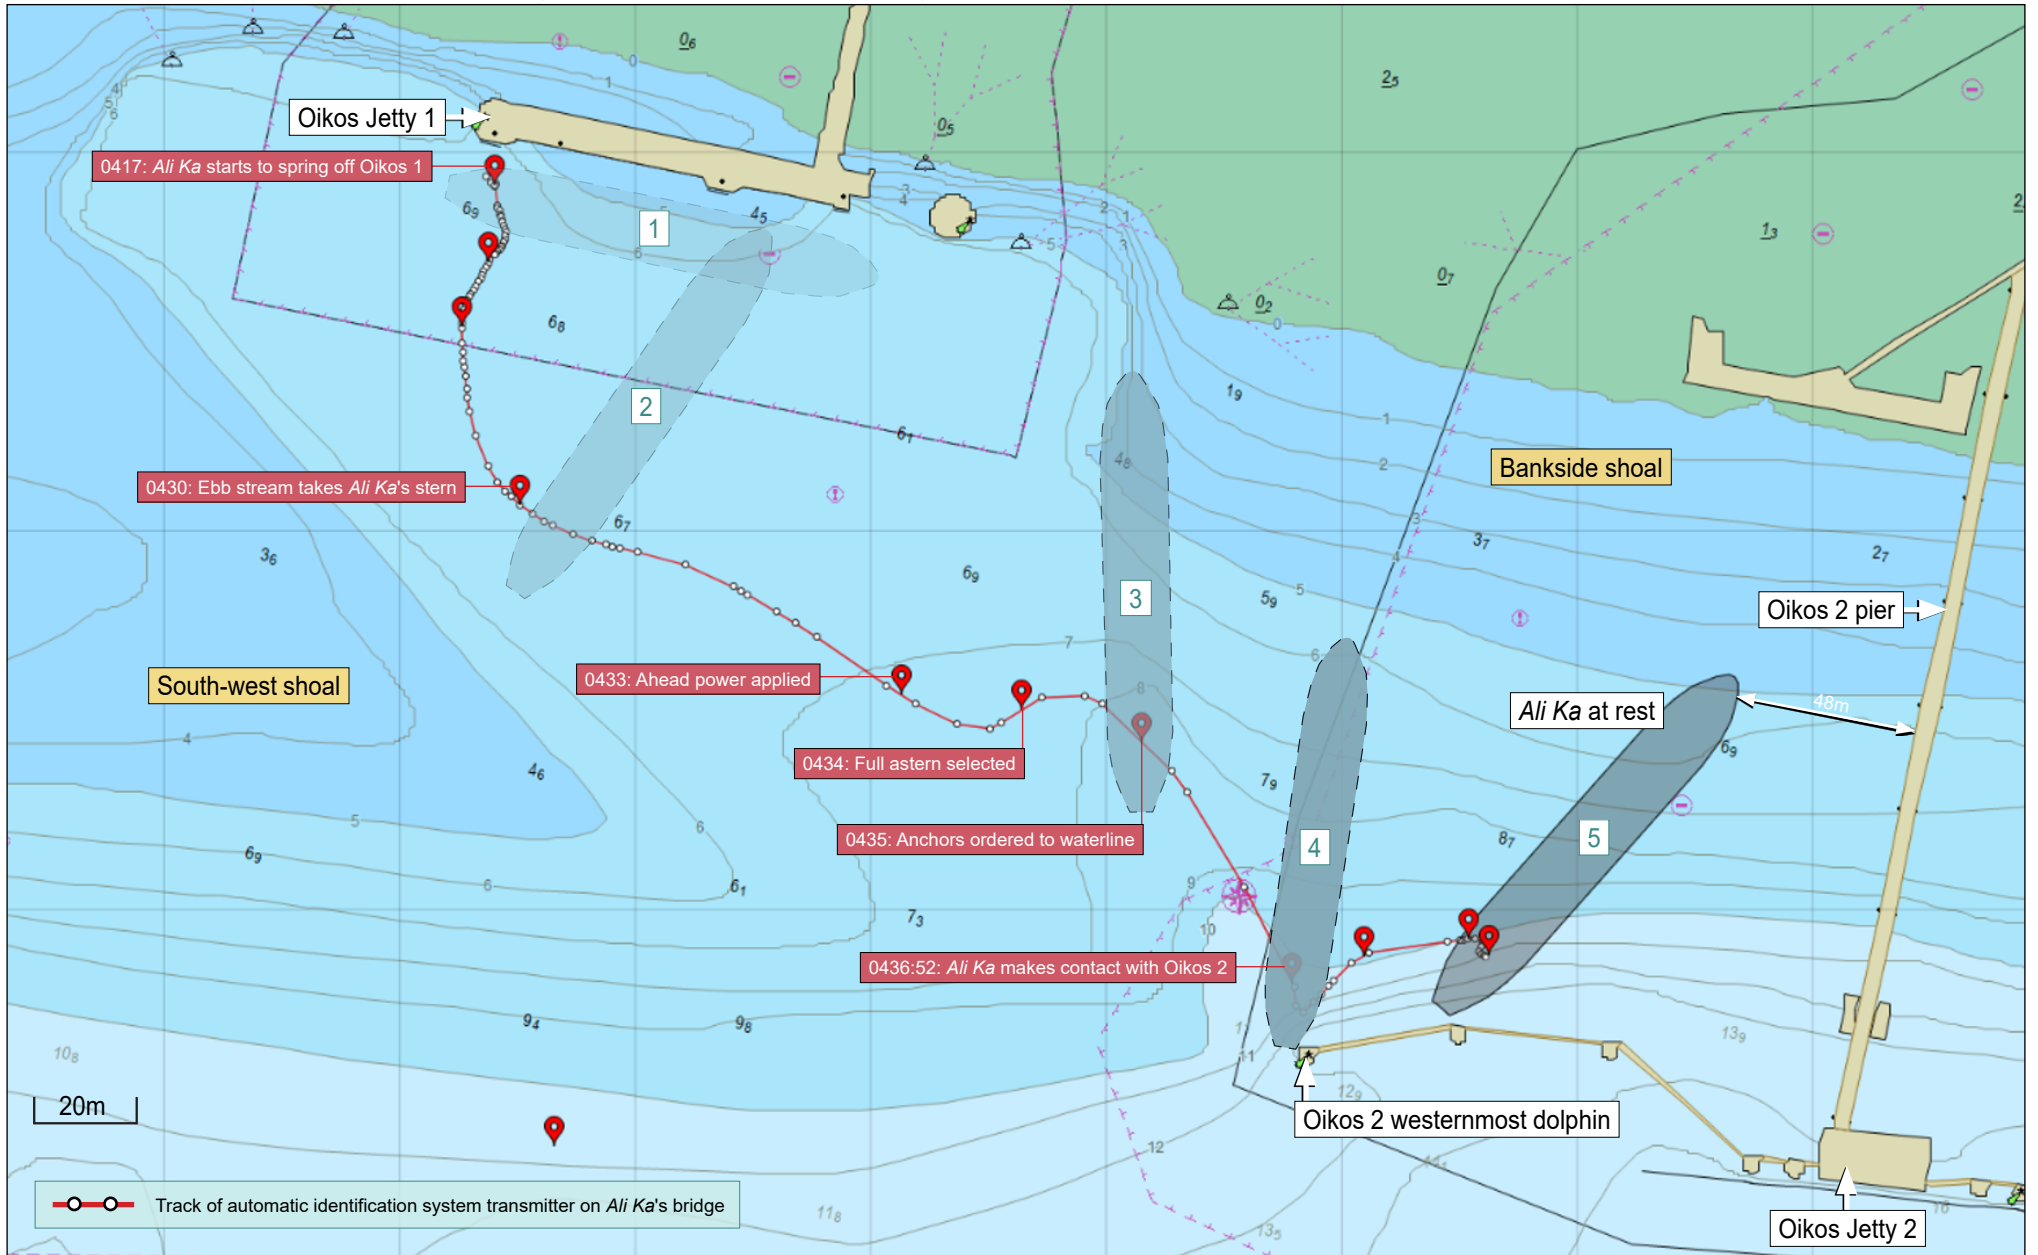
Figure 5: The sequence of events

In the 17 minutes between slipping the final line ashore at Oikos 1 and hitting Oikos 2 the weaknesses in the departure plan were realised. Pilot A did manage to manoeuvre *Ali Ka* to 90° off the line of Oikos 1 as intended. This manoeuvre presented the maximum aspect of *Ali Ka* to the ebbing tidal stream. While the bows were experiencing 0.5kts of tidal stream setting to the east south-east, the stern was placed in an area where the tidal streams were at least three times as strong, being greater than 1.5kts (**Figure 16**). The further south *Ali Ka* moved the stronger the effect of the tidal stream became, setting *Ali Ka* into Oikos 2. Impacted by fatigue and bereft of effective support from the bridge team, pilot A did not detect the effect of the tidal stream until it was too late.

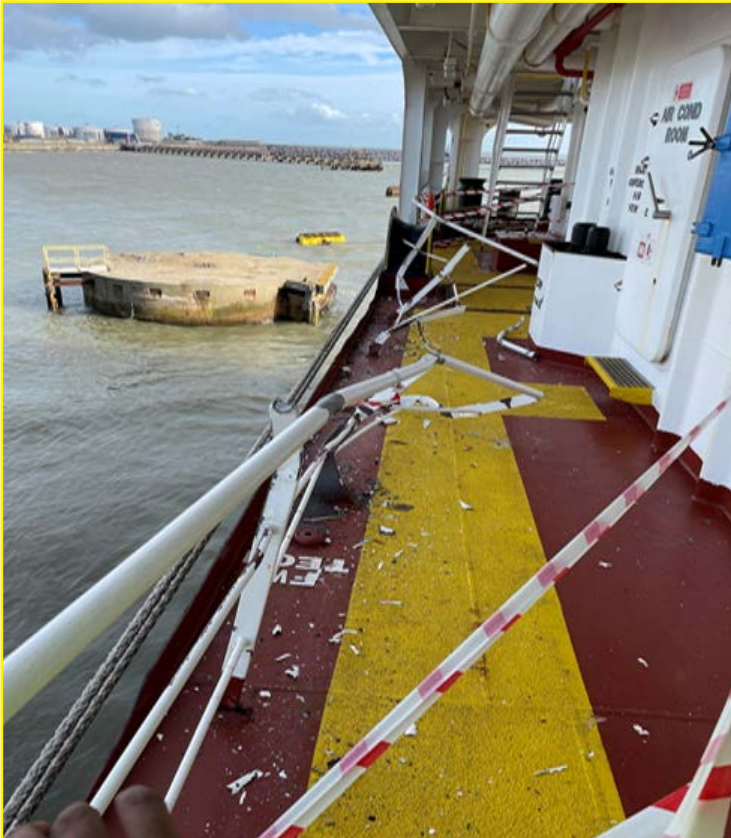
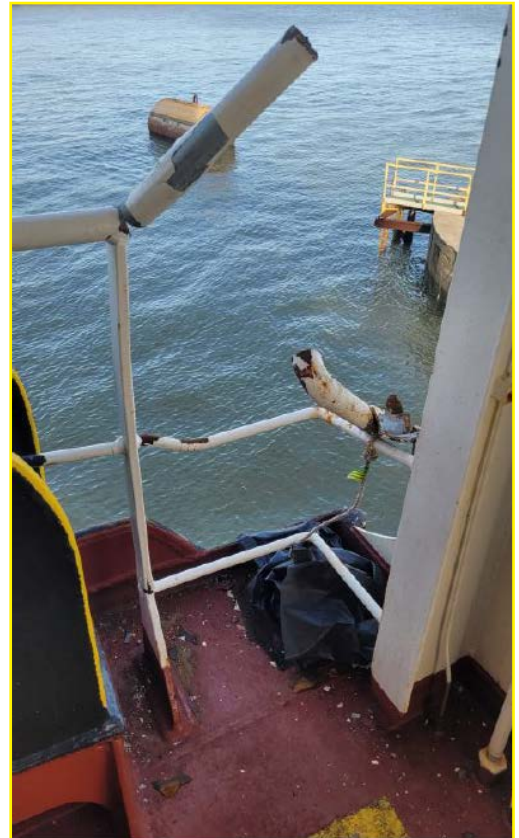
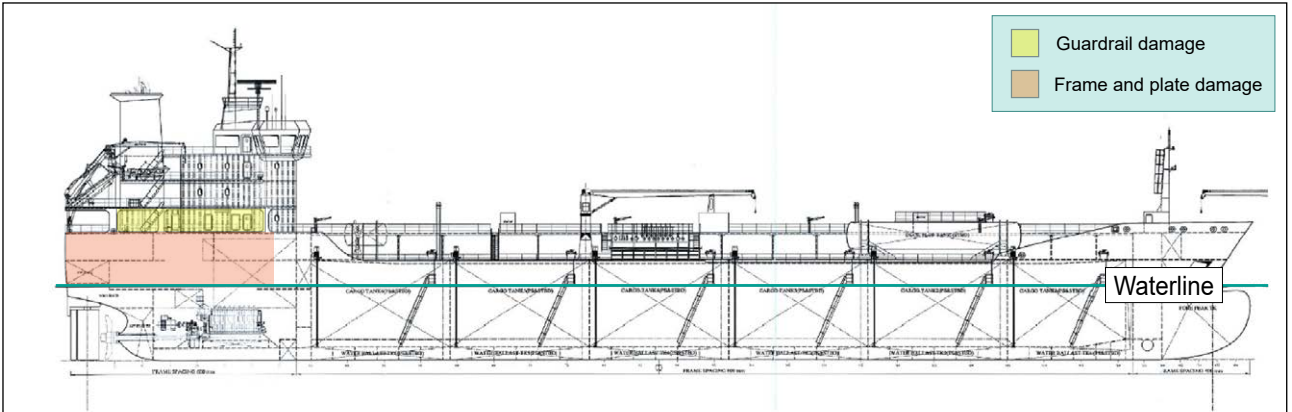
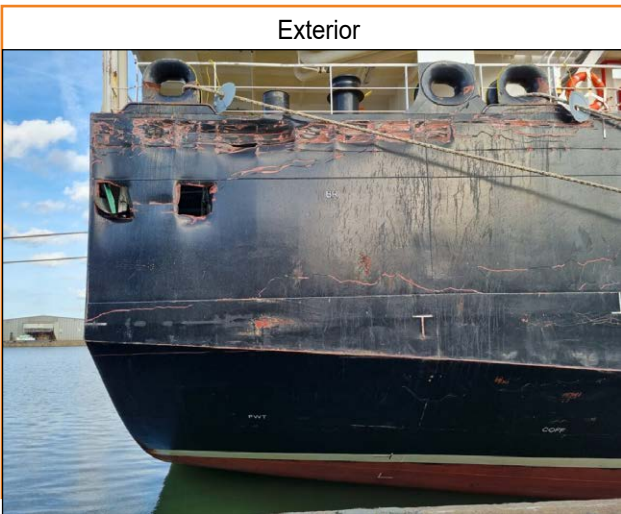
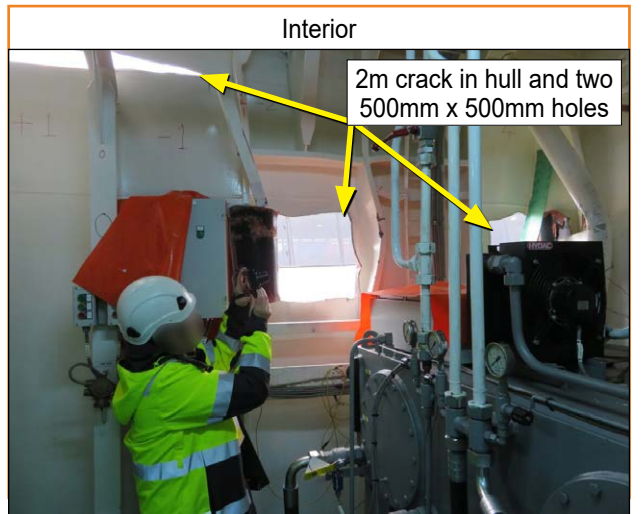
Figure 6: Damage to Ali Ka

At 0439, pilot A called London VTS and requested tug assistance as soon as was possible. At 0449, the tug *Craigleith* arrived, followed at 0504 by the tug *Svitzer Bootle*. Pilot A then arranged for the tugs to take the weight, recovered the anchors and, by 0630, had berthed *Ali Ka* alongside Oikos 1, starboard side to, head-up. Damage on board comprised some indentations, bent frames and deep scours along the starboard quarter; there were two 500mm x 500mm holes punched into the hull and some guardrails had been bent flat. All the damage was above the waterline (**Figure 6**). Oikos 2 suffered damage to the westernmost dolphin, with power cables cut and the structural integrity of the dolphin in doubt. The walkway had fallen into the river where *Ali Ka*'s stern had struck it (**Figure 7**). There were no injuries to personnel.

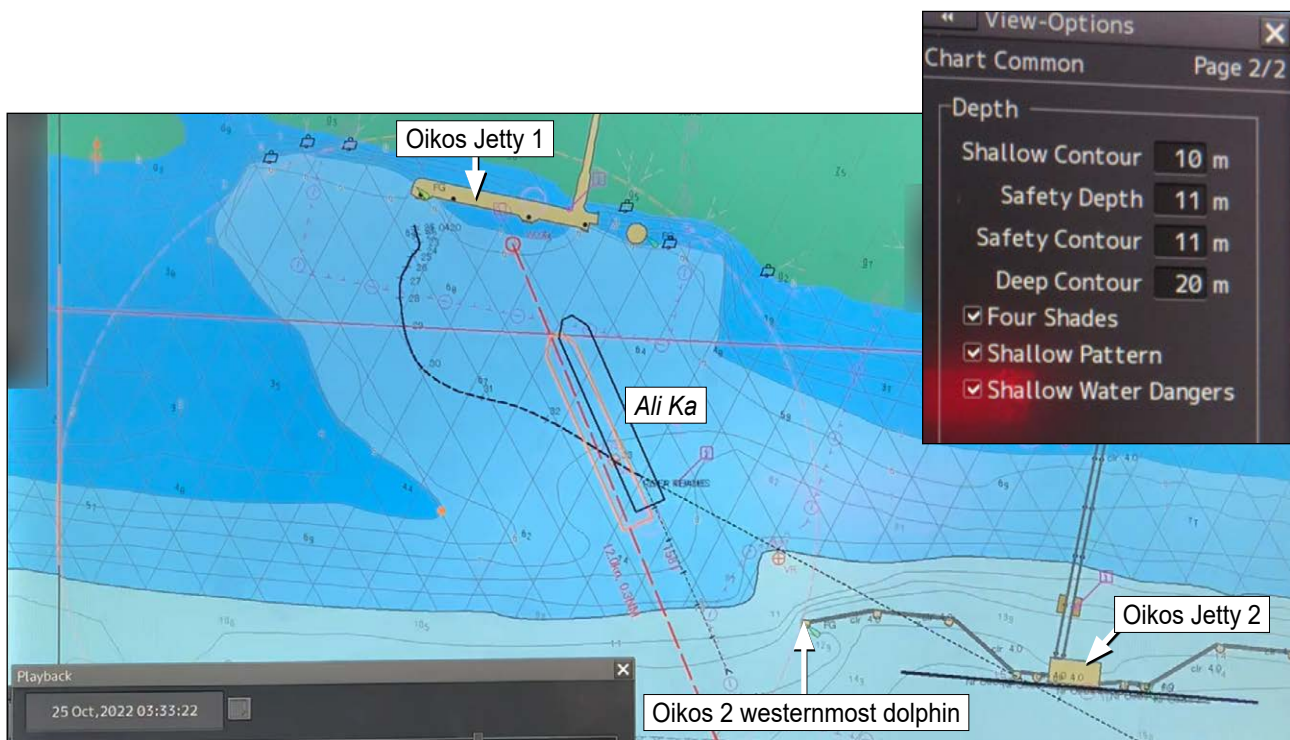
Figure 11: Safety contour used for the move and (inset) *Ali Ka*'s ECDIS settings

To calculate the safety contours to be applied in ECDIS the 2/O was required to apply squat⁹ for the departure from Oikos 1. The 2/O was presented with several different values of squat to choose from. The detail in voyage number 29 used a block coefficient of 0.73¹⁰, a squat value of 0.36m and a dynamic draught of 7.86m for transit *to and from the berth*. That voyage plan listed the calculated depths that included Trans Ka *safety parameters* and stated that the minimum depth for transit *to and from berth* was 8.65m with a minimum dynamic UKC of 0.79m. The 2/O set the ECDIS shallow contour at 10m, the safety depth and safety contour of 11m and the deep contour of 20m (**Figure 11**) and had uploaded the most up-to-date charts. These ECDIS settings indicated that the departure from Oikos 1 was in waters shallower than the calculated safety contours as the minimum charted depth between Oikos 1 and the entrance to the Yantlet Channel was 6.4m.

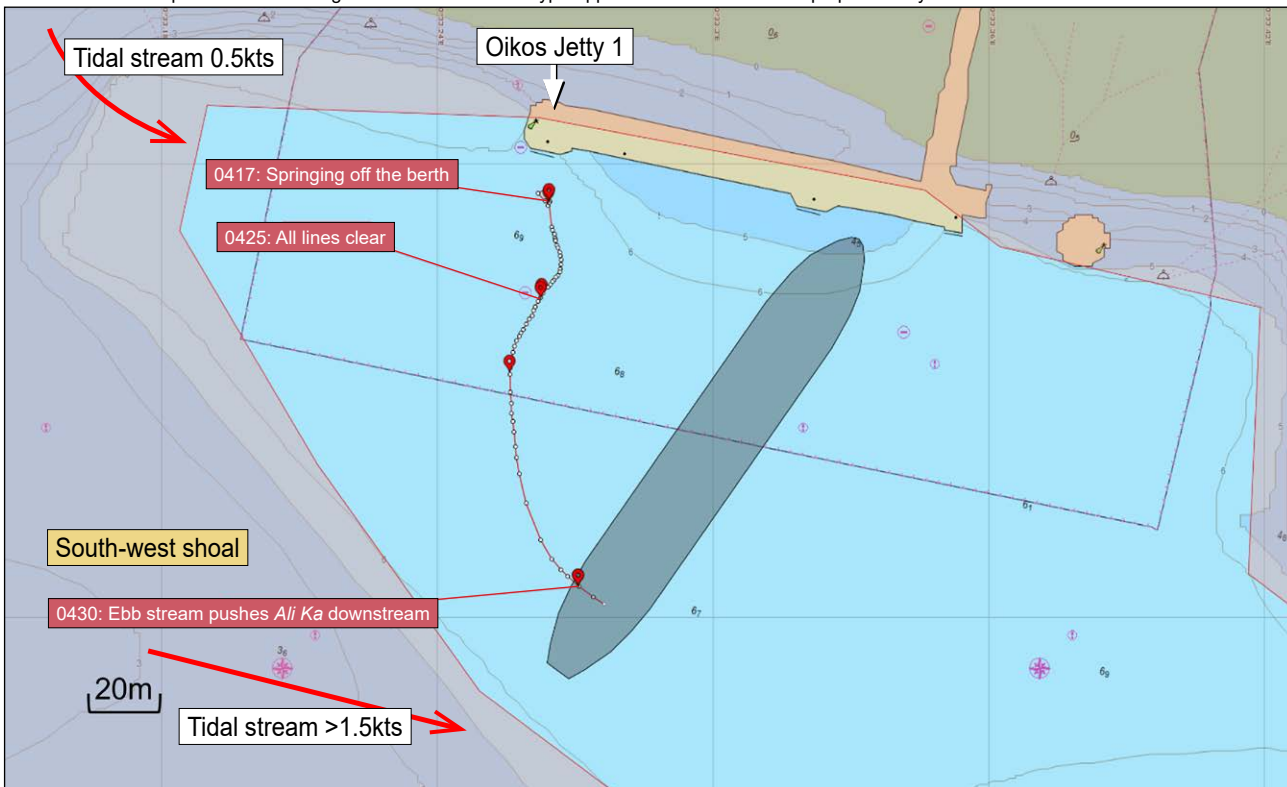
Figure 16: Increasing tidal stream strength during the manoeuvre away from Oikos 1

When pilot A ordered slow astern it was unclear what the master was expected to set on the lever, given that a -12 setting delivered a neutral effect. Staying at slow astern for almost 2 minutes, and primarily monitoring the manoeuvre using the ship's radar display, it slowly dawned on pilot A that this was insufficient to clear the western arm of Oikos 2. With a very brief window of time to exit safely between the shoal and Oikos 2, pilot A did not set sufficient astern power to make a safe exit. Aside from reporting the depth and the proximity to Oikos 1 during the initial departure from the berth, the bridge crew were broadly silent and did not challenge the pilot's decisions. The National Occupational Standards for Marine Pilotage performance criteria indicated an expectation that *the vessel's track and progress* were to be *effectively and frequently monitored* by the bridge team. The ICS Bridge Procedures Guide also included the need for crew to monitor the track and UKC and advise the master of any doubt about the ship's safety. No such monitoring or advice was evident by, and from, the crew of *Ali Ka*. Pilot A decided that the stern needed to move to port and consequently applied maximum starboard rudder and ahead power, with which the master and bridge team complied. The Guide to Good Practice on Port Marine Operations described the expectation for the bridge team to query the pilot's actions or omissions; however, no such queries were evident. This manoeuvre was successful in temporarily adjusting *Ali Ka's* orientation but had placed the ship further north. Without tugs, or letting go the anchors and accepting a grounding, it was now almost impossible to avoid a contact with Oikos 2.

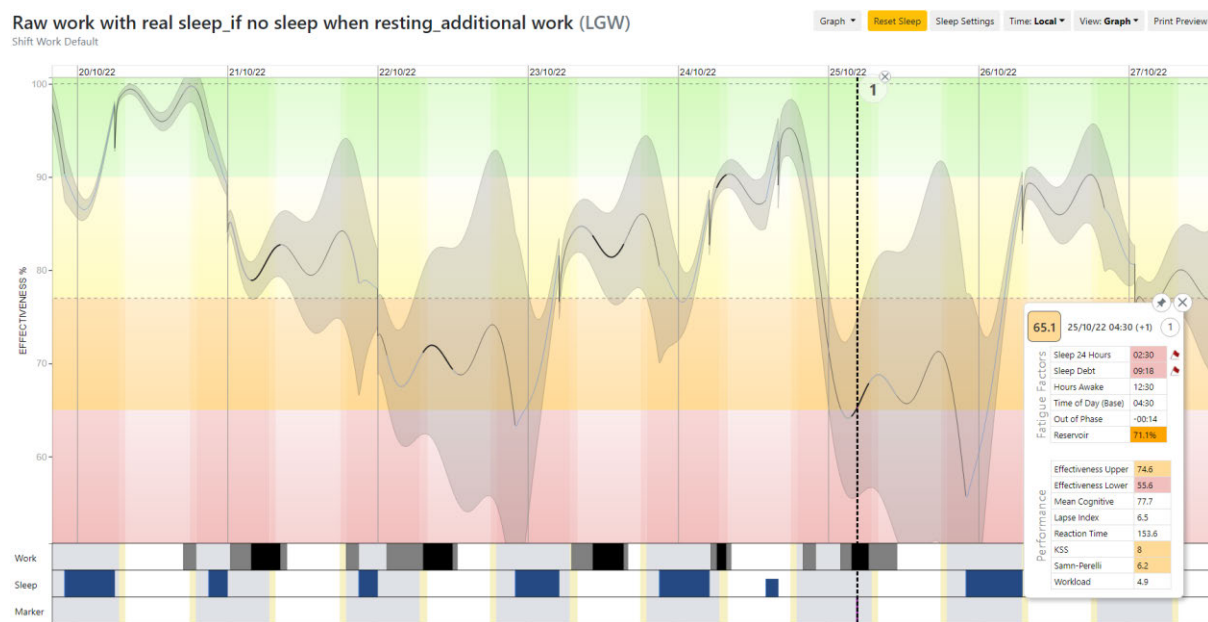
Figure 1: SAFTE-FAST output for the watches immediately preceding the accident, assuming no sleep was obtained the night immediately before the pilotage act of interest. The vertical dashed line is positioned at 04:30 (UTC+1), during the course of the events leading to the collision.

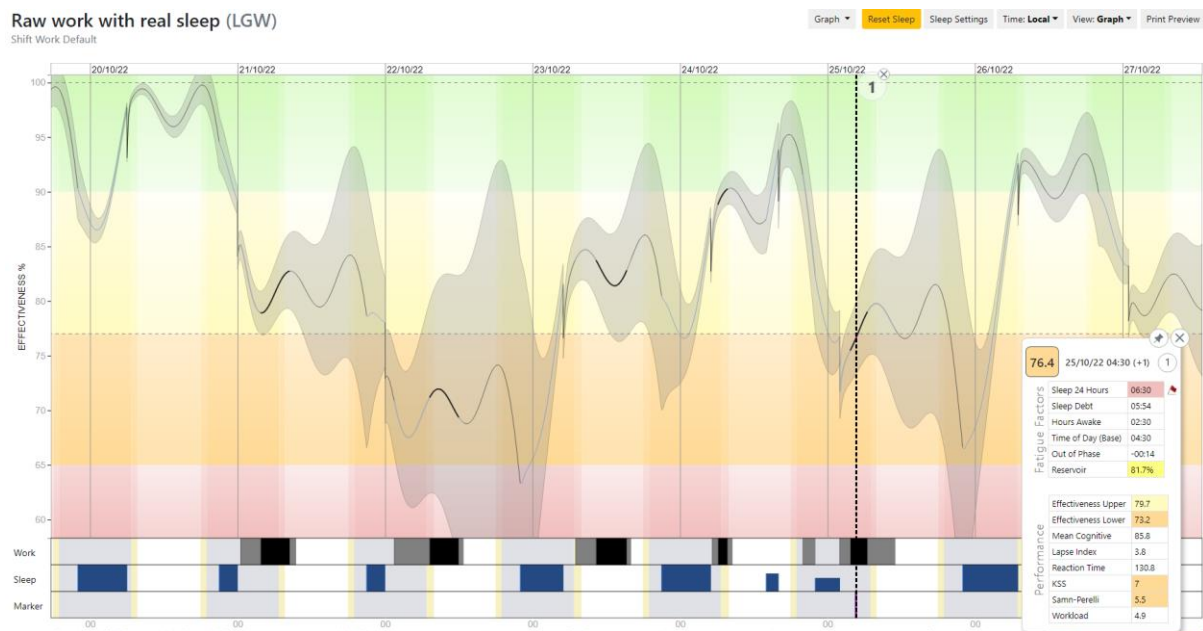
If sleep was obtained during the 4 hours spent in bed, even of low quality, the average predicted fatigue score is 76.4%, equivalent to a KSS of 7 ('sleepy, no effort to keep alert'). This average predicted fatigue level is high (compared to severe when no sleep is obtained), whilst the spread of the data means that the predicted level of fatigue for the population ranges between moderate/high (predicted fatigue score of 79.7%) to high (predicted fatigue score of 73.2%).

Figure 2: SAFTE-FAST output for the watches immediately preceding the accident, assuming a small amount of low quality sleep was obtained during the night immediately prior to the pilotage act of interest.
