AAIB Bulletin

7/2024

Boeing 737-8K5	G-FDZS	4-Mar-24	3
----------------	--------	----------	---

ATR 72-202	G-NPTF	17-Jan-23	13
------------	--------	-----------	----

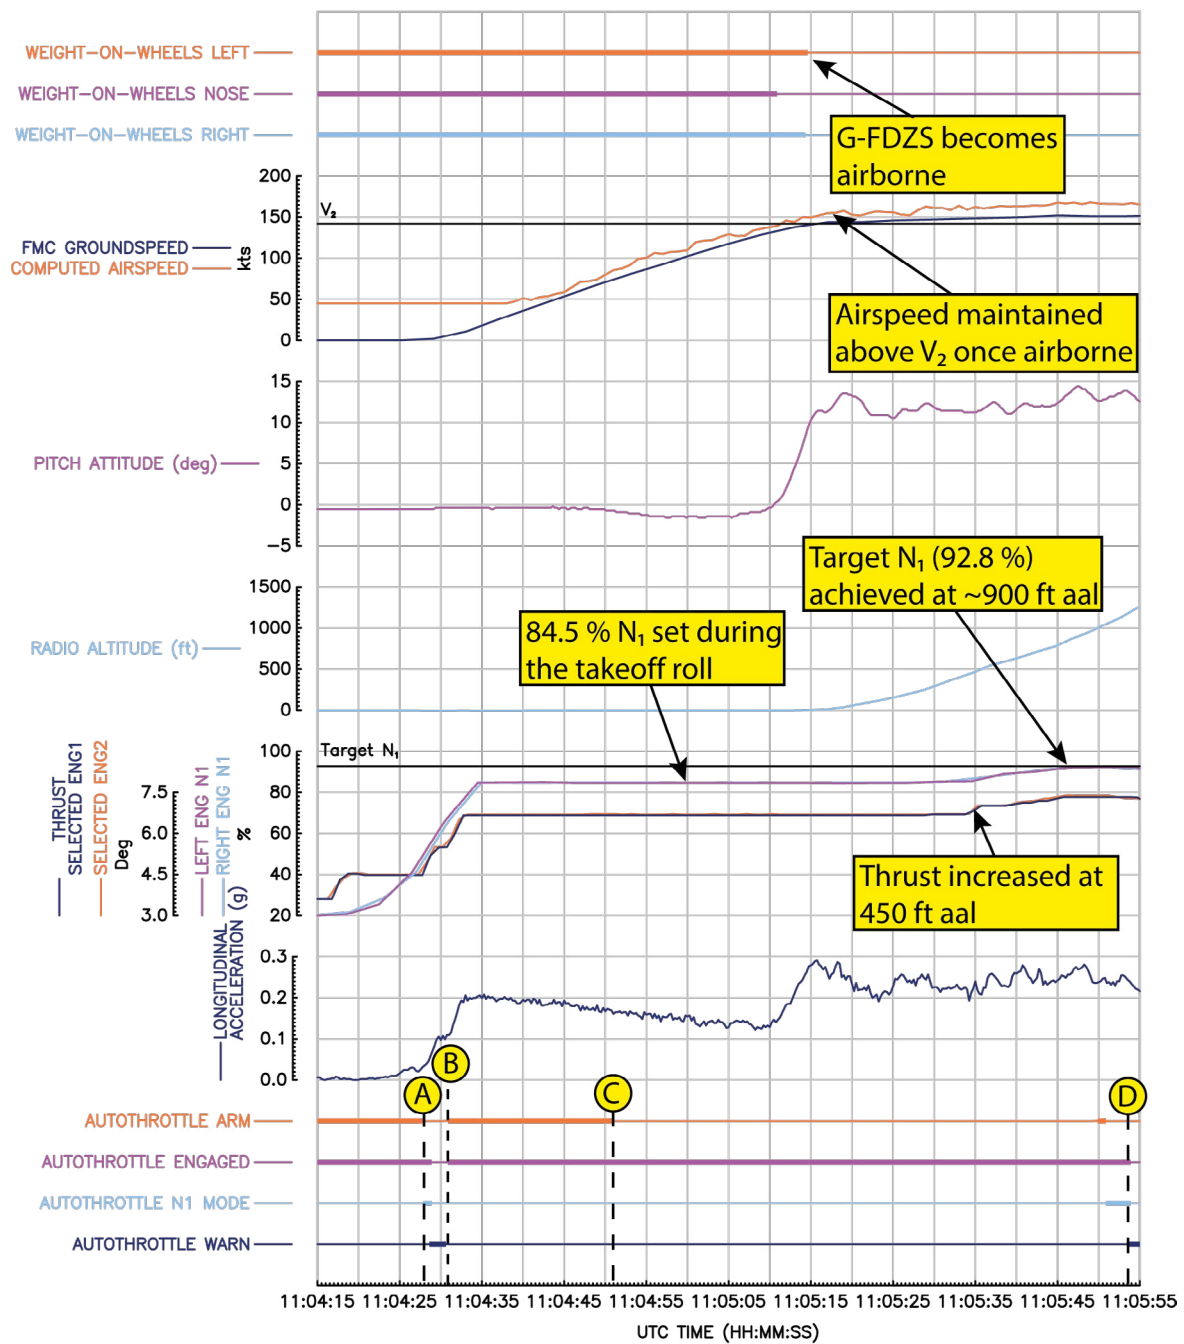
Figure 1
FDR data for the takeoff

- (A) A/T transitions from ARM to N1 mode on TOGA selection, disconnects almost immediately with a warning
- (B) A/T re-armed within five seconds but no active mode selected
- (C) A/T transitions to ARM HOLD mode, as per design, at 84 kt
- (D) A/T transitions from ARM to N1 mode, but disconnects with a warning almost immediately (2nd uncommanded disconnect)

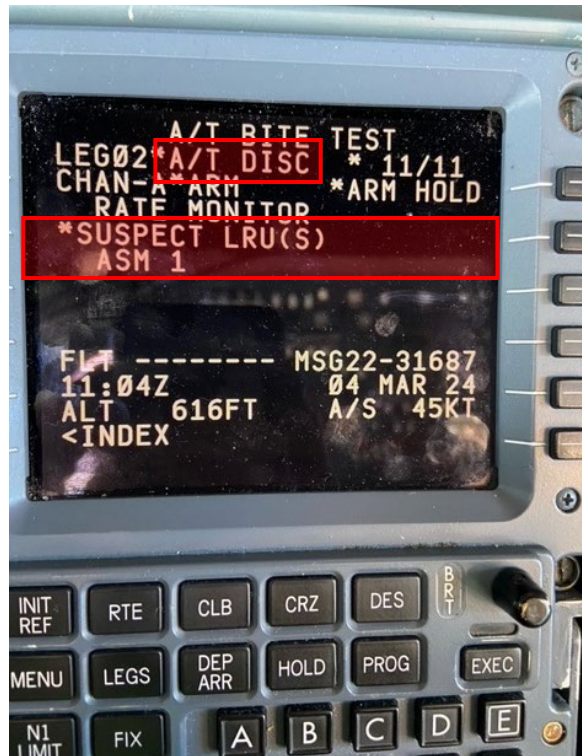
Figure 3

Detailed fault record for the initial uncommanded A/T disconnection, showing the suspected cause as ASM 1

The fault record indicates the suspected cause of the uncommanded A/T disconnection as ASM 1, the A/T servo motor for the number 1 engine throttle lever. A further four uncommanded A/T disconnections occurred during the flight to Las Palmas, two during the initial climb to altitude and two during the cruise. A series of other fault messages were logged, after the initial A/T disconnection, as G-FDZS accelerated for takeoff. These were generated passing 90 kt airspeed and all related to the mis-set thrust, indicating that the correct takeoff thrust had not yet been set.

A newer model of the ASM is more robust to the power quality issues associated with power on and power transfer events and the manufacturer recommends that any operators of the 737NG who are affected by these disconnects should retrofit their aircraft with the newer model of ASM and associated Flight Control Computer software. The manufacturer released a Fleet Team Digest in October 2021 detailing the issue and the available service bulletin (SB) for replacement. At the time of this event G-FDZS was fitted with the earlier model of ASMs.

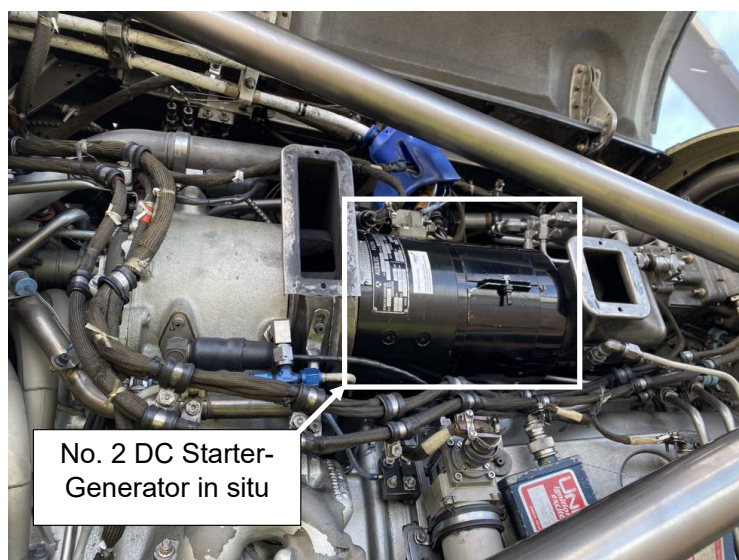
Figure 8

The DC Gen 2 was examined in-situ (Figure 8) for signs of external damage or faults, and none were found.

DC Gen 2 was replaced, and further engine ground runs were conducted. The CNTR BPCU fault reset itself, indicating the fault's causal condition had been removed. No further faults were logged on the GCUs and no other electrical anomalies were observed.

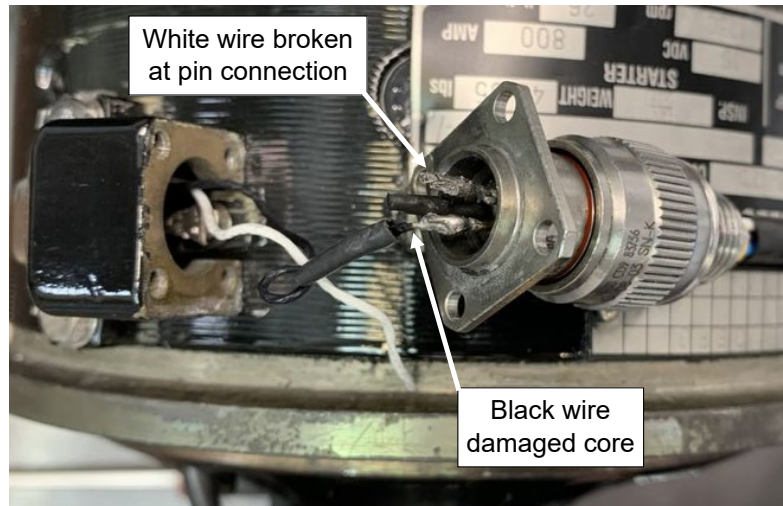
Figure 11

The wires are soldered to pins at the rear face of the connector, and the soldered joint covered with heat-shrink sleeve. Removing the heat-shrink sleeve from the white wire showed the wire to be completely broken but, whilst held in place by the heat-shrink sleeve, close enough to make intermittent contact. Removing the heat-shrink sleeve on the black wire showed damage to the wire core (Figure 11).

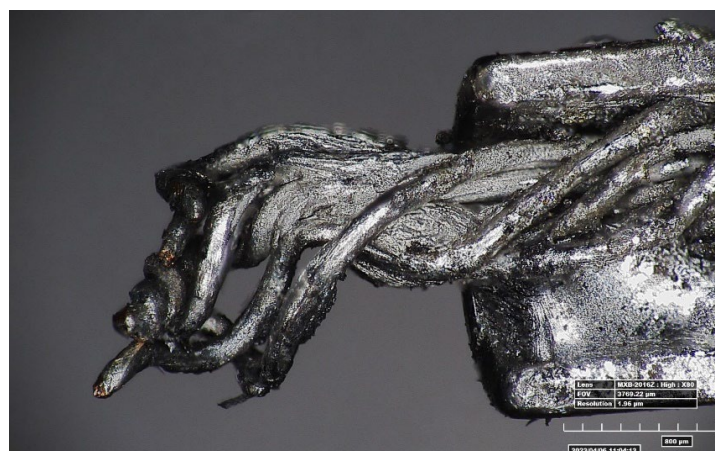
Figure 12

Further microscopy analysis by the AAIB of the white wire showed partial unravelling of the core and breakage damage at the pin connection soldered joint (Figure 12), and evidence of mechanical insulation removal (Figure 13).

Speed sensor connector soldered pin and broken white wire conductors

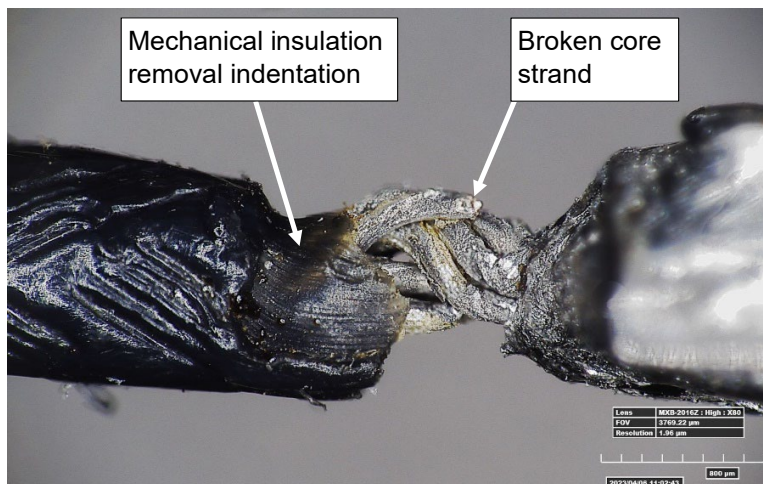
Figure 14

The core of the black wire had two broken strands at the soldered pin joint and evidence of mechanical insulation removal (Figure 14).

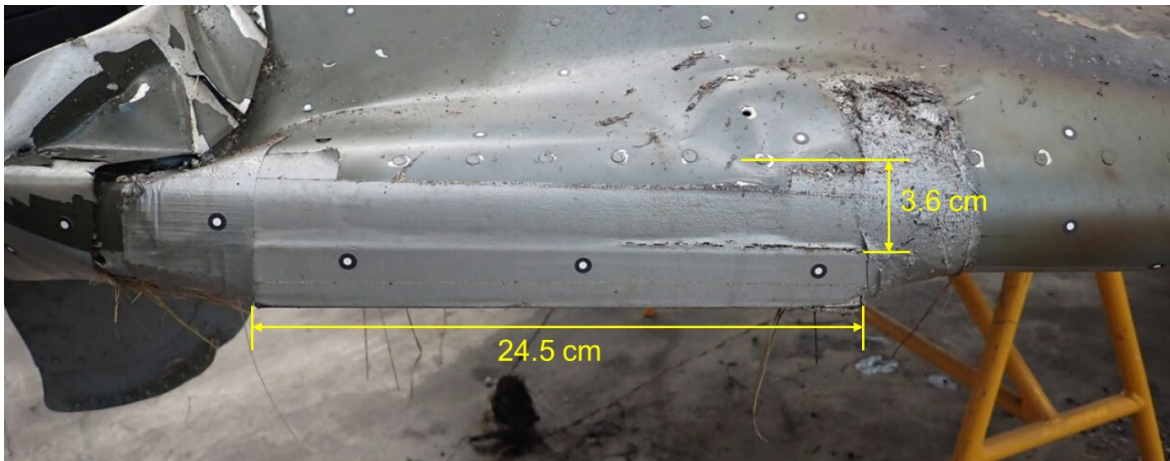
Figure 6

The stall strip fitted to the leading edge of the right wing was still in place (Figure 6) although there was distortion on its surrounding structure. The stall strip that had been fitted to the left wing was found lying beneath the wing at the accident site. The leading edge section to which it had been attached was melted and burnt through and there was no duct tape present. Therefore, the left wing stall strip position on the wing could not be accurately determined. Both stall strips were 24.5 cm in length.

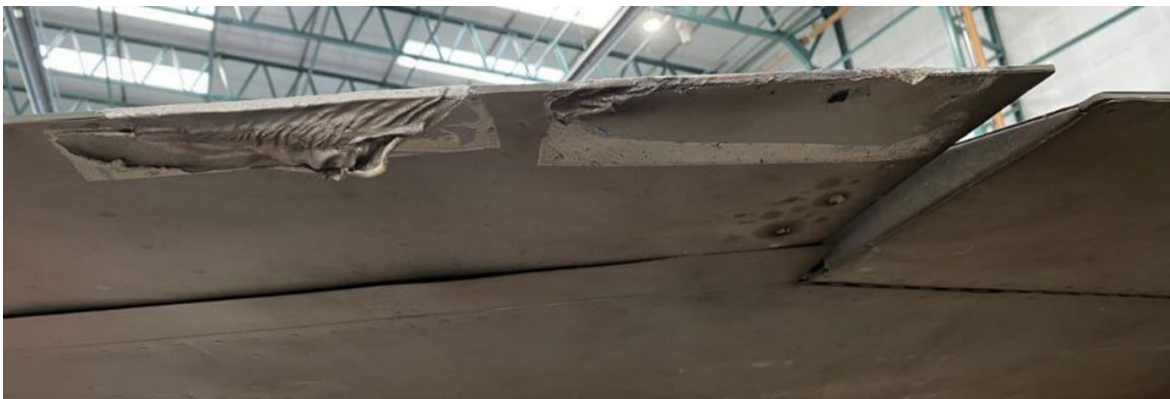
Figure 7

Remains of the duct tape attached to the left aileron trailing edge were present with signs of heat degradation of the tape surface. The foam wedge piece or remains of any material identified as such were not found. (Figure 7)

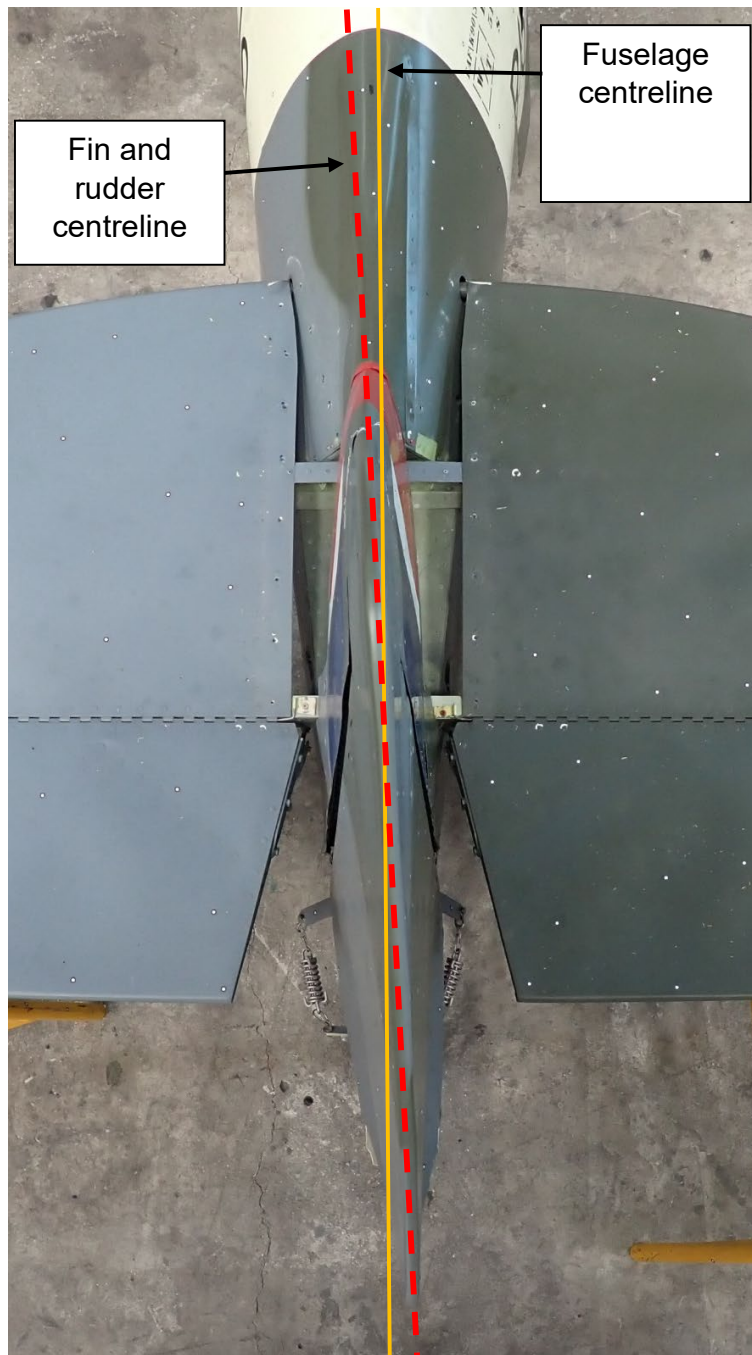
Figure 8

centre line (Figure 8). Removal of the left and right fin root fairings confirmed this and revealed the position of the fin relative to the centre line of its support frame. The left and right tailplane inboard rib measurements show the base of the fin, where it attaches to the fuselage, was misaligned 5 mm to the left of the centre line. Detailed examination of the structure around this area and the fin root fairings found no evidence that the misalignment was because of the impact sequence.

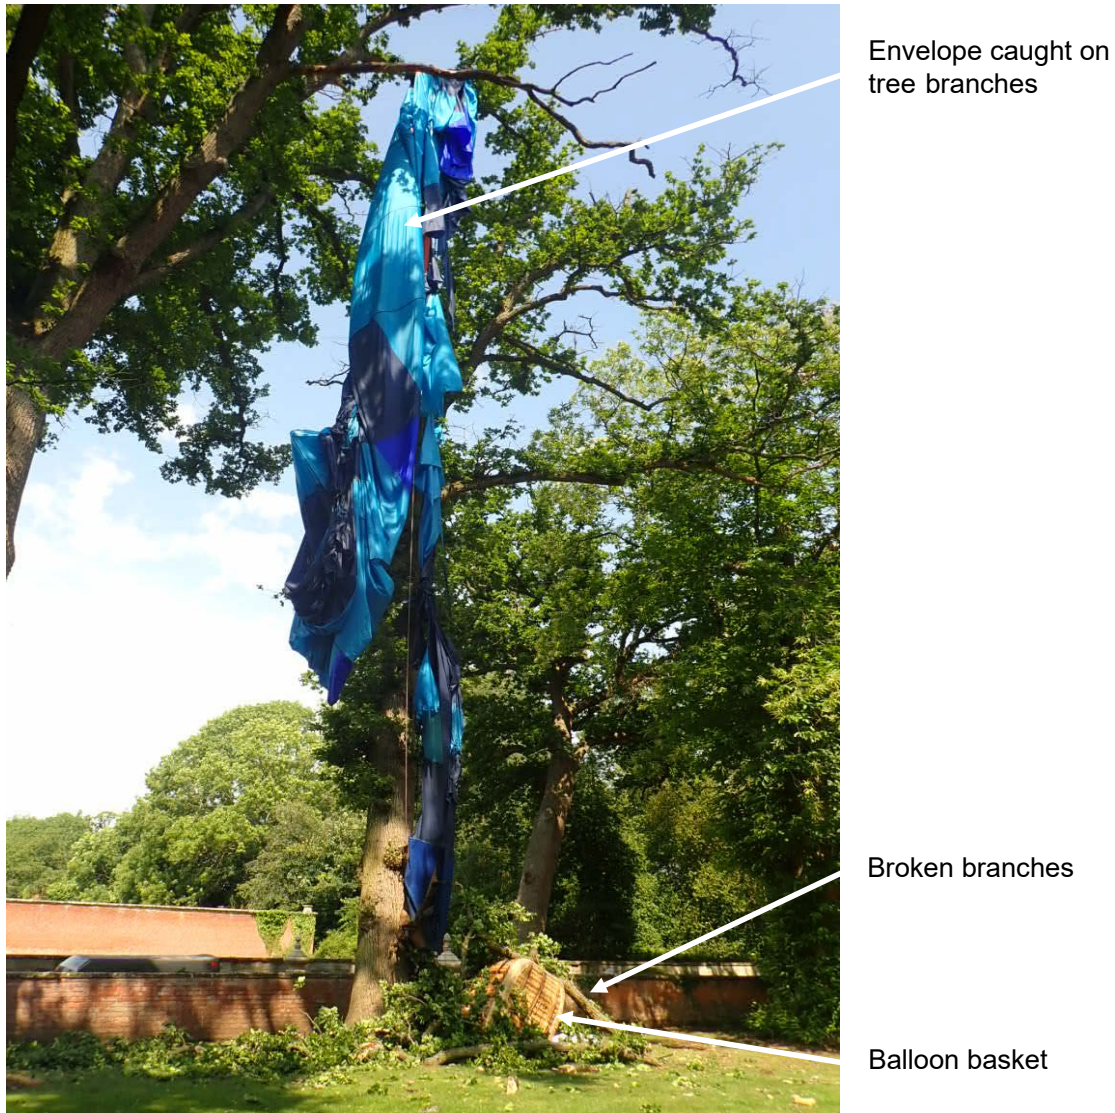
Figure 13

The balloon's envelope was suspended vertically above the ground where it had snagged on the fractured remains of tree branches (Figure 13). Broken branches were scattered around the base of the tree with some landing on top of the balloon's basket.

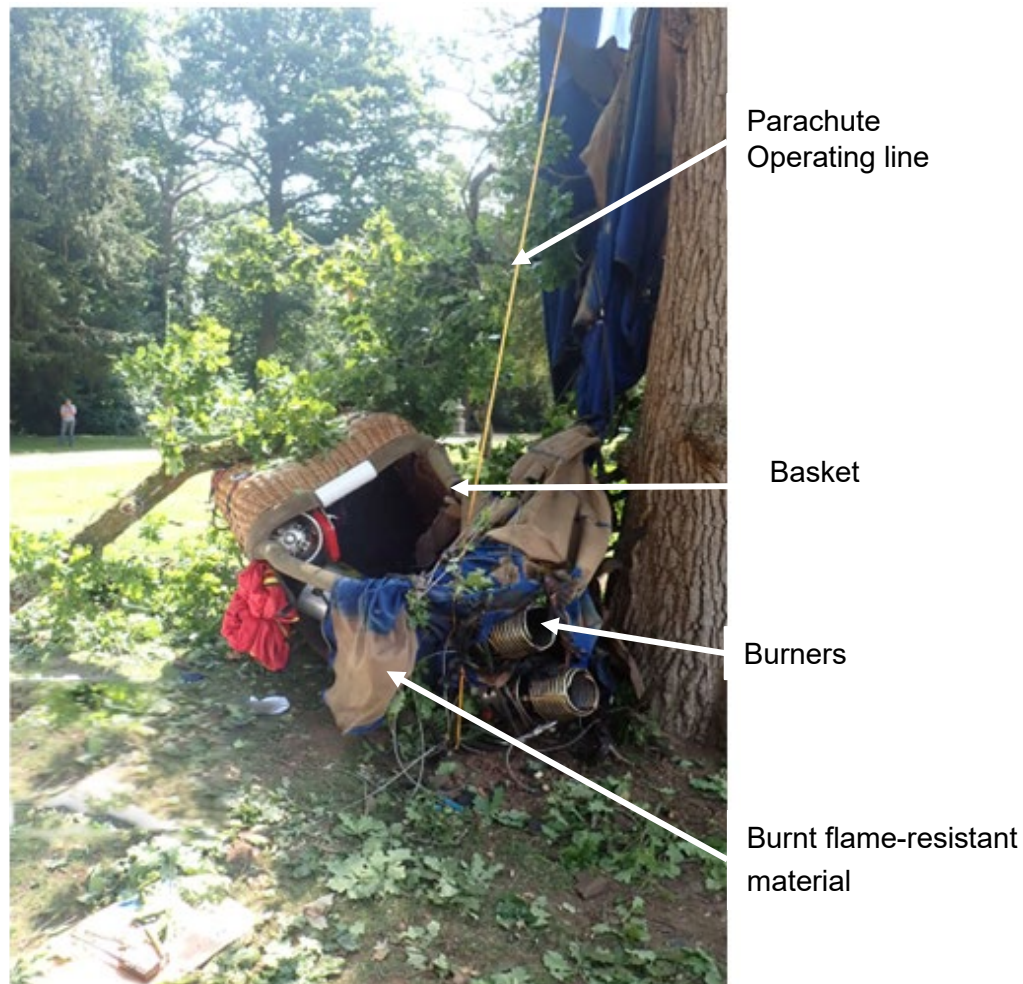
Figure 14

At the base of the tree, the balloon's basket was on its side with the burners still mounted to the basket by burner support rods. The rigging points and karabiners were intact and remained attached to their steel rigging lines. The charred remains of blue heat-resistant material were wrapped around the burners, rigging lines, and the bright orange and yellow fluorescent parachute operating line (Figure 14).

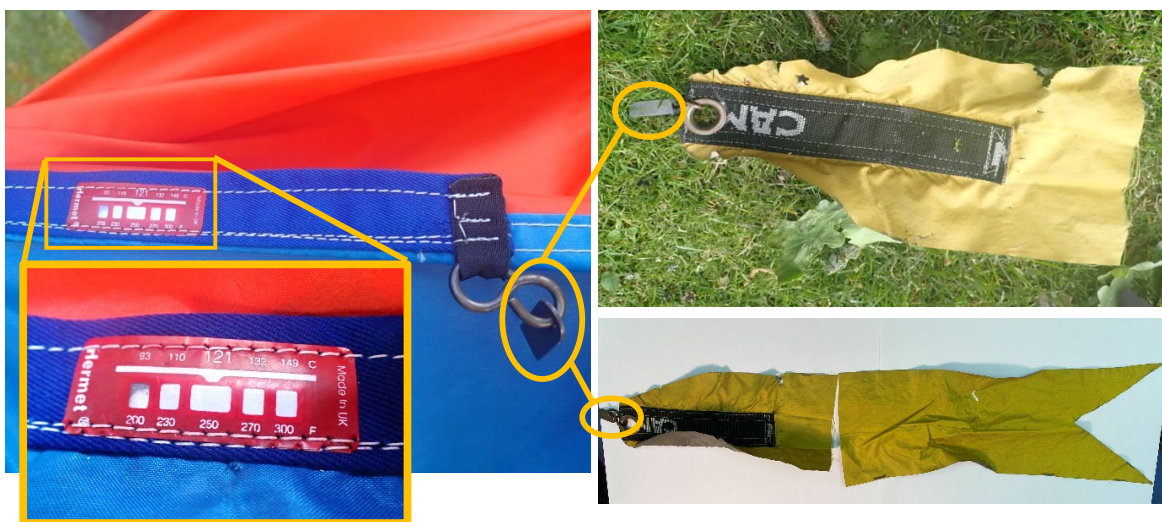
Figure 18

The envelope material was substantially ripped and torn where it had been dragged through the broken tree branches during the accident and later by the sharp edges of the broken tree limbs when the wind increased. Where the material had been ripped and the tear had reached load tapes or seams, the rip had not propagated further. The seam around the circular aperture at the top of the balloon was in good condition with no rips or tears and no sign of distortion or melting from potential overheating. Whilst the temperature streamer had separated from its soldered link, which was clipped to the envelope (Figure 18), there were no signs of heat damage on the upper sections of the envelope. The streamer flag material had also been torn in half widthways. The temperature sensor did not indicate that there had been excessive air temperatures present in the upper areas of the envelope, although the 93°C indicator showed potential signs of discolouration.

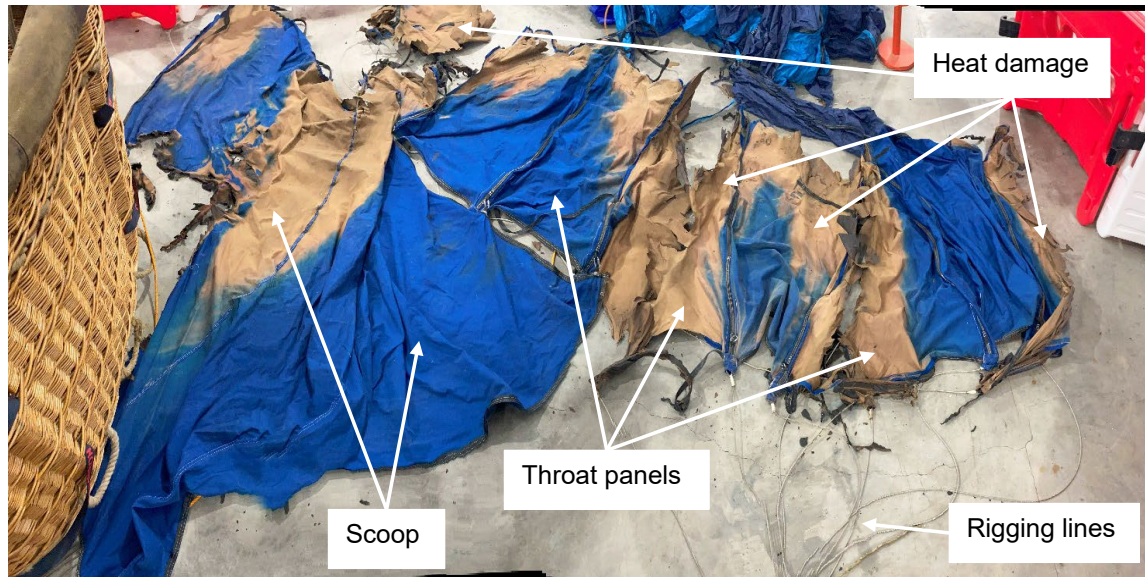
Figure 19

At the bottom of the envelope, all the vertical load tapes that connected the envelope to the steel rigging lines remained fastened to the lowest edge of the heat resistant throat material. The throat panels showed significant signs of heat damage (Figure 19). The original blue colour of the material was discoloured in multiple, vertical burn patterns. The horizontal load tape seams along the lower edge of the envelope had melted in several places together with some of the vertical load tapes and envelope material.

Panoramic picture of the heat resistant throat section with the scoop attached and showing multiple areas of significant heat damage

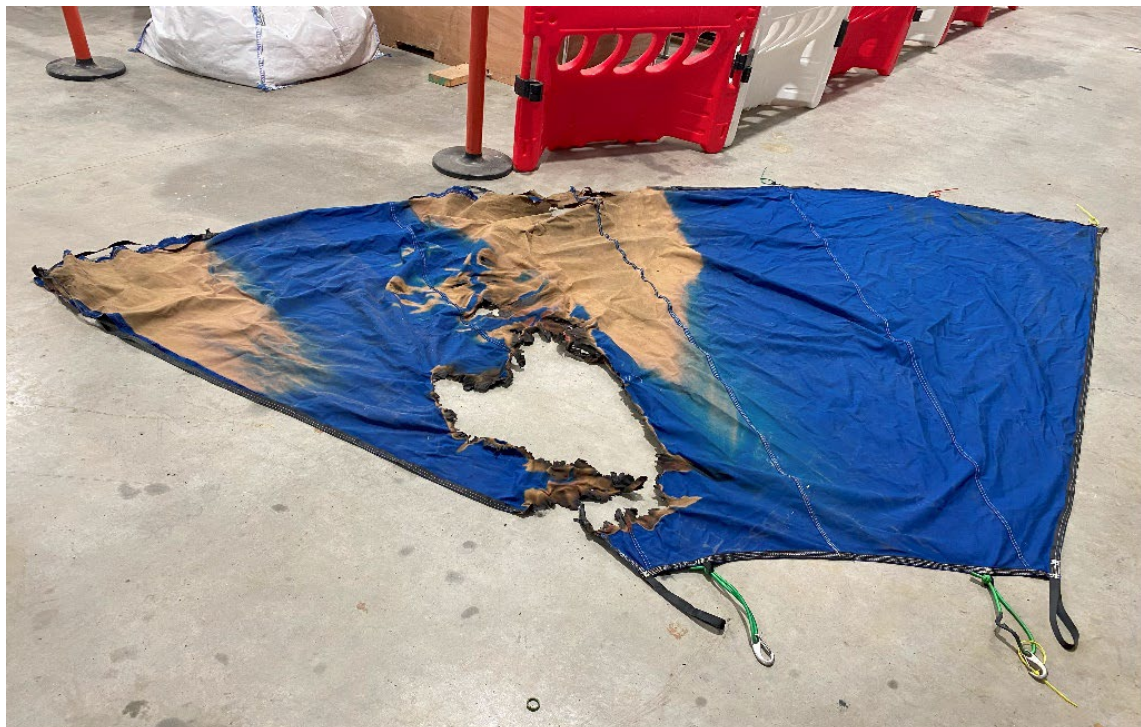
When the throat and the scoop were separated, the full extent of the burn patterns were revealed. The scoop shown in Figure 20 had a large hole burned through the fabric and two V-shaped burn patterns. Much of the upper horizontal seam of the scoop had melted and separated from the edge of the scoop.
