Rail Accident Investigation Branch

Rail Accident Report

**Member of staff struck by a train at St Philips
Marsh depot, Bristol
26 September 2023**

Report 08/2024
July 2024

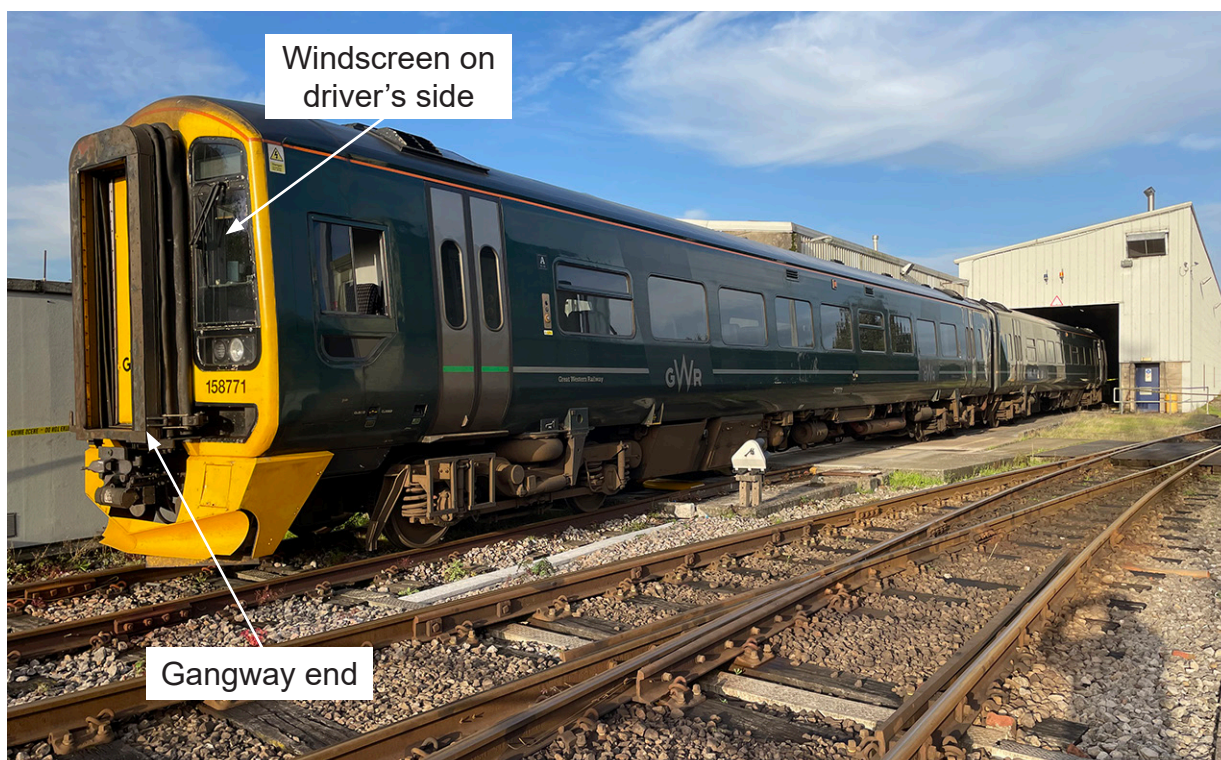
Figure 5: Unit 158771, where it stopped after the accident.

- 10 The train involved in the accident was a two-car class 158 diesel multiple unit, number 158771 (figure 5). It had arrived onto the depot earlier that morning from Bristol Temple Meads station.
- 11 At the time of the accident, the unit was moving out of the main shed building along line D (figure 2). Its initial destination was the West End Spur line, where it was to stop behind PM6 signal, then reverse direction to go to the New Sidings (figure 6).

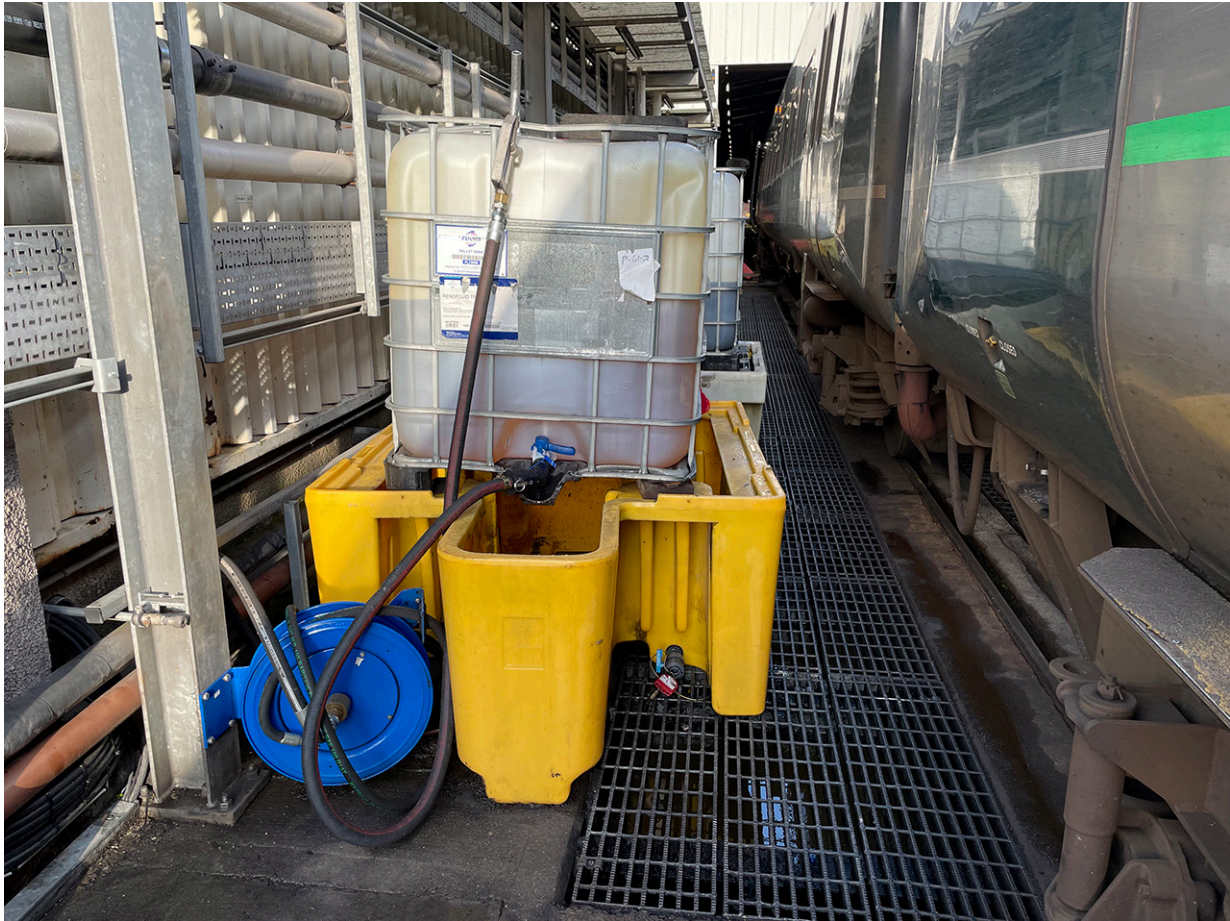
Figure 9: The intermediate bulk containers.

61 In places on the right-hand side in the direction of travel, the space to the outside of the yellow line was restricted at the time of the accident by five intermediate bulk containers that were used to store liquids (figure 9). This limited the available space (paragraph 33) and the shunter was walking next to two of these containers when they were struck. Therefore, the shunter had very little space on either side of the walkway in which to walk to the level crossing without being foul, or very close to being foul, of the train's path.

- 142 GWR has repainted the yellow lines along the length of the walkway between the roller shutter door and level crossing (figure 20). It has also moved all but one of the intermediate bulk containers that were stored on the side of the walkway where the shunter was struck, so there is now space to walk or stand and not be foul of a train's path. One of the intermediate bulk containers, next to the roller shutter door, could not easily be moved as it is part of an oil recovery system, so plans to move it are ongoing.
- 143 GWR is considering what options exist to widen the walkway on the opposite side to where the shunter was struck, so there is space to walk on that side without being close to, or foul of, the train's path.

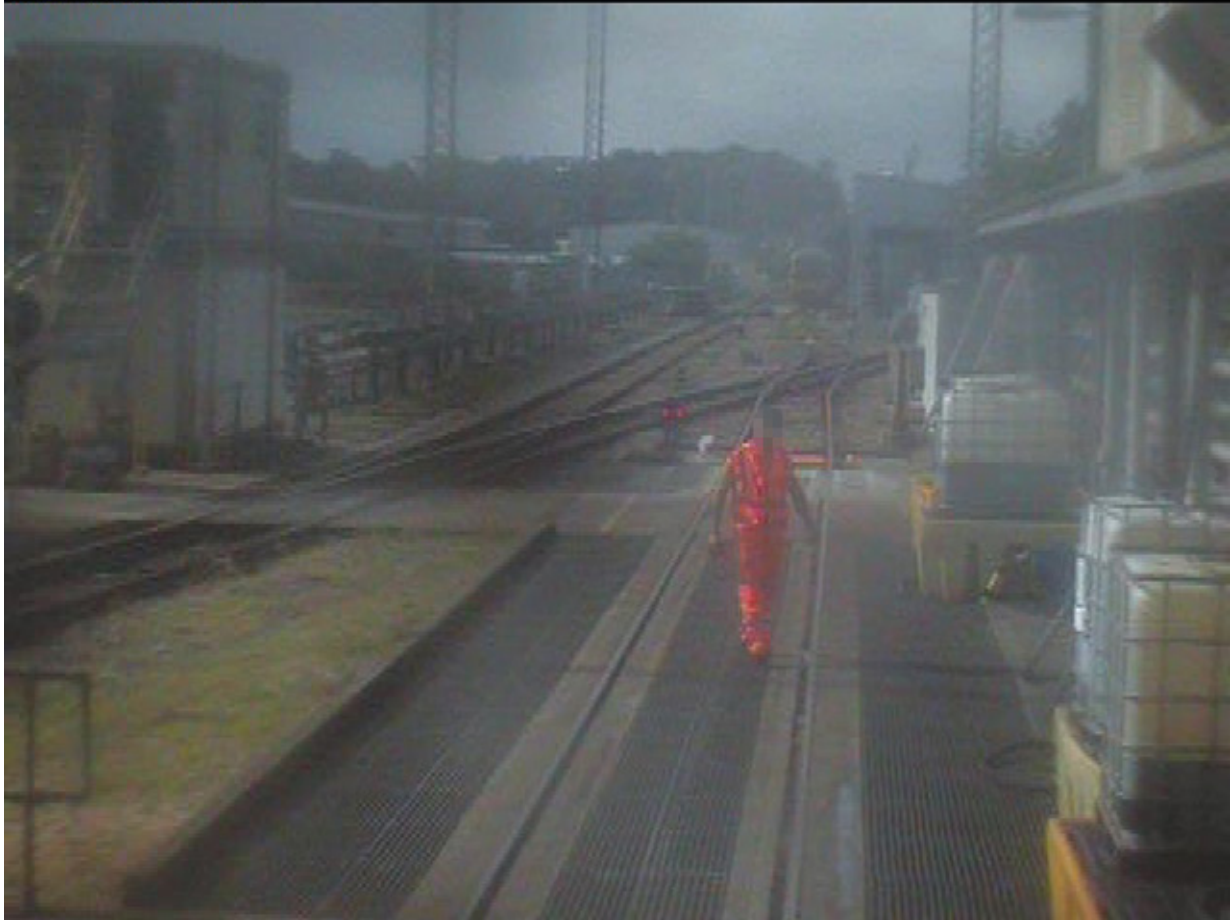
Figure 11: Forward-facing CCTV image of the shunter walking along line D to get to the main shed building (courtesy of Great Western Railway).

- 47 GWR advised that, while this area was shown as an authorised walking route on its authorised walking route map, and repeated in the site induction, this was an error. It considered that only the area covered by the concrete apron for the level crossing, running across the end of the main shed building, is actually an authorised walking route. The driver held a similar view that this area was not an authorised walking route, which meant they did not expect anyone to be there when they were moving a train.

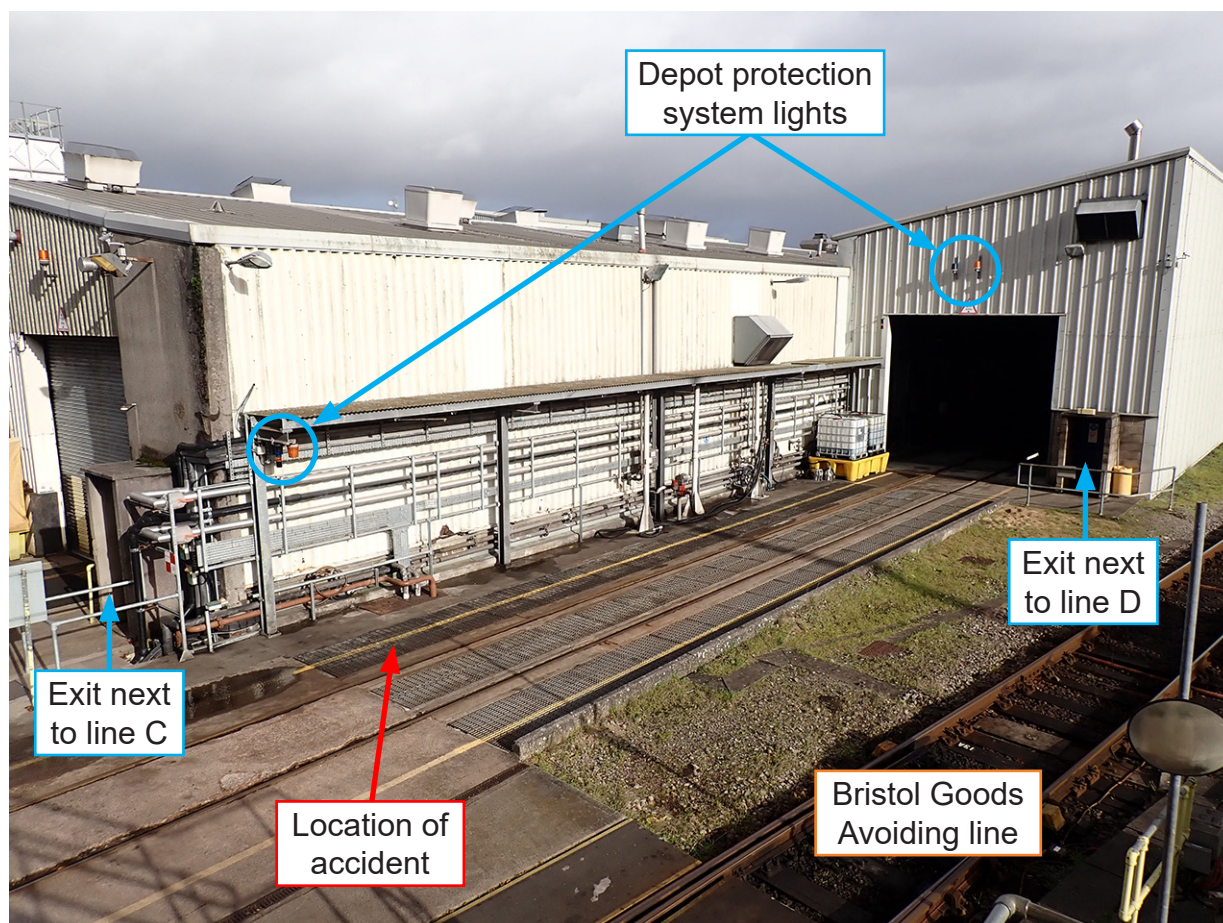
Figure 14: The pedestrian exits at the end of the main shed building (photograph taken after all but one of the intermediate bulk containers have been relocated).

- 48 Depot engineering staff usually exit the main shed building at that end via a pedestrian door next to the roller shutter door for line C (figure 14). There is also a pedestrian exit next to the roller shutter door for line D (figure 14), which depot engineering staff could use, although management at the depot considered its use to be limited to that of a fire exit. The fence outside this pedestrian exit stops anyone coming through the door from going towards the adjacent Bristol Goods Avoiding line, but this also directs them towards the track for line D, which they can walk along to reach the crossing.

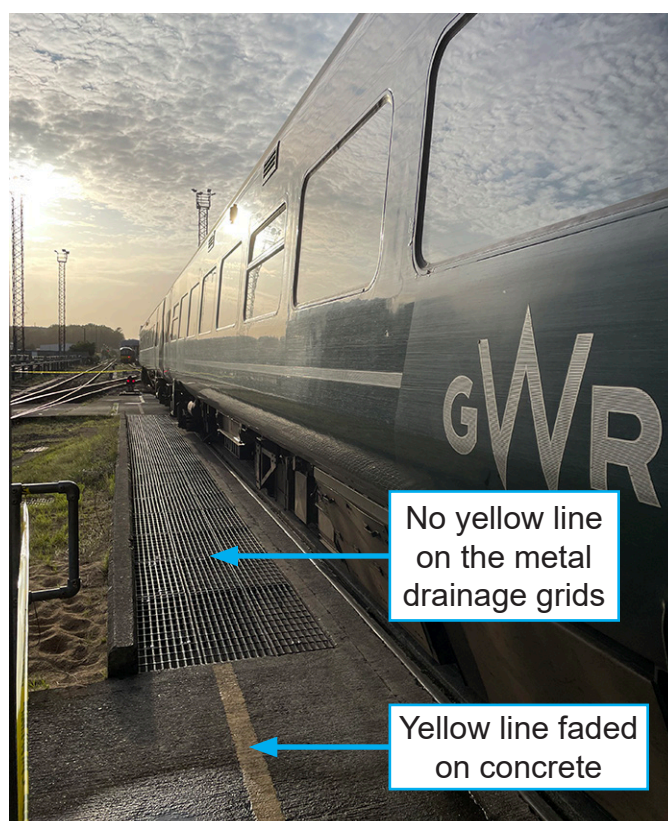
Figure 15: The faded yellow lines along the walkway.

- 59 Yellow lines are painted on the ground between the main shed building and the level crossing, on both sides of the track, to denote the safe area clear of the path of a train. At the time of the accident, these yellow lines were faded but still visible on the concrete sections of the walkway. The yellow lines should have continued onto the metal drainage grids running most of the distance to the level crossing, but GWR believed these lines had not been painted (figure 15).

60 The yellow lines are positioned 1 metre from the nearest running rail on each side. This is less than the minimum of 1.25 metres that PTS competency holders must be from a running line to be in a position of safety when a train is passing (for a railway line with a permissible speed of 100 mph (160 km/h) or less). On the left-hand side in the direction of travel, the raised kerb edging means the strip of walkway that the shunter could walk along on this side was limited to 0.45 metres wide (figure 16). Further to the left, the ground is unpaved and uneven, presenting a potential tripping hazard if walked on. This area is also adjacent to the Bristol Goods Avoiding line running through the depot.

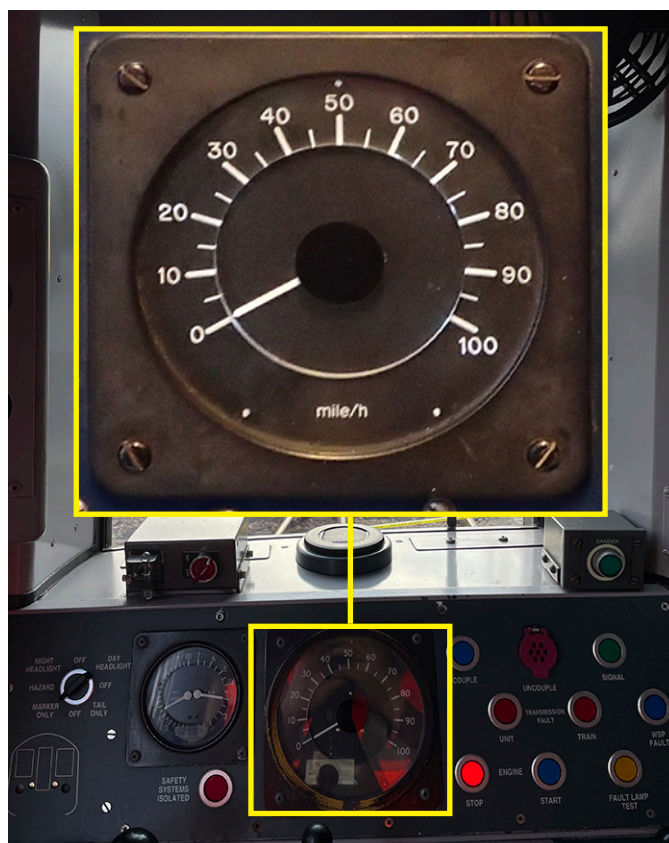
Figure 17: The speedometer in the leading cab of unit 158771.

- 78 GWR told RAIB that it believed that drivers should be able to read the speedometer accurately enough to know when their train was moving at 5 mph (8 km/h). The speedometer fitted to unit 158771 had major markings in 10 mph (16 km/h) increments, along with minor markings at intermediate 5 mph (8 km/h) increments (figure 17). Maintenance staff tested the speedometer in the leading cab after the accident, in 10 mph increments from 0 to 100 mph, and no fault was found with the readings it displayed.

- 79 The driver stated that they did not know they were travelling as fast as they were. The driver knew what the permissible speed was and stated that they would try to keep to 5 mph (8 km/h) as much as they could but explained that they found this was difficult to do when starting a movement out of a shed building. After starting a movement, to know when to move the traction handle to off and start coasting, the driver stated that they tended to judge their speed by observation just as much as they did by looking at the reading displayed on the speedometer. The driver acknowledged they must have misjudged their speed when leaving the shed building, which they explained was due to their focus being on the level crossing ahead of them, although they did not observe the shunter walking ahead of the train when looking ahead (see paragraph 86). The driver was also aware that the contractors were working nearby so was watching out in case one of them walked out from the blind side of the crossing.

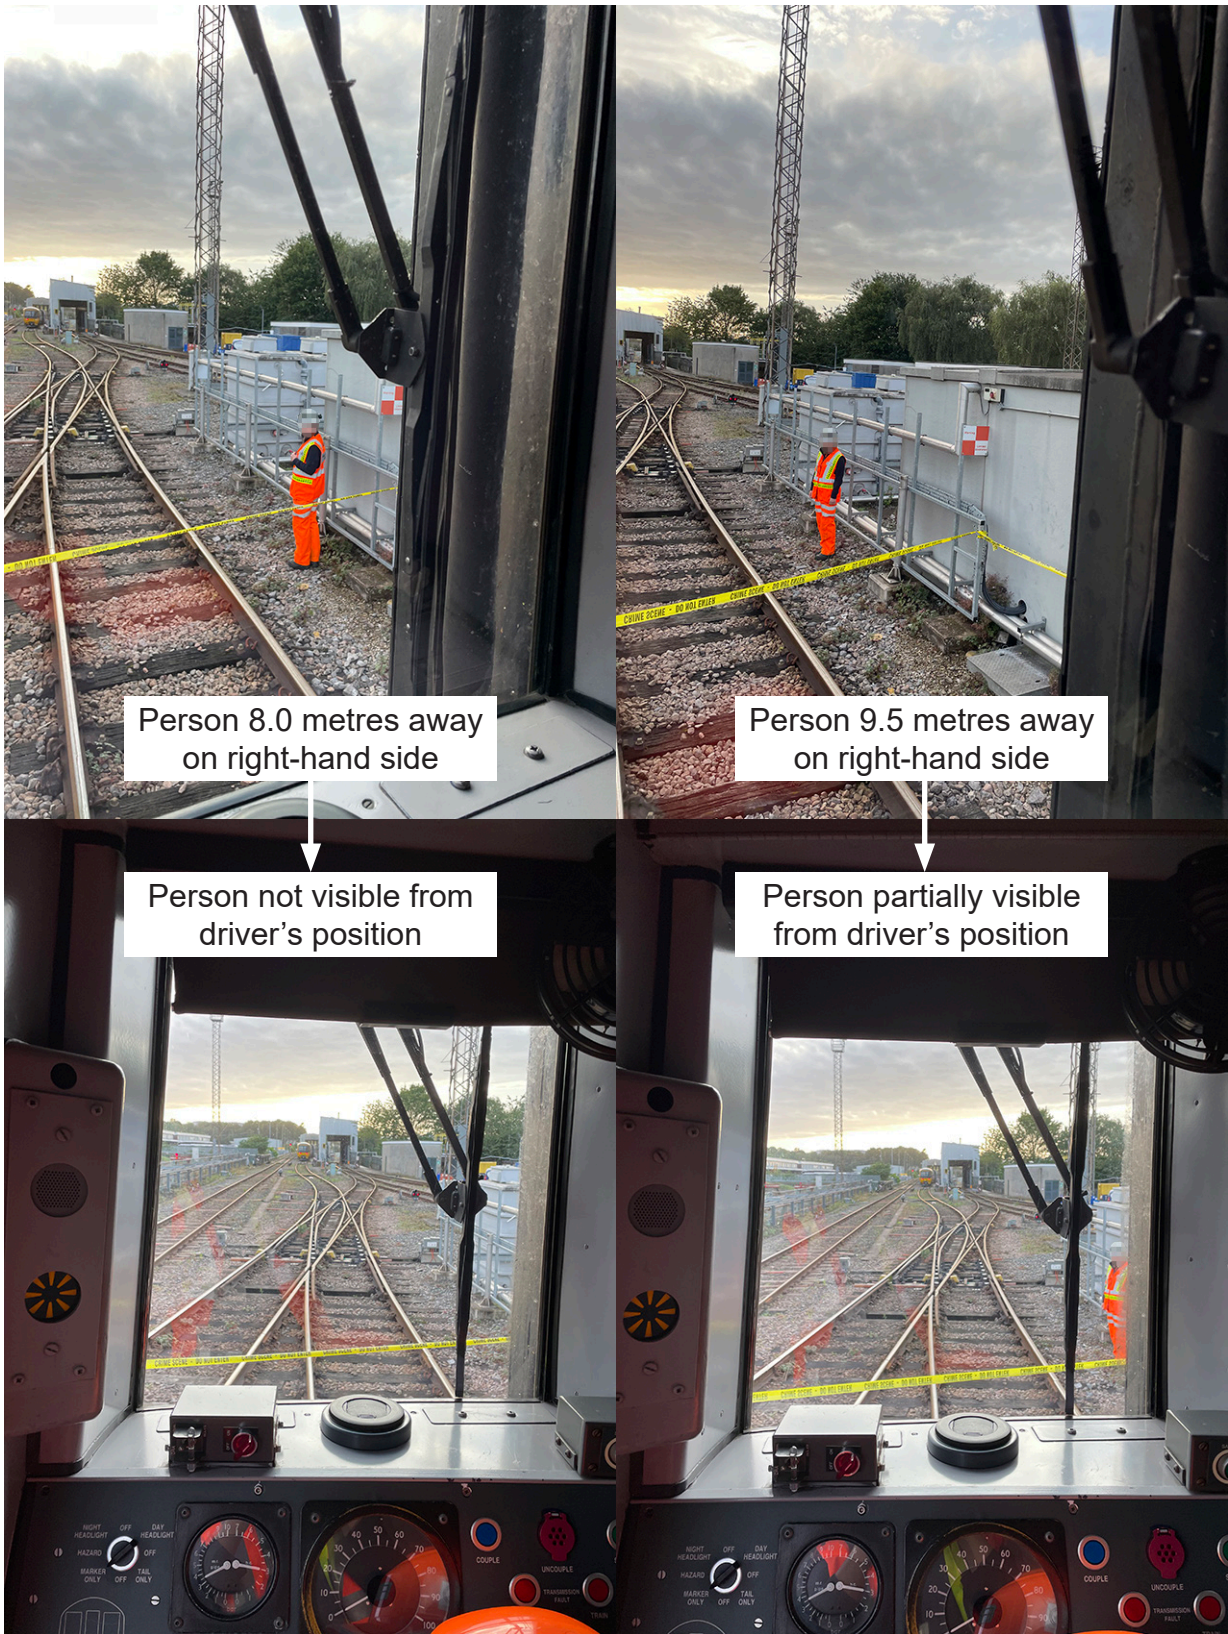
Figure 18: View from the driving position on a class 158 unit.

- 87 Sightlines from the driving position in the cab of a class 158 unit are more restricted to the right (in the direction of travel). This is because the cab is set on the left-hand side with the width of the windscreen limited by the gangway end (figure 5), which allows staff and passengers to move between units when two or more units with gangway ends are coupled together. The gangway end curtain extends from the centre at the front, which further reduces the field of view to the right (figure 5). RAIB measured that when a person is 8 metres or less from the front of the unit, standing in the cress on the right-hand side of the unit in the direction of travel, they are no longer visible from the driving position (figure 18). A person is partially visible between 8 and 10 metres away, and fully visible once more than 10 metres away (figure 18). RAIB also measured that when a person is closer than 4 metres from the front of the unit, they are not visible from the driving position. This occurs even when the person is standing directly in front of the unit on the driver's side, as they are hidden by the cab desk.

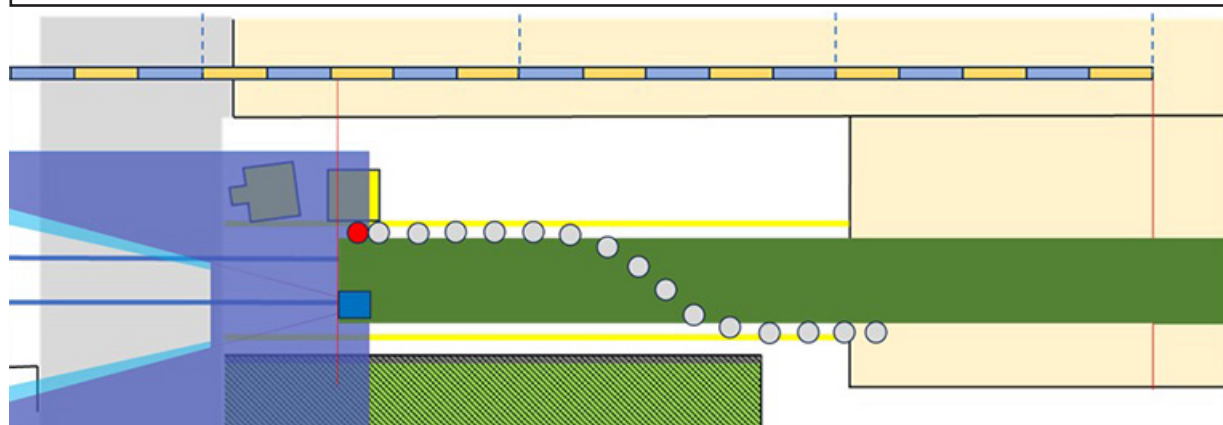
Figure C17: Shunter and train positions at 13:01:14.5 hrs.

At 13:01:14.5 hrs, the train had moved 25.7 metres, its speed was 10 mph (16 km/h), and it had caught up with and struck the shunter who was next to one of the intermediate bulk containers
