# Near miss with track worker at Euxton Junction, Lancashire, 14 March 2024

## Summary of the incident

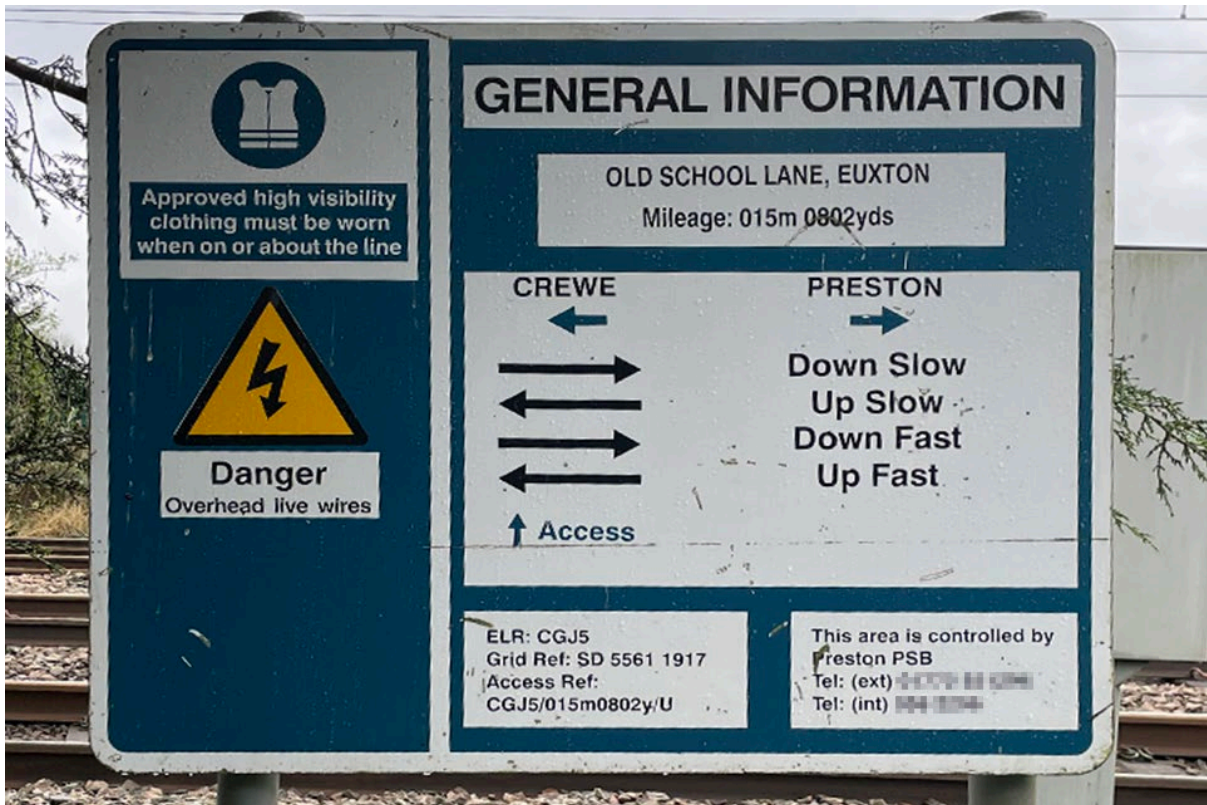
**Photograph of Old School Lane access point general information board.**

The general information board provided at the Old School Lane access point indicates that the railway line closest to the access point is the Up Fast line. However, the COSS remained certain that the LOC they were required to work on was adjacent to a down line, and that the nearest line to the access point was therefore the Down Fast.

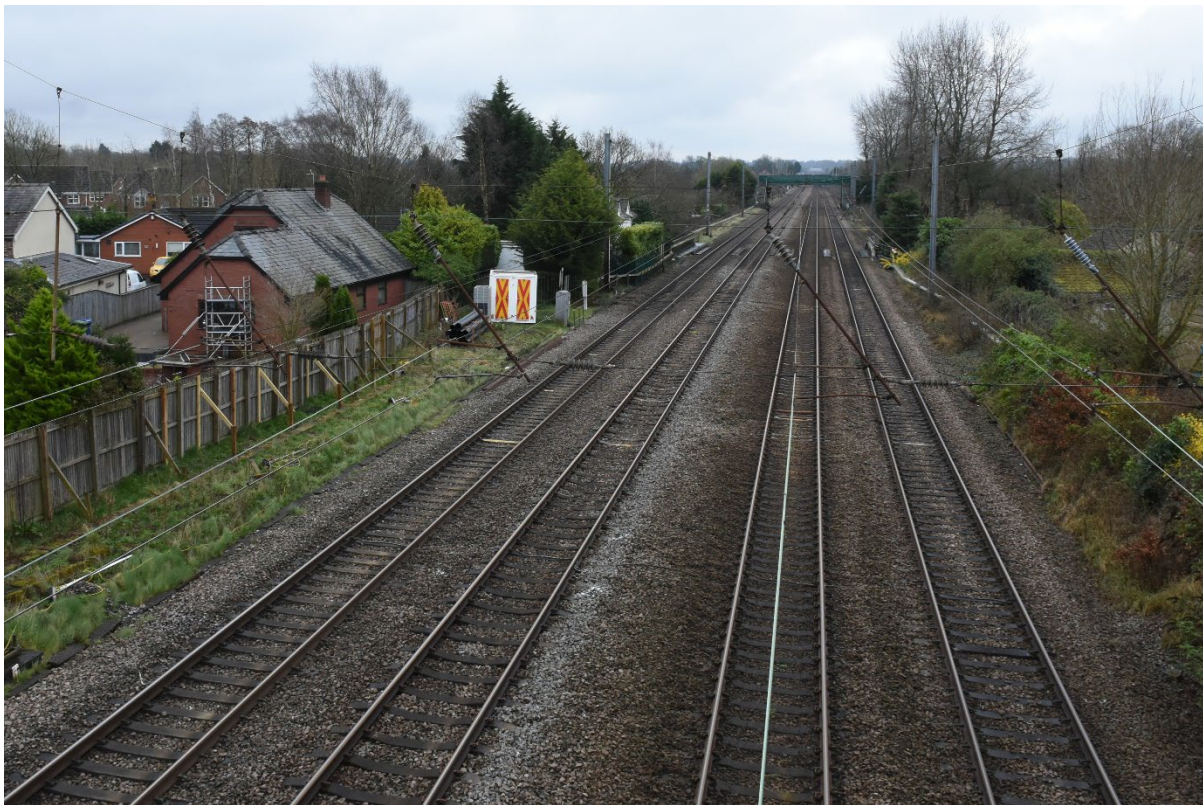
Having entered the railway at Old School Lane, the COSS and the technician walked north, adjacent to the Up Fast line, towards the second LOC. However, they found that they were unable to reach it safely due to the area of limited clearance between the Up Fast line and a structure (Oak Avenue footbridge). This meant there was no position of safety throughout the length of the structure. There were two access points adjacent to this footbridge, one on either side of the limited clearance, which would have allowed the team to bypass the structure. However, the southernmost of these access points was found to be secured out of use. The team therefore decided to return to the original access point at Old School Lane, and to use public roads to walk north to reach the access point beyond Oak Avenue footbridge. There was no general information sign showing the layout of the railway at this access point.

Photograph taken from Oak Avenue footbridge, looking towards the south. Railway lines, from left to right, are Up Fast, Down Fast, Up Slow and Down Slow. Old School Lane access point is to the left of centre behind the white cabin.

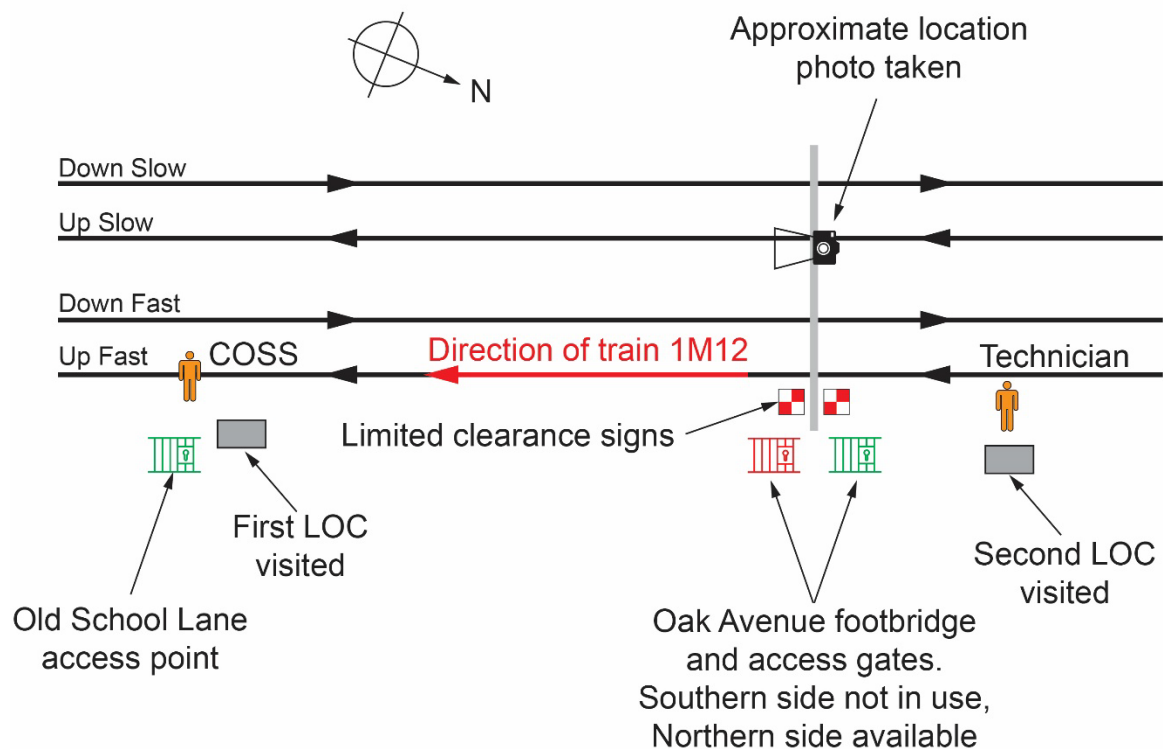
Diagram showing location layout and points of interest, staff positions shown at time of incident. Not to scale.

A visual inspection was made of a track circuit, although the team were unaware that the equipment examined was actually located on the Up Fast line and not on the (blocked) Down Fast line. The COSS then decided to walk back south towards the Old School Lane access point in search of the LOC which the team still needed to access for the other maintenance task. In doing so, the COSS walked between the rails of the Up Fast line, which was open to rail traffic, still believing that it was the blocked Down Fast line. The COSS was also walking with their back towards any trains that would approach on the Up Fast line.

As the COSS walked southwards, train 1M12 approached at 110mph (177 km/h), within the permissible line speed of 125 mph (201 km/h). As the train approached, it was seen by the technician, who expected it to be routed onto another line. Once the technician realised that the train was continuing on the Up Fast line, they shouted a warning to the COSS. However, the COSS was too far away to hear this warning.
