Rail Accident Investigation Branch

Rail Accident Report

Unsafe movement of a train at Styal station 3 May 2023

Report 07/2024
July 2024

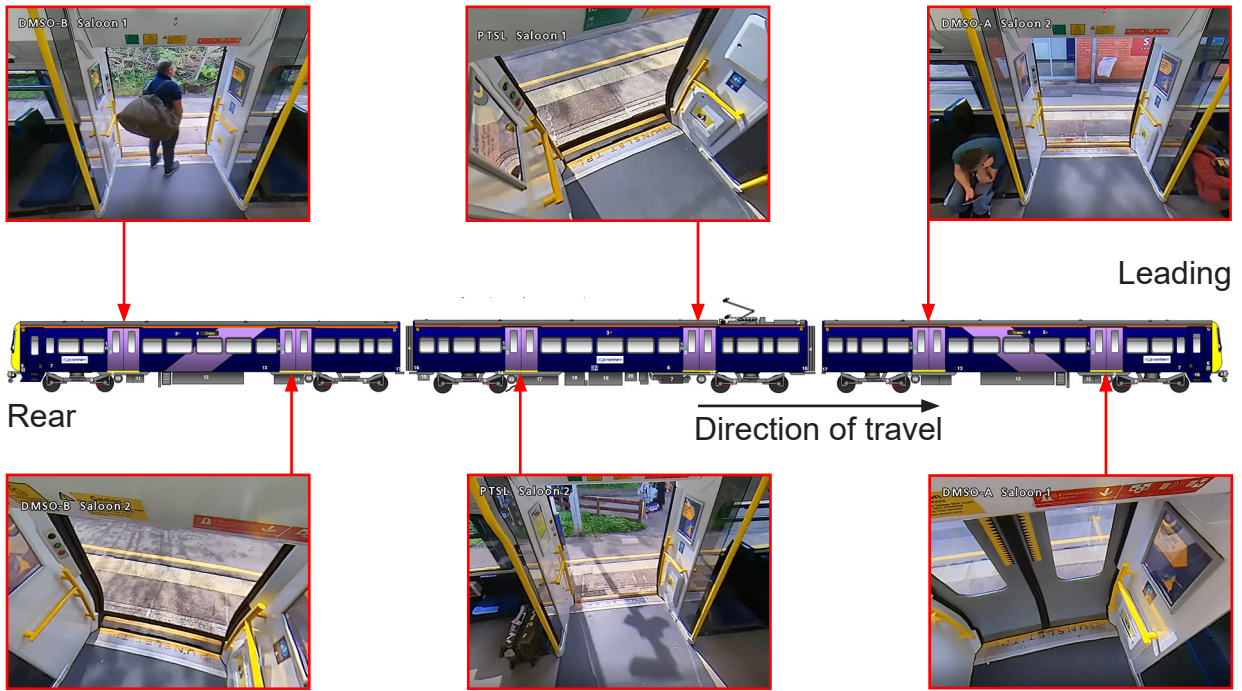
The train travelled for approximately 10 seconds with five doors open. Once the train reached 3.1 mph (5 km/h), a safety system caused the open doors to close automatically. No one was hurt in the incident, although people were moving towards the train and a passenger was standing in an open doorway when the train started to move.

Figure 2: Images from the internal CCTV showing the status of the train bodyside doors when the train started to move (courtesy of Northern Trains Ltd).

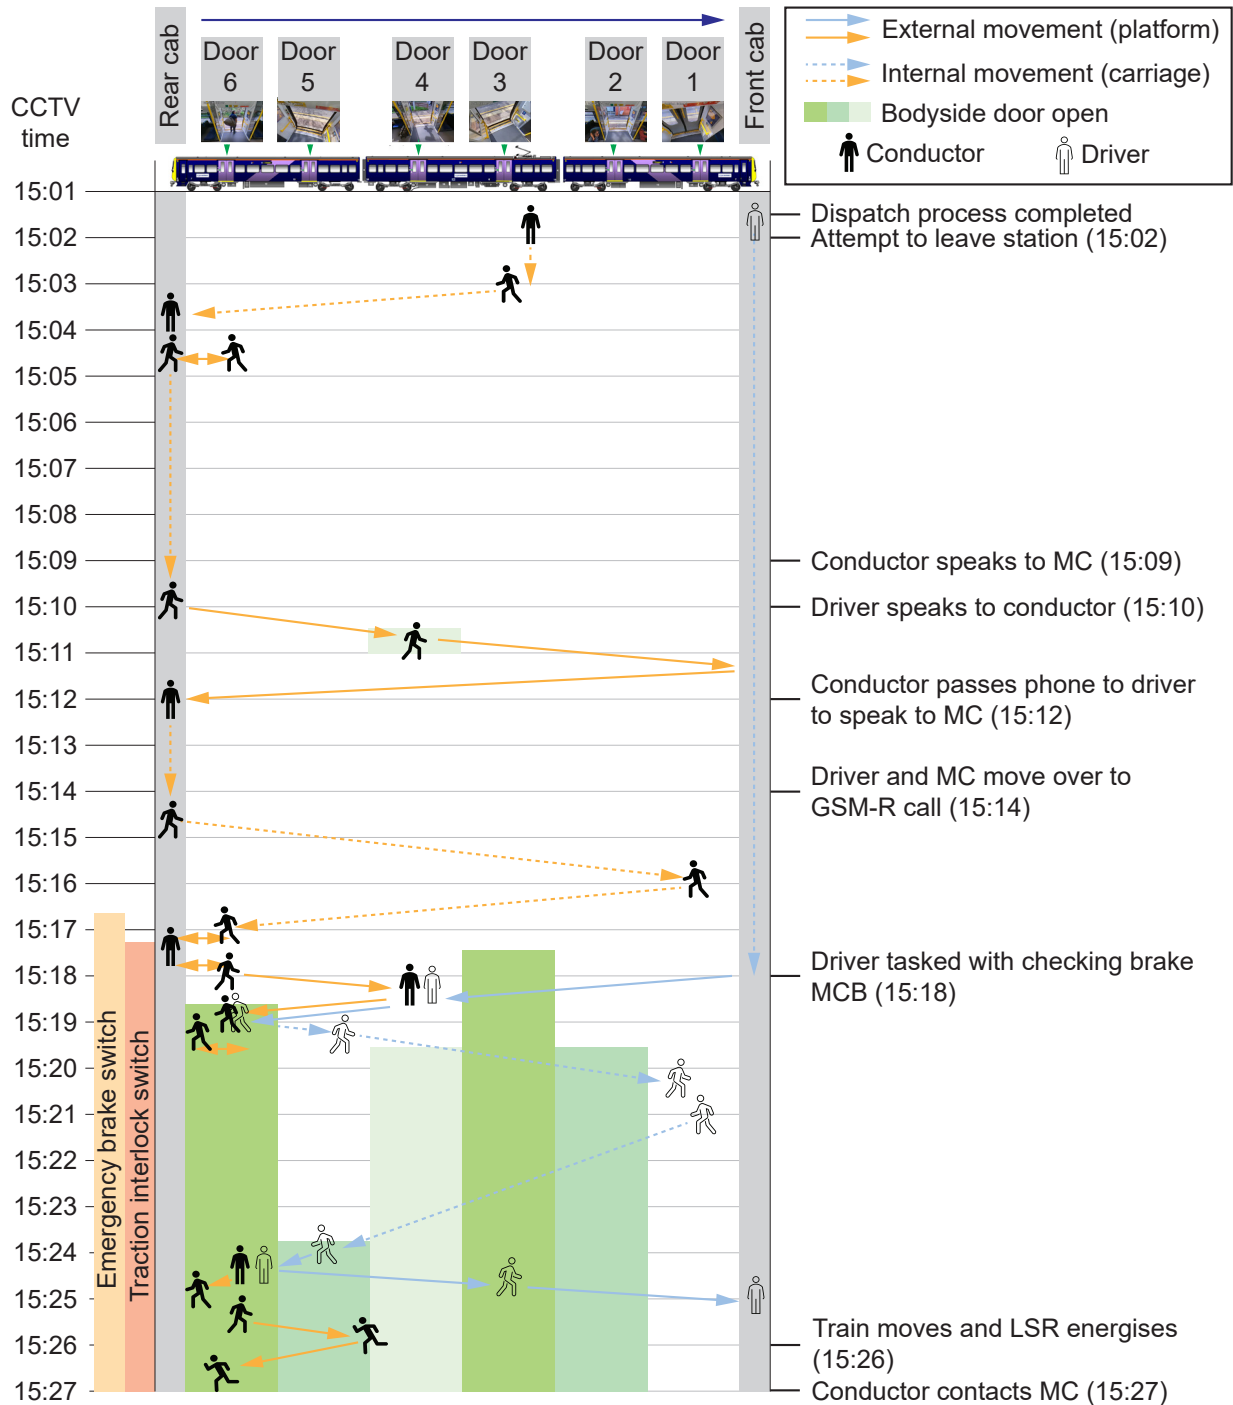
- 53 Meanwhile, the driver ran along the platform and returned to the front cab at 15:26 hrs. Within the next 30 seconds, the driver was able to get brake release and apply traction power. Although the conductor was standing on the platform and had not initiated the dispatch process, the driver sent an RTS acknowledgement to the conductor, normally the final step in the train dispatch sequence (see paragraph 105). The train then started to move with five bodyside doors open. The conductor, on the platform, shouted at the passengers on the platform to stand back from the moving train, while running towards the rear cab.

- 54 The passengers and conductor on the platform observed the five open bodyside doors automatically close as the train departed. This was due to the LSR being activated (paragraph 32) as the train accelerated to 3.1 mph (5 km/h).

Figure 5: The movements of the driver and conductor during the 25 minutes train 2A89 was at Styal station.
