Accident

Aircraft Type and Registration:	Jabiru UL-450, G-CDFK	
No & Type of Engines:	1 Jabiru 2200A piston engine	
Year of Manufacture:	2006 (Serial no: PFA 274A-14144)	
Date & Time (UTC):	4 April 2023 at 1107 hrs	
Location:	Damyns Hall Aerodrome, Upminster, Essex	
Type of Flight:	Private	
Persons on Board:	Crew - 1	Passengers - 1
Injuries:	Crew - 1 (Serious)	Passengers - 1 (Serious)
Nature of Damage:	Extensive	
Commander's Licence:	National Private Pilot's Licence	
Commander's Age:	57 years	
Commander's Flying Experience:	230 hours (of which 173 were on type) Last 90 days - 1.5 hours Last 28 days - 0.5 hours	
Information Source:	AAIB Field Investigation

Synopsis

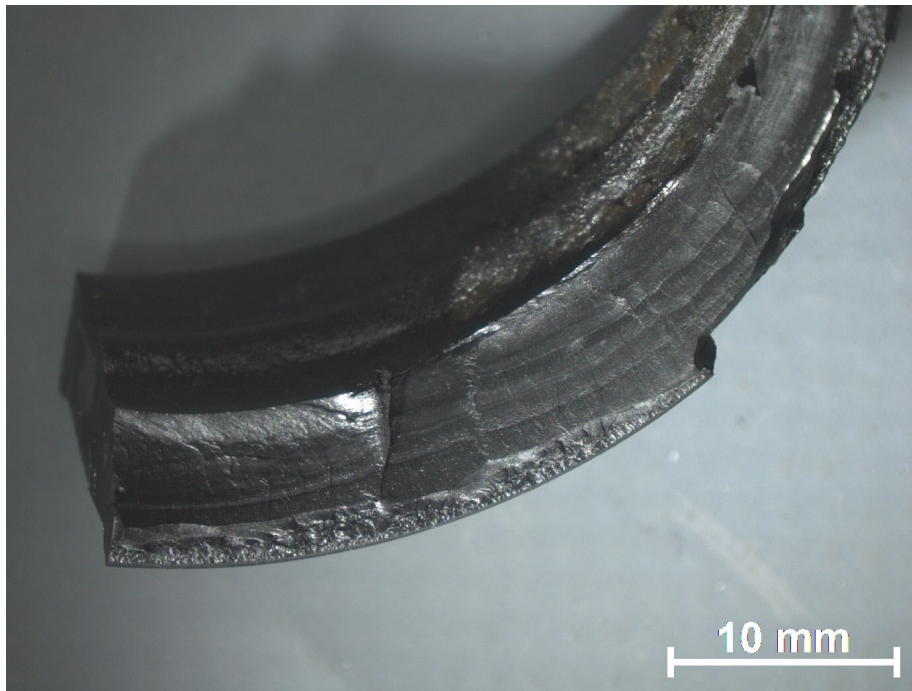
Figure 3

Assessment of the fracture surfaces indicated that the main crack from the inner diameter had been present for some time and exhibited fatigue striations (Figure 3). It could not be determined for certain whether the external cracks were present during the accident flight, as a result of the impact or during later manipulation when the coupling was removed, but there were five distinct areas of different external crack morphology, two of which exhibited fracture surfaces consistent with overload, leaving the remaining three areas likely to have been present during the accident flight. This suggests that at least 30% of the circumference was fractured during the flight. External cracks were also present in the coupling that had not joined with the main inner crack.

Cracks in coupling wall, showing fatigue propagation from inner diameter

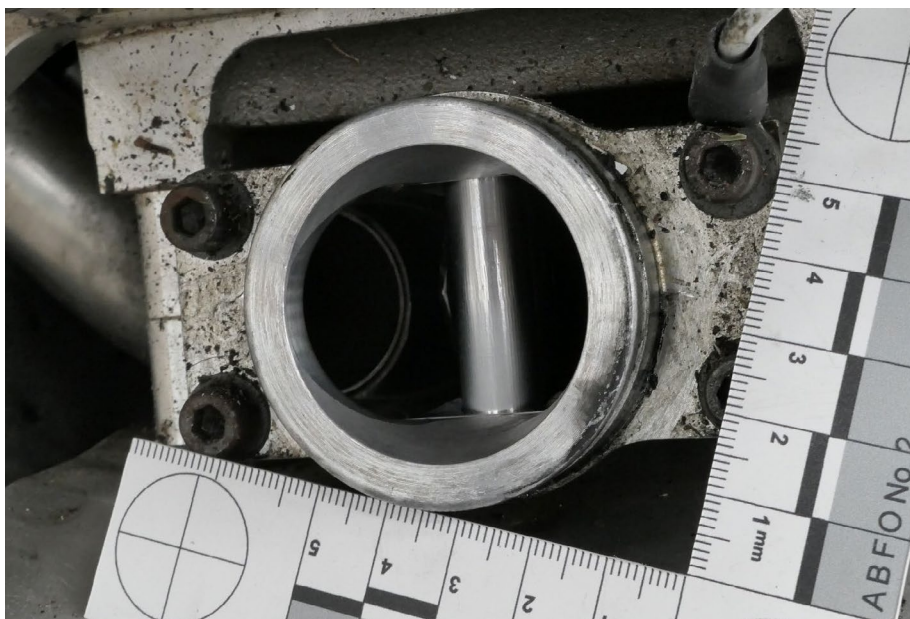
Figure 4

The rear face of the inlet to the plenum chamber showed staining (Figure 4), possibly indicating the location of the split in the coupling,

Inlet to plenum chamber showing marking indicating leak in coupling

Evidence of staining in an arc on the rear face of the plenum chamber union indicates that there was disrupted airflow in that location. This suggests a split in the coupling had been present for some time.
