## Accident

<b>Aircraft Type and Registration:</b>	Piper PA-28-180, G-AYUH	
<b>No &amp; Type of Engines:</b>	1 Lycoming O-360-A4A piston engine	
<b>Year of Manufacture:</b>	1970 (Serial no: 28-7105042)	
<b>Date &amp; Time (UTC):</b>	21 August 2023 at 0820 hrs	
<b>Location:</b>	Near Stanley Hall, Halstead Hall, Essex	
<b>Type of Flight:</b>	Private	
<b>Persons on Board:</b>	Crew - 1	Passengers - None
<b>Injuries:</b>	Crew - 1 (Fatal)	Passengers - N/A
<b>Nature of Damage:</b>	Aircraft destroyed	
<b>Commander's Licence:</b>	Private Pilot's Licence	
<b>Commander's Age:</b>	72 years	
<b>Commander's Flying Experience:</b>	407 hours Last 90 days - 7 hours Last 28 days - 1 hour	
<b>Information Source:</b>	AAIB Field Investigation

## Synopsis

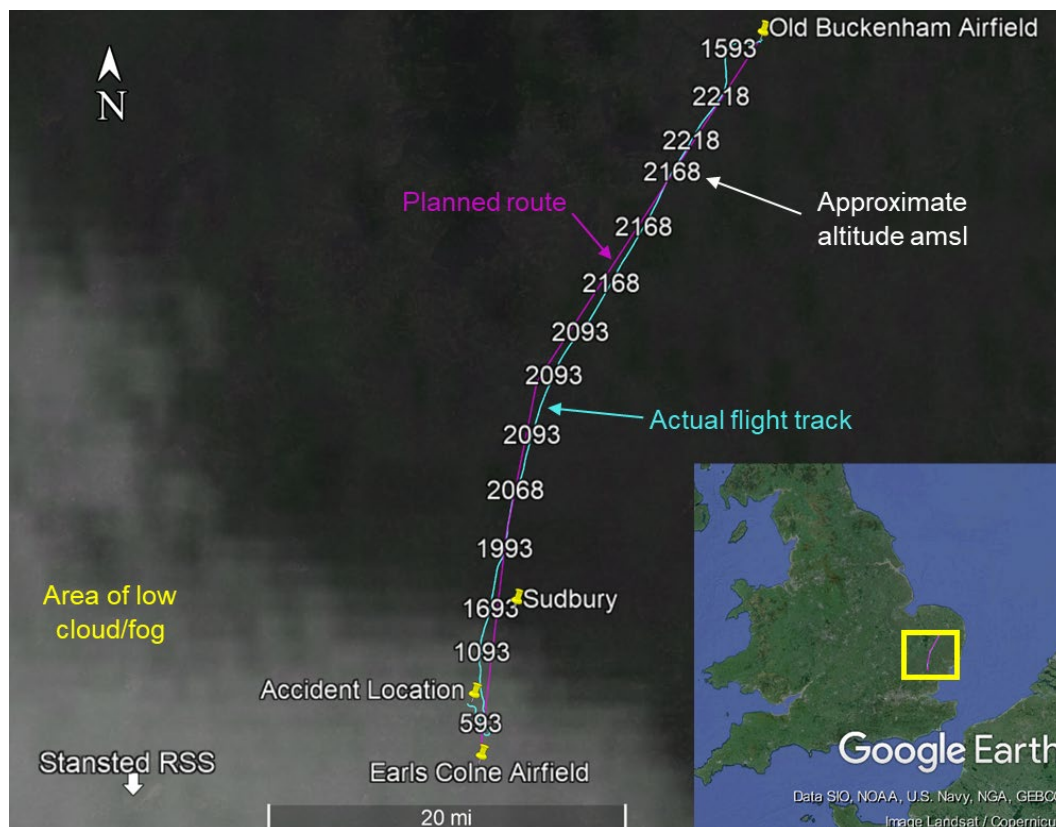
**Figure 1**

Figure 1 shows the aircraft's planned route and its actual track flown. A visible satellite image provided from the Met Office, showing the approximate location of low cloud and/or fog at 0745 hrs, is overlaid.

Planned route and actual flight track, with fog/cloud overlaid.

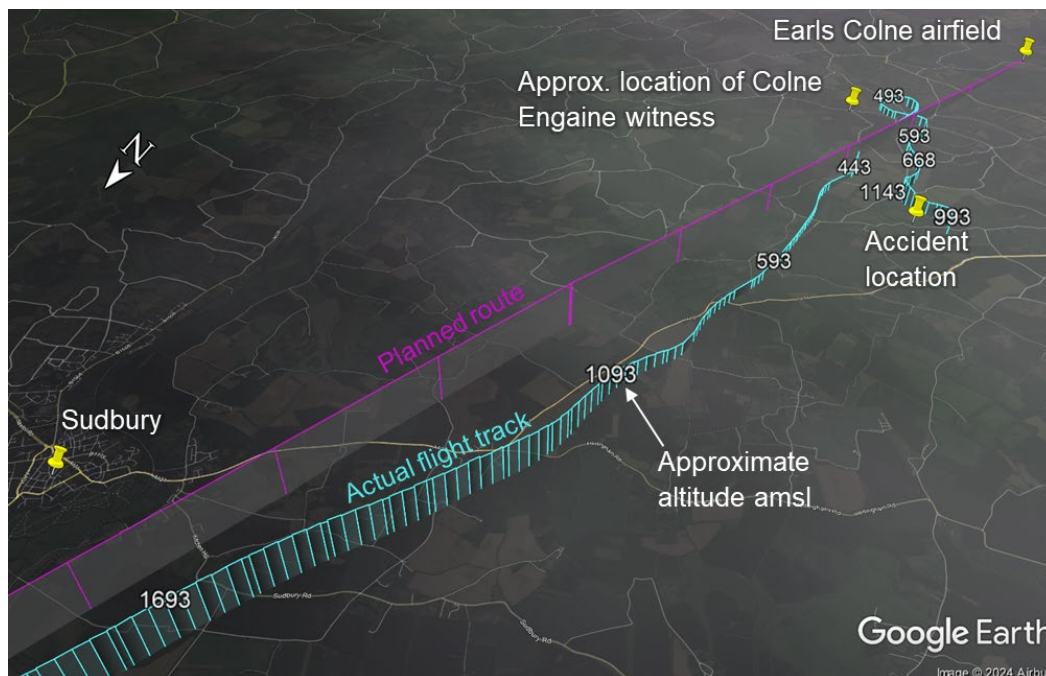
**Figure 2**

As G-AYUH approached Earls Colne, it began to descend at a location consistent with the edge of the band of low cloud / fog captured by the Met Office satellite image. The aircraft continued at an altitude of around 500 ft amsl (approximately 250 ft aal for Earls Colne).

View from the north-west showing the planned route and actual flight track for the final part of the flight, with fog/cloud overlaid.

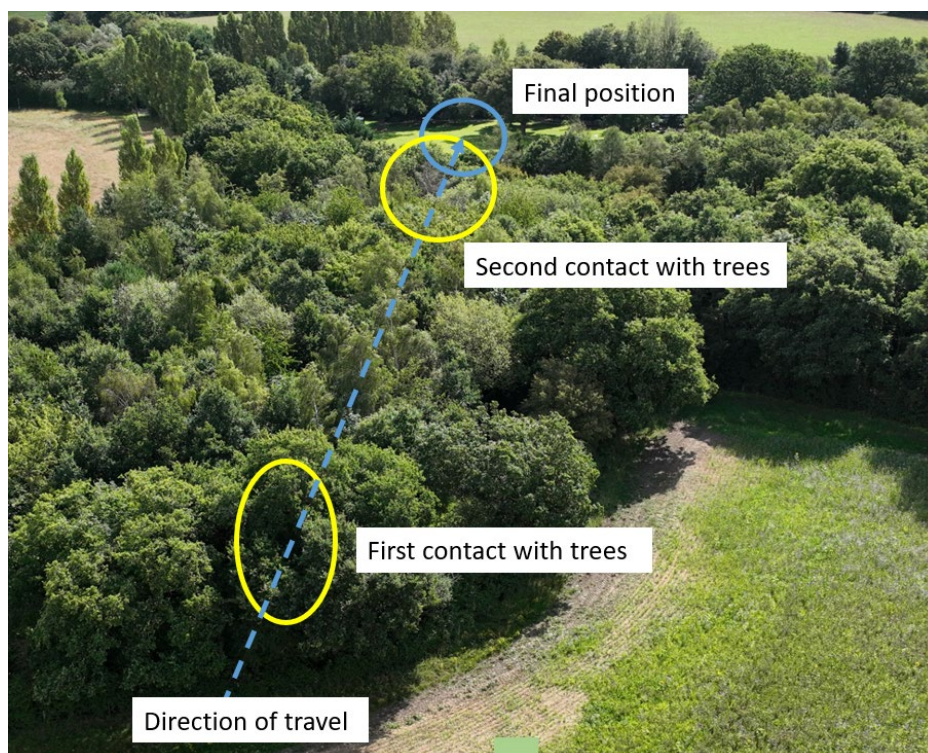
**Figure 3**  
Aerial view of accident site

The accident site was approximately 3 nm north of Earls Colne Airfield at an elevation of 240 ft amsl. An aerial view of the site is shown in Figure 3.

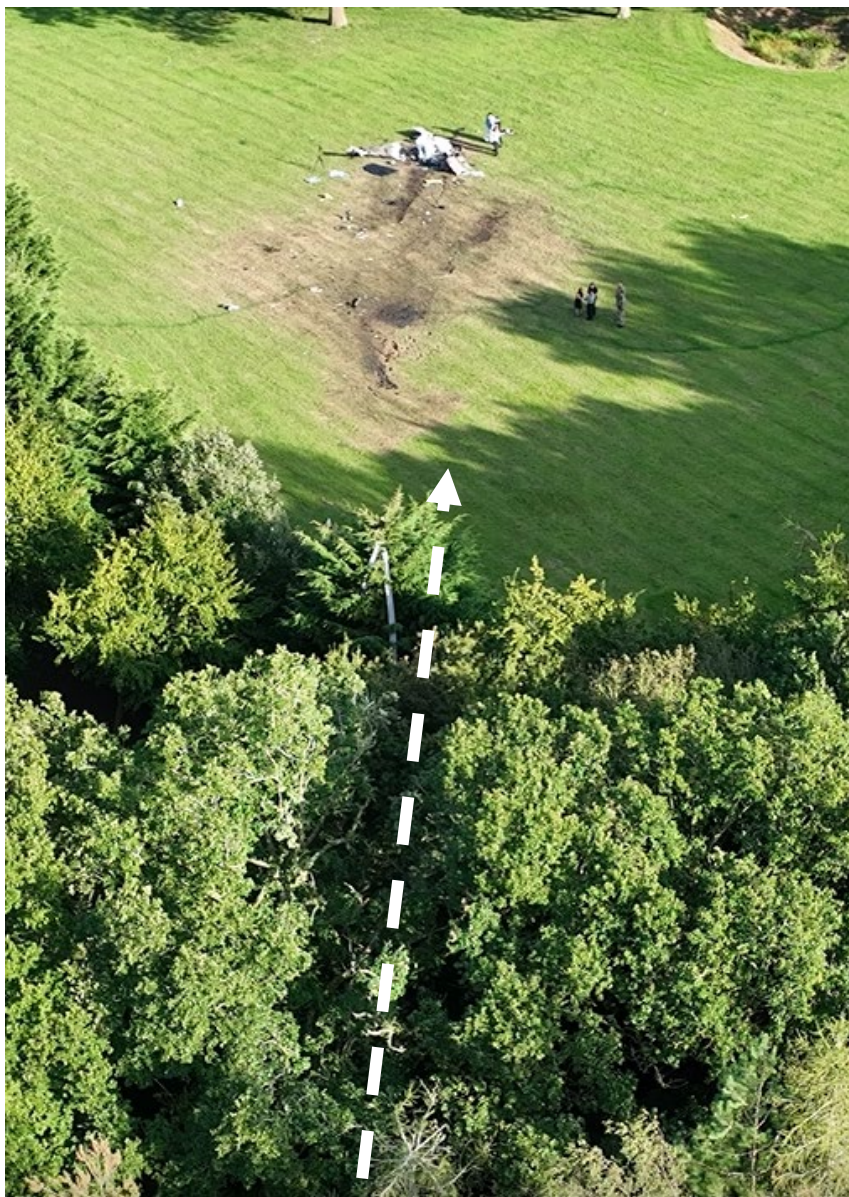
**Figure 4**

Inspection of the accident site and wreckage indicated that the aircraft first contacted the top of trees approximately 200 m before its final resting place. The initial contact was made by the right wingtip, evidenced by remains of the right wingtip green navigation light found on the ground underneath these trees. The second contact with the trees occurred approximately 75 m further along the path of travel. On the ground in this area were the remains of the left wingtip, red navigation light, and the beacon light mounted on top of the fin, along with pieces of clear plastic from the windows. This indicated that the aircraft was in a right-wing low attitude when it first contacted the trees and, by the time of the second contact, the aircraft was inverted with the left wing low. The aircraft continued in an inverted attitude until it came to rest in the grass field where the central part of the fuselage was consumed by the post-accident fire (Figure 4).

Final part of flight path through trees, looking along direction of travel

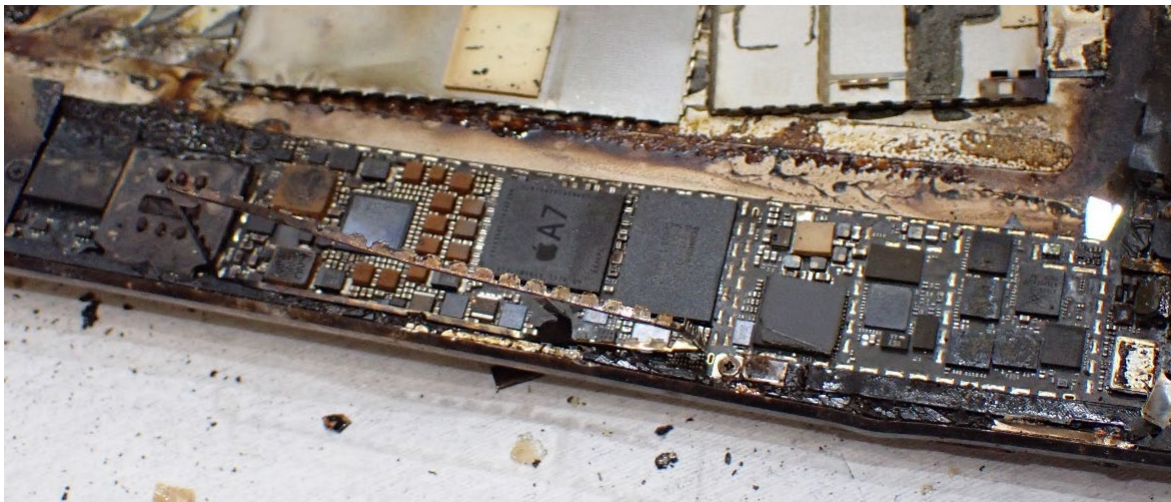
**Figure 5**

A significantly fire-damaged tablet was recovered from inside the aircraft, and a fire-damaged mobile phone was also retrieved from the accident site. The batteries of the tablet exhibited evidence of having combusted in the post-accident fire, exposing the internal circuitry to high temperatures. Some components on the circuit board had been displaced due to the high temperatures melting the solder joints. Some of the damage is shown in Figure 5.

Circuit board from the fire-damaged tablet.

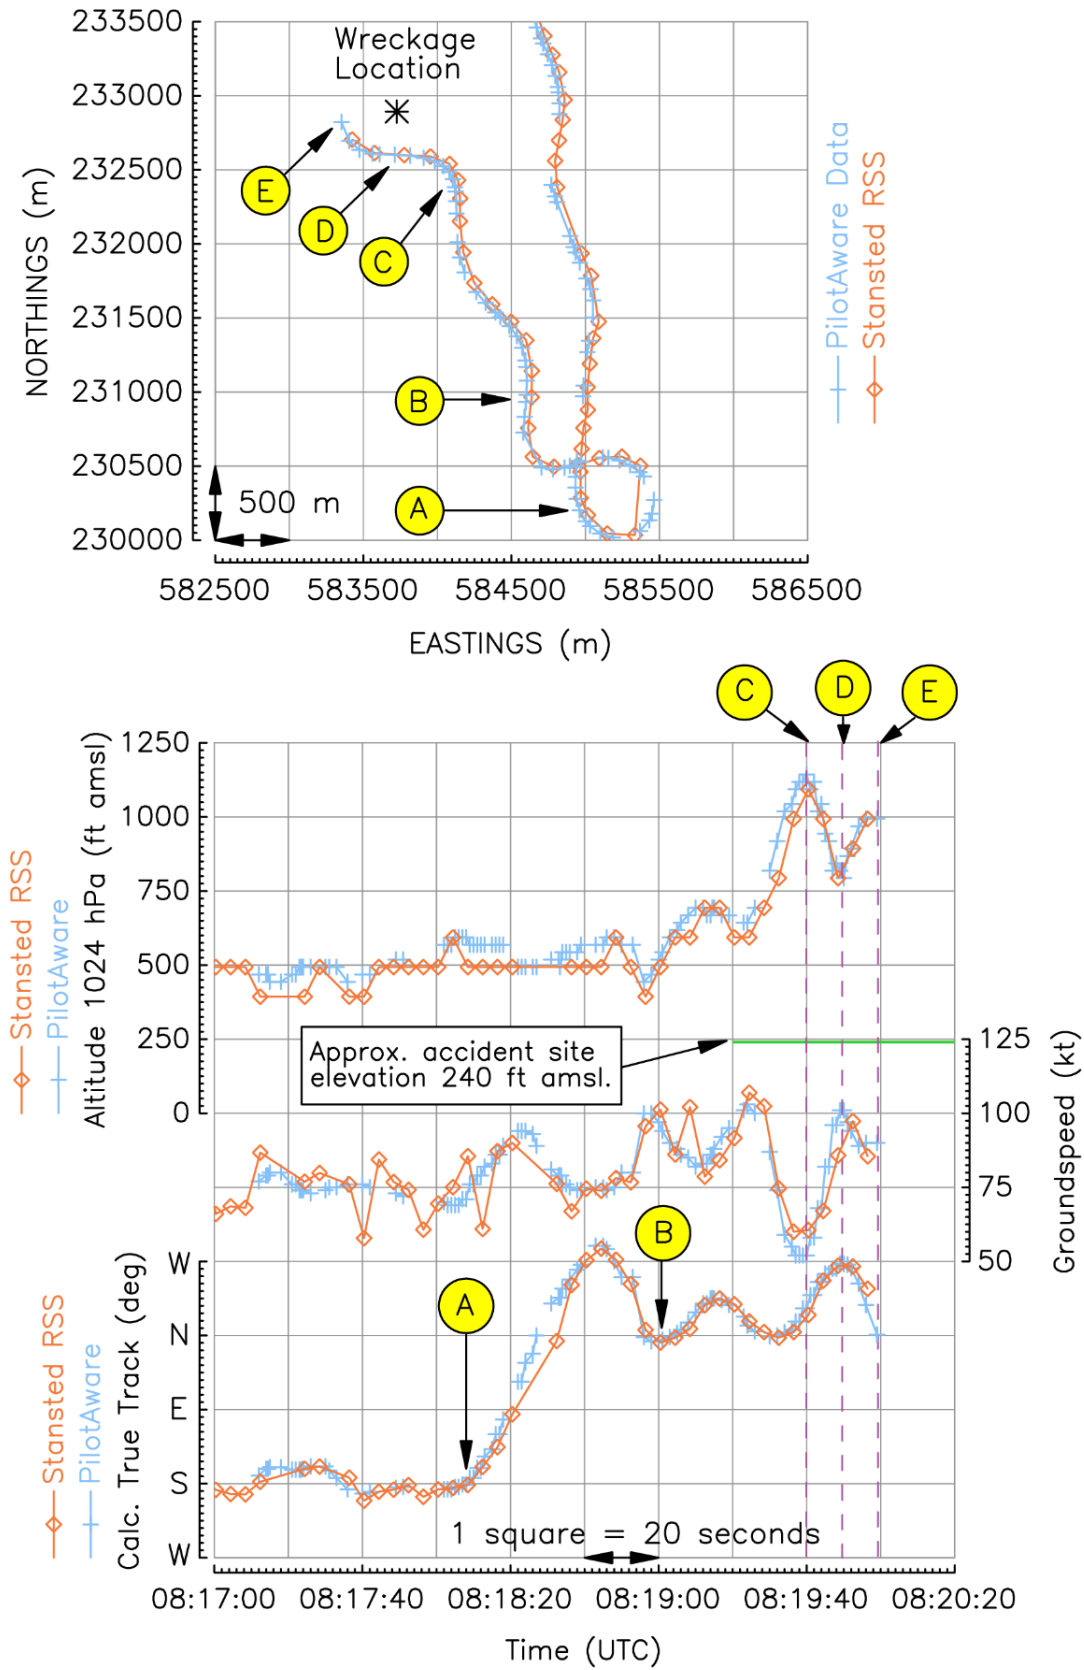
**Figure 6**

The start of G-AYUH's left turn over Colne Engaine is indicated by point A. G-AYUH then exited the turn flying west, later turning right to fly north in the direction it arrived from (point B). G-AYUH continued in this general direction and climbed to reach about 1,100 ft amsl, approximately 20 seconds before the last recorded position.

At point C, the calculated groundspeed from online tracking data was 52 kt and from radar it was 60 kt. The latter value is considered to be an overestimate due to errors which are normally expected in radar position measurements. The data indicates the aircraft then commenced a left turn and its altitude started to decrease, whilst groundspeed increased.

Altitude, groundspeed and heading from radar and PilotAware data, with an insert showing a plan view of the aircraft's recorded positions.

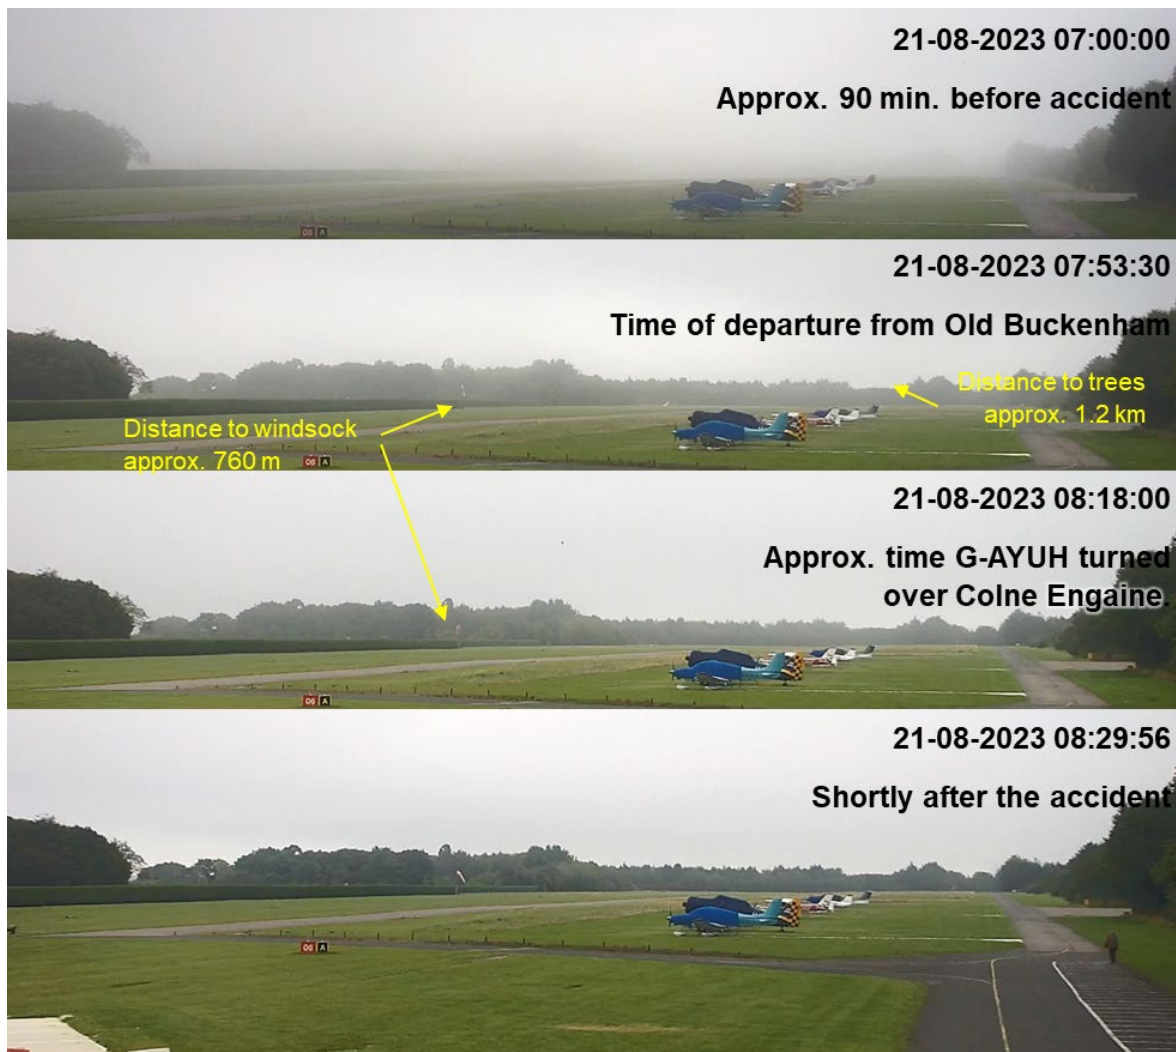
**Figure 8**

CCTV at Earls Colne Airfield (Figure 8) did not show the aircraft but provided evidence of the meteorological conditions at the following times; when the radio operator arrived at the airfield; when the pilot took off from Old Buckenham; at the approximate time the aircraft turned around over Colne Engine (about 2 minutes before the accident), and approximately 10 minutes after the accident. The timestamps shown are converted to UTC from the embedded video timestamps.

Snapshots from CCTV footage at Earls Colne, showing changing visibility in the area.

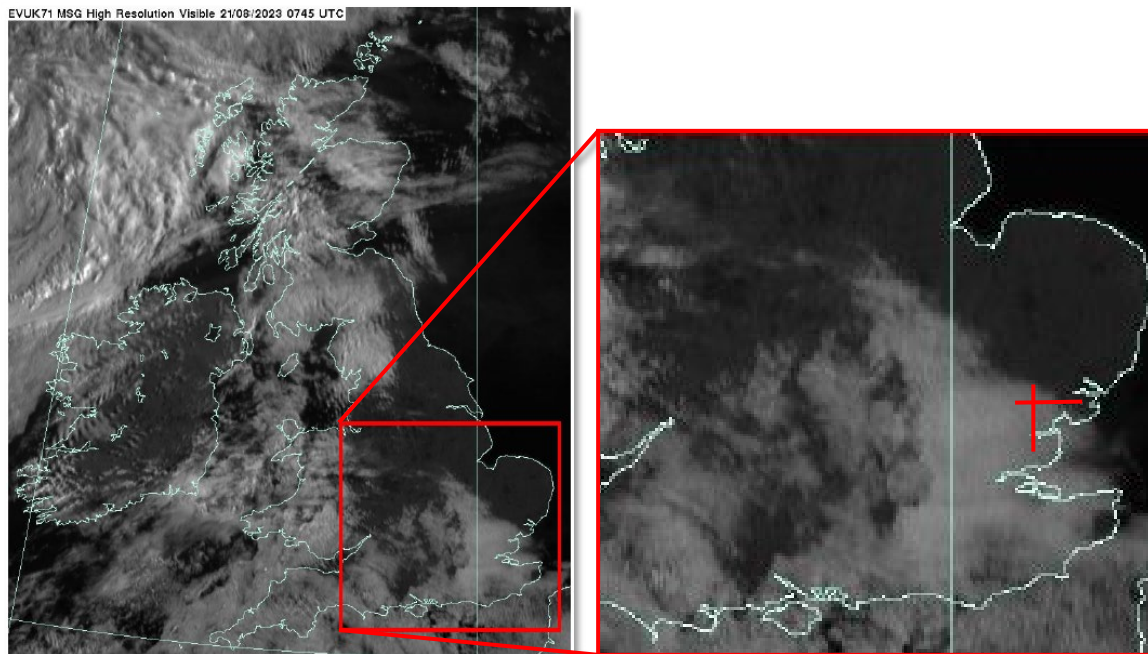
**Figure 11**

A visible satellite image taken at 0745 on 21 August 2023 (Figure 11) shows that the frontal edge of the cloud had moved across the area of Earls Colne.

Visible satellite image taken at 0745 hrs on 21 August 2023 – intersection of red lines on right image shows approximate position of Earls Colne Airfield (© Met Office)

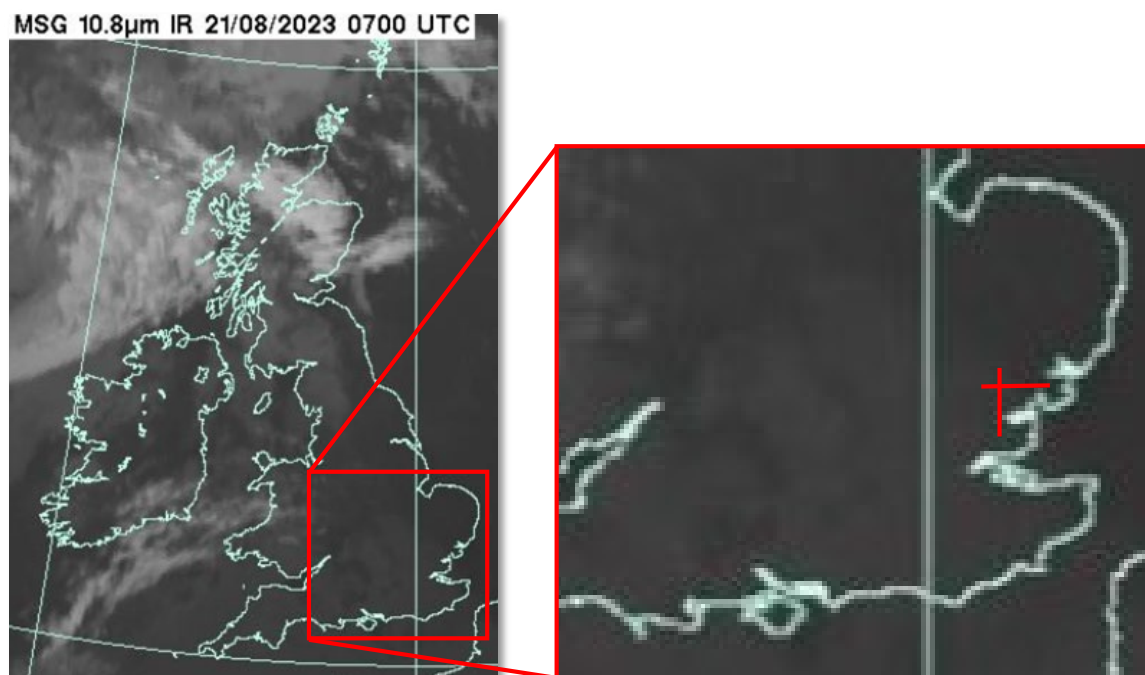
**Figure 12**

Infra-red satellite image taken at 0700 hrs on 21 August 2023 - intersection of red lines on the right image shows the approximate position of Earls Colne Airfield (© Met Office)
