Serious Incident

Aircraft Type and Registration:	Boeing 767-332(ER), N197DN	
No & Type of Engines:	2 Pratt & Whitney PW4060 turbofan engines	
Year of Manufacture:	1997 (Serial no: 28454 LN: 683)	
Date & Time (UTC):	10 February 2023 at 1130 hrs	
Location:	Prestwick Airport	
Type of Flight:	Commercial Air Transport (Passenger)	
Persons on Board:	Crew - 10	Passengers - 211
Injuries:	Crew - None	Passengers - None
Nature of Damage:	Contained engine failure, fractured water drain tube	
Commander's Licence:	Airline Transport Pilot's Licence	
Commander's Age:	62 Years	
Commander's Flying Experience:	21,000 hours (of which 12,000 were on type) Last 90 days - 180 hours Last 28 days - 50 hours	
Information Source:	AAIB Field Investigation

Synopsis

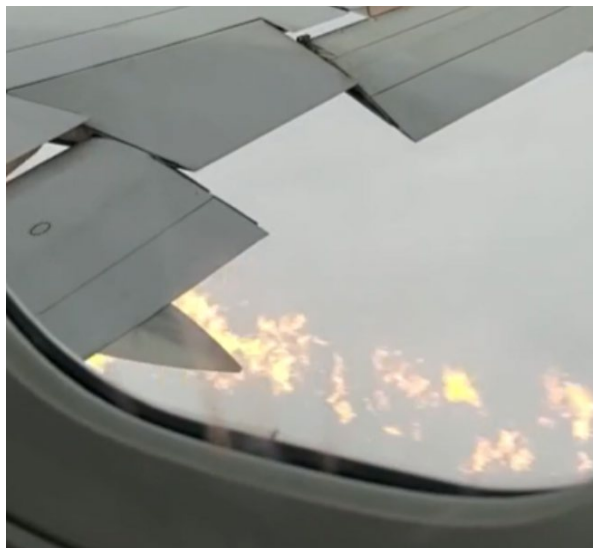
Figure 2

Image from passenger video

The recorded engine fire parameters did not indicate a fire at any point during the flight or taxi. The passenger video (Figure 2) shows fire evident in flight. This was recorded approximately 8 minutes before landing, as the aircraft was levelling from a left turn with flaps deploying. No evidence of fire was found after this time.

The passenger video of flames coming from the rear of the wing was likely to be the fuel streaming from the dry bay drain hole into the air flow and being ignited in the hot jet efflux. The absence of soot or heat damage on the engine cowlings suggests that the flames were behind the engine rather than being an engine fire. None of the witnesses on the ground reporting seeing any flames during the approach, and the fuel leak was first noticed by a ground marshaller as the aircraft taxied to the stand. The wind direction and the orientation of the aircraft on stand resulted in fuel being blown aft towards the landing gear. The brake temperatures were monitored when the aircraft was on stand and the initial readings were in excess of the fuel ignition temperature. No ignition took place, but this did present significant potential for a fuel fire.

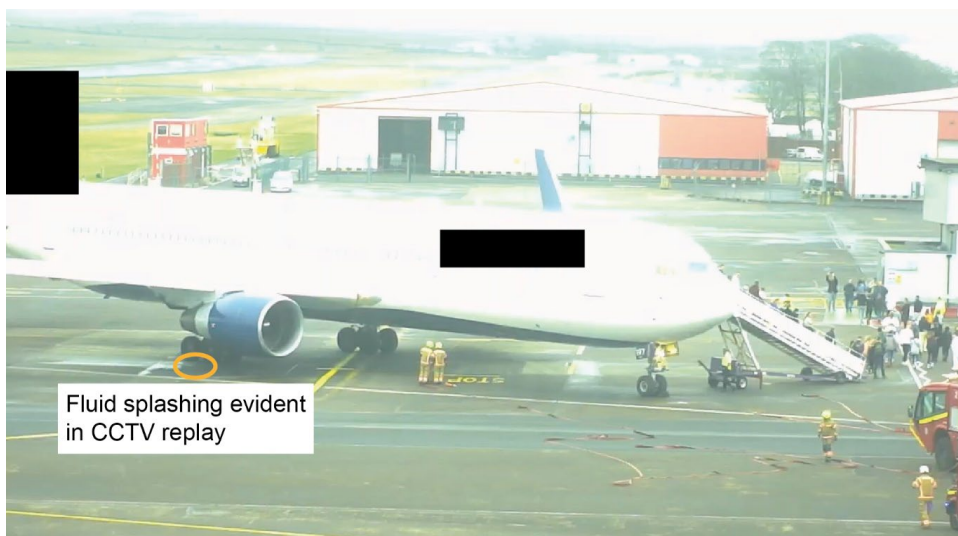
CCTV snapshot showing fuel leak location, disembarkation and AFS attendance

The presence of the fuel leak can be identified when a CCTV camera was zoomed in to the relevant location after the aircraft came to a halt. The first passengers started disembarking via steps at the front left door within 5 minutes of the aircraft coming to a stop, and the last less than 6 minutes later. Figure 7 shows a snapshot from one of the CCTV recordings.

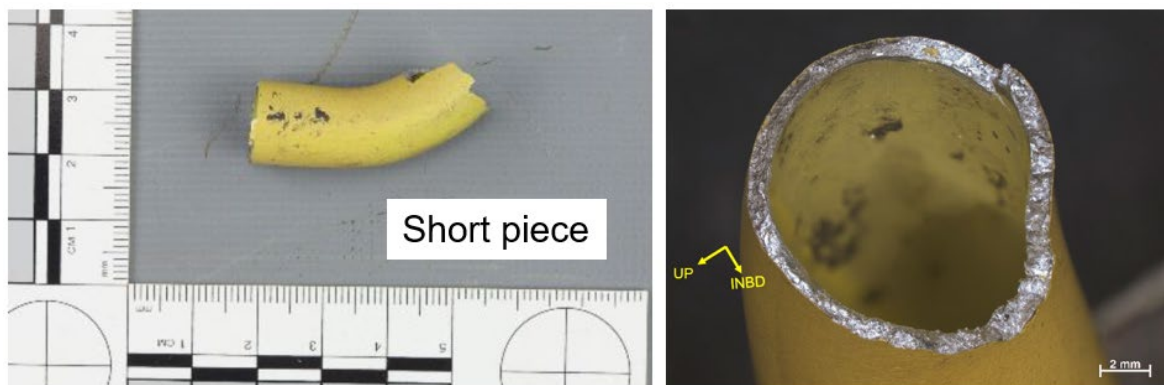
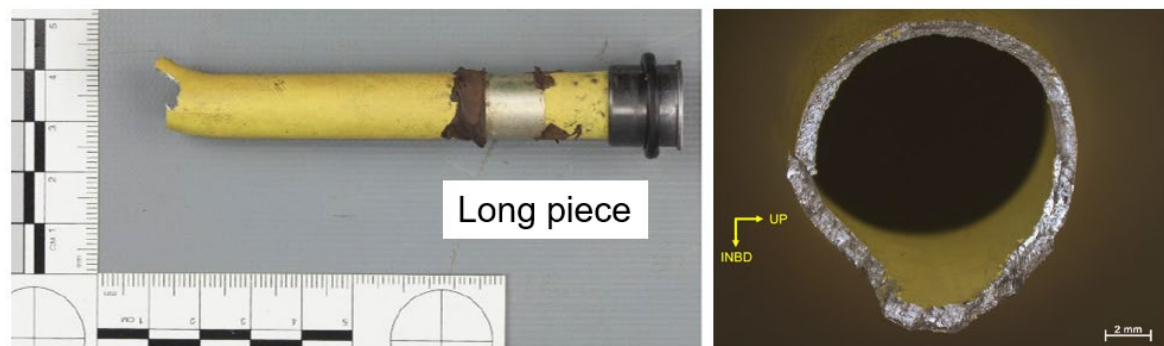
The two pieces of the upstream drain tube (Figure 15 and 16) were examined at a specialist forensic laboratory using an optical microscope and a Scanning Electron Microscope (SEM). Initial examination of the fracture surfaces identified extensive mechanical damage consistent with rubbing between the opposing halves of the fracture. Areas of the fracture surface also exhibited deposits which masked the underlying fracture surface. Energy Dispersive X-ray (EDX) analysis of the deposit found that it was consistent with the primer paint on the inner and outer surfaces. It appeared that once the crack had developed, fragments of paint from the surface had migrated into the crack and had been ground between the opposing fracture faces.

Short piece of drain tube (adjacent to slat track housing)

Long piece of drain tube (adjacent to the coupling)

Striations were visible at discrete areas across most of the fracture surface indicating that crack growth was the result of fatigue. The orientation of the striations suggested that fatigue cracks had initiated on the upper surface of the tube and propagated in both directions around the circumference (Figure 17). Although the main crack growth suggested initiation in an area at the top of the tube, it was apparent that multiple cracks had initiated at both the inner and outer surfaces of the tube ahead of the main crack front. These secondary cracks propagated for short distances before joining the main crack. Towards the

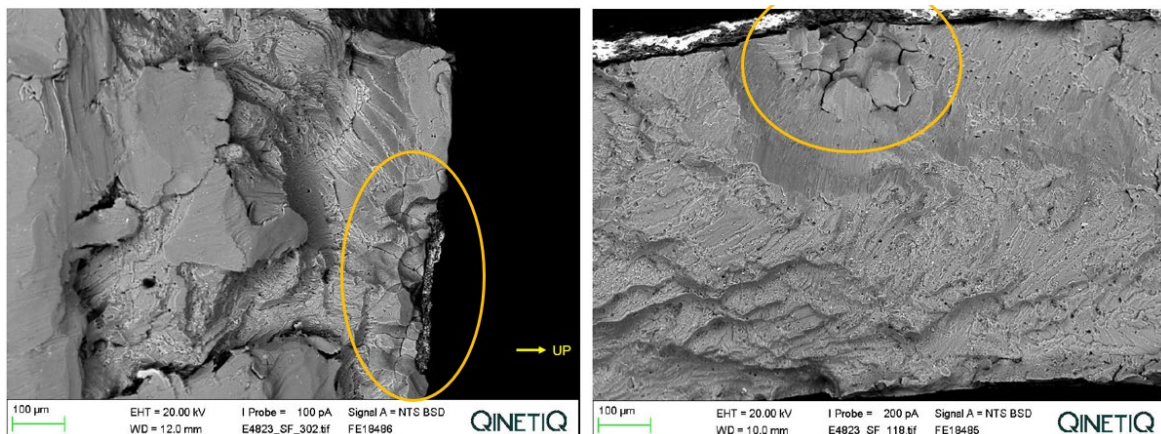
It was noted at the fatigue initiation point on the outer edge at the top of the tube, that an area of intergranular fracture approximately 100 μm deep was present (Figure 18 left). Further instances of intergranular fracture were observed on the fracture surface at both the inner and outer edges. At the outboard side of the fracture an area of intergranular fracture was observed on the outside edge which extended approximately 180 μm in from the outboard edge (location identified in Figure 17 left, shown in Figure 18 right).

Left - Intergranular fracture at the initiation point
Right - Intergranular fracture at the outboard edge of the fracture

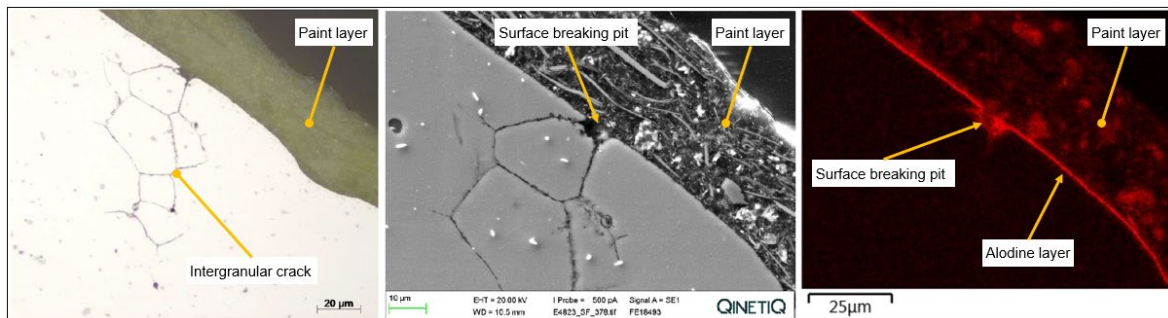
Figure 19

A series of micro-sections were removed from both pieces of the tube away from the fracture face. All the sections highlighted further intergranular cracking present on both the inside and outside of the tube, although it was more prevalent on the outer surface. In some cases, the micro-section showed the intergranular fracture breaking onto the surface (Figure 19), and it appeared to have initiated from a small pit approximately 5 µm deep on the surface of the tube. Further analysis using EDX mapping (Figure 19 right) showed that the surface breaking feature was covered with a chromium rich layer consistent with the Alodine process applied during manufacturing.

Example surface breaking intergranular fracture

It was observed that the chromium rich layer had formed around the bottom of the pit and had partially extended along the grain boundaries which indicated the pitting and intergranular cracking was present before the application of the chromate conversion coating. It also showed that it was present before the part was painted. The pitting and intergranular cracking was therefore not a result of in-service degradation and had been present since the drain tube was manufactured.

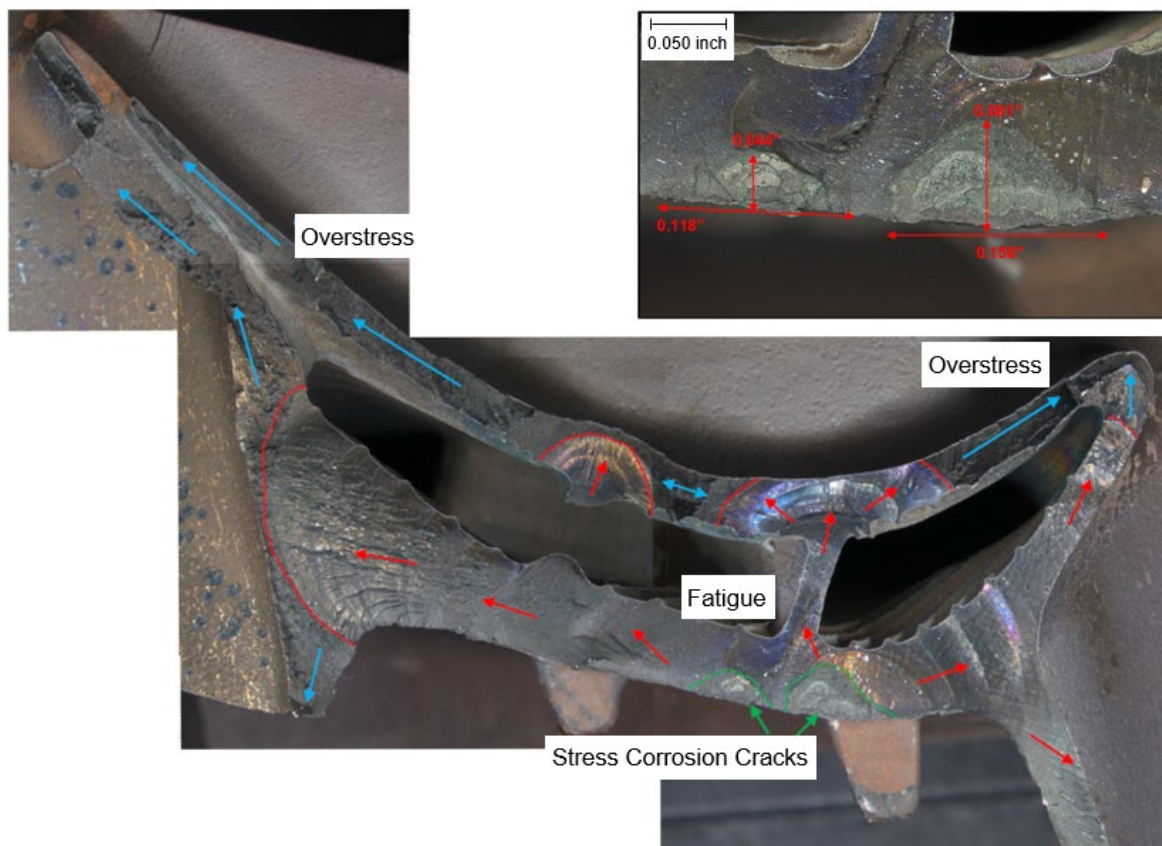
Figure 21

Detailed examination indicated that the fracture initiated from two Stress Corrosion Cracks (SCC) at the forward rib external convex wall (identified in green in Figure 21), which measured 3.96 mm (0.156 inch) wide by 2.06 mm (0.081 inch) deep and 3.00 mm (0.118 inch) wide by 1.12 mm (0.044 inch) deep. SEM examination of these areas revealed these cracks extended from multiple origins along the external convex wall surface, but the exact origins could not be determined due to oxide scale and rubbing damage. EDX mapping of the fracture surface and exterior convex wall surface revealed it was composed primarily of mixed nickel-based alloy oxides and aluminium-platinum based coating oxides. The regions of pitting and oxide scale also exhibited silicon, which could have originated from dirt ingested during engine operation. EDX mapping of the crack attack front of a pit, paired with Wavelength Dispersive Spectroscopy revealed the presence of sulphur, indicative of sulphation attack, otherwise known as hot corrosion. Further evaluation of the fracture surface found evidence of fatigue on both the convex and concave side walls. The fatigue progressed from the extremity of the cracks (identified in red in Figure 21) and exhibited arrest features indicative of high cycle fatigue. Final blade fracture was by overload stress, identified in blue in Figure 21.

Detail of the Blade 7 fracture face (Used with permission)

An HPT 2 blade in the right engine fractured and the detached blade then damaged a further five HPT 2 blades, the majority of which were subsequently liberated from the disk. The initial fracture was a result of fatigue cracks initiated from two SCCs on the exterior convex face of the blade. Similar cracks were also seen on the adjacent (non-damaged) blades. Detailed metallurgical examination revealed the presence of sulphur, indicative of a sulphation attack, hence pitting of the blade surface during normal engine operation, rather than a specific blade problem.
