Report on the investigation of  
the capsizing and foundering of the fishing vessel

***Angelena (BM271)***

south-east of Exmouth, England

REPORT NO 8/2024

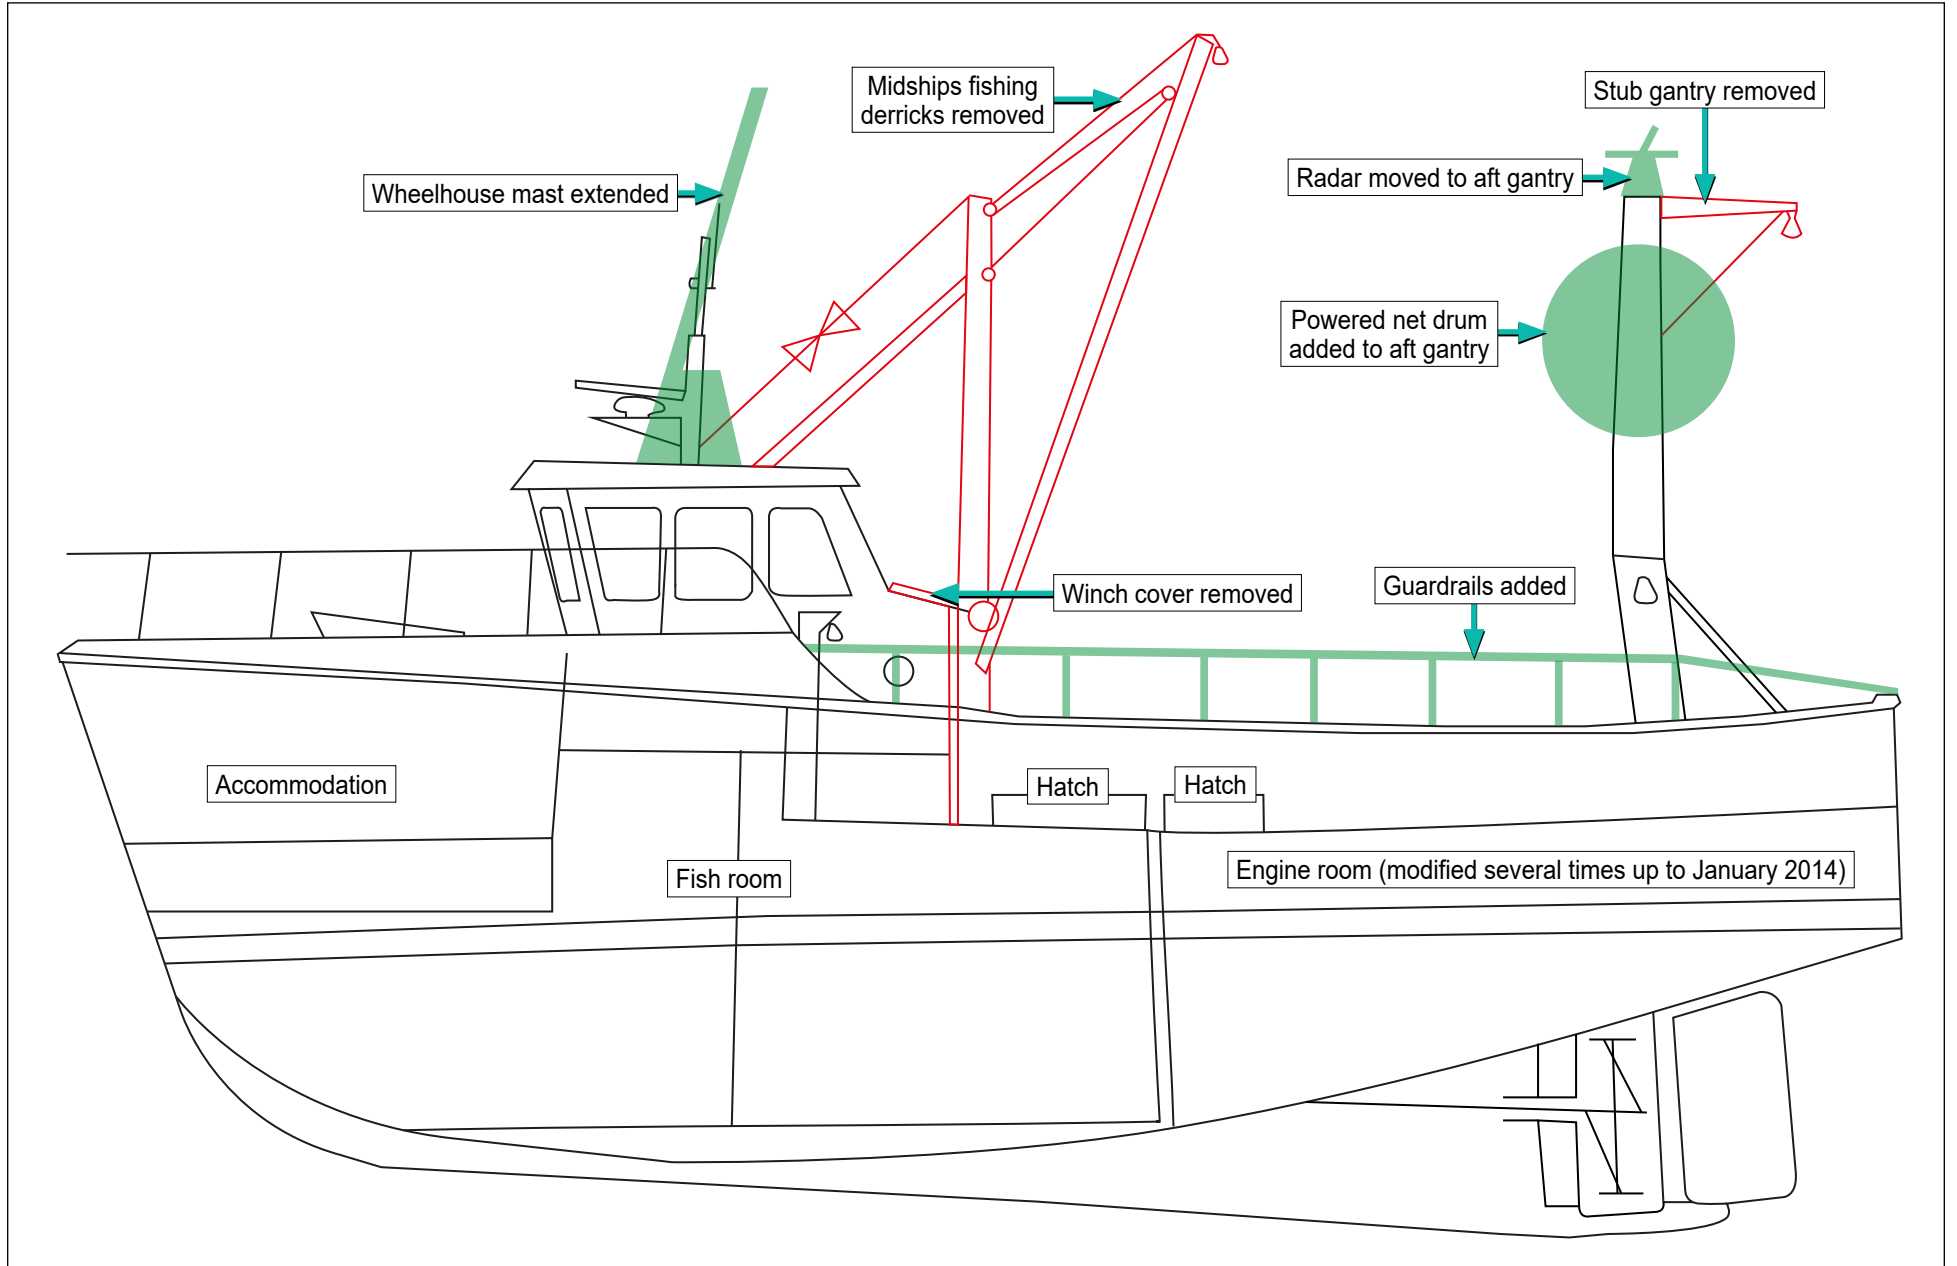
Figure 3: *Angelena* modifications from 1988 to 2021

Since its build in 1988, *Angelena* had undergone a series of modifications. The removal of the derricks and the removal of the solid steel deck winch cover both had a positive impact on stability by lowering the VCG. Conversely, the addition of the powered net drum and guardrails, lengthening of the wheelhouse roof mast and relocation of the radar to the top of the aft gantry had a negative impact on stability by raising the VCG. It was not possible to obtain a precise post-accident stability calculation for *Angelena* as height and weight detail was missing from the modification records. Using the MCA's *Fishing Vessel Stability Guidance* booklet as a basis for understanding, it was highly likely that the net change due to the modifications would have increased the VCG above its 'at build' position in 1988 and thus reduced *Angelena's* stability.

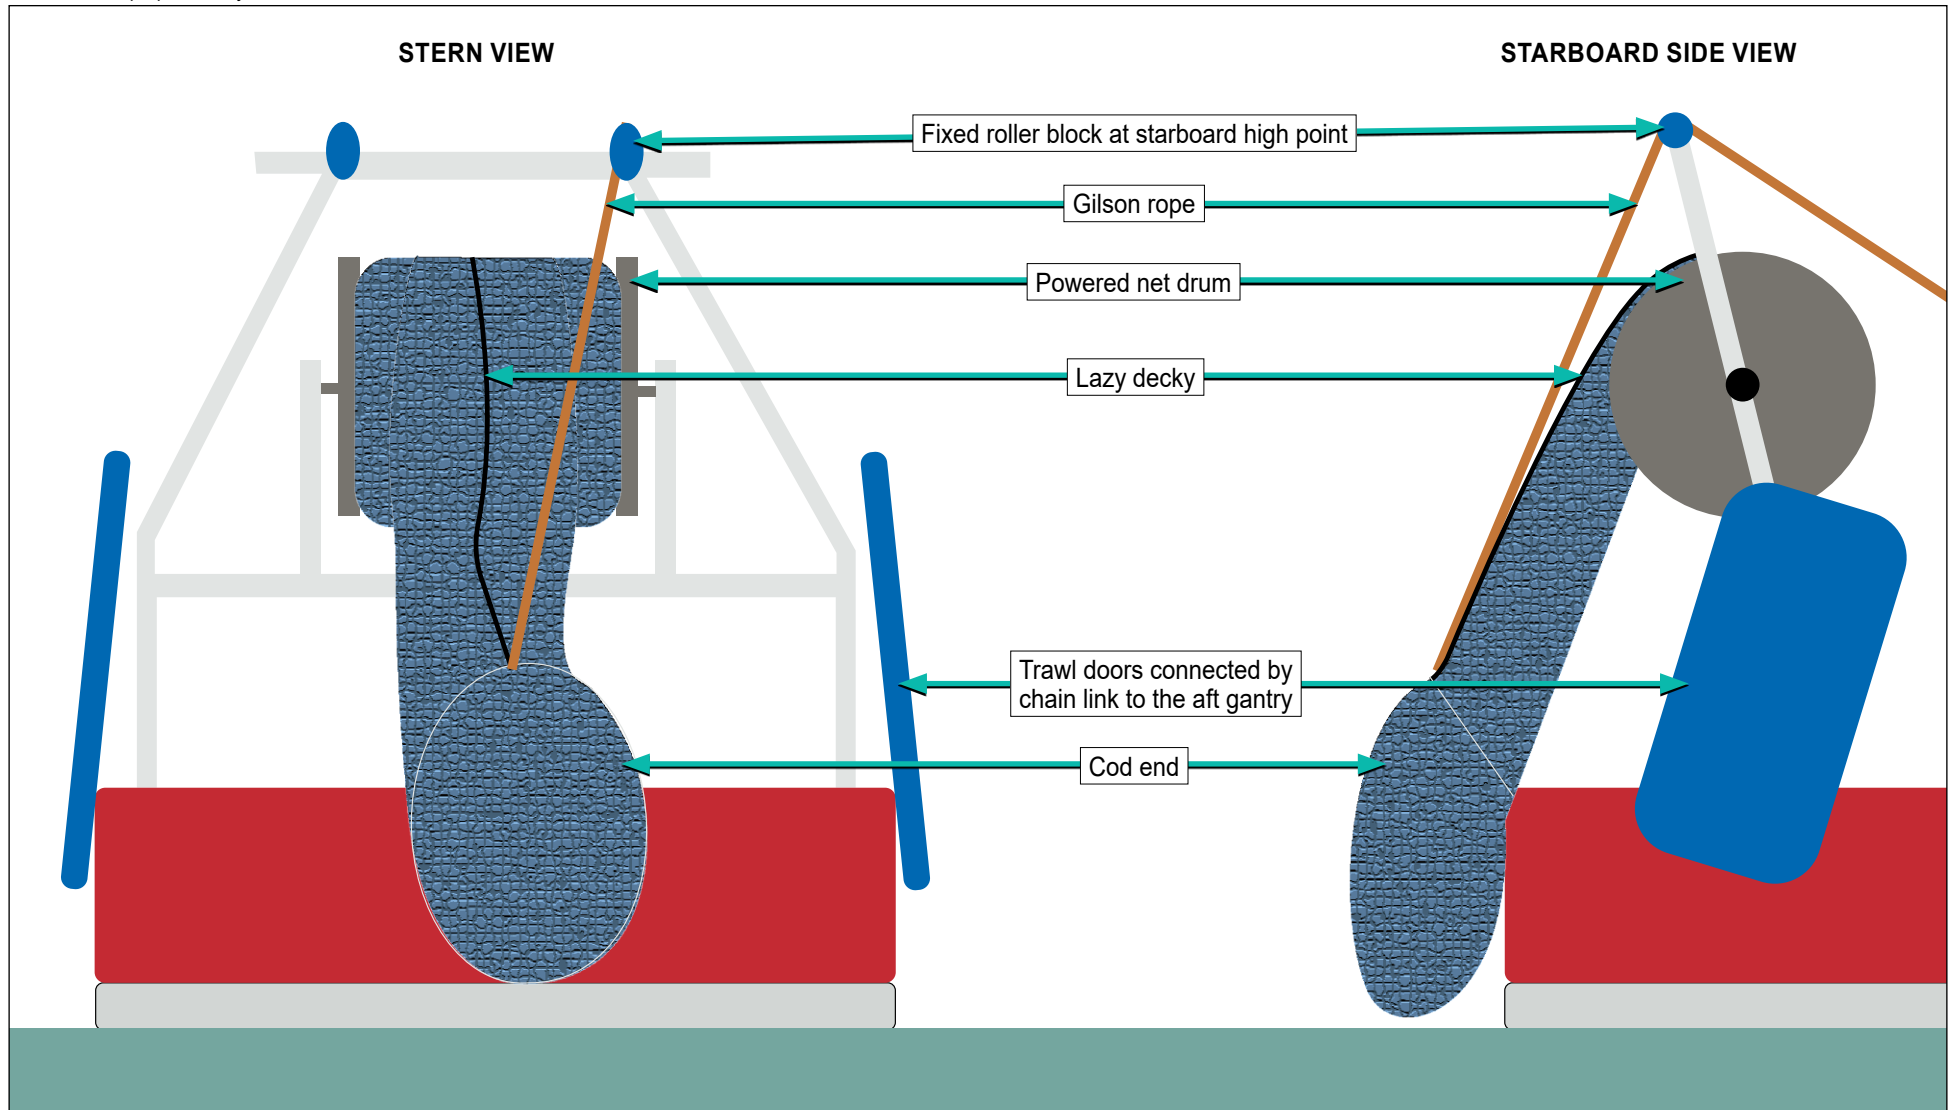
**Figure 4:** Cod end lifting arrangement

Further, once the cod end cleared the water its full weight became suspended from the starboard lifting point on the high aft gantry. This induced a list, which also had the effect of swinging the cod end outboard to starboard. As *Angelena* continued to heel, the point of effort moved further away from the VCG and increased the capsizing moment. This was further exacerbated by the catch on deck sliding to starboard. The vessel's VCB would have started to reduce once the deck edge aft became immersed, with the situation deteriorating further when downflooding started. Once the cod end was clear of the water *Angelena's* capsizing became a continuous roll that could not be halted.

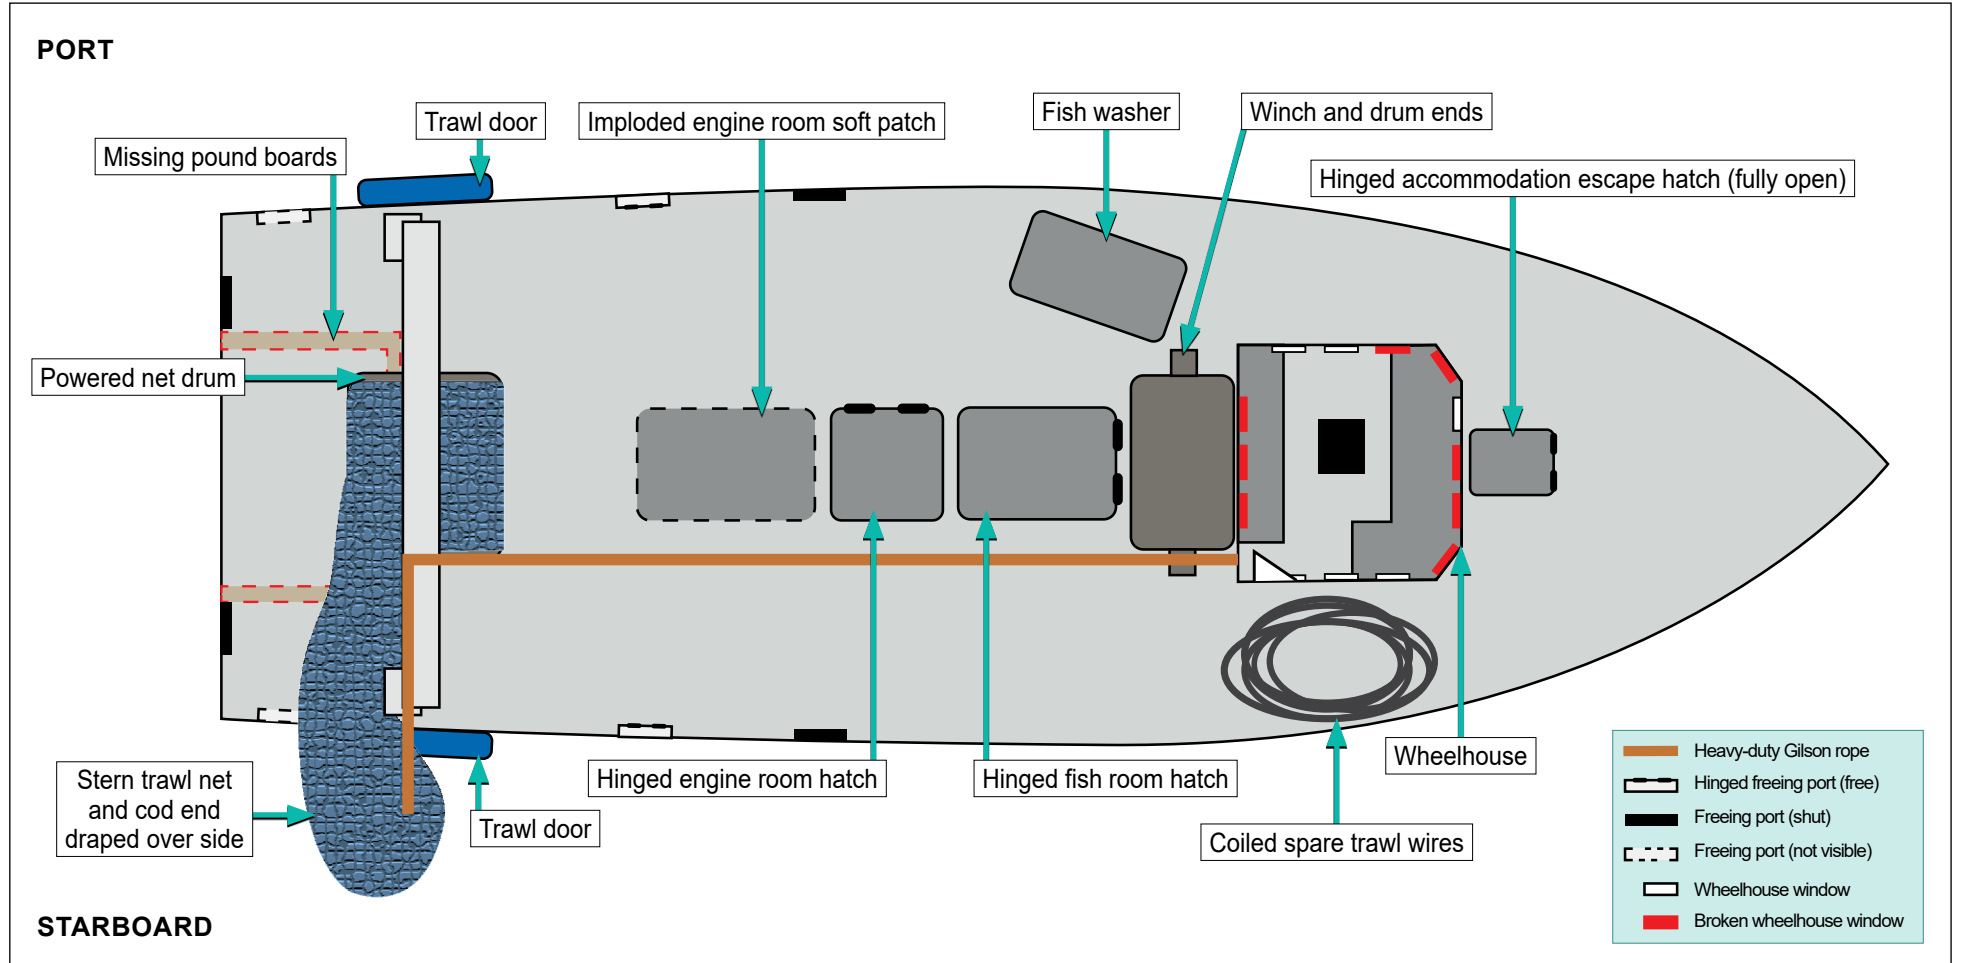
Figure 5: Detail from the 4 August 2021 dive survey

- the hull was intact;
- the fish room and engine room hatches were closed but not secured;
- the accommodation escape hatch was fully open;
- the watertight wheelhouse door was open;
- of the six freeing ports inspected, none were fully open<sup>9</sup>; the remaining two freeing ports were obscured by thick protective rubber sheeting and could not be seen;
- the cod end was draped around the starboard trawl door;
- several of the wheelhouse windows were broken and the engine room soft patch had imploded;
- both trawl doors were secured to the aft gantry and the Gilson rope was still in place; and
- no pound boards were on board.

<sup>9</sup> Two were hinged and operated correctly to allow easy egress of water from the deck, three were seized shut. The remaining freeing port was stuck slightly open.

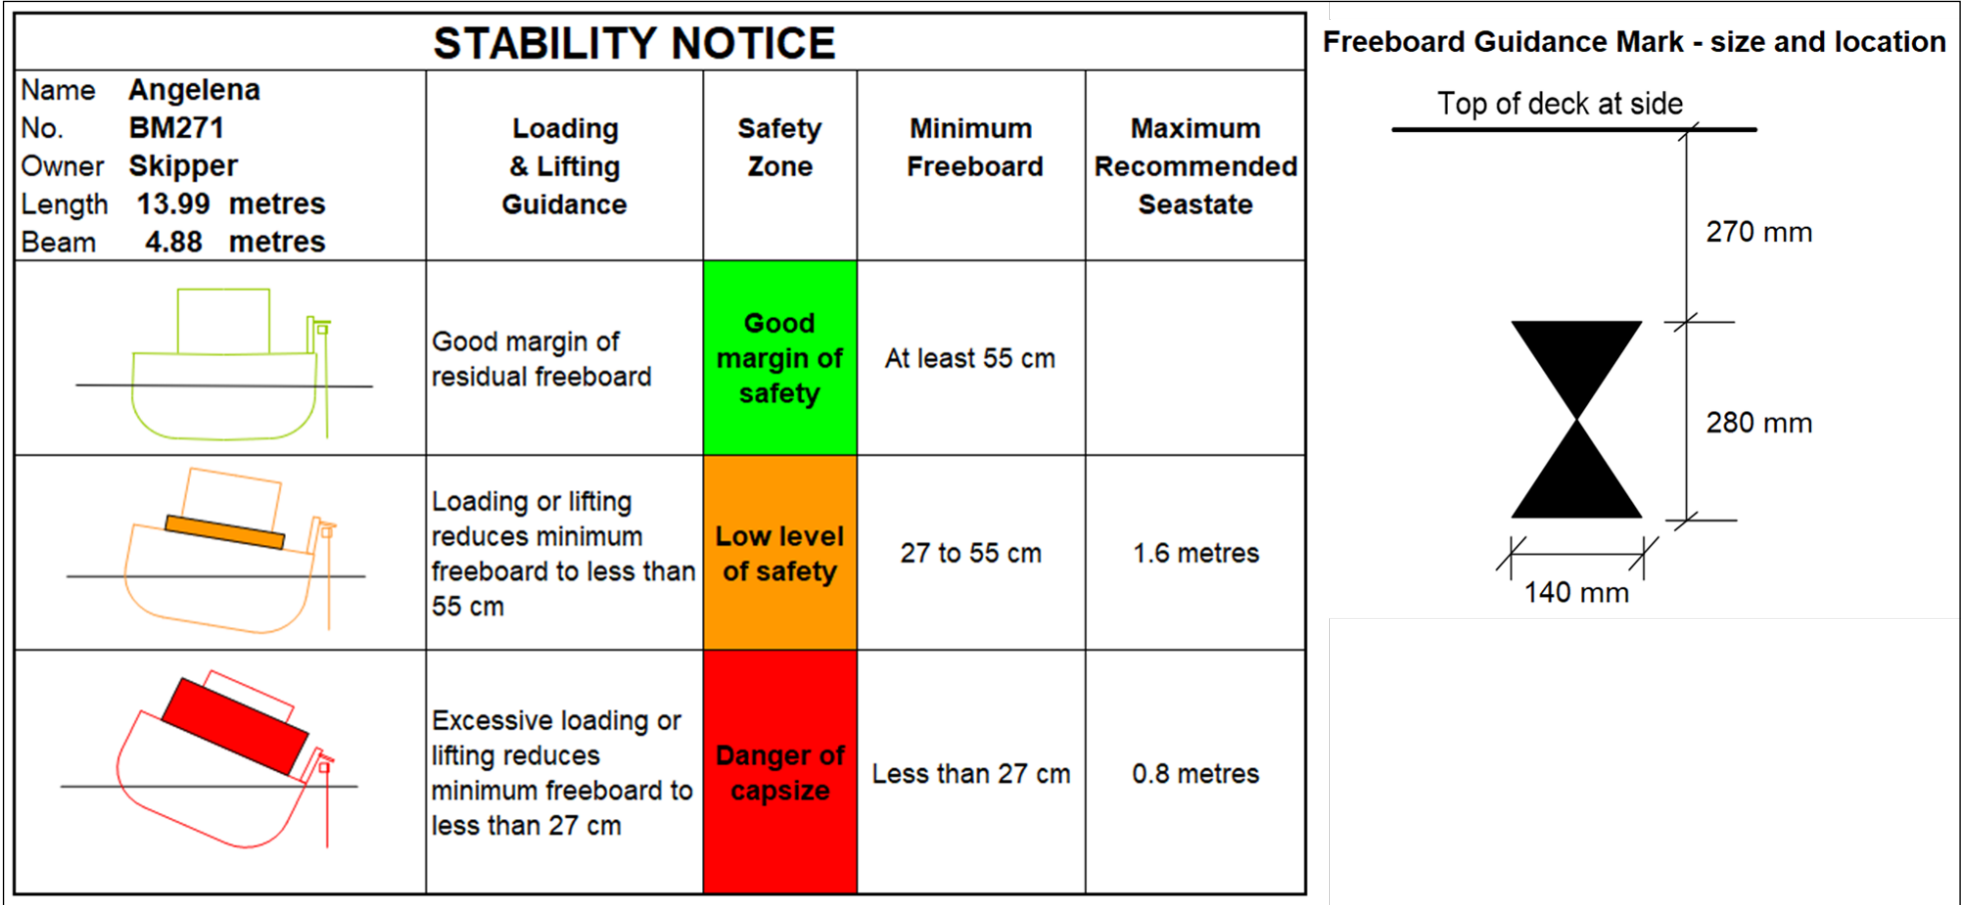
Figure 6: Wolfson Guidance Freeboard Mark calculation for *Angelena*

It is highly likely that *Angelena* experienced wave heights of above 1.5m associated with force 4 winds at the time of the capsizing. The Wolfson Guidance Freeboard Mark calculated during the investigation indicated a *low level of safety* for *Angelena*; operating in seas any greater than the maximum recommended 1.6m height would have presented significant risk.

*Angelena's* freeboard was only 35mm clear of the Wolfson *Danger of capsizing* red zone, within which the maximum recommended sea state was 0.8m. Given the sea state at the time of the accident, it is likely that these fine margins of stability reduced *Angelena's* capacity to withstand any off-centre loading, such as the lifting of the heavy cod end.

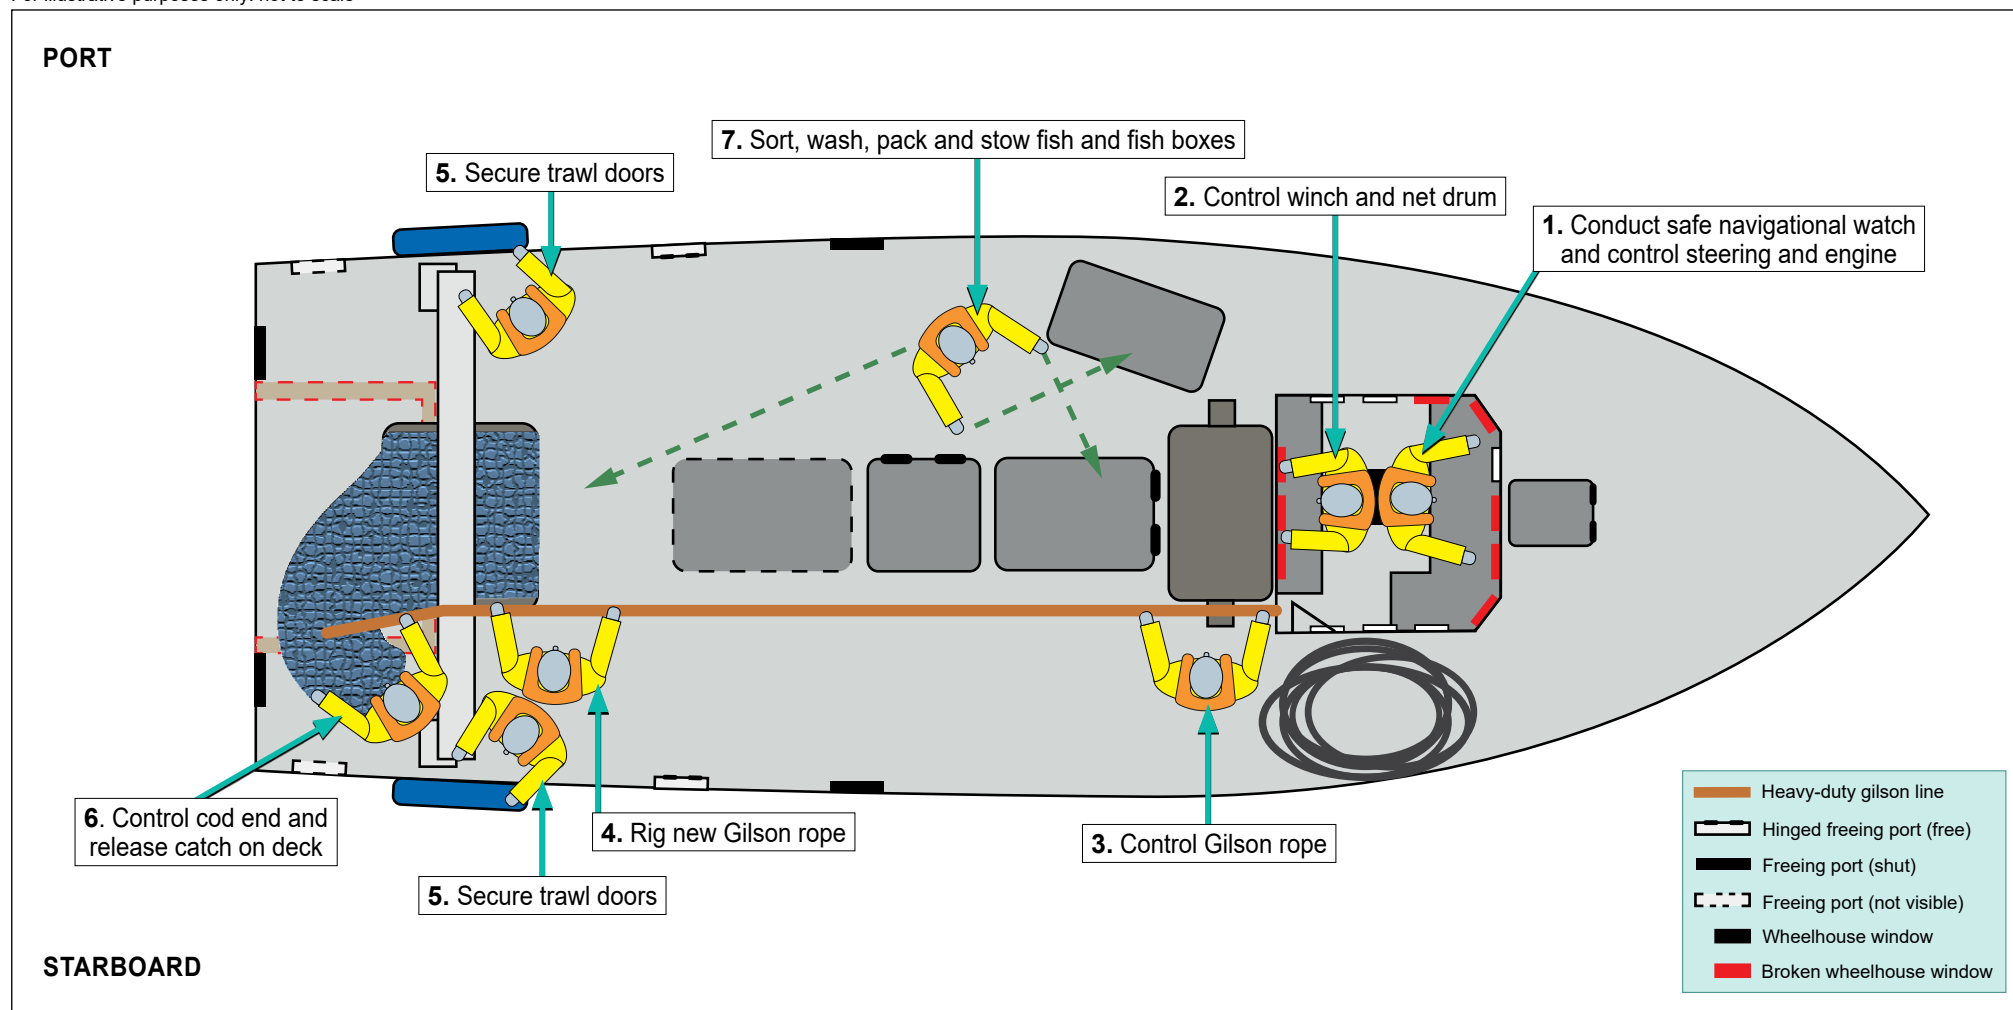
**Figure 7:** Seven operations carried out by *Angelena's* skipper

While no minimum safe crewing level was mandated for fishing vessels under 15m, MGN 313 (F) stated that *The wheelhouse must not be left unattended at any time.* For *Angelena*, this indicated at least two crew were needed to operate safely: one to maintain a navigational watch and a minimum of one more to work the fishing gear. There was complexity in the tasks involved with hauling *Angelena*'s fishing gear and the associated positions from where each of these was undertaken on the main deck (**Figure 7**); it would therefore have been impossible for the lone skipper to simultaneously maintain a safe navigational watch and operate the fishing gear, as was the case for *Sapphire III/Silver Chord*. Analysis of all the tasks required of the skipper concluded that, when operating *Angelena* alone, the skipper could neither react quickly in the event of an emergency nor ensure the safety of their operation.
