# Collision between a train and an object left on the track at Kings Langley, Hertfordshire, 25 April 2024

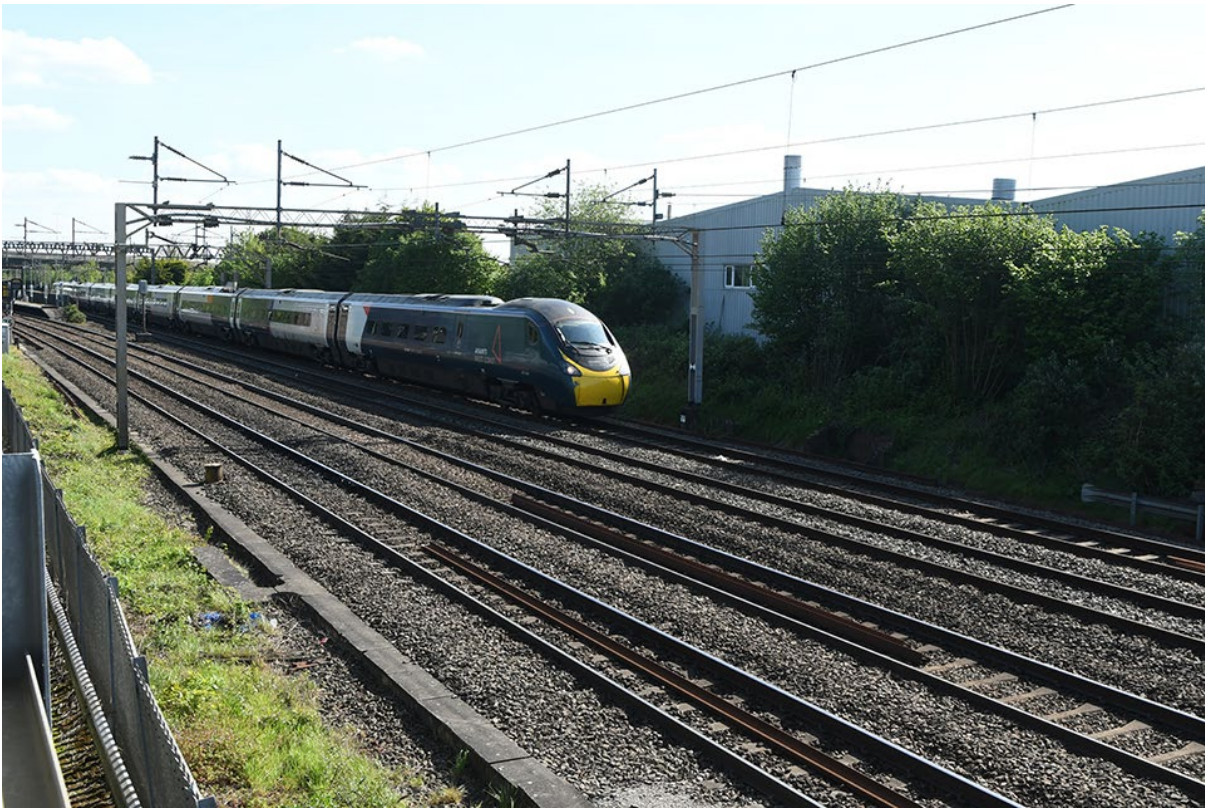
At around 06:43 hrs on 25 April 2024, a train travelling between Wolverhampton and London struck part of a temporary road-rail vehicle access point (RRAP) which had been left on the track near to Kings Langley on the West Coast Main Line (WCML). The temporary RRAP had been used during the previous night as part of work on overhead line equipment (OHLE).

**Location of the collision near Kings Langley access point, looking south towards the station.**

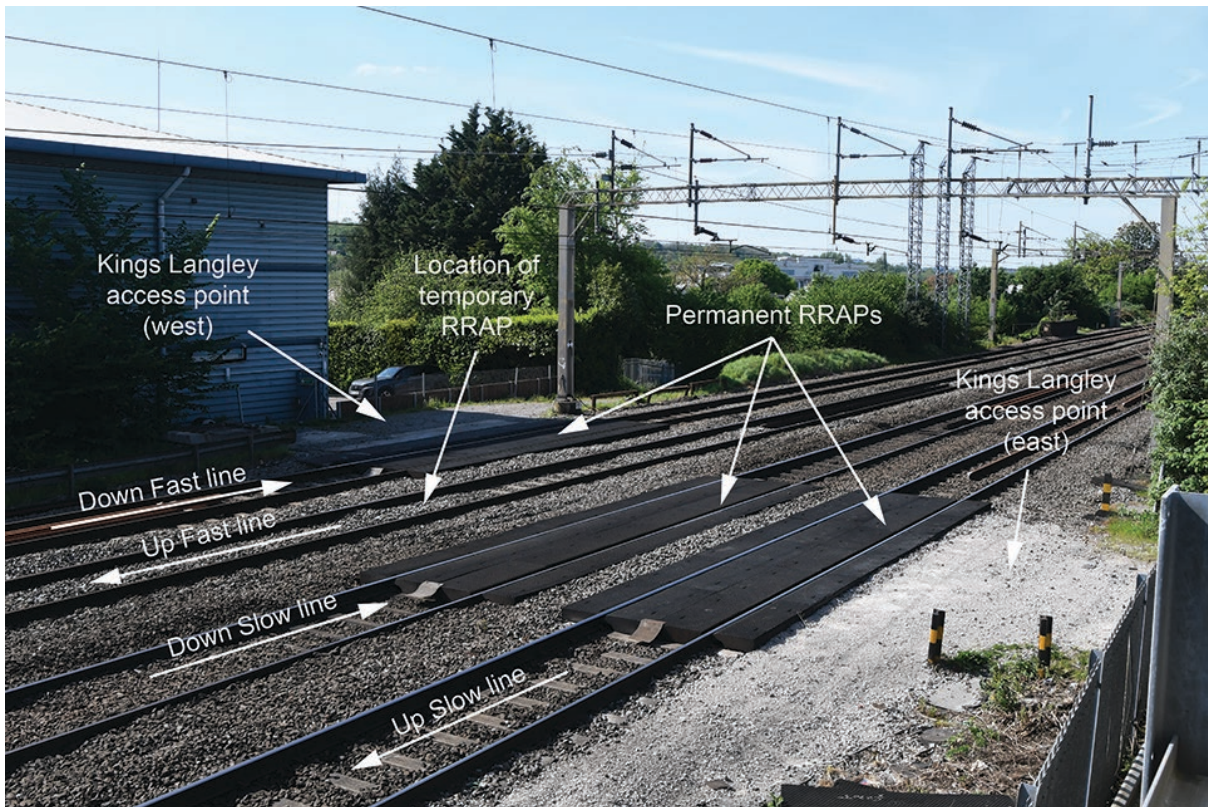
Kings Langley access point has a permanent RRAP on three of the four running lines. The permanent RRAP from the Up Fast line had been previously removed and stored near to the eastern access gate. The first MEWP was to be on-tracked using the permanent RRAP on the Down Fast line, accessed from the western gate. The second MEWP was to be on-tracked on the Up Fast line, which was also accessed from the western gate. The 'on track plant' work plan identified the missing RRAP and stated that a temporary RRAP was to be installed on the Up Fast line. The plan did not specify what type of temporary RRAP was to be used, how it was to be used, any restrictions which would apply to its use, or identify any risks associated with its use.

**Kings Langley access point from the eastern access side.**

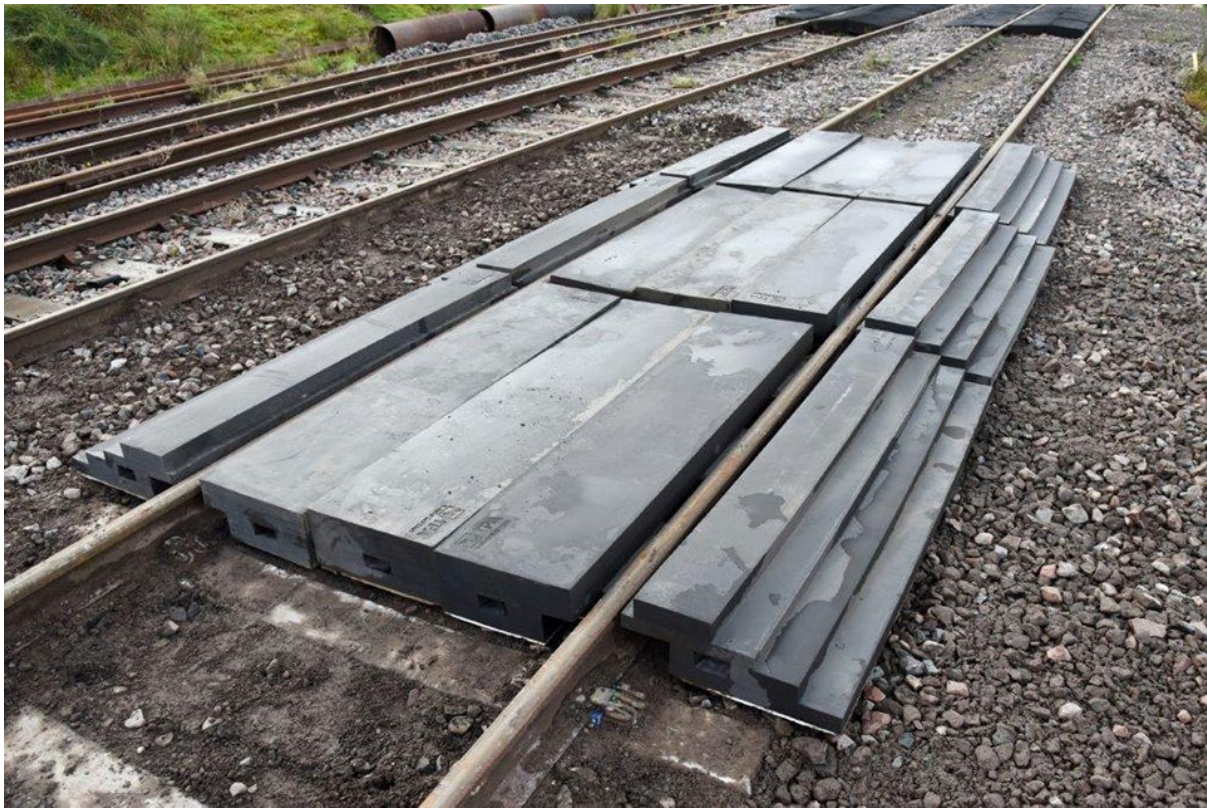
The temporary RRAP used consisted of four separate kits. Each kit contained five pieces made of a high-density foam material (two ramp pieces, which were to be placed outside of the running rails, with a further three pieces placed between the running rails). Each kit provides approximately 2 metres of usable RRAP length, totalling 8 metres with all four kits placed end-to-end. The maximum weight of each piece of the kit is 25 kg and they are manually lifted into place by two workers. The RRAP must be installed on track where the ballast is below the level of the sleepers. No training or guidance was provided to the staff involved as to how to install the kits.

**High density foam temporary RRAP kit installation demonstration (courtesy of VP plc).**

The team had trouble installing the temporary RRAP due to the high level of ballast present on the Up Fast line, which was outside the RRAP manufacturer's installation guidelines. The team's only available method of moving the ballast was by using their hands and feet, as no shovels or similar tools were available. As a result, it is probable that the temporary RRAP was installed sitting higher than was allowable, meaning there was insufficient clearance from the underside of any MEWP passing over it.

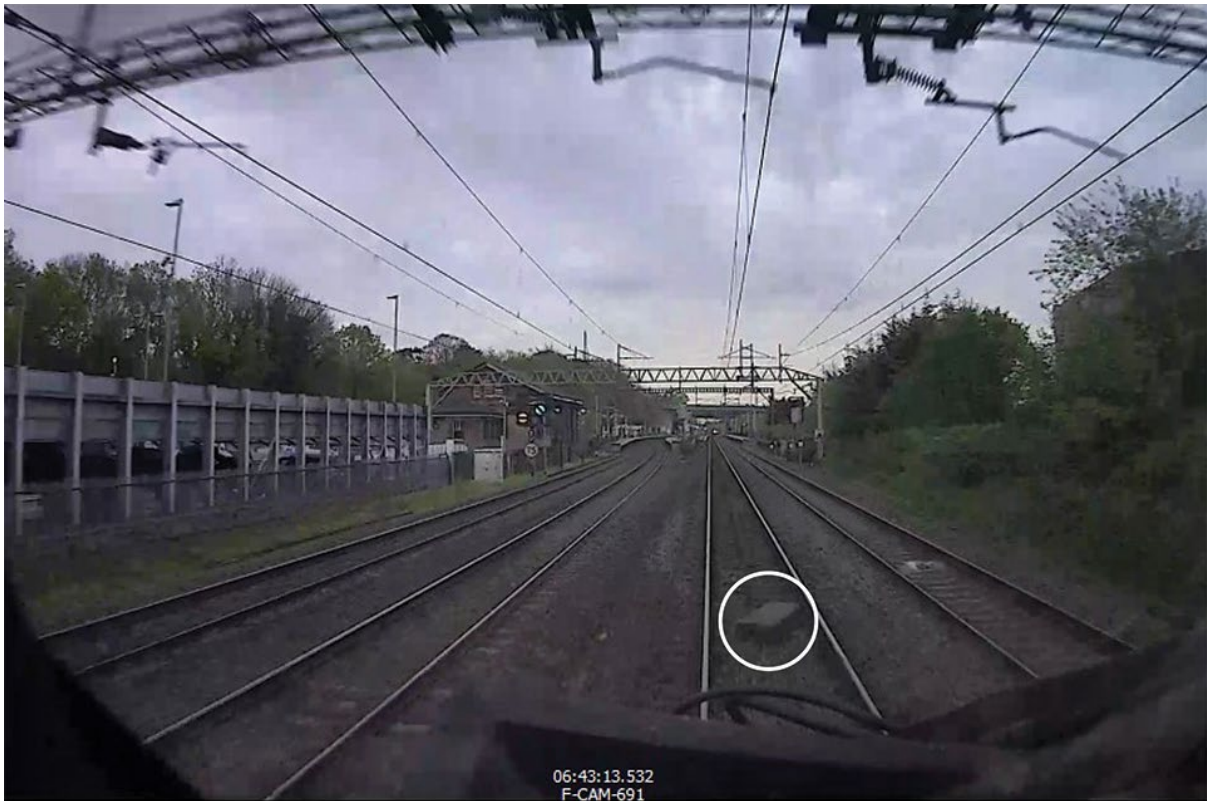
Train 1R00, the 04:57 hrs service from Wolverhampton to London Euston, operated by Avanti West Coast, was the first movement of the day over the Up Fast line after the possession was given up. This train struck the temporary RRAP piece which remained on the Up Fast line. The train's on-train data recorder recorded that the train was travelling at a speed of 124 mph (200 km/h) at the point of the collision. The permissible speed for this train on the Up Fast line at the location is 125 mph (201 km/h).

**Forward-facing CCTV from the cab of train 1R00. The displaced piece of the temporary RRAP can be seen in between the running rails of the Up Fast line (courtesy of Avanti West Coast).**

The RRAP piece became trapped under the rear of train 1R00, disturbing ballast and dislodging a brake pad. The drivers first became aware of an issue when the train's systems indicated a loss of electrical power. Staff further along the train also reported a loud noise which was followed by the deflation of a secondary suspension airbag on the rearmost coach.

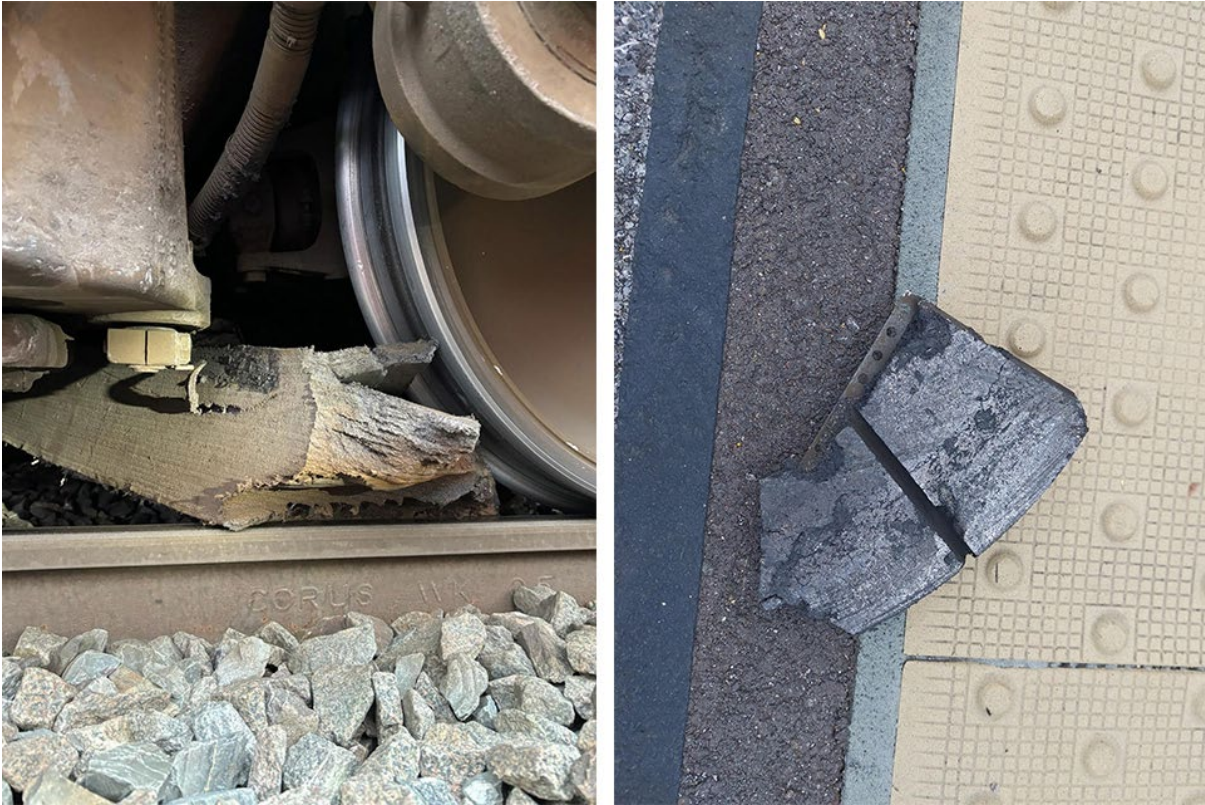
Ballast and the brake pad from train 1R00 were later found on the platform of Kings Langley station. Train 9S44 was allowed to move forward to Milton Keynes Central station where its passengers were disembarked and it was removed from service. The section of the temporary RRAP was removed from under train 1R00. This train was moved forward to Watford Junction station where its passengers were disembarked and it was also removed from service.

**Remains of the temporary RRAP found under train 1R00 (left) and the brake pad found on Kings Langley station platform (right) (courtesy of Network Rail).**
