Serious Incident

Aircraft Type and Registration:	Boeing 737-4K5, G-JMCV
No & Type of Engines:	2 CFM56-3C1 turbofan engines
Year of Manufacture:	1989 (Serial no: 24128)
Date & Time (UTC):	1 December 2023 at 0613 hrs
Location:	East Midlands Airport
Type of Flight:	Commercial Air Transport (Cargo)
Persons on Board:	Crew - 2 Passengers - None
Injuries:	Crew - None Passengers - N/A
Nature of Damage:	Damage to tail skid and drainage mast
Commander's Licence:	Airline Transport Pilot's Licence
Commander's Age:	44 years
Commander's Flying Experience:	7,649 hours (of which 2,720 were on type) Last 90 days - 39 hours Last 28 days - 10 hours
Information Source:	Aircraft Accident Report Form submitted by the commander and subsequent enquiries by the AAIB

Synopsis

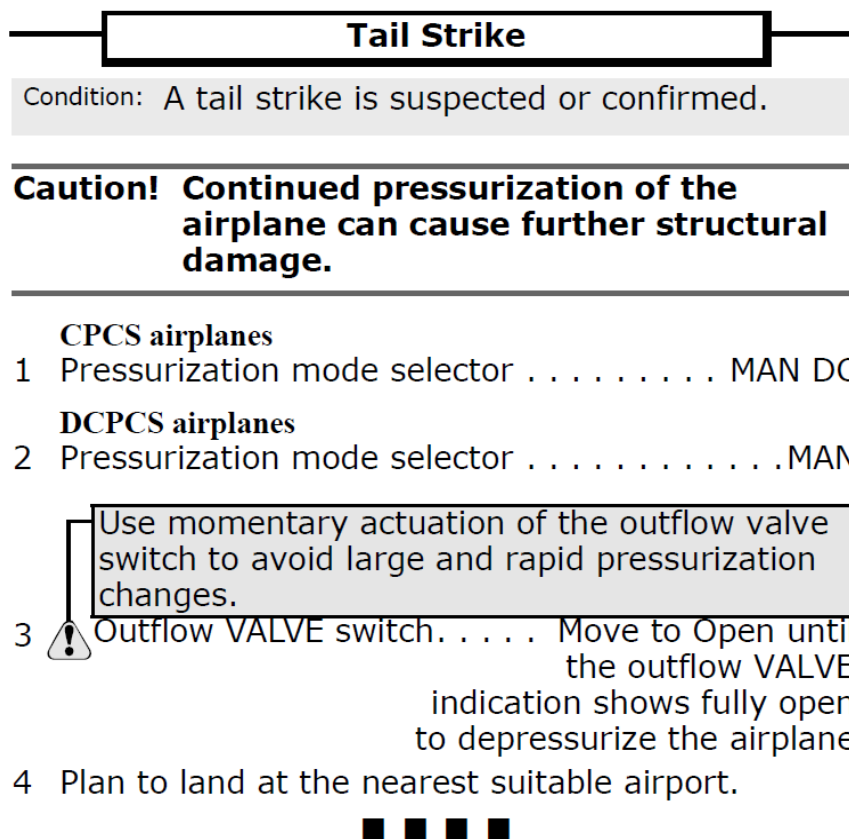
Figure 1

Though the aircraft was handling normally and there were no abnormal indications, given the absence of any other explanation for the ‘bump’ at takeoff, the commander decided to action the tail strike checklist in the QRH. The checklist directed the crew to depressurise the aircraft but, due to the inexperience of the co-pilot, the commander decided to descend to FL90 before actioning the depressurisation. He checked the fuel figures before descent to confirm sufficient fuel remained to reach Aberdeen at the reduced flight level.

QRH Tail Strike Checklist

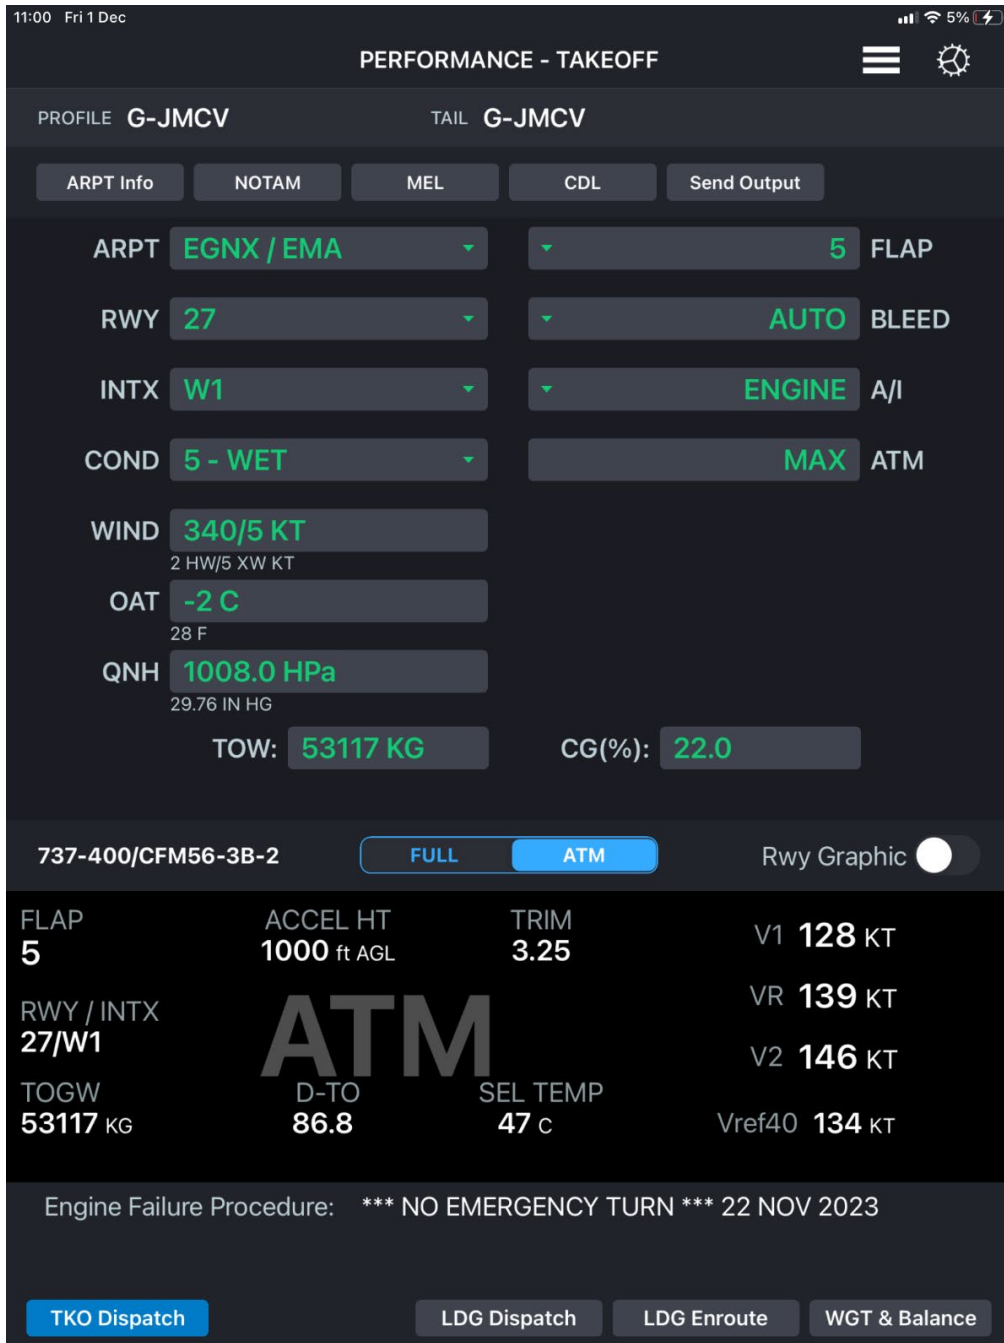
Figure 2

Performance calculation with actual aircraft mass

The PF commences the rotation at V_R^1 , which was 139 kt for the correct mass but only 124 kt for the calculation used by the crew. Calculated thrust setting was also lower on the calculation used for the flight with N_1 calculated at 81.9% against 86.8% for the actual mass. The OPT also outputs a setting for the stabiliser trim, intended to give consistent handling of the aircraft at takeoff. In this event the setting used by the crew gave a slightly more nose-up trim than the actual mass figures.

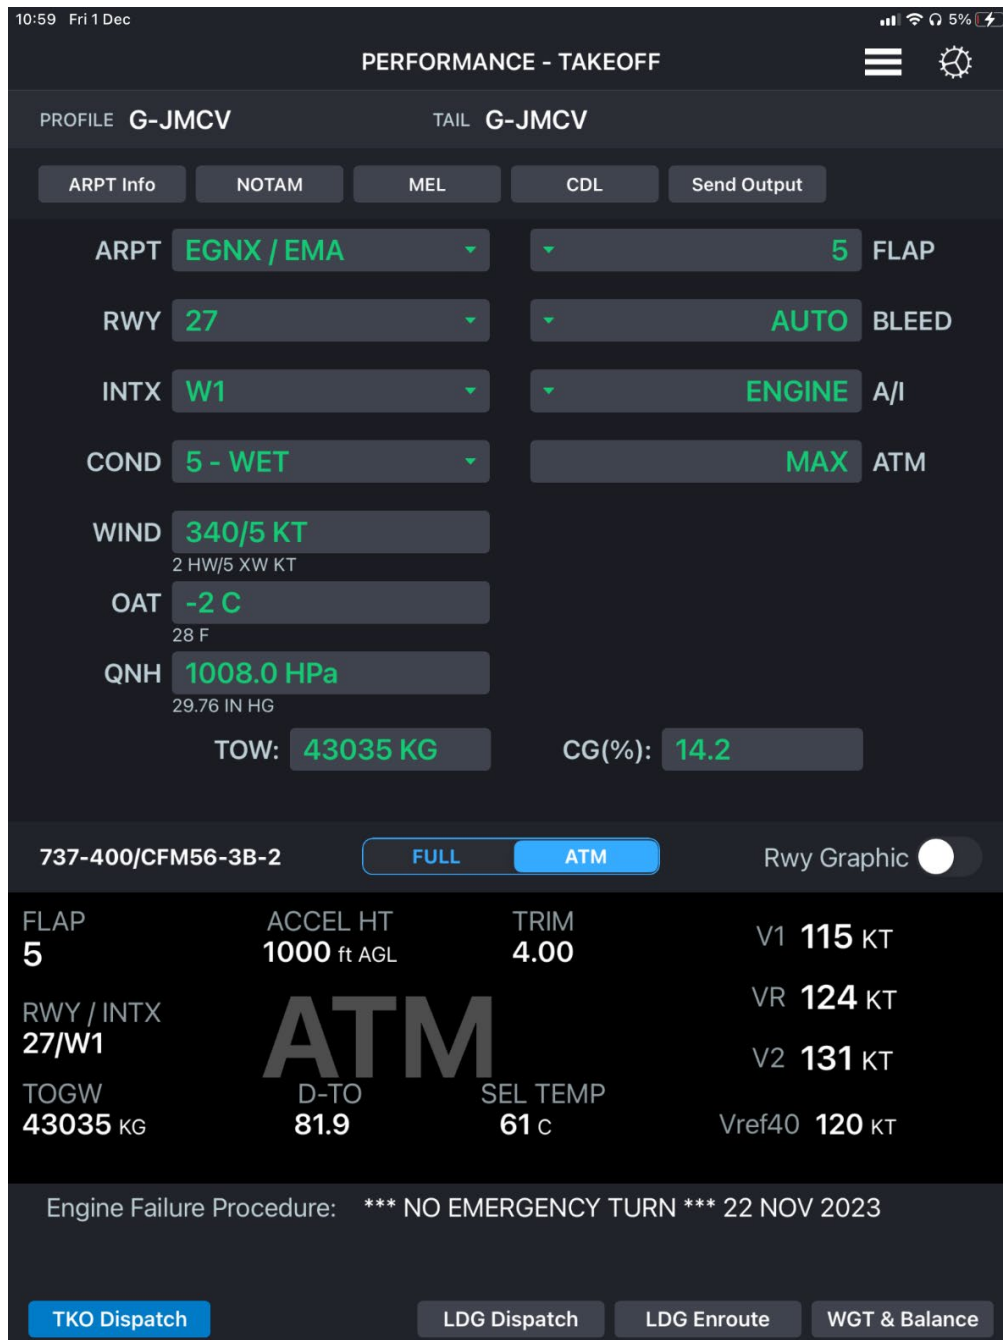
Figure 3

Performance calculation with mass from previous flight

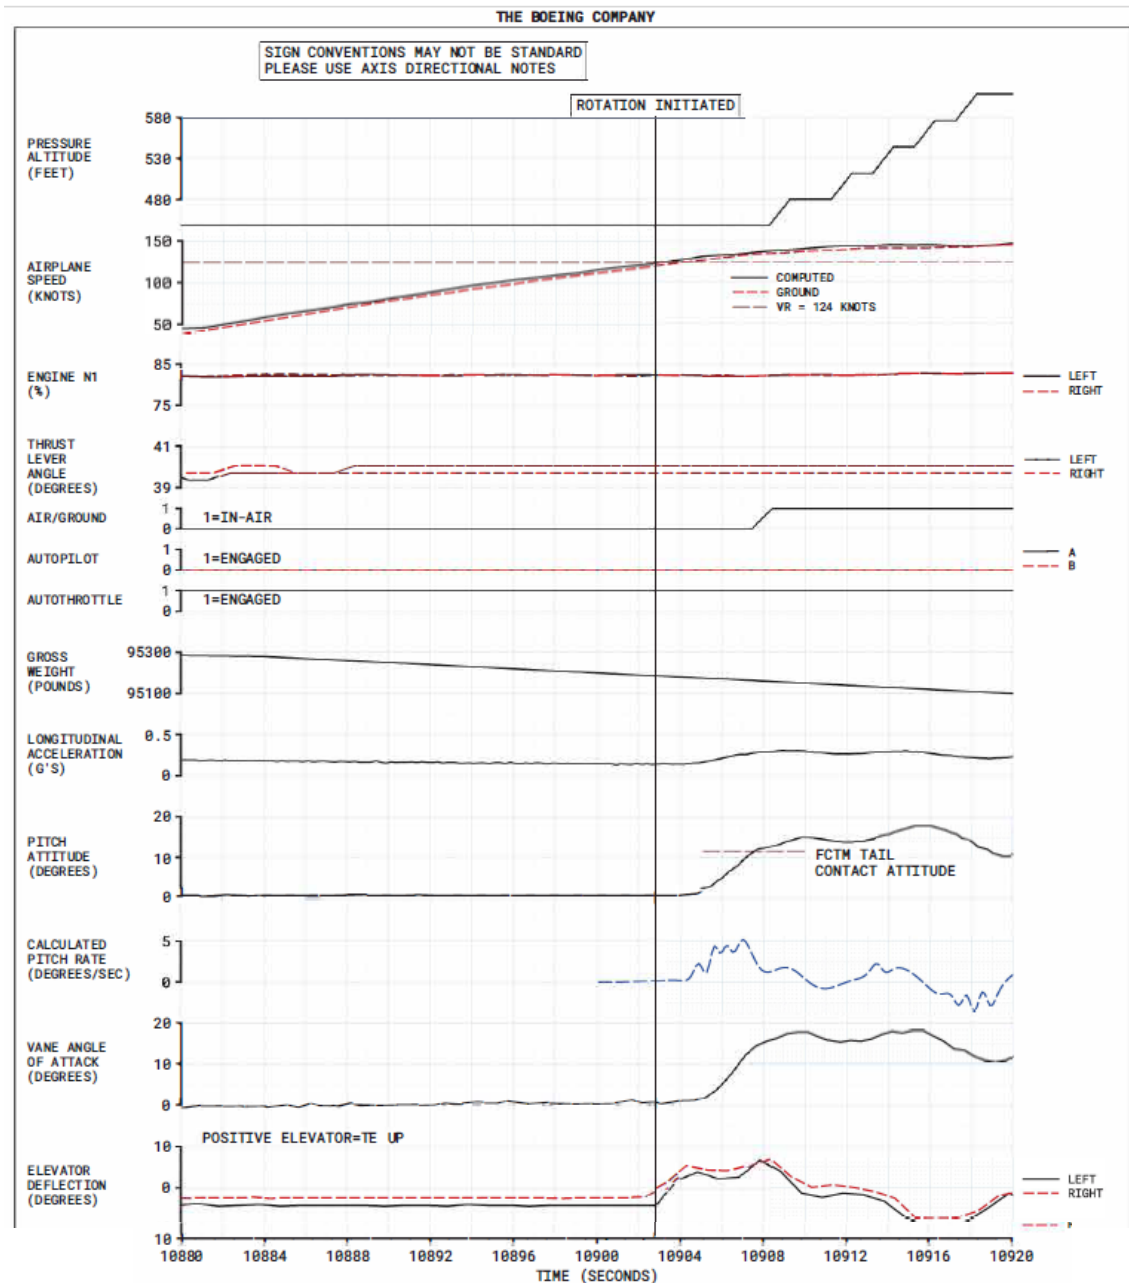
Figure 4

Extract of QAR information.

The QAR data shows that the elevator deflected trailing edge up to commence the takeoff rotation at an airspeed of approximately 123 kt which is consistent with the V_R calculated by the crew. The V_R for the actual mass of the aircraft was 139 kt. The aircraft's attitude

started to increase approximately 2 seconds after rotation was initiated. Around 4 seconds after rotation was initiated the calculated instantaneous pitch rate peaked at $5^\circ/\text{s}$ just prior to liftoff. The air/ground discrete parameter indicated liftoff occurred at a computed airspeed of around 137 kt, approximately 5 seconds after rotation was initiated. Pitch attitude was then 12.3° which exceeded the pitch attitude for a tail strike (11.4°).

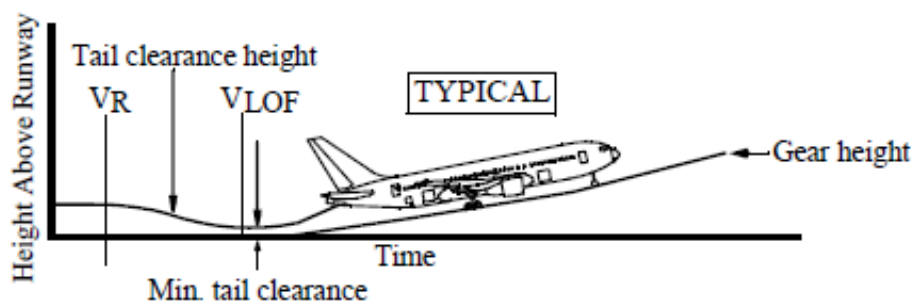
The FCTM contains the image at Figure 5 for a typical takeoff which shows that the lowest tail clearance will occur close to lift off speed (V_{LOF}).

Typical takeoff profile for B737 FCTM
Image Copyright © Boeing. Reproduced with permission

The actual tail clearance distance and the pitch attitude for a tail strike varies with the length of the aircraft. G-JMCV is a B737-400 and the FCTM states that for a takeoff with flap 5 set, lift off should occur at 9.1° pitch attitude, the minimum tail clearance will be 23 inches and the tail strike attitude will be 11.4° with the main wheels on the ground.
