Accident

Aircraft Type and Registration:	Boeing 737-8AS, EI-EGD
No & Type of Engines:	2 CFM56-7B26/3 turbofan engines
Year of Manufacture:	2010 (s/n 34981)
Date & Time (UTC):	4 October 2023 at 1320 hrs
Location:	London Stansted Airport
Type of Flight:	Commercial Air Transport (Passenger)
Persons on Board:	Crew - 6 Passengers - 103
Injuries:	Crew - None Passengers - None
Nature of Damage:	Right wing leading edge damaged
Commander's Licence:	Airline Transport Pilot's Licence
Commander's Age:	42 years
Commander's Flying Experience:	10,803 hours (of which 7,915 were on type) Last 90 days - 102 hours Last 28 days - 41 hours
Information Source:	Air Accident Report Form submitted by the commander and subsequent enquiries by the AAIB

Synopsis

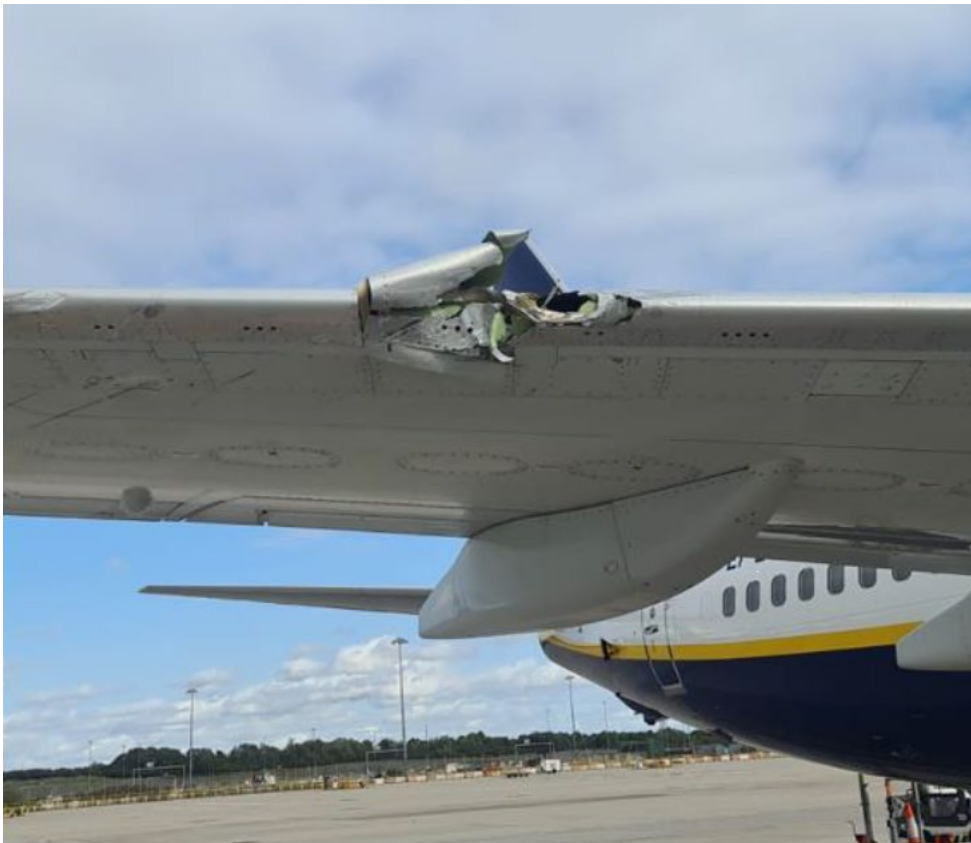
Figure 2
Damage to the aircraft

Just before the collision, the driver noticed the aircraft, performed an emergency stop and attempted to reverse out of the way but the right wing of the aircraft collided with the roof of the vehicle and then travelled over it. EI-EGD was travelling at 8 kt with engine 1 at 24% N_1 when the collision occurred. At this point the vehicle was behind the cockpit.

During the collision the aircraft's wing passed over the vehicle and the vehicle ended up behind the right wing. The vehicle was then driven behind EI-EGD and stopped on Stand D62L next to the back-of-stand road where the driver reported the accident to the relevant parties. The damage to the aircraft is shown in Figure 2.

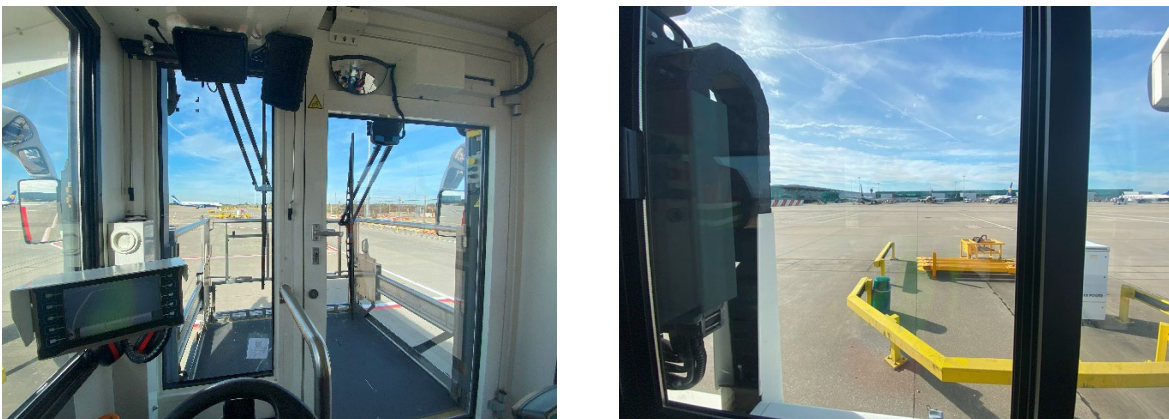
The vehicle provided a wide direct field of view through the windows as shown in Figure 4 with some obscuration caused by the vehicle structure. Vision to the rear was enhanced with multiple mirrors and the camera system.

The vehicle provided a good overall field of view and the obscuration caused by the vehicle structure was not sufficient to hide EI-EGD. The aircraft was visible through the windows and the vehicle design did not contribute to the accident.
