## Accident

<b>Aircraft Type and Registration:</b>	Rotorsport UK Cavalon, G-CLDV	
<b>No &amp; Type of Engines:</b>	1 Rotax 915 iS piston engine	
<b>Year of Manufacture:</b>	2019 (Serial no: RSUK/CVLN/032)	
<b>Date &amp; Time (UTC):</b>	16 January 2024 at 1019 hrs	
<b>Location:</b>	Field near Breedon Holt, Norfolk	
<b>Type of Flight:</b>	Training	
<b>Persons on Board:</b>	Crew - 2	Passengers - None
<b>Injuries:</b>	Crew - 1 (Serious) 1 (Minor)	Passengers - N/A
<b>Nature of Damage:</b>	Aircraft destroyed	
<b>Commander's Licence:</b>	Private Pilot's Licence	
<b>Commander's Age:</b>	65 years	
<b>Commander's Flying Experience:</b>	3,500 hours (of which 100 were on type) Last 90 days - 25 hours Last 28 days - 6 hours	
<b>Information Source:</b>	Aircraft Accident Report Form submitted by the commander

## Synopsis

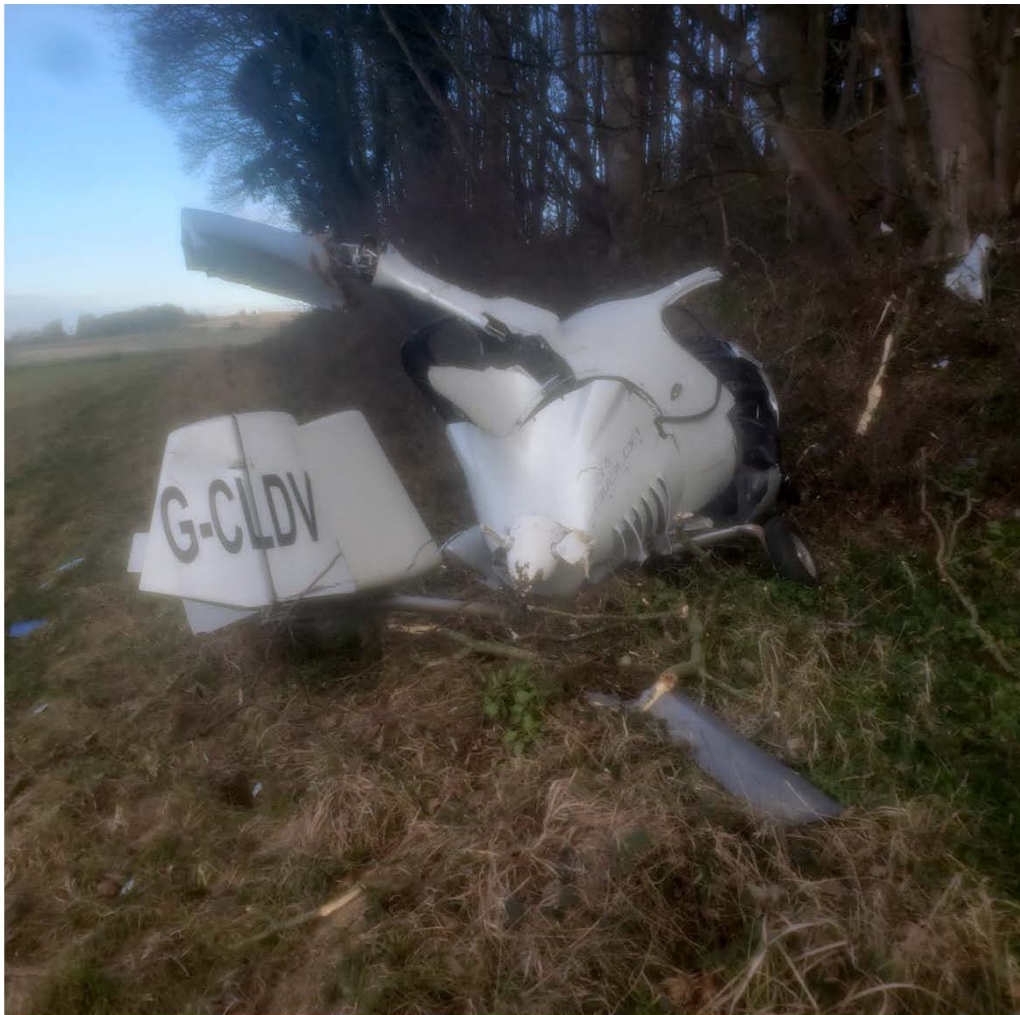
**Figure 2**

The instructor stated that the student “pulled the stick hard back and applied partial power.” The standard go-around actions are to apply full power, correct any yaw, and pitch the aircraft to achieve 60 mph. The student recalled applying full power for the go-around. The instructor stated he applied full power and placed his hand on the control column to pitch down but could not recall if he was able to get the stick forward at all. He could not recall if he said “I have control.” The aircraft struck the edge of the trees and fell to ground (Figure 2).

Aircraft at accident site

The aircraft did not recover to the climb and struck the edge of the trees before falling to the ground. As the recollections of those on board differed and with no data retrieved from the aircraft, it was not possible to determine the cause of the aircraft striking the trees.
