AAIB Bulletin

8/2024

Aircraft Type and Registration:	Grumman FM2, Wildcat, G-KINL
No & Type of Engines:	1 Wright Aeronautical Corp CT7-9B piston engine
Year of Manufacture:	1942 (Serial no: 5744)
Date & Time (UTC):	6 July 2023 at 1615 hrs
Location:	Heveningham Hall, Suffolk
Type of Flight:	Private
Persons on Board:	Crew - 1 Passengers - None
Injuries:	Crew - 1 (Serious) Passengers - N/A
Nature of Damage:	Windscreen and canopy broken, propeller, fin and rudder disrupted
Commander's Licence:	Commercial Pilot's Licence
Commander's Age:	63 years
Commander's Flying Experience:	4,238 hours (of which 2 were on type) Last 90 days - 28 hours Last 28 days - 17 hours
Information Source:	AAIB Field Investigation

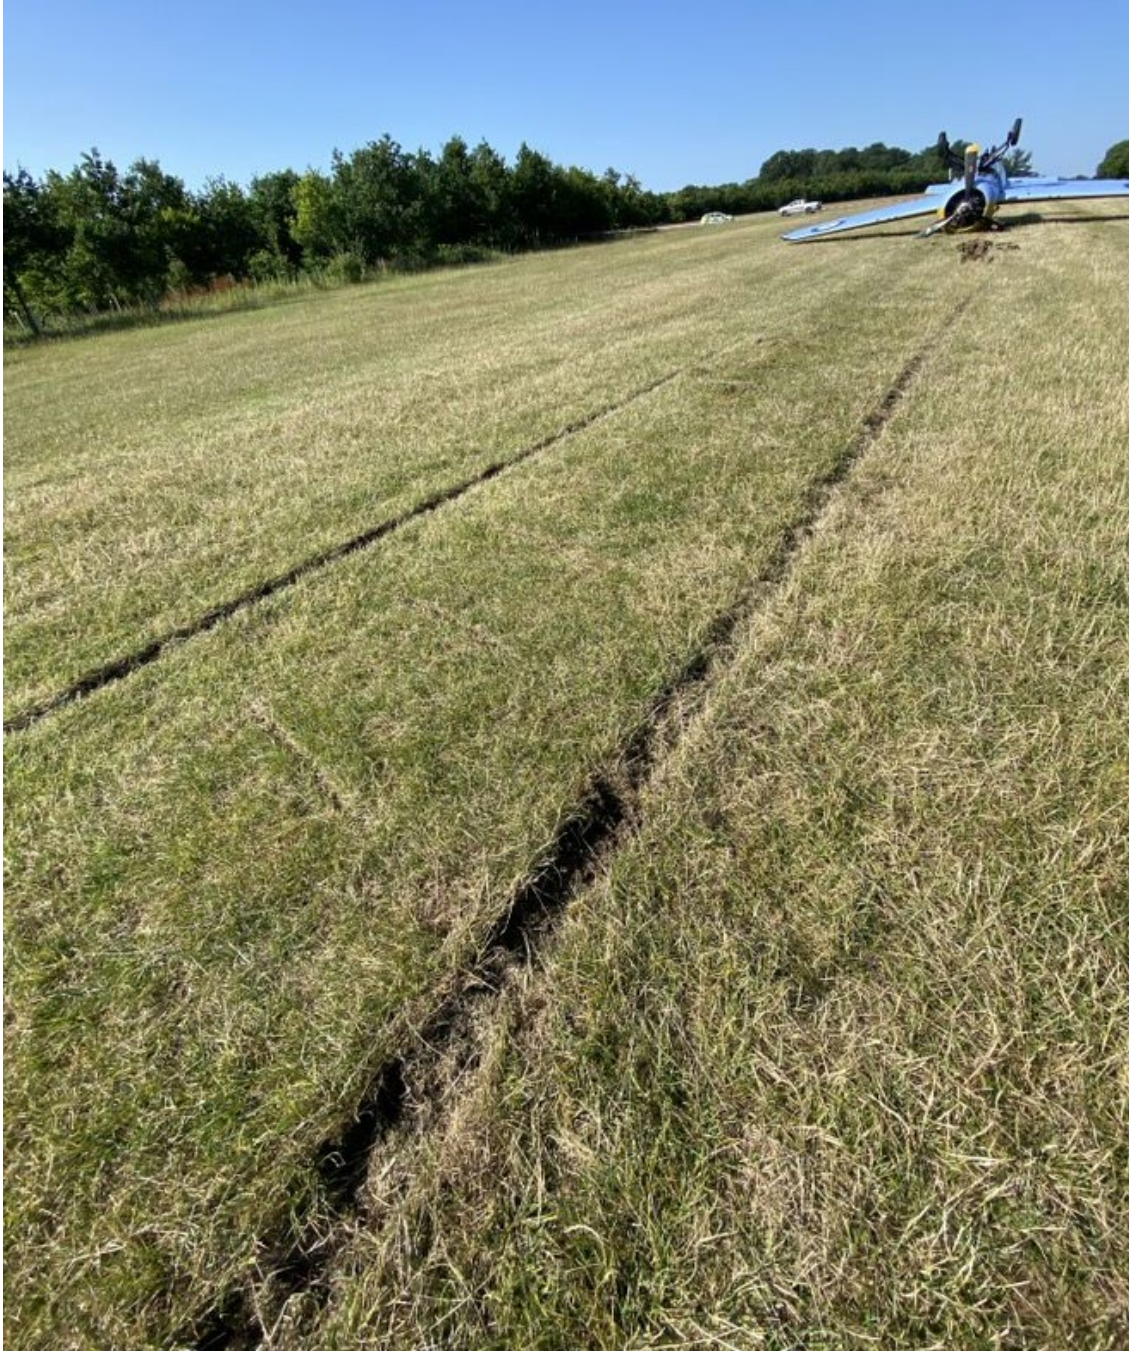
Figure 2

Accident site with ground marks

Apart from the marks left by this aircraft, there were no other identifiable marks on the runway surface. A subjective test the day after the accident was carried out using a steel spike (part of an electric fence pole) to penetrate the runway surface and found it had a hard turf surface crust approximately 2 cm thick on top of a softer substrate. It was noted that when the test was done, the daytime temperature reached 28°C by midday¹¹, which was much warmer and sunnier than the day of the accident. This would have had the effect of drying the crust and making it slightly harder when this test was carried out.

A closer examination of the marks made by both mainwheels, their effect on the blades of grass and soil in the tyre tracks, show that compression of the surface was the prominent factor rather than skidding. Calculations show the static ground pressure from each wheel to be 1,360 kg over an area of 180 cm² and that the tyre pressure of 103 psi presents a stiff running face of the tyre. In practice, this loading would be less at initial touchdown but would rise to this magnitude as the wing lift reduces. No marks attributable to the tailwheel were found on the runway.

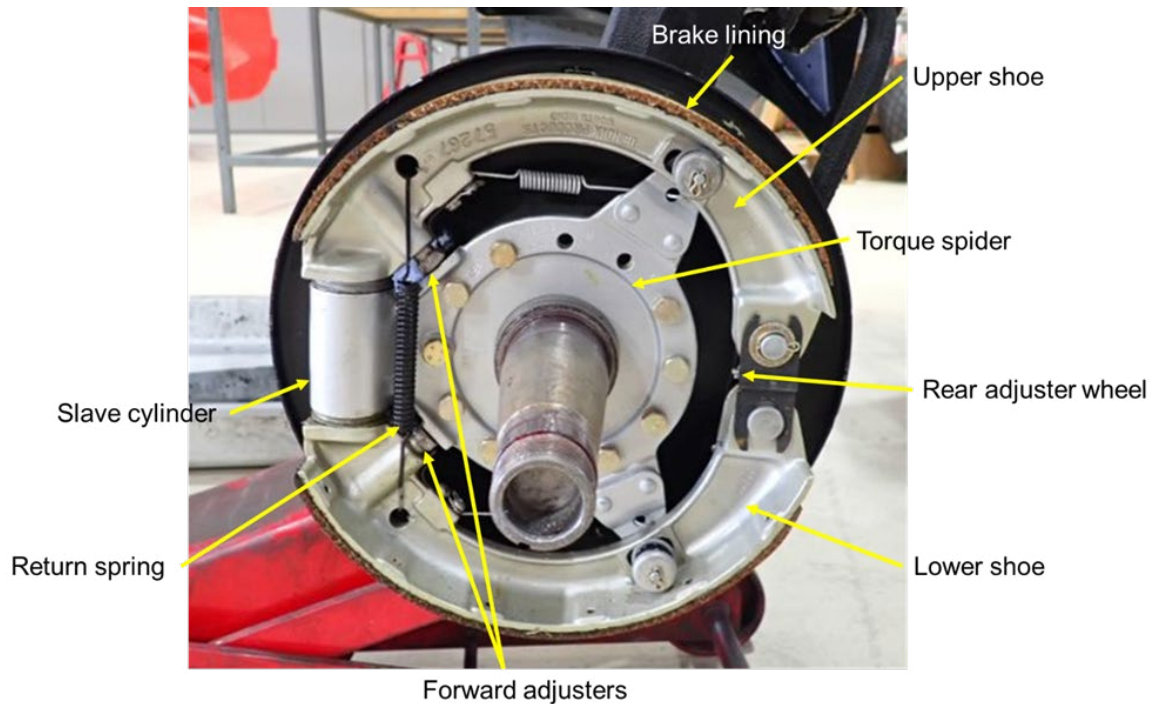
Figure 3

Wheel brake assembly (left side, drum removed)

The aircraft braking system was examined and there were no obvious signs of damage or malfunction. However, the left brake pedal was firmer when compared to the right. The double acting slave cylinders and shoes can be seen with the wheel hub cover removed. The left and right wheel brake shoes could be seen moving on and off although the left set appear to move to a lesser extent than the right.

After recovery, the aircraft braking system was examined. The left brake drum and shoe linings had started to bed in with evidence of high spots¹³ on the surfaces. Experience has found that the combination of a new drum and linings bed in slightly more slowly than an older, used drum with new linings. The right brake drum and shoe linings had bedded in commensurate with the number of aircraft landings since restoration. The resultant level of binding on each wheel was considered normal by the experienced aircraft restoration engineers present during the examination.

The right brake had bedded in more than the left brake with its newer drum, but this was considered unremarkable by experienced engineers. This explains why there appeared to be slightly less movement of the left brake shoes when observed at the accident site. The operation of the braking system was not a factor in this accident.

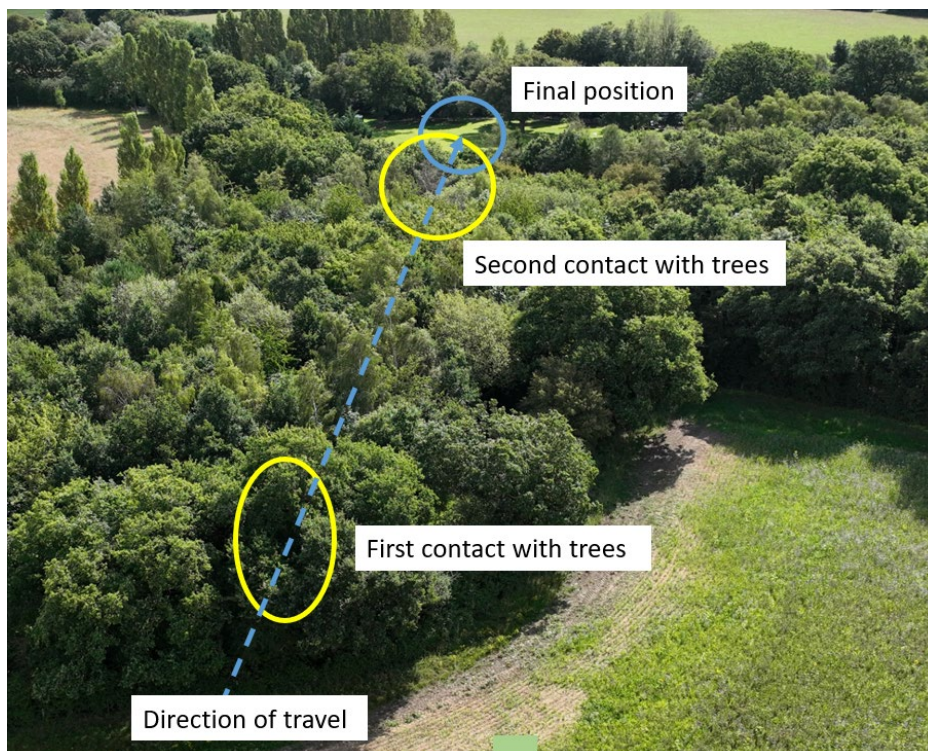
The accident site was approximately 3 nm north of Earls Colne Airfield at an elevation of 240 ft amsl. An aerial view of the site is shown in Figure 3.

Figure 3
Aerial view of accident site

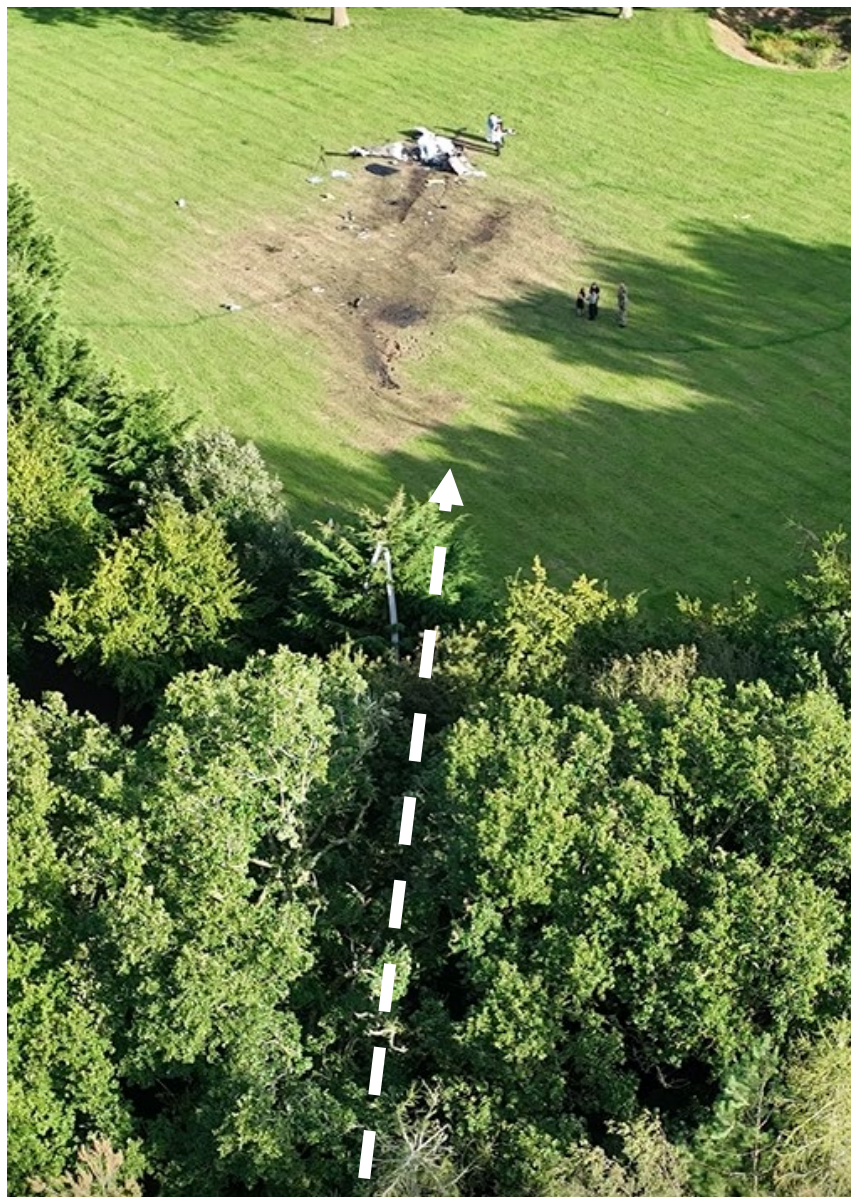
Figure 4

Inspection of the accident site and wreckage indicated that the aircraft first contacted the top of trees approximately 200 m before its final resting place. The initial contact was made by the right wingtip, evidenced by remains of the right wingtip green navigation light found on the ground underneath these trees. The second contact with the trees occurred approximately 75 m further along the path of travel. On the ground in this area were the remains of the left wingtip, red navigation light, and the beacon light mounted on top of the fin, along with pieces of clear plastic from the windows. This indicated that the aircraft was in a right-wing low attitude when it first contacted the trees and, by the time of the second contact, the aircraft was inverted with the left wing low. The aircraft continued in an inverted attitude until it came to rest in the grass field where the central part of the fuselage was consumed by the post-accident fire (Figure 4).

Final part of flight path through trees, looking along direction of travel

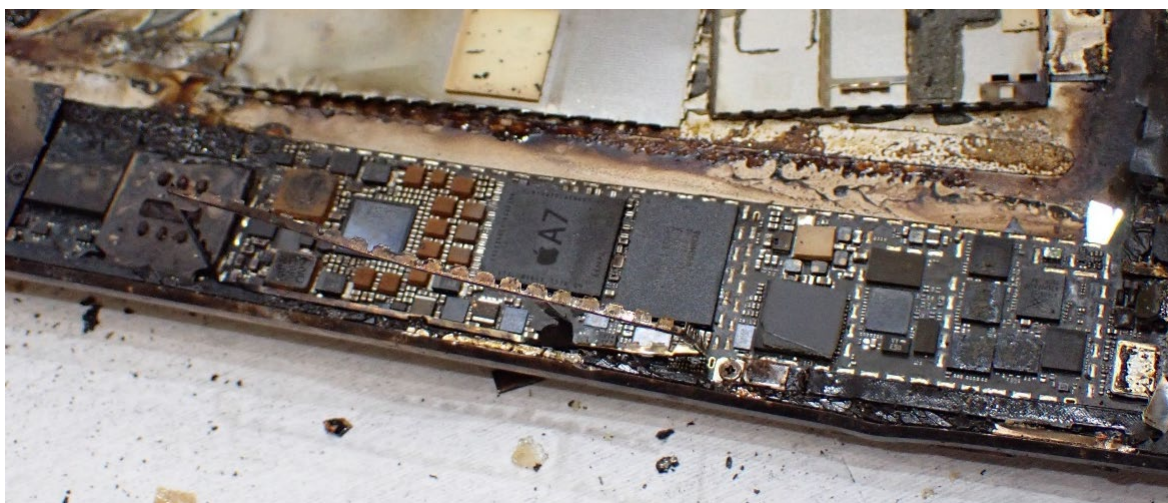
Figure 5

A significantly fire-damaged tablet was recovered from inside the aircraft, and a fire-damaged mobile phone was also retrieved from the accident site. The batteries of the tablet exhibited evidence of having combusted in the post-accident fire, exposing the internal circuitry to high temperatures. Some components on the circuit board had been displaced due to the high temperatures melting the solder joints. Some of the damage is shown in Figure 5.

Circuit board from the fire-damaged tablet.

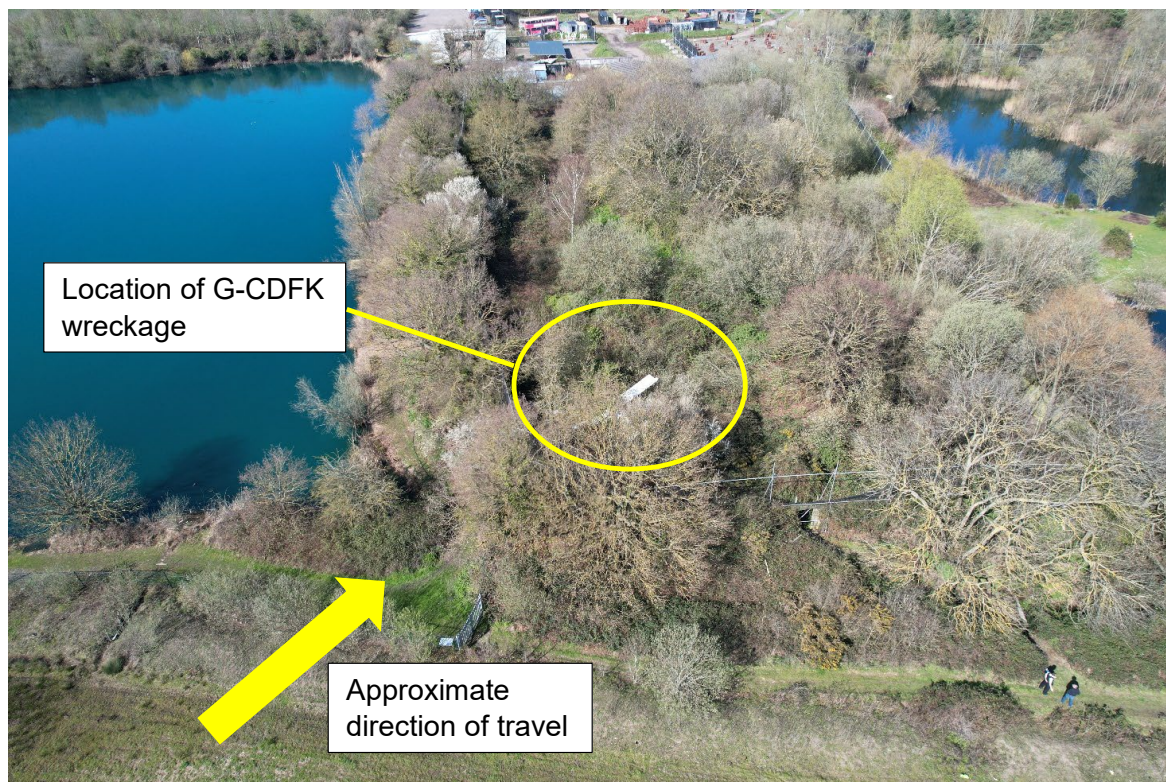
Figure 1

The accident site was in a wooded area (Figure 1) approximately 900 m from the start of the aircraft’s takeoff roll and 390 m from the upwind threshold of Runway 21 at Damyns Hall Aerodrome. Damage to the trees indicated that it had entered them nearly vertically, striking the trunk of a mature tree before coming to the ground.

Area of woodland in which G-CDFK came to rest (courtesy of London Fire Brigade)

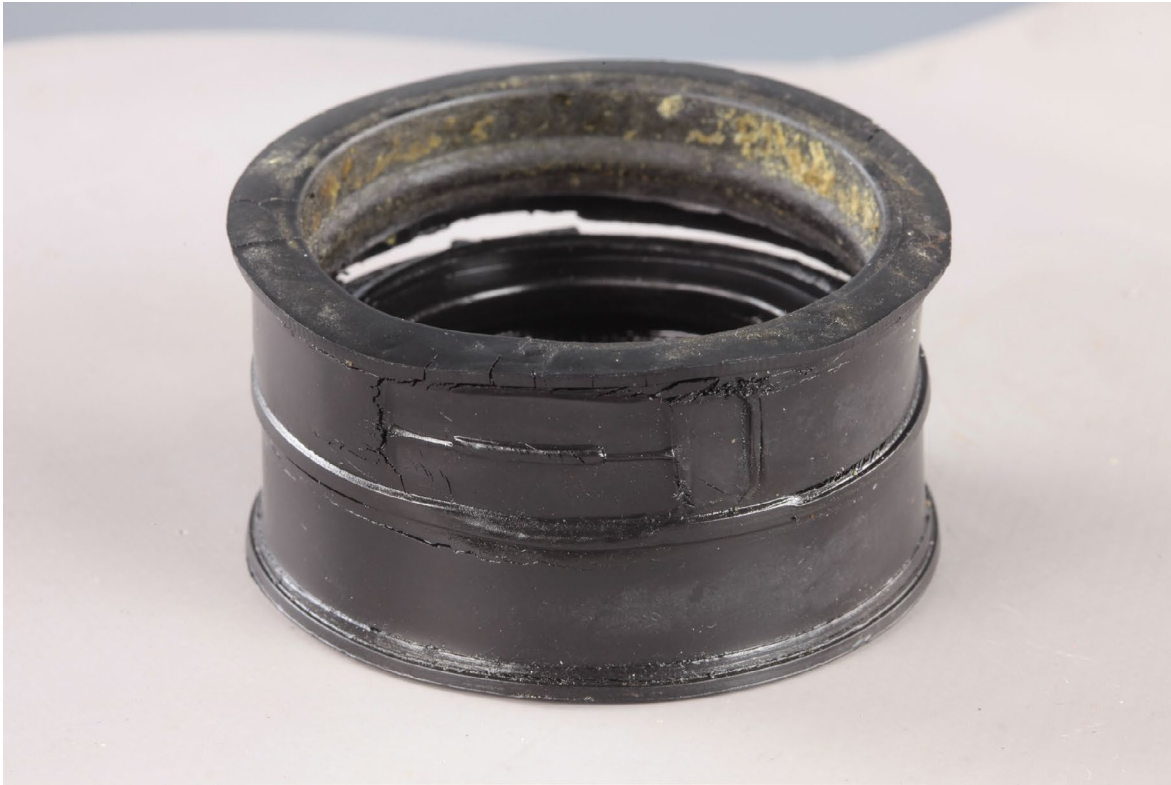
Figure 2

The nitrile rubber coupling (Figure 2), part number 4691084, removed from the engine was examined in a laboratory. A 360° crack radiating from the inner diameter outward through most of the coupling was found. Additionally, cracks were present radiating inboard from the outer diameter that met the 360° crack. The coupling had a through crack around 65% of the circumference.

Split carburettor coupling from G-CDFK

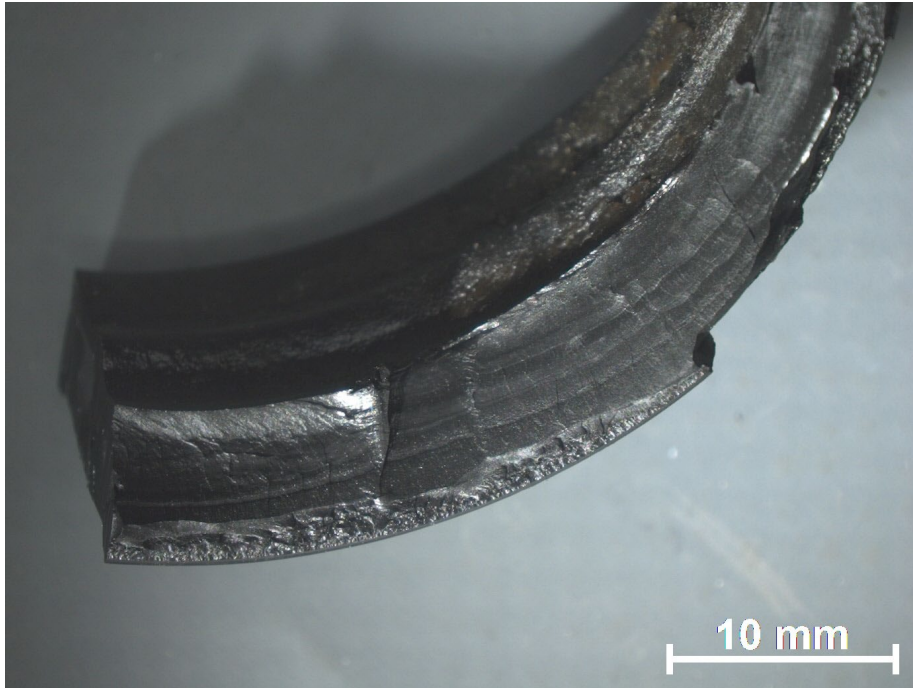
Figure 3

Assessment of the fracture surfaces indicated that the main crack from the inner diameter had been present for some time and exhibited fatigue striations (Figure 3). It could not be determined for certain whether the external cracks were present during the accident flight, as a result of the impact or during later manipulation when the coupling was removed, but there were five distinct areas of different external crack morphology, two of which exhibited fracture surfaces consistent with overload, leaving the remaining three areas likely to have been present during the accident flight. This suggests that at least 30% of the circumference was fractured during the flight. External cracks were also present in the coupling that had not joined with the main inner crack.

Cracks in coupling wall, showing fatigue propagation from inner diameter

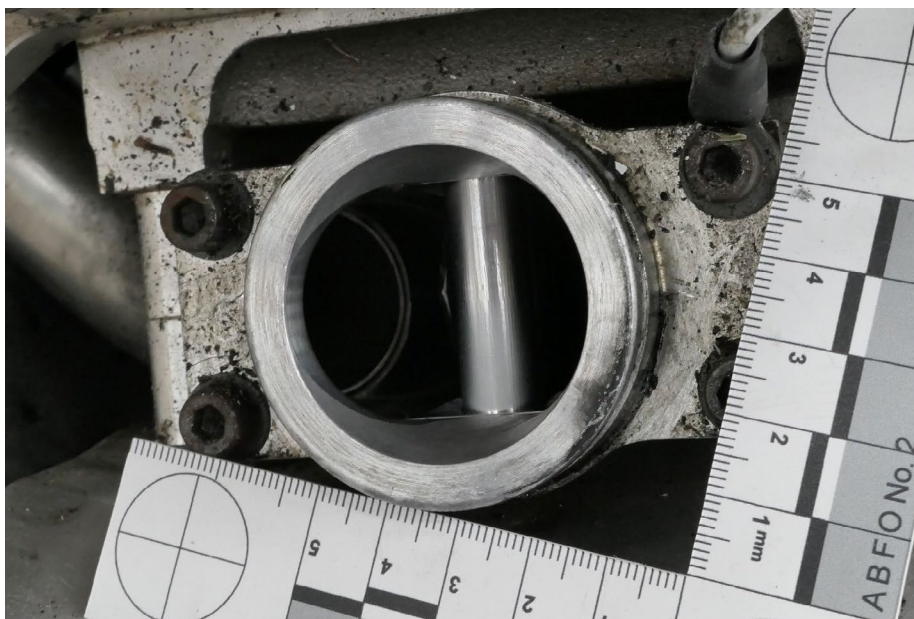
Figure 4

The rear face of the inlet to the plenum chamber showed staining (Figure 4), possibly indicating the location of the split in the coupling,

Inlet to plenum chamber showing marking indicating leak in coupling

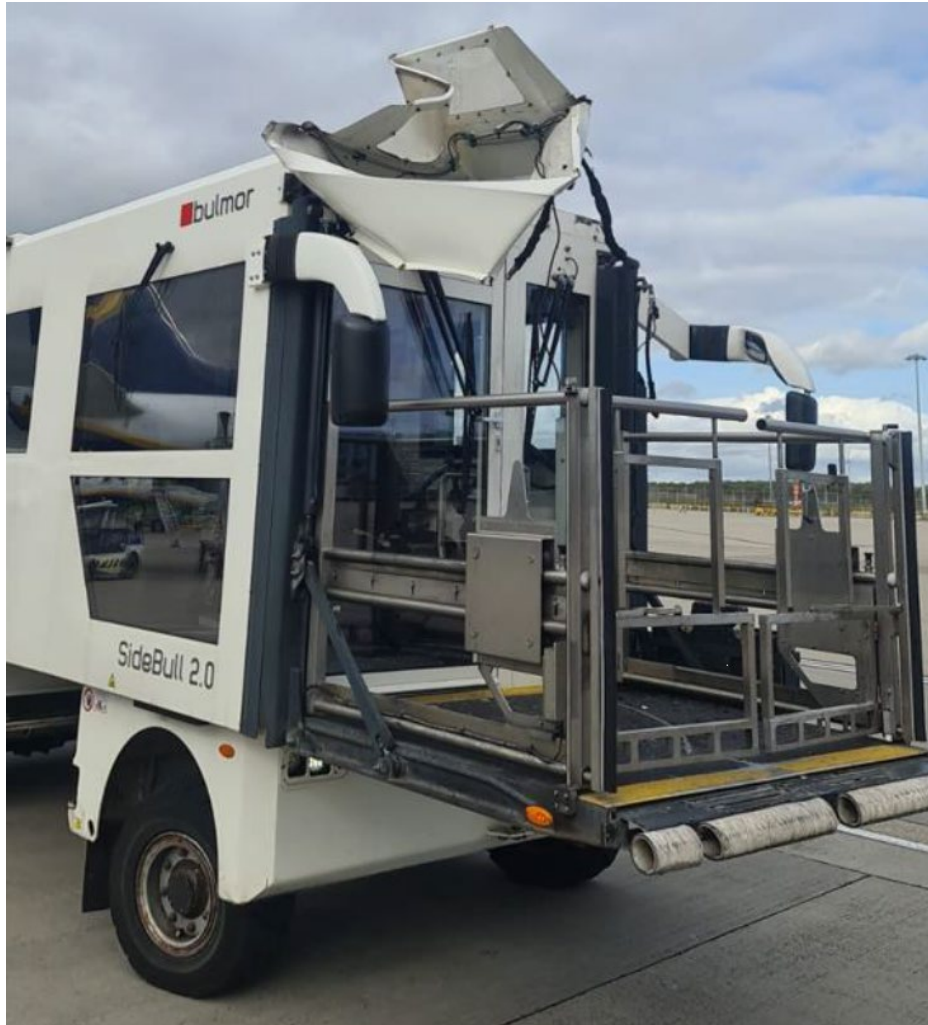
Figure 5
Damage to the vehicle

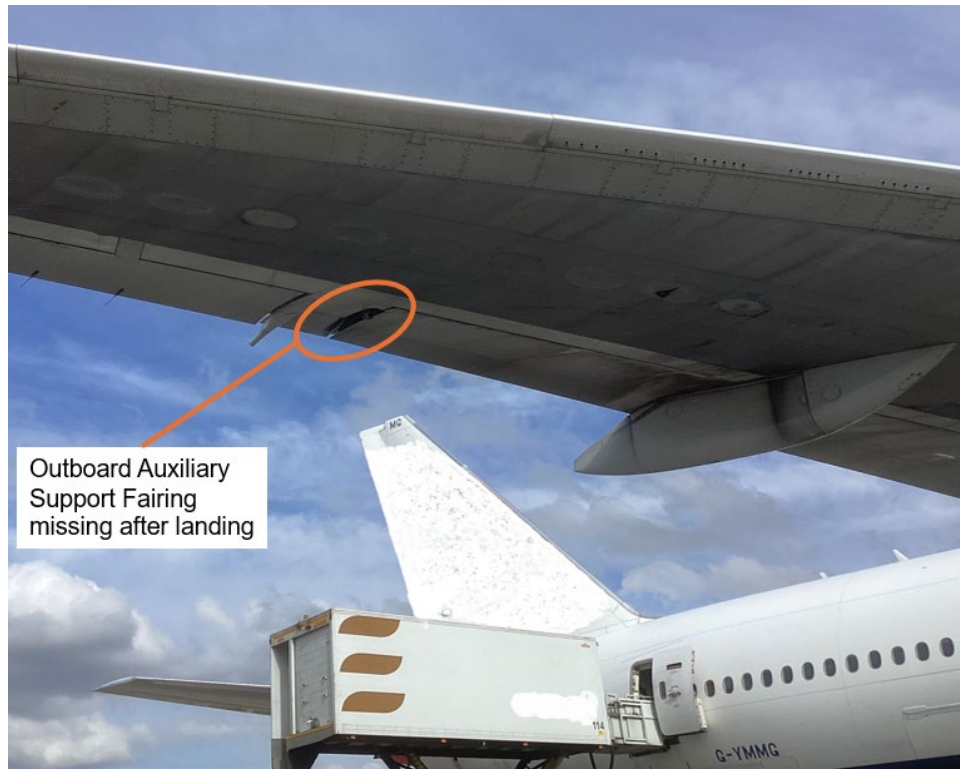
Figure 1

Both fairing attachments on the incident aircraft were inspected in accordance with the SB in June 2010 and cracks were found on the left-wing fairing. The aircraft was modified as per the SB and returned to service. The right-wing fairing was the original equipment fitted to the aircraft and no cracks were detected at the time of the inspection.

G-YMMG right wing after landing at Gatwick Airport

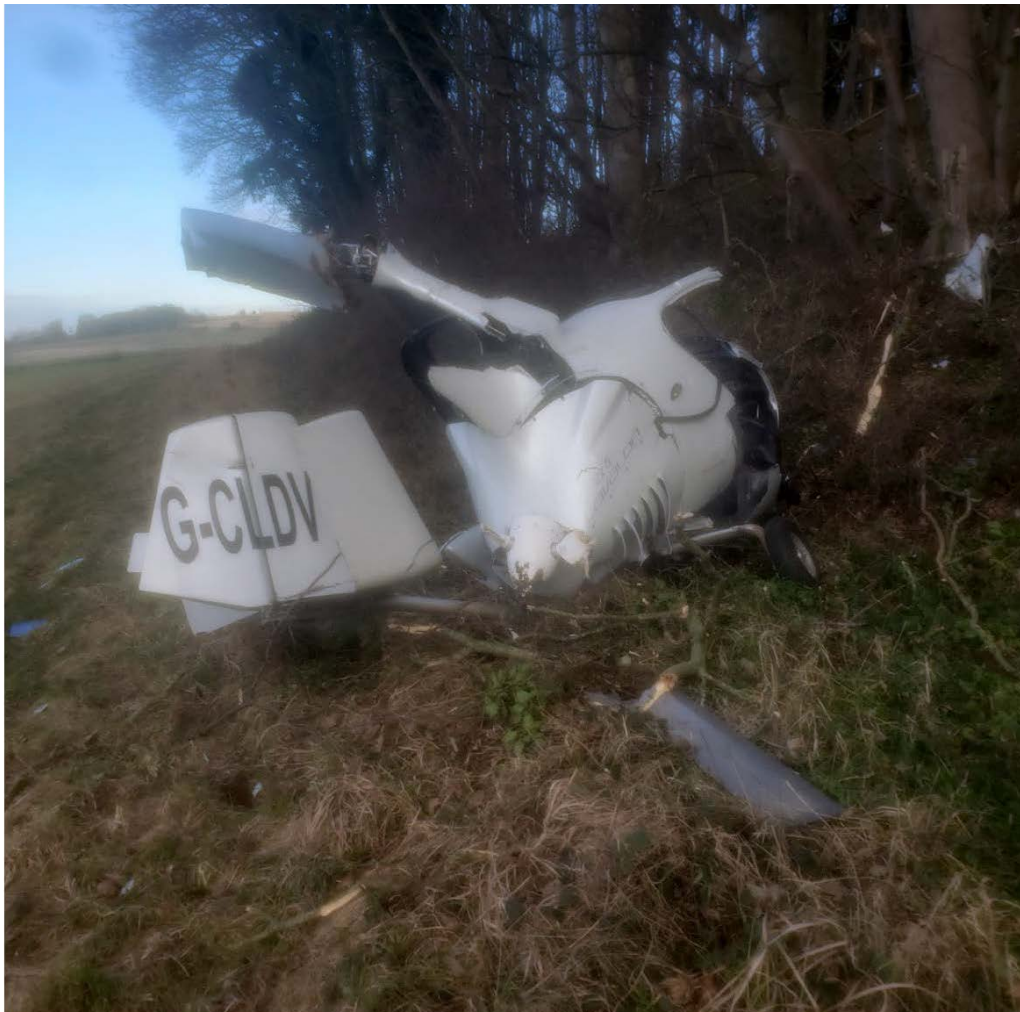
Figure 2

The instructor stated that the student “pulled the stick hard back and applied partial power.” The standard go-around actions are to apply full power, correct any yaw, and pitch the aircraft to achieve 60 mph. The student recalled applying full power for the go-around. The instructor stated he applied full power and placed his hand on the control column to pitch down but could not recall if he was able to get the stick forward at all. He could not recall if he said “I have control.” The aircraft struck the edge of the trees and fell to ground (Figure 2).

Aircraft at accident site
