Accident

Aircraft Type and Registration:	Vans RV-6A, G-RVSH	
No & Type of Engines:	1 Lycoming IO-360-A1AD (Modified) piston engine	
Year of Manufacture:	2004 (Serial no: PFA 181A-13026)	
Date & Time (UTC):	3 September 2023 at 1406 hrs	
Location:	Truro Airfield, Cornwall	
Type of Flight:	Private	
Persons on Board:	Crew - 1	Passengers - None
Injuries:	Crew - 1 (Fatal)	Passengers - N/A
Nature of Damage:	Aircraft destroyed	
Commander's Licence:	Private Pilot's Licence	
Commander's Age:	60 years	
Commander's Flying Experience:	261 hours (of which 115 hours were on type) Last 90 days - 6 hours Last 28 days - 3 hours	
Information Source:	AAIB Field Investigation

Synopsis

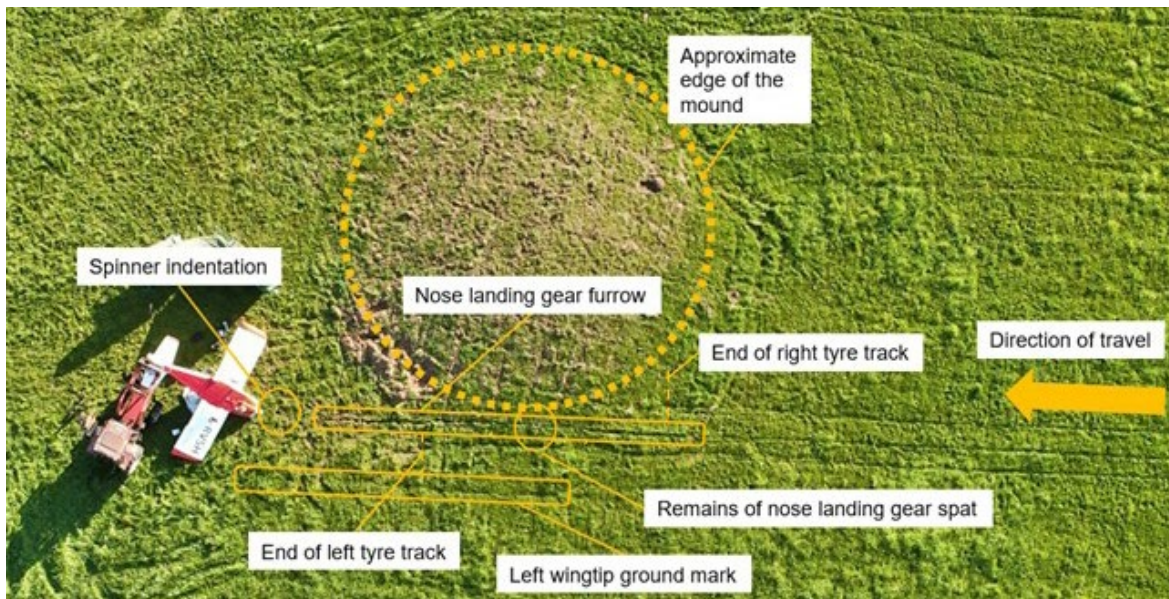
**Figure 3**

The three tracks were consistent with the three wheels touching down at the same time and were parallel to the runway until adjacent to the north side of the mound (Figure 3). The right landing gear wheel track ended near the periphery of the mound. Approximately 6 m after the right track ended, the partial remains of the nose wheel spat were found. Leading up to the spat was a deep furrow created by the nose landing gear, which started before the point where the right tyre track ended. At the same approximate position there was evidence that the left wing tip was in contact with the grass, and this was further confirmed by light scratches on the left wingtip structure. The nose landing gear furrow extended a further 10 m beyond the remains of the spat with the left tyre track ending approximately halfway along. After a gap of approximately 2 m beyond the nose landing gear furrow, an indentation had been made by the propeller spinner. The aircraft came to rest inverted just beyond this indentation.

Accident site ground marks

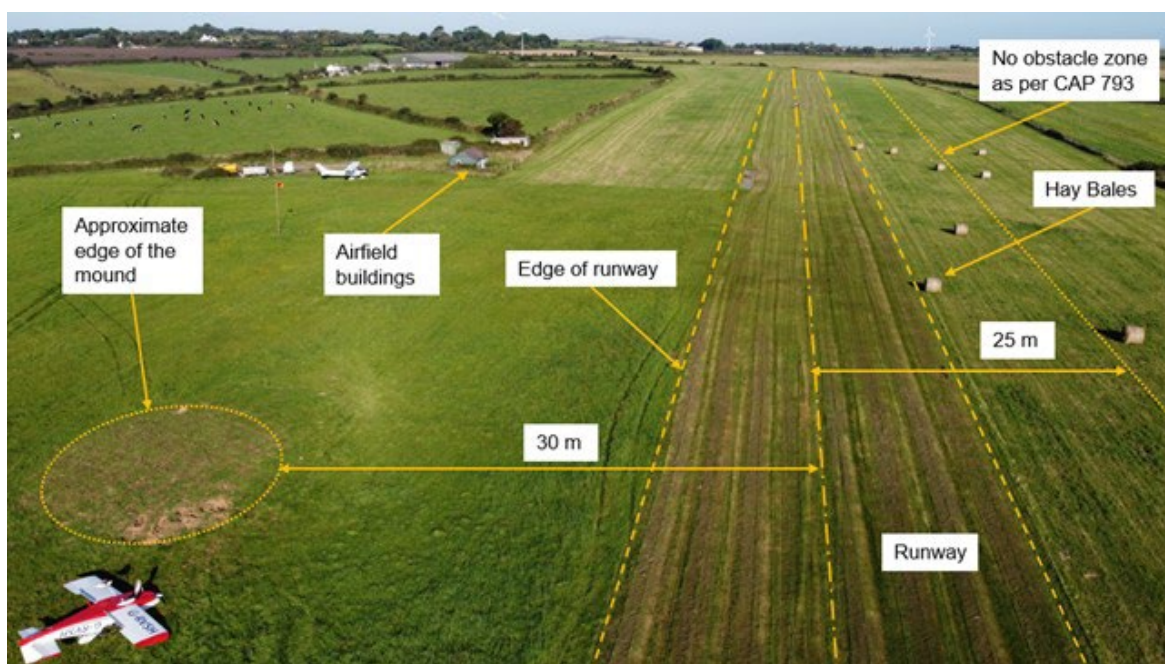
Figure 7

On the day of the accident flight there were large hay bales to the north of the runway at various locations, some of which were adjacent to the edge of the runway. At the time of the accident, a farmer was collecting bales on the north-eastern side, towards the Runway 14 threshold. Several bales remaining on the north-eastern side of the runway were within 25 m from the centreline (Figure 7).

The airfield was also used as a training location for helicopters to conduct sloping ground landing training and practice. To facilitate this, a mound, about 30 m from the centre of the runway to the south-west between the windsock and the Runway 32 threshold, had been constructed. The base of the circular mound was 18 m in diameter with a 10° slope to a maximum height of 1.5 m. The Pooley's plate made no reference to the mound.

Truro airfield viewed in direction of Runway 32 showing hay bales and the mound

- The airfield owner has instructed the farmers to remove the hay from the airfield as soon as it is baled and not to store it on the airfield.
- The airfield owner has provided additional guidance in the Pooley's Plate on which runway to use depending upon the wind conditions.
- The airfield owner has removed the training mound.

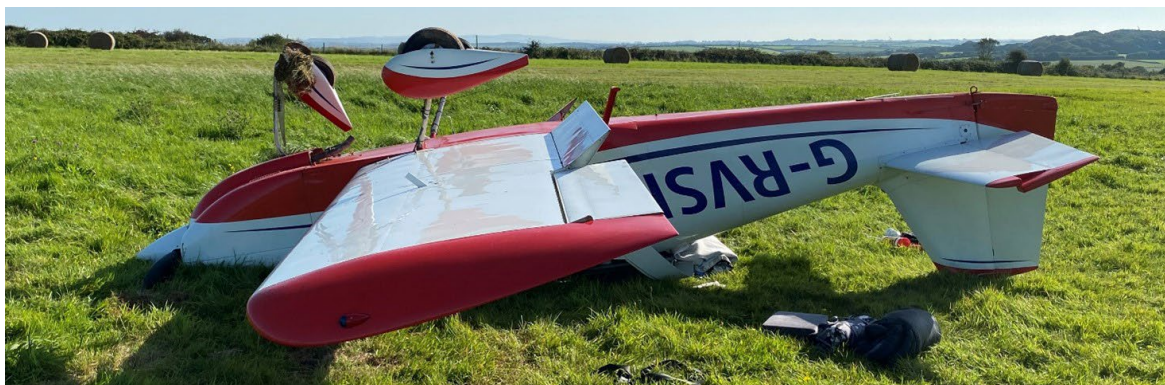
**Figure 8**

The aircraft structure was intact with crush damage to the top of the vertical fin and deformation of the canopy frame and the Perspex shattered. The main landing gear was intact and there was evidence on the tyres of skidding on earth and grass. The nose landing gear strut was bent rearwards, and the front of the spat was damaged with a section missing. The aircraft was recovered to the AAIB facilities for further inspection.

G-RVSH at the accident site

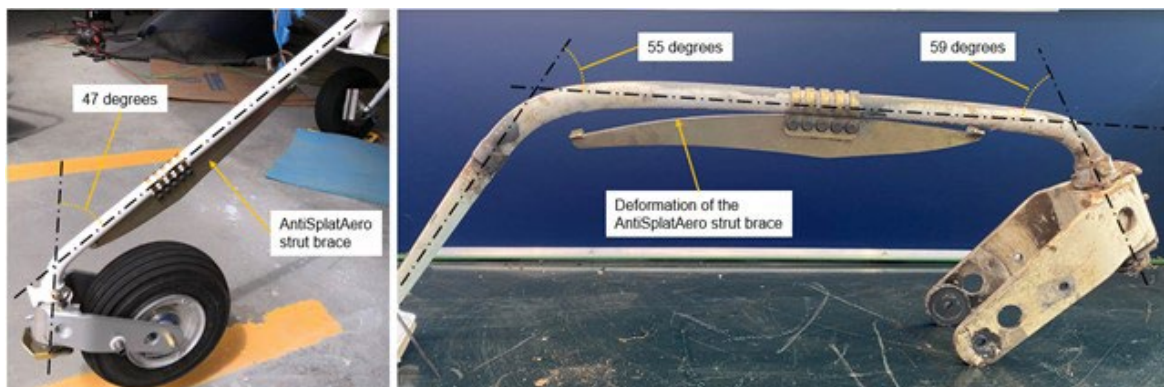
**Figure 9**

The nose landing gear was disassembled to enable inspection of the individual components and measurements to be taken. The landing gear usually has a 47° bend at the lower end and following the accident this had increased to 59°. An additional bend had occurred just before the mounting position of 55° (Figure 9). The blade of the strut brace had also been deformed rearwards.

Nose landing gear damage detail
