# Rail Accident Report

## **Passenger train collision with a derailed locomotive at Bromsgrove 23 March 2020**

Report 14/2020  
November 2020

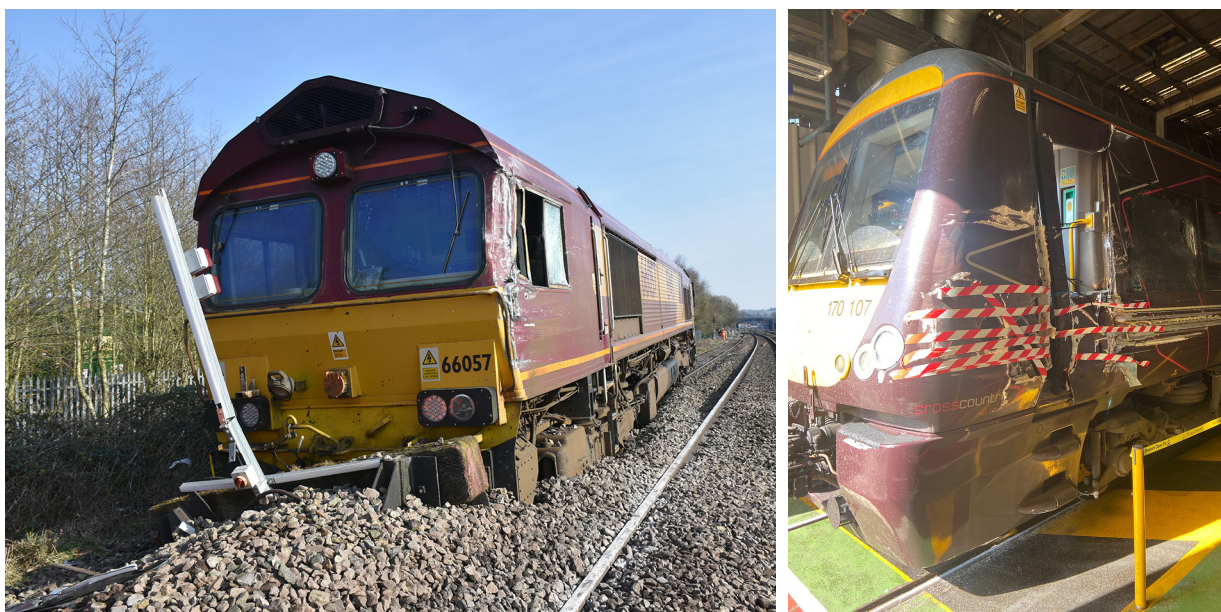
- 4 No-one was hurt.
- 5 The passenger train suffered extensive damage to one side of all three vehicles. The front left corner of the leading vehicle was particularly damaged in the area of the driver's door. The locomotive suffered damage to the front left corner of the leading cab. There was also damage to the underside of the locomotive and this resulted in a diesel fuel spill during recovery (figure 1).

Figure 1: The locomotive and the passenger train after the accident (second image courtesy of CrossCountry)

- 36 The locomotive tore the buffer stop off the end of the siding, pushing it for about 20 metres before coming to a stop. The locomotive ran off the end of the track, ploughing into the ballast, with only the last two sets of wheels remaining on the track. As it ran on, unguided by the track, the locomotive deviated to the left, coming to a stop with its front left corner about 600 mm away from the nearest running rail of the up Gloucester main line (figure 1).

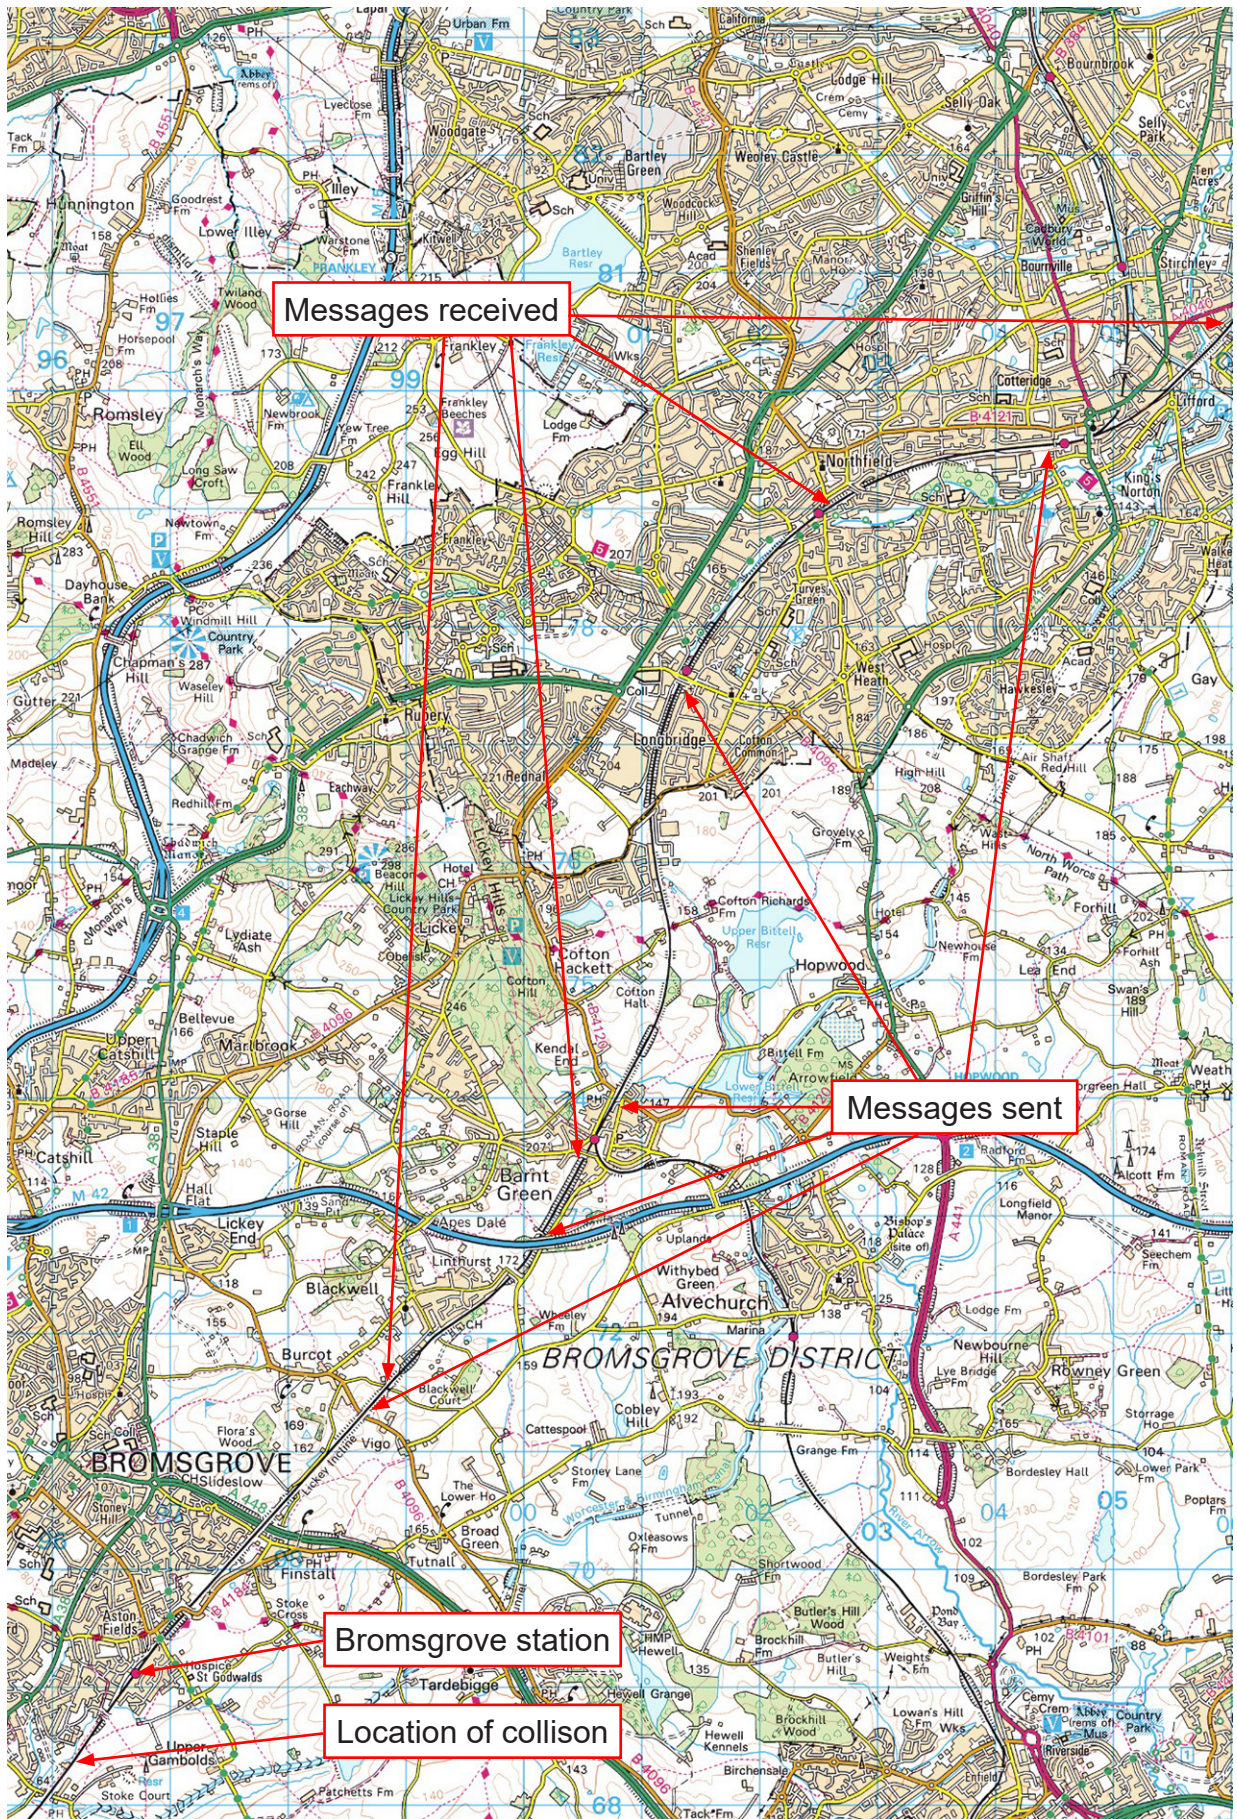
- 30 After passing Kings Norton, over a period of 11 minutes, the driver received three text messages on his personal mobile phone. These were from the same family member as the earlier phone call and all related to concerns about childcare and the closure of schools. The driver sent four text message replies to these. At 22:38 hrs he received a picture message showing advice from the school relating to school provision, and he sent a text reply. Table 1 and figure 6 show details of these timings and the approximate locations at which the messages were received.

Figure 6: Approximate locations of the locomotive when messages were received and sent

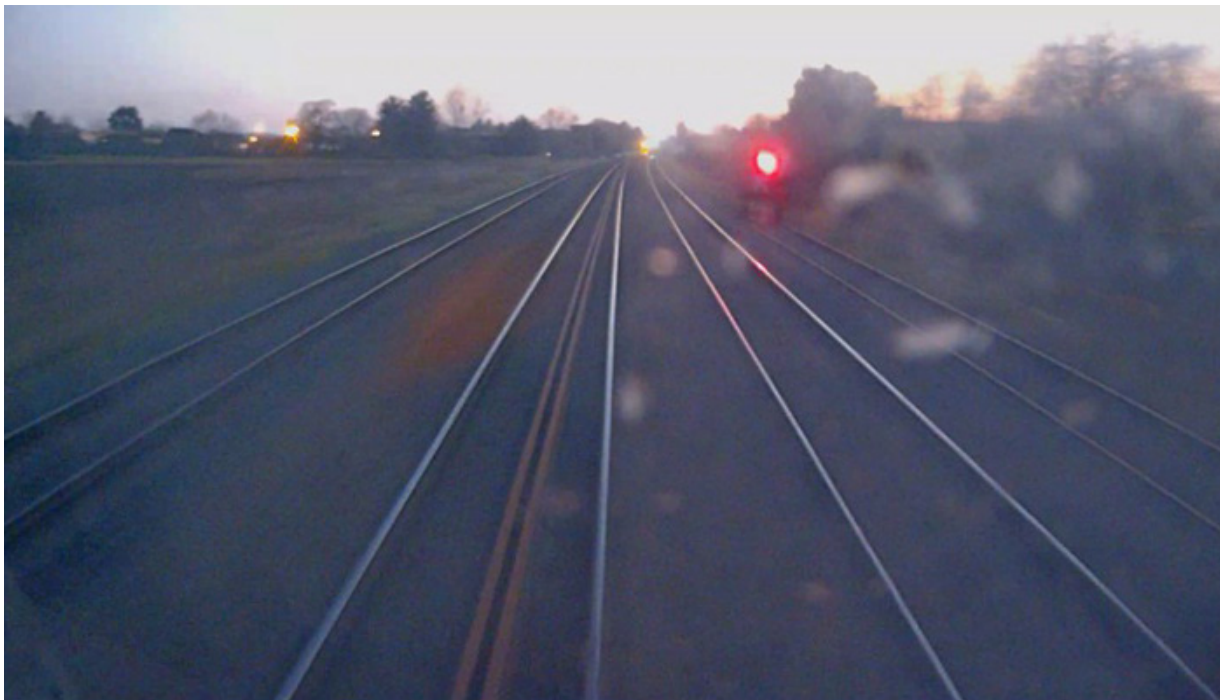
- 68 The red lights on the buffer stop were subject to regular inspection by Network Rail's Distribution and Plant team. This included replacement of the lamps every six months. Records show that this was being carried out. In addition, CCTV from a passing train shows that the buffer stop lighting was illuminated four hours before the accident (figure 7), indicating that it was almost certainly lit at the time of the accident.

Figure 7: Train CCTV image showing buffer stop light illuminated at 18:47 hrs on 23 March 2020 (image courtesy of CrossCountry)
