Rail Accident Investigation Branch

Rail Accident Report

**Passenger trapped in a closed train door,
Tooting Broadway, Northern Line,
London Underground
1 November 2007**

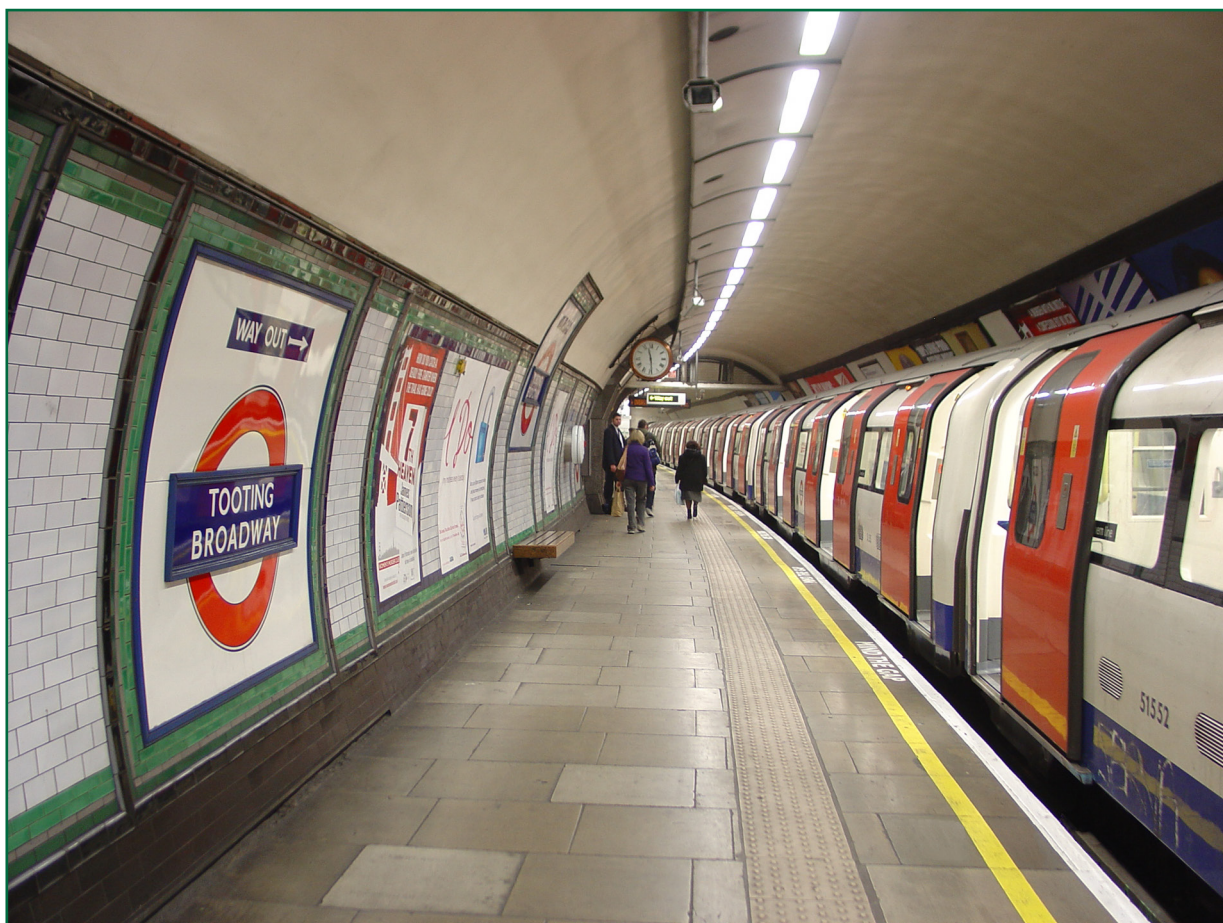
Figure 2: Southbound platform at Tooting Broadway, Northern Line

- 32 The platform edge and surface were in good condition with no damage or surface contamination which might have caused a person to fall.
- 33 The station lighting was in good order.
