Rail Accident Report

Fatal accident at Morden Hall Park footpath crossing 13 September 2008

Report 06/2009
March 2009

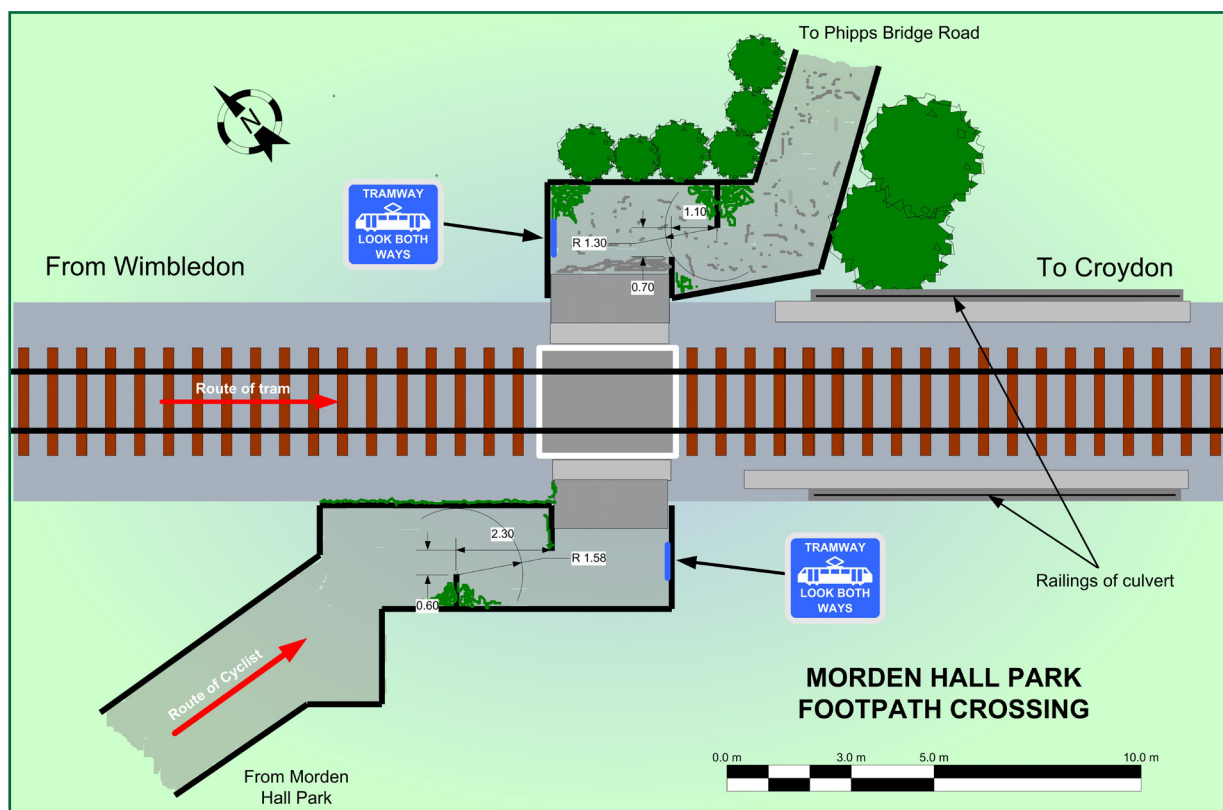
Figure 2: Layout of foot crossing

- 18 The crossing is approached through *chicanes* on both sides, constructed of wooden post and rail fencing about 1.25 m high. The chicanes on each side have quite different dimensions, but a common factor is that the barriers which form the chicanes do not overlap, but have a clear gap 0.6 m - 0.7 m wide between them, which gives a clear path width of at least 1.3 m through the chicane (Figure 2).

- 52 Mr Sivalingam cycled towards the crossing with his back to the tram. The design of the chicane at the crossing made him slow down, but did not cause him to stop or dismount. After passing through the chicane, he turned left to cross over the track, but he did not complete the turn (so that he was at right angles to the track), until he reached the centre of the track. The design of the chicane and crossing permitted him to approach the tramway without turning to be at right angles to the track, and hence he remained with his back to the approaching tram. If he had turned and seen the tram before moving onto the crossing, he would probably have been able to stop clear of the track.

- ‘Fencing or pedestrian guard rails should be provided where necessary to guide pedestrians to face oncoming trams before they cross the track.’
- 55 The chicanes at Morden Hall Park crossing were not effective in this respect because the distance between the chicane barriers and their orientation at right angles to the track, combined with the very short final approach to the crossing, did not force users, both on foot and on bicycles, to turn fully towards the tramway when passing through the chicane and before turning onto the track. This was a causal factor in the accident.

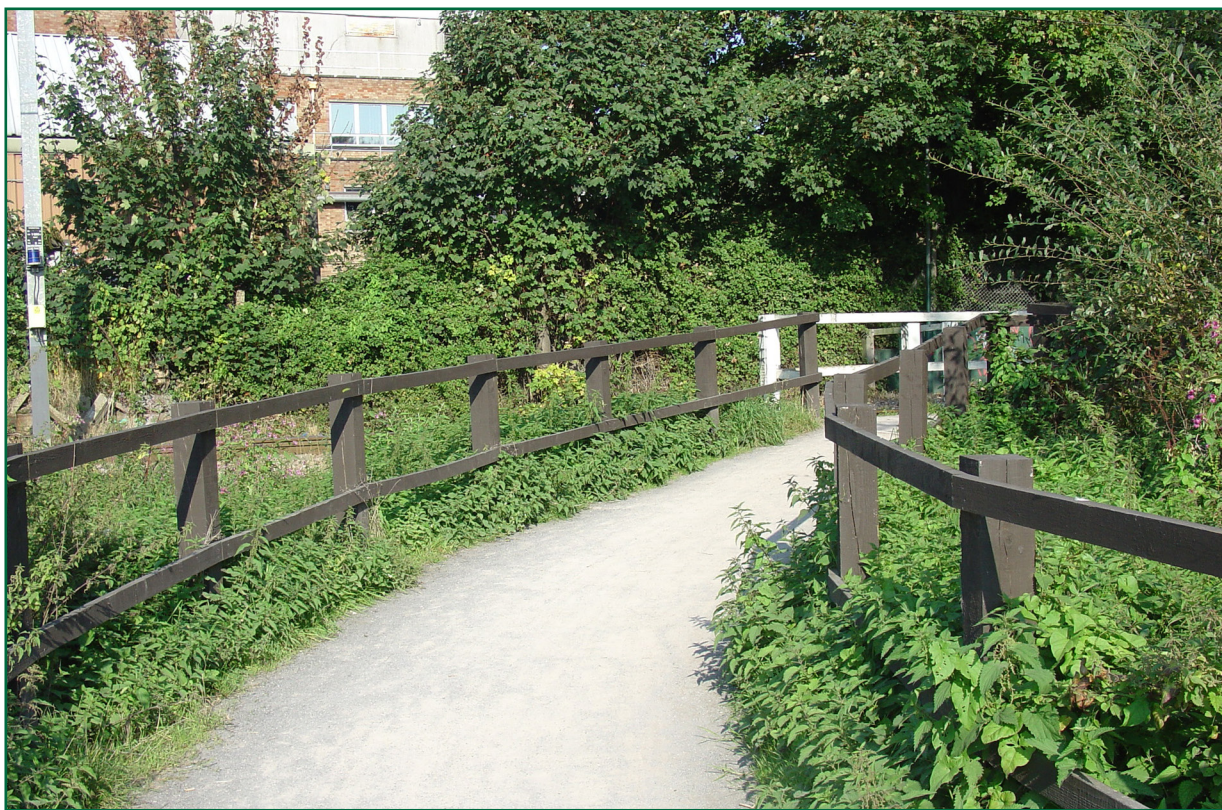
Figure 3: Approach to crossing from south-west

- 19 The approach to the crossing from the south-west is along a fenced, curving path 2.6 m wide (Figure 3). Before 2006, this approach was by a narrower path which ran directly towards the tramway at right angles to the track. In the winter of 2005/06 the layout of the approach paths was altered as part of a project to re-route the Wandle Trail around the edge of the wetlands which are an important feature of the park (Figure 4). The re-routed path curves round to approach the tramway at an angle of about 40°, and then bends sharply to enter the chicane, which is parallel to the tramway. Visibility along the tramway in both directions is unobstructed for several hundred metres in both directions from the point when a potential user reaches the centre of the chicanes (Figures 5 and 6).

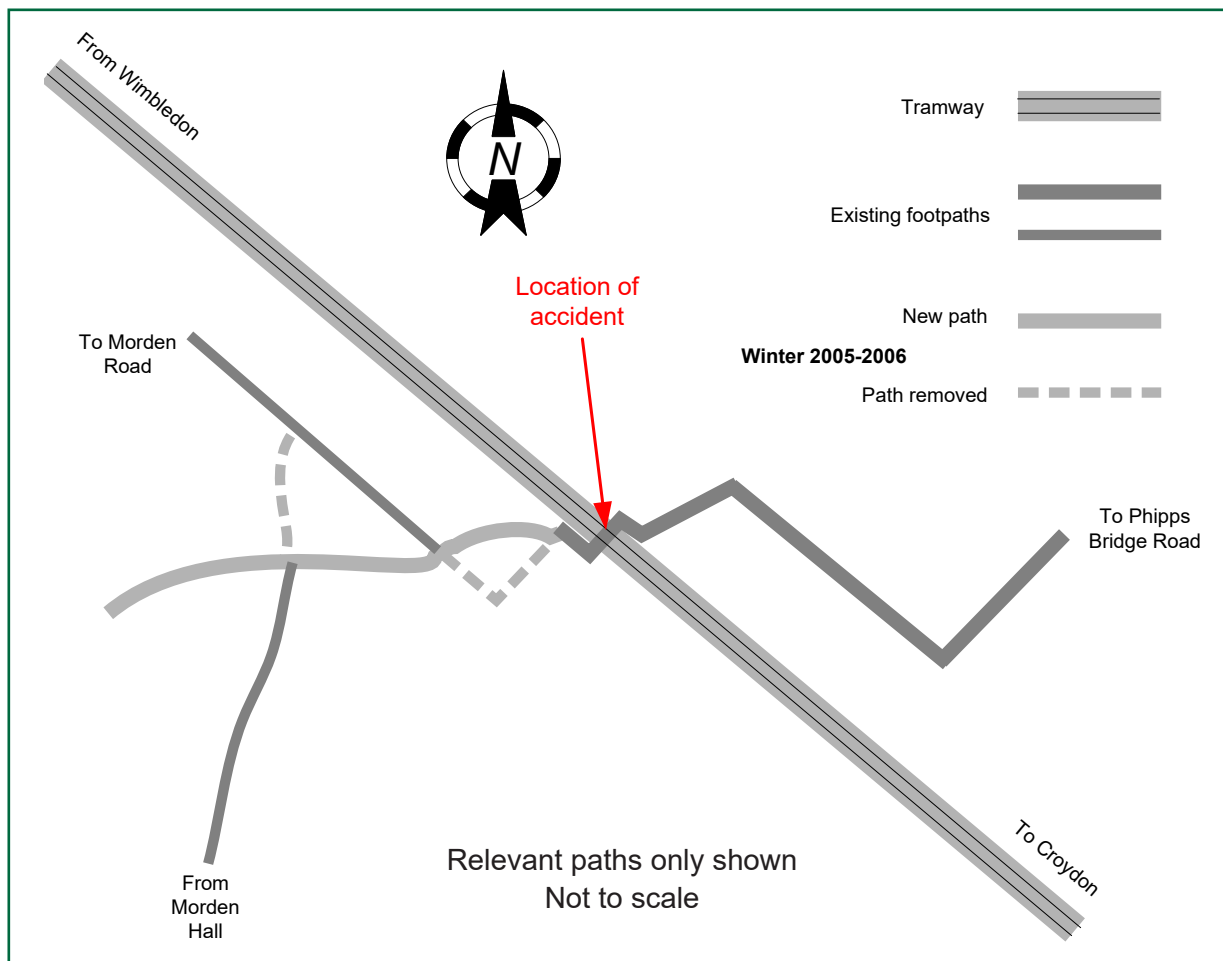
Figure 4: Footpaths near tramway crossing

- 60 The layout of the path on the south-west side of the crossing was altered over the winter of 2005-06 (paragraph 19 and Figure 4). As originally installed, the path approached the crossing at right angles, giving a user the opportunity to look both ways before turning right to pass through the chicane. The revised layout turns the user to the right gradually as they approach the crossing. This means that as they enter the chicane cyclists and pedestrians have their back to trams approaching from the Wimbledon direction, making it less likely that such people will become aware of trams unless they deliberately turn to look.

- 62 There was consultation between SWELTRAC, the National Trust and TCL before the work was done, but there is no evidence that the risk associated with the revised layout was identified by TCL. The change to the layout was a possible contributory factor in the accident.

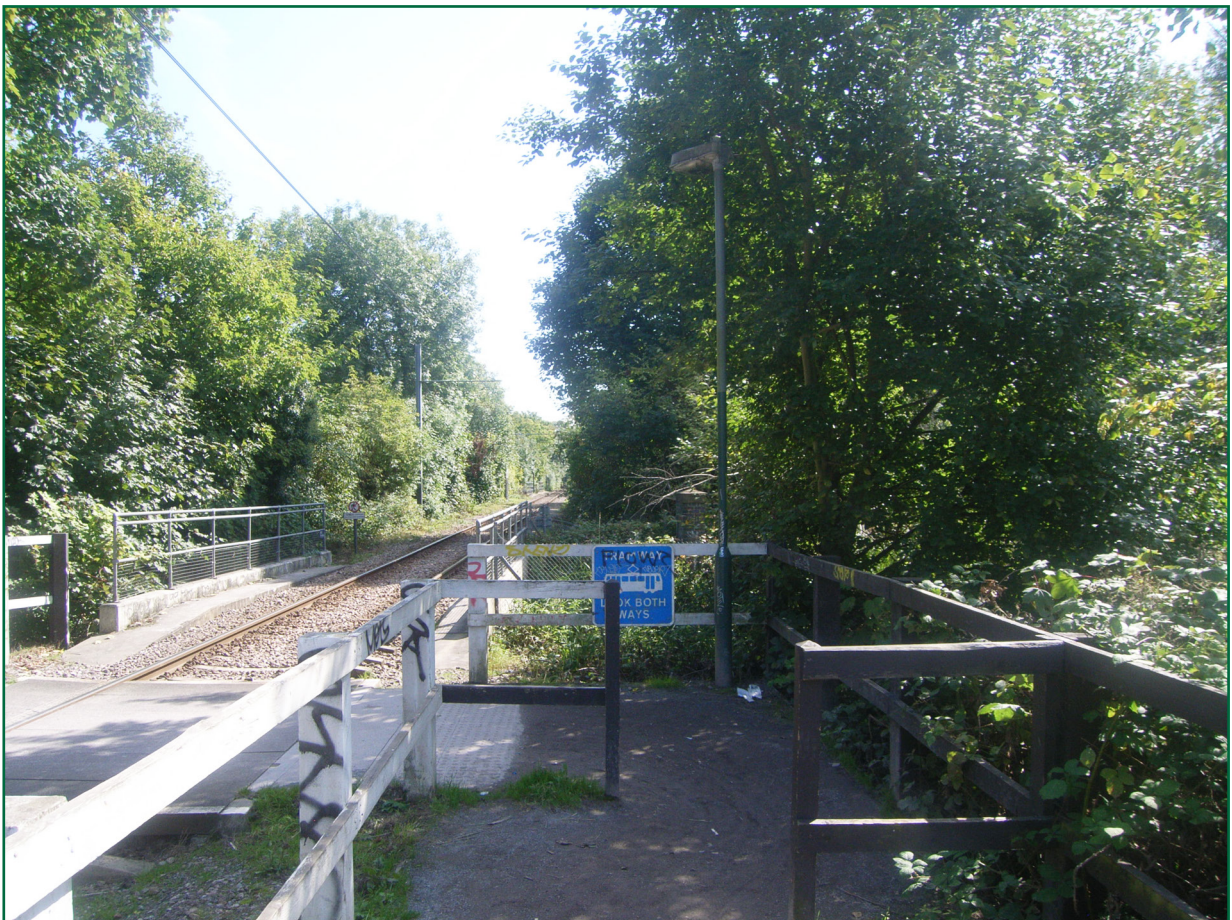
Figure 6: View towards Phipps Bridge, south-east from crossing

- 58 The sign warning of the tramway was slightly obscured by graffiti (Figure 6). Mr Sivalingam was a local resident who is known to have been familiar with the crossing, and the condition of the sign and its position (paragraph 20) are not considered to have contributed to the accident.

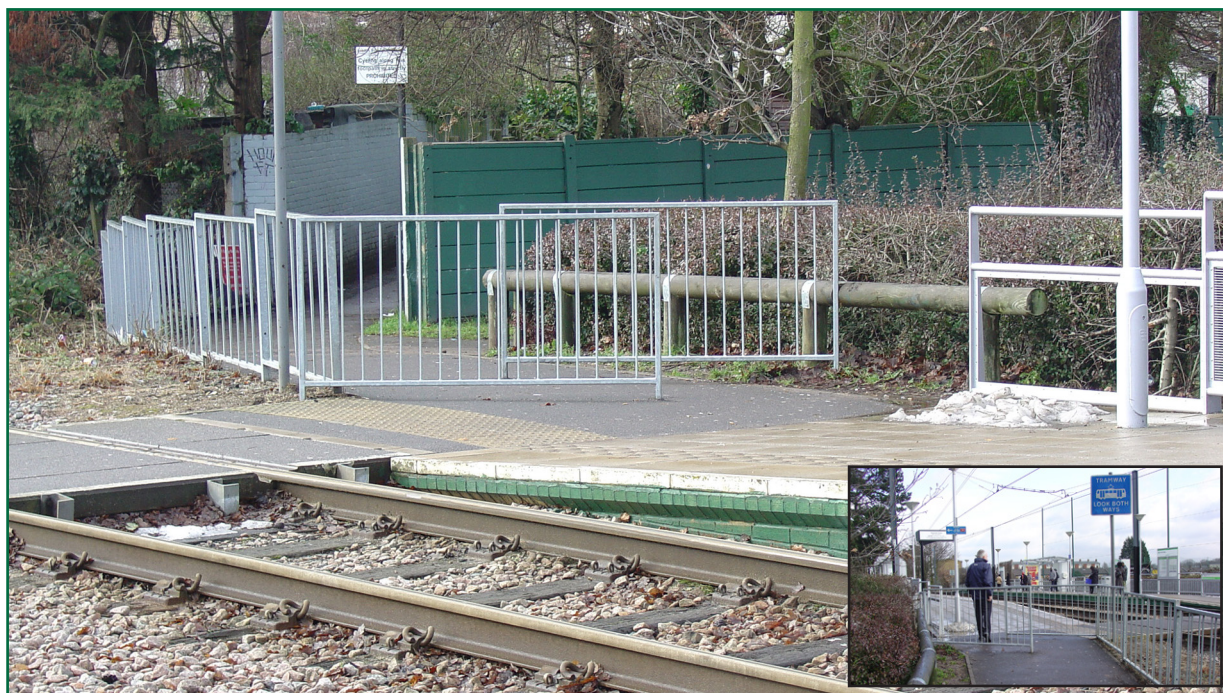
Figure 7: Chicane installed at Arena tram stop

- 72 If the risks at other crossings on the network (including Morden Hall Park) had been considered at the time the chicane was introduced at Arena, and appropriate action taken, the risk of an accident might have been reduced. However, given the absence of any previous accidents at this location, it is possible that an assessment of this crossing would not have given a high priority to changes to the design of the chicane. The absence of an adequate risk assessment for the use of footpath crossings was a contributory factor in the accident.

- 74 These considerations mean that chicane barriers with the dimensions of those at Arena are unlikely to be suitable for use on the designated cycle track at Morden Hall Park. However, a design along similar lines, which would have the effect of turning a cyclist to face towards Wimbledon during their approach, might reduce the risk at this crossing.
