Rail Accident Investigation Branch

Rail Accident Report

Collision at Exeter St Davids station 4 January 2010

Report 10/2010
June 2010

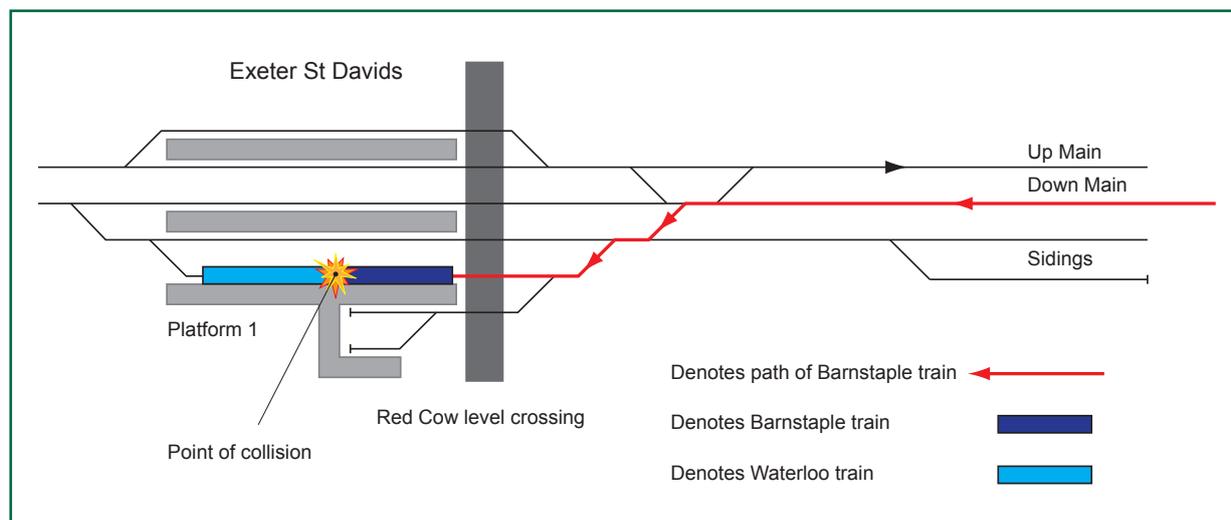
Figure 2: Layout of track and path of train involved

- 15 On the immediate approach to platform 1 from the east end of the station, trains pass over Red Cow closed circuit television (CCTV) level crossing (see figure 2). This level crossing is situated on a busy road linking the A377 with the Exwick area of Exeter.

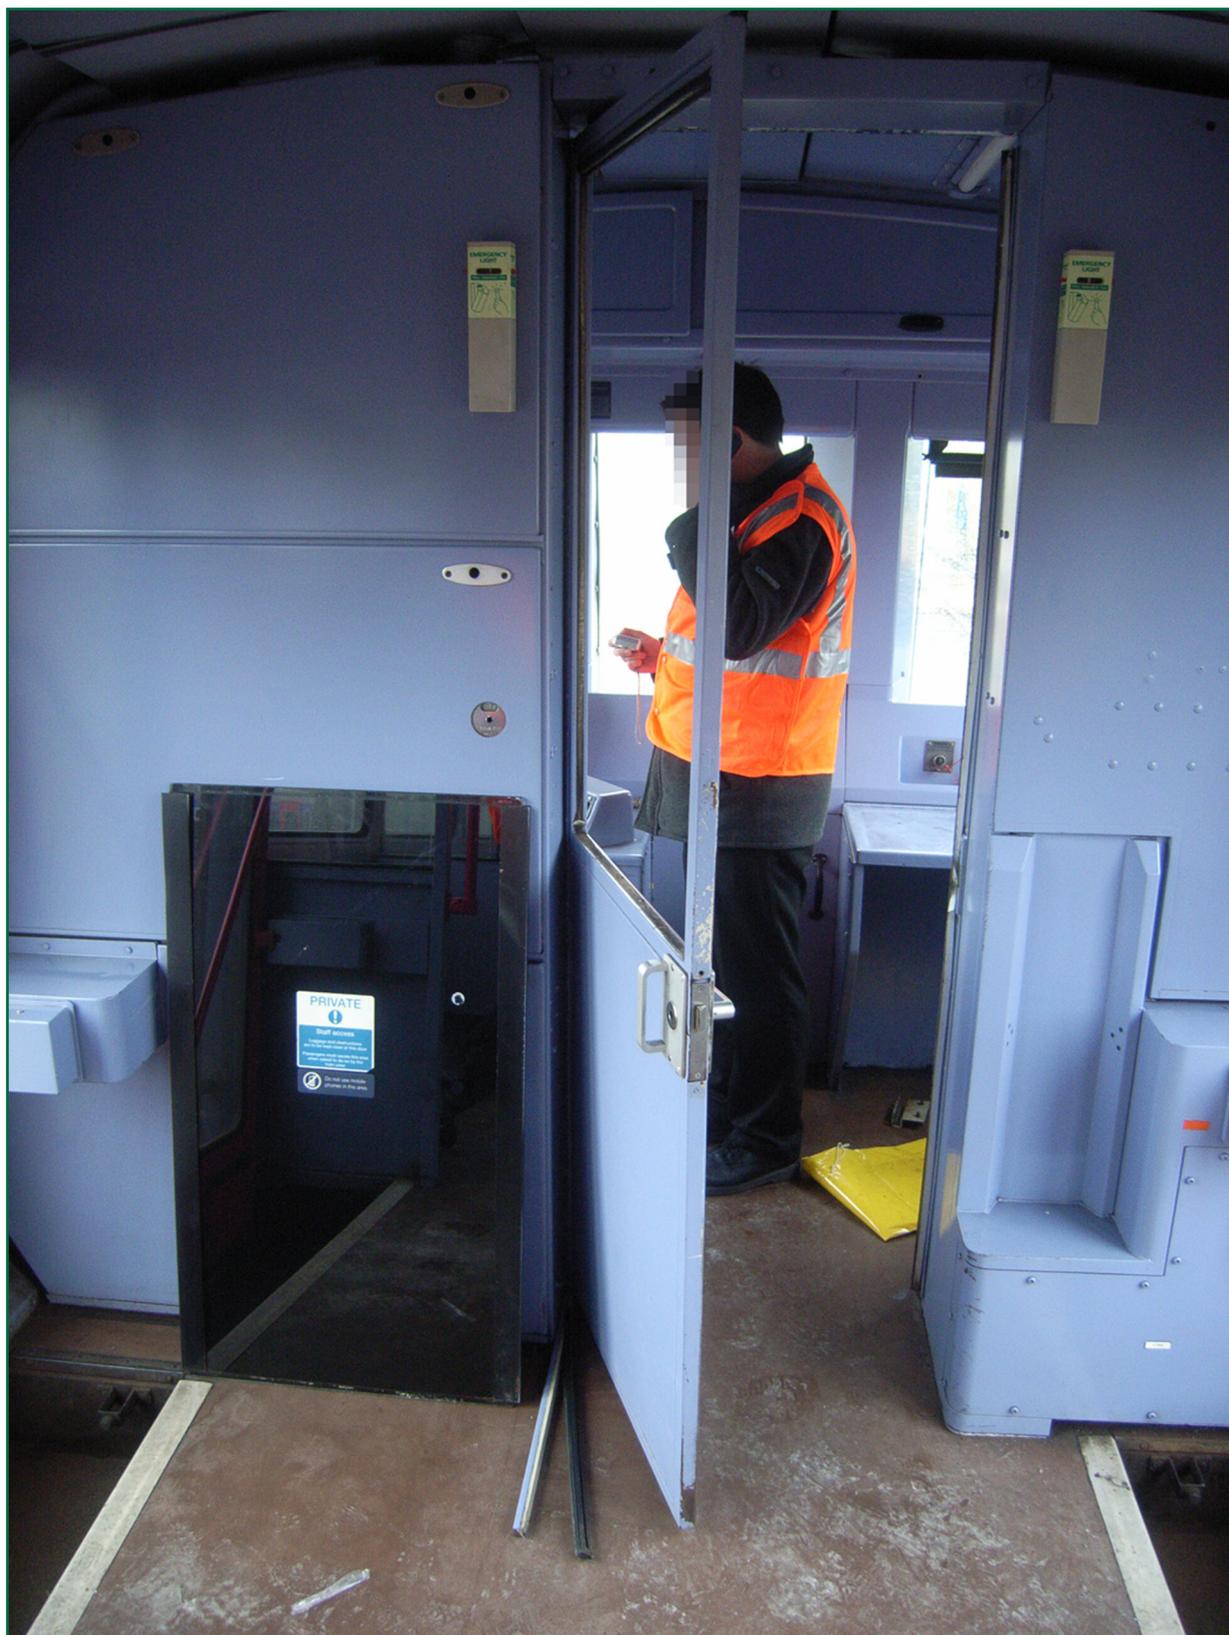
- 72 The damage to both trains was minor. However, on the class 142 unit, a large window located in the door giving access to the rear driving cab from the passenger saloon became detached from its frame and fell to the floor as a result of the impact (see figure 4). At the time of the collision there were no people in the vicinity of the window.
- 73 It was established that the glass unit sits in a bottom channel that is held in place by six welds which secure it into the door window frame. Of the six welds, two were in good condition, two were incomplete and exhibited signs of rust, and two had failed completely before the accident. The force of the collision overloaded the welds allowing the bottom channel to detach from the door frame and the glass unit to slide out (see figure 5). This created the potential for an injury for anyone who had been in the vicinity.

Figure 4: Glass window ejected from door following collision

- 80 Following the accident, FGW issued an urgent safety advice in accordance with Railway Group Standard GE/RT8250 'Reporting High Risk Defects' to inform other operators of class 142 units of the door glass detachment weld issue.
- 81 In the light of this action addressing the factor identified in paragraph 79a, the RAIB has decided not to issue a further recommendation.

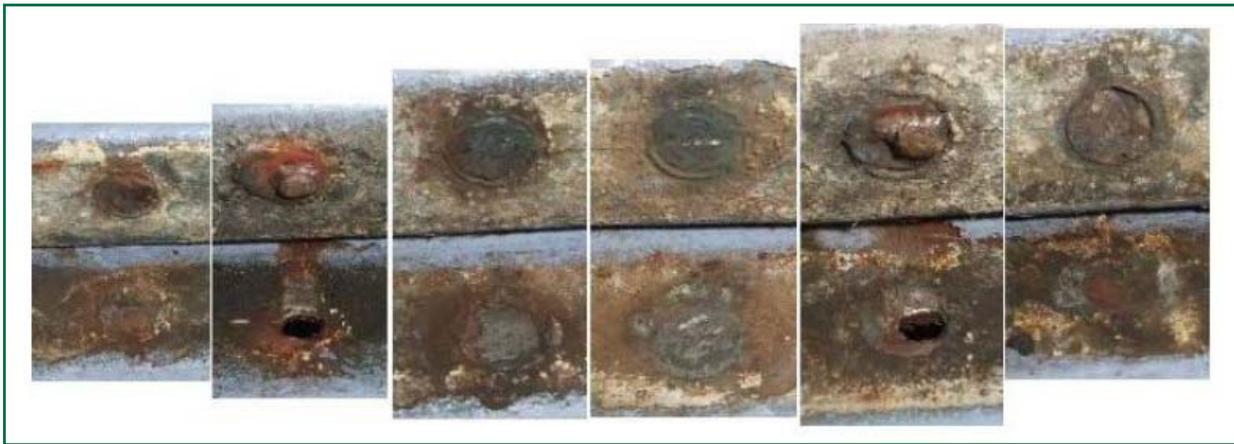
Figure 5: Failed welds (channel weld portion in top images and doorframe in bottom images) (Images courtesy of FGW)

- 79 Although not linked to the accident at Exeter St Davids on 4 January 2010, the RAIB observes that:
- a. the failure of the welds holding the window in the door giving access to the rear driving cab from the passenger saloon and subsequent detachment of the glass on the class 142 unit created the potential for an injury for anyone who had been in the vicinity (paragraph 73, see paragraph 80);
 - b. not all train operators systematically identify in their route risk assessments the potential hazards associated with low adhesion where there may be a need for trains to stop immediately beyond a level crossing (paragraph 75, **Recommendation 1**).
