Rail Accident Investigation Branch

Rail Accident Report

Derailment at Knaresborough 7 November 2015

Report 16/2016
August 2016

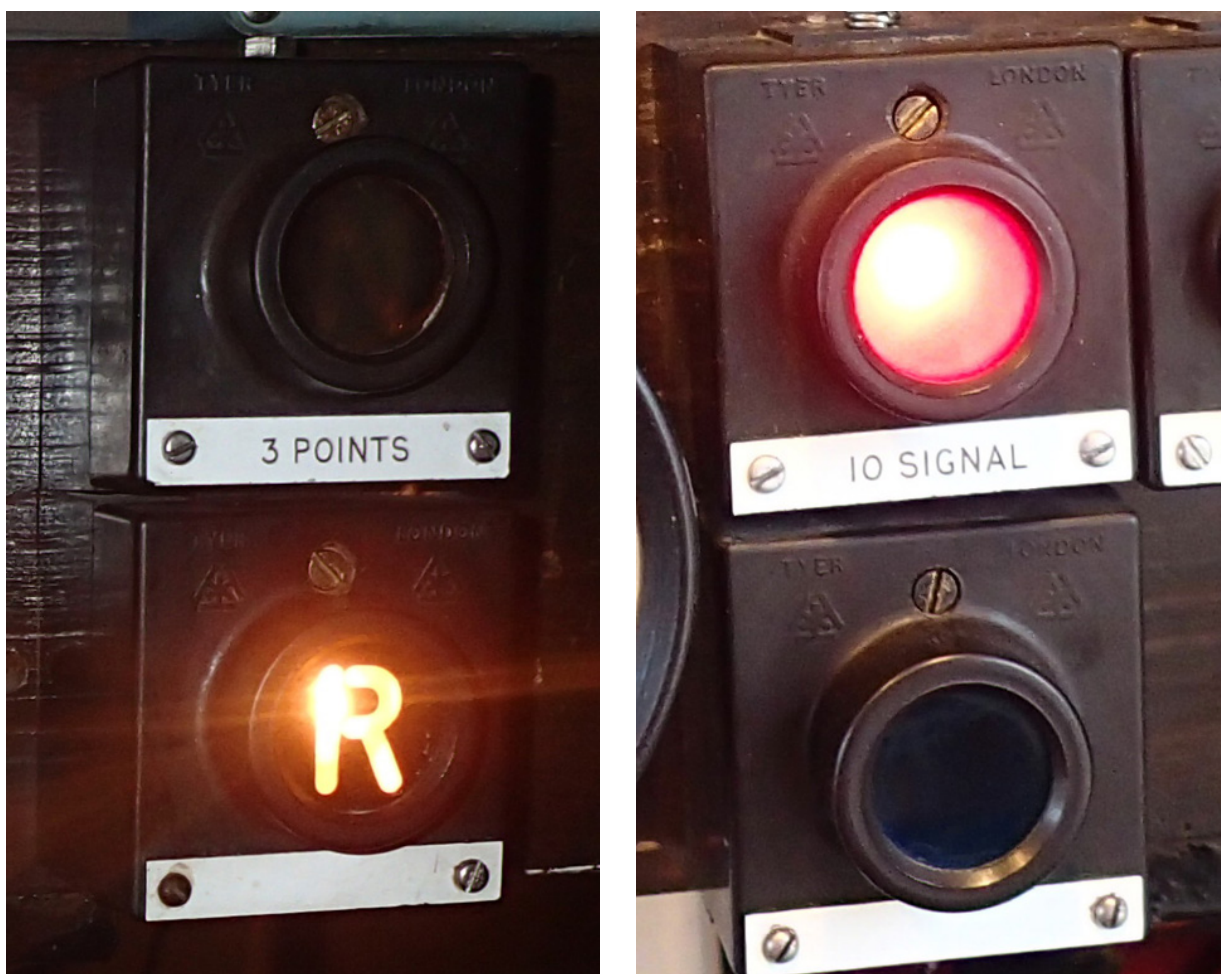
Figure 7: Points position indication³ and signal aspect indication

- 72 The signaller (MOM) did not check the indication on points 3. Had he checked the indication, he would have discovered that neither the normal nor reverse lamp for points 3 was illuminated, indicating that the points were not correctly set. Signal K10 did not clear because of a points failure, and for no other reason.

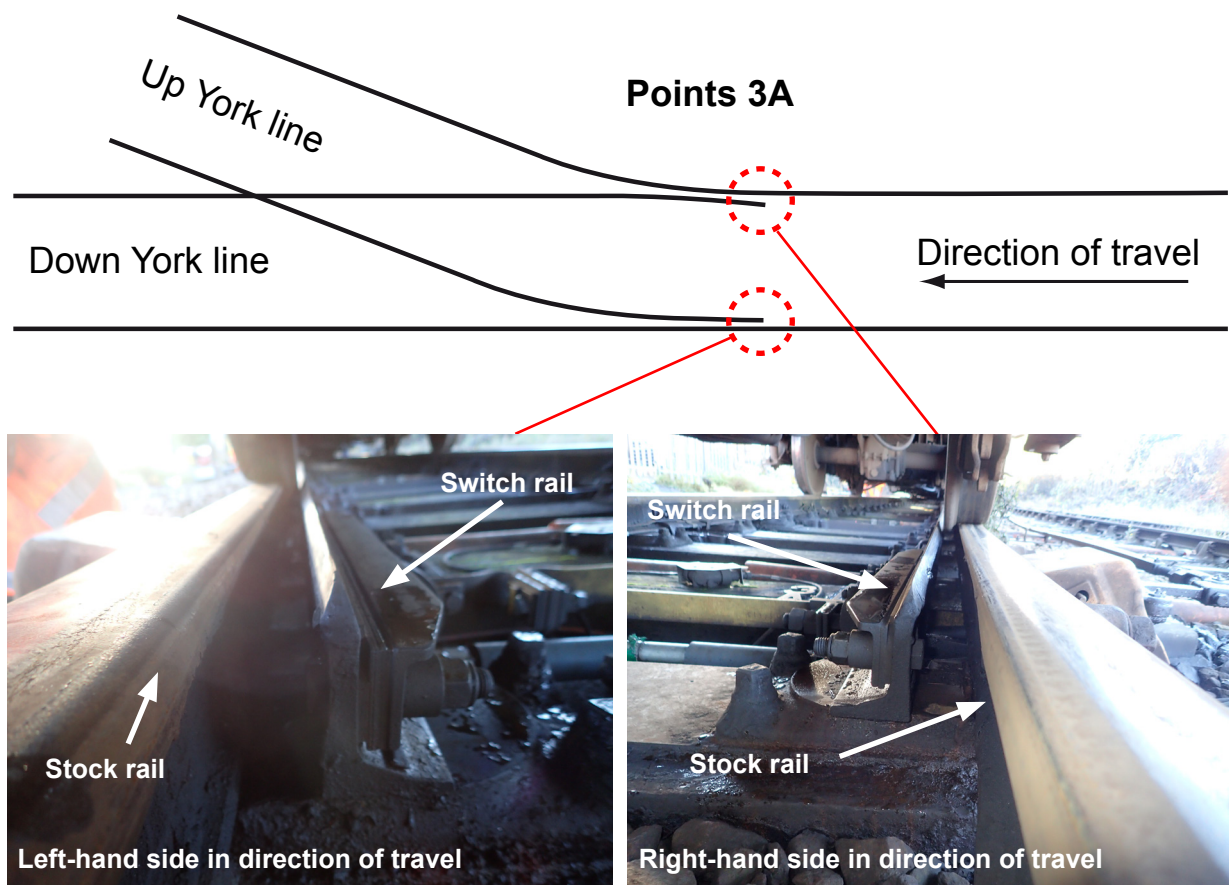
Figure 8: Toes of points 3A after the derailment

- 49 Train 2C07 derailed on points 3A on the approach to Knaresborough station because the signaller (MOM) authorised the train to proceed towards the points when they were not set in either normal or reverse.
- 50 There was no *data-logger* at the signal box to confirm the state of the points at the time of the derailment. The lack of tell-tale derailing wheel marks on the switch rails after the derailment, indicated that the derailed wheels had passed between the switch and *stock rails* on both the left and right-hand sides (figure 8). This shows that the points were not set in either the normal or reverse position at the time (ie neither switch rail was fully in contact with the adjacent stock rail).

- 51 Points 3 are interlocked with signal K10. The fact that points 3A were not set in either normal or reverse would explain why signal K10 remained at danger when the signaller (MOM) tried to clear the signal for a second time⁸ (paragraph 42). When tested after the accident the interlocking and indicator worked correctly.

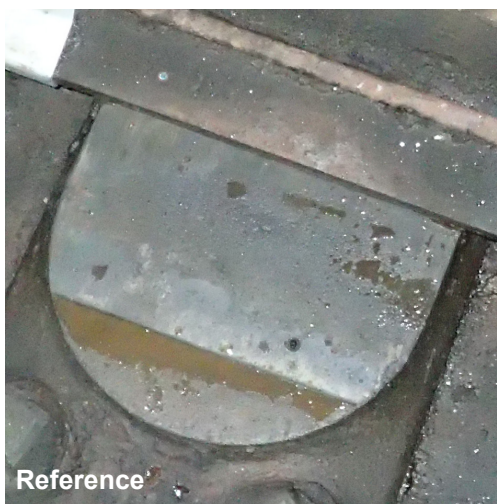
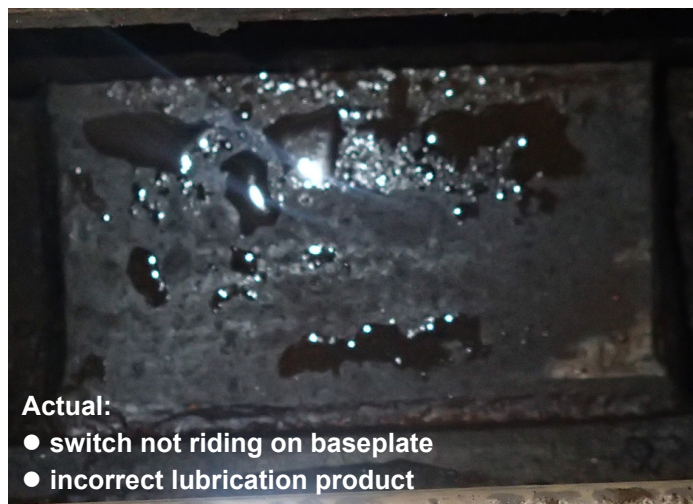
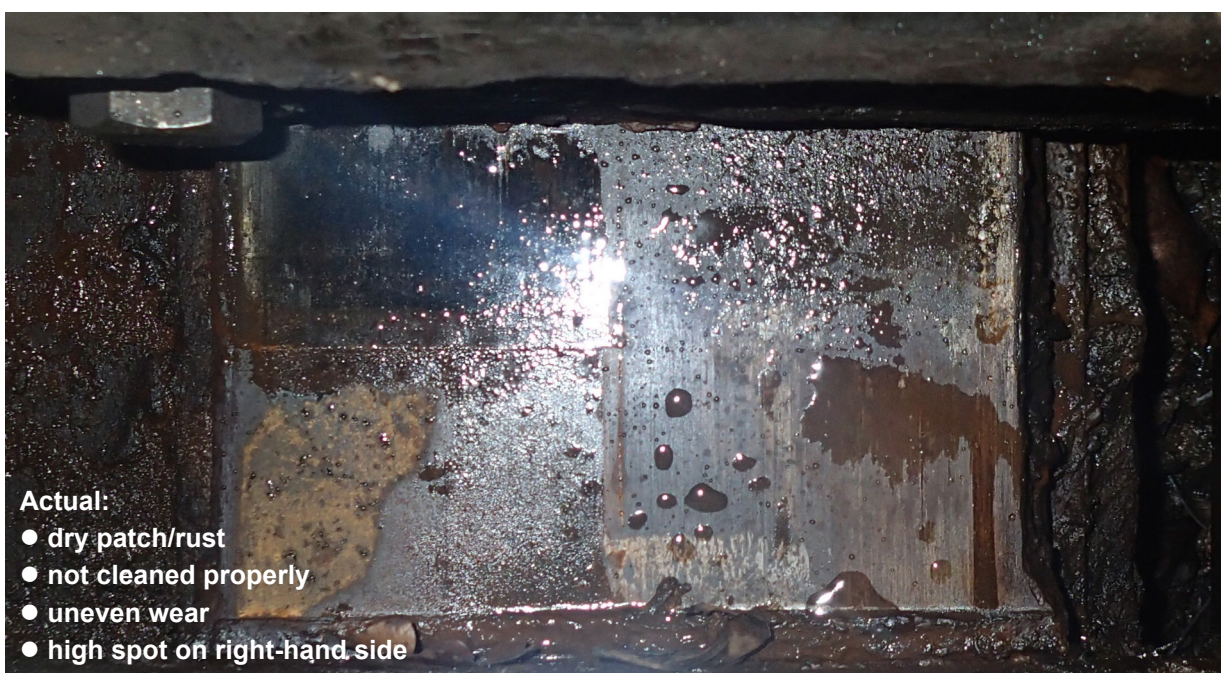
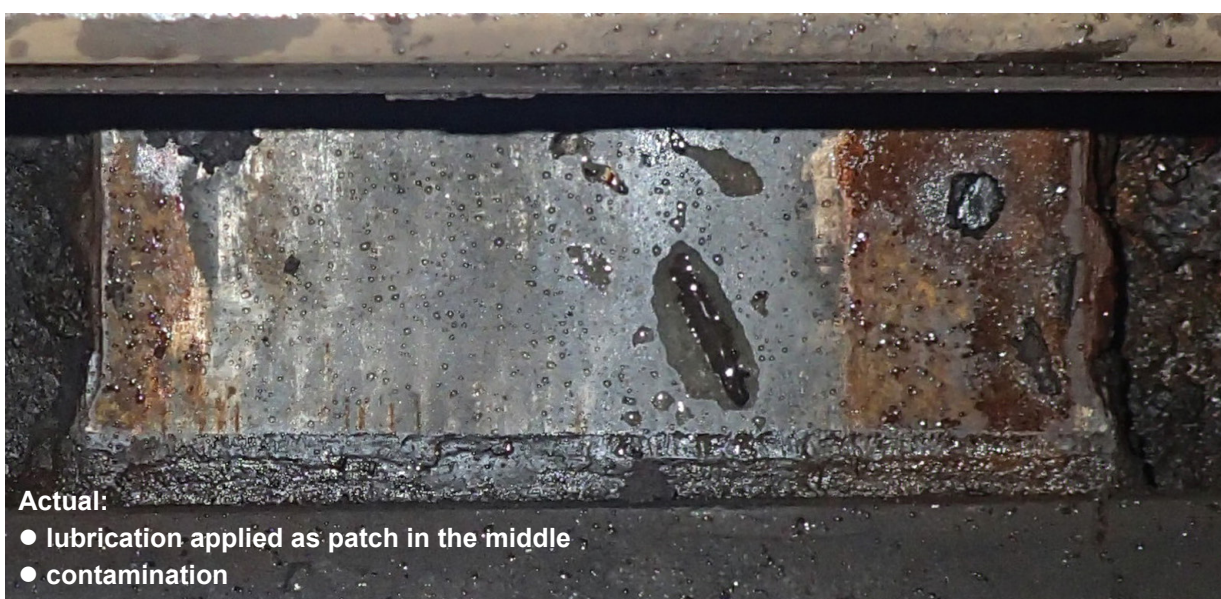
Figure 9 – Switch rail to baseplate interfaces (representative examples)

- 62 The lubrication principle relied on two layers of the lubricant: a base layer which was applied only once and a second layer which was renewed during routine maintenance every 4 weeks. The application of the first layer involved cleaning the baseplates back to bare metal, applying a thin, uniform layer of lubricant and letting it dry. The application of the second layer involved, among other steps, wiping clean the baseplates down to the base layer to remove all contamination, and smearing the product across the baseplates if there was evidence that the switch rail might not uniformly contact the baseplate when the points were thrown. Witness evidence indicated that these steps were not always followed by the patrollers during routine maintenance.

- 63 The photographic evidence captured by the RAIB of the baseplates showed that close to the toe of points 3A, the switch rails were not riding correctly on the baseplates on both sides. This suggested that the bearers (sleepers) had been incorrectly installed at an angle and were causing high spots on the baseplates.
- 64 An examination of the full length of the points showed uneven contact between the baseplates and switch rails on more than 50% of the baseplates. An uneven contact between the baseplates and the switch rail meant that the lubrication product was not uniformly smeared over the baseplates when the points were thrown from one position to the next, possibly leading to high friction.

- 66 According to Network Rail's records, points 3A had previously failed on three separate occasions in 2015: on 9 January 2015, on 27 April 2015 and on 21 August 2015. All three instances had been attributed to high friction and had been addressed by the S&T fault team by re-applying the lubrication product¹⁰. It is also possible that the indication fault reported by the signaller on 31 October 2015 (paragraph 30) which the S&T fault team could not replicate on 5 November was also associated with high friction.

- 106 The maintenance team in charge of the track at Knaresborough is planning to replace the bearers under points 3A in 2017/2018 with a possibility of bringing it forward to 2016/2017.

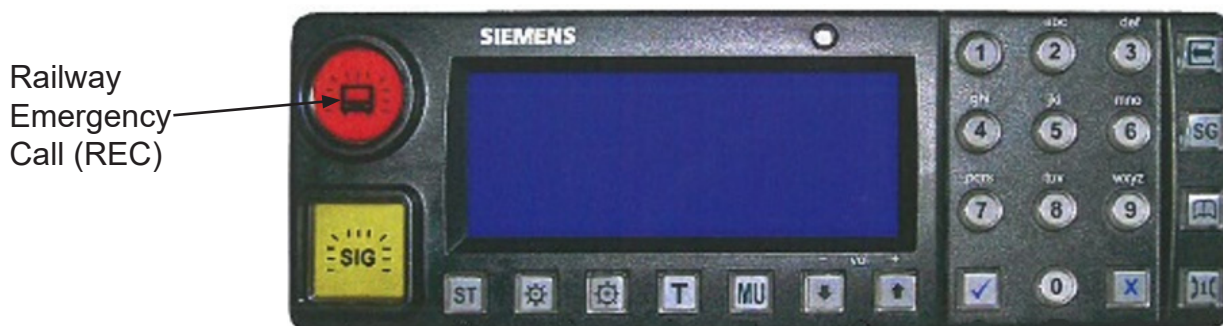
Figure 10: GSM-R terminal

93 The driver used the yellow button on his GSM-R terminal to try to contact the signaller after the derailment (figure 10). This was unsuccessful as the signaller was on the station platform at the time, waiting for the token to be handed back to him. This had no effect on the incident but it would have been more appropriate to immediately use the REC button to raise the alarm. The REC button sends an 'all trains stop' signal to any train in the same operational area to reduce the risk of a secondary collision.
