# Rail Accident Report

**Serious operational irregularity at Bagillt user worked crossing, Flintshire, involving an abnormally heavy road vehicle  
17 August 2018**

Report 11/2019  
August 2019

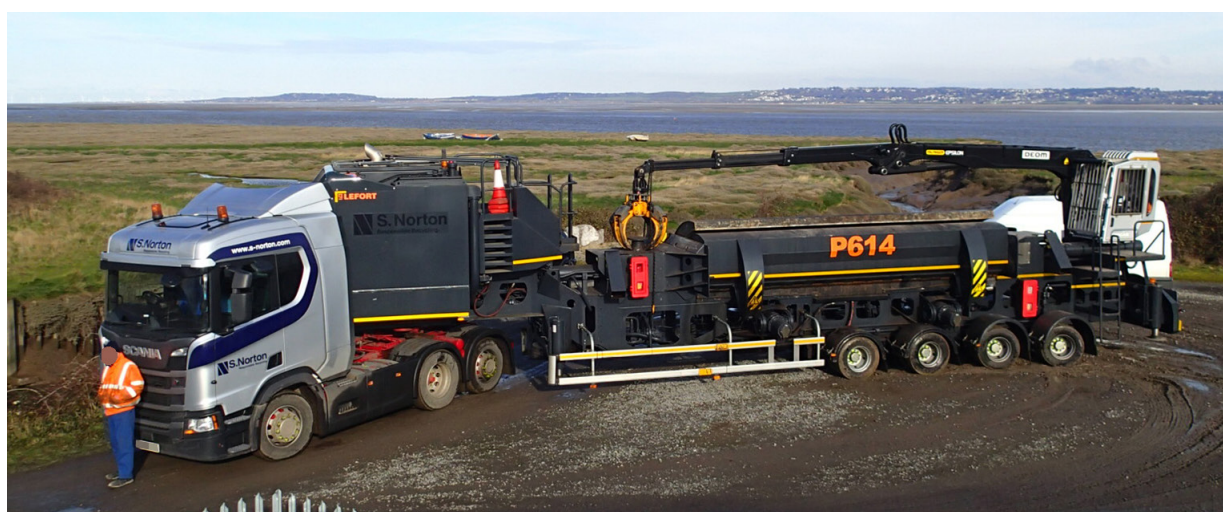
Figure 3: The baler

- 15 The combined tractor unit and semi-trailer is approximately 60.5 tonnes in weight, 19.1 metres long and 2.7 metres wide. Individual vehicles and vehicle combinations permitted to operate without special restrictions on public roads in the UK are usually limited by UK highway legislation to a maximum weight of 44 tonnes, a maximum length of 18.75 metres and a maximum width of 2.55 metres. Vehicles exceeding these criteria are described in this report as 'abnormal vehicles'.

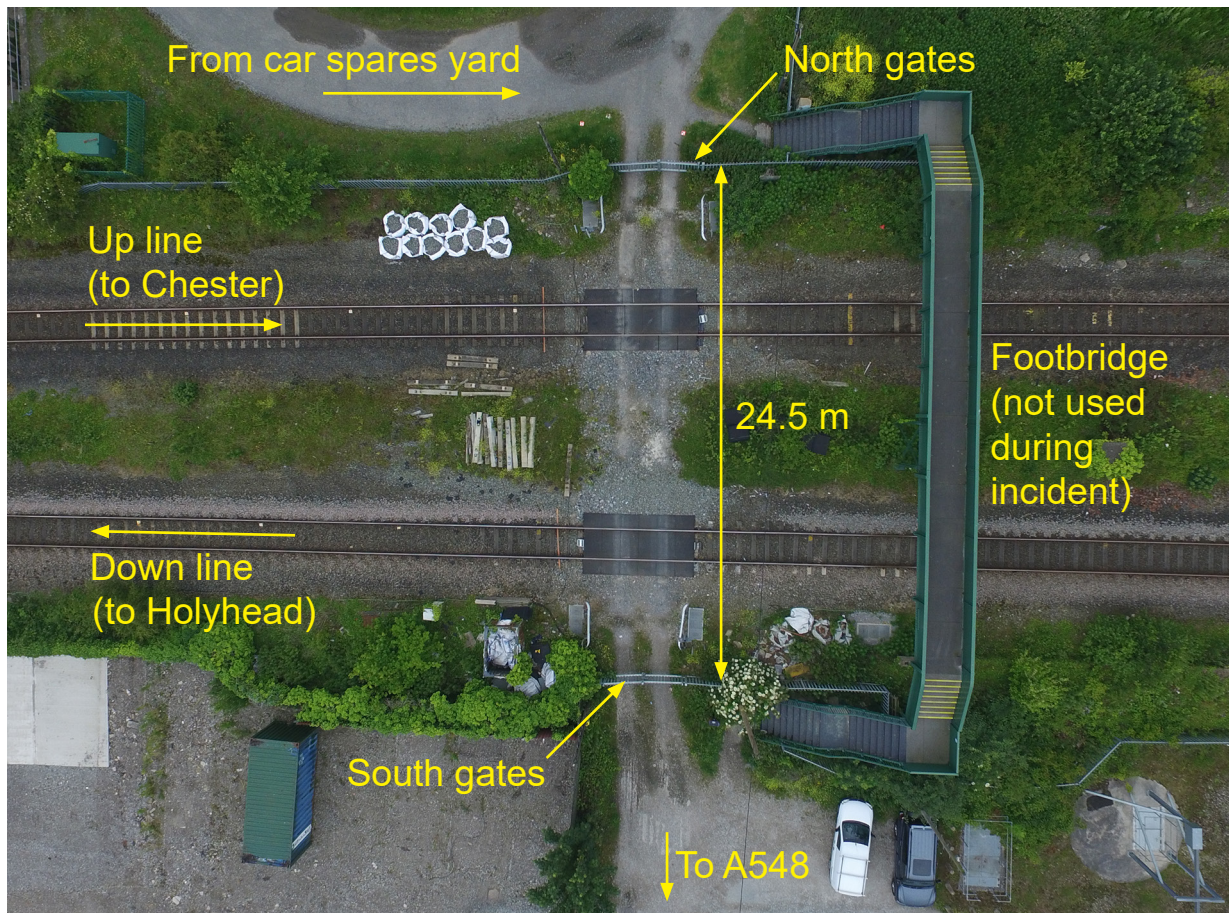
Figure 4: Overview of Bagillt UWC-T

- 16 Bagillt UWC-T has a pair of gates on each side of the railway situated 24.5 metres apart (figure 4). The crossing is equipped with a telephone outside each pair of gates which connect to the signaller's workstation supervising the crossing (figure 6, paragraph 19). Signs positioned inside the gates on both sides of the crossing tell users with vehicles or animals that they must telephone the signaller to obtain permission before opening the gates, crossing the railway and closing the gates. Vehicle users are required to obtain permission because sighting distances along the railway are not sufficient for users to see trains in time to determine if it is safe to cross.

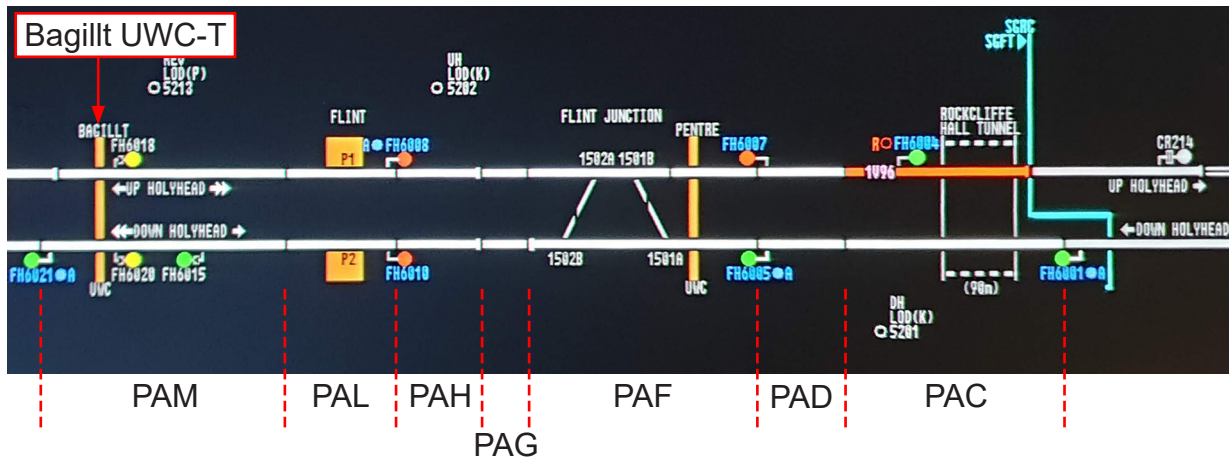
Figure 8: Rhyl workstation display annotated to show track section designations

- 43 On the basis of the most likely sequence of events (table 3), the evidence indicates that the signaller gave the user permission to cross between 2 minutes 30 seconds and 2 minutes 17 seconds before the front of the train arrived at the crossing. Signalling data shows that the first of these times corresponds to the rear of the train being in section PAC and the front in section PAD. The second time corresponds with the entire train being in section PAD.

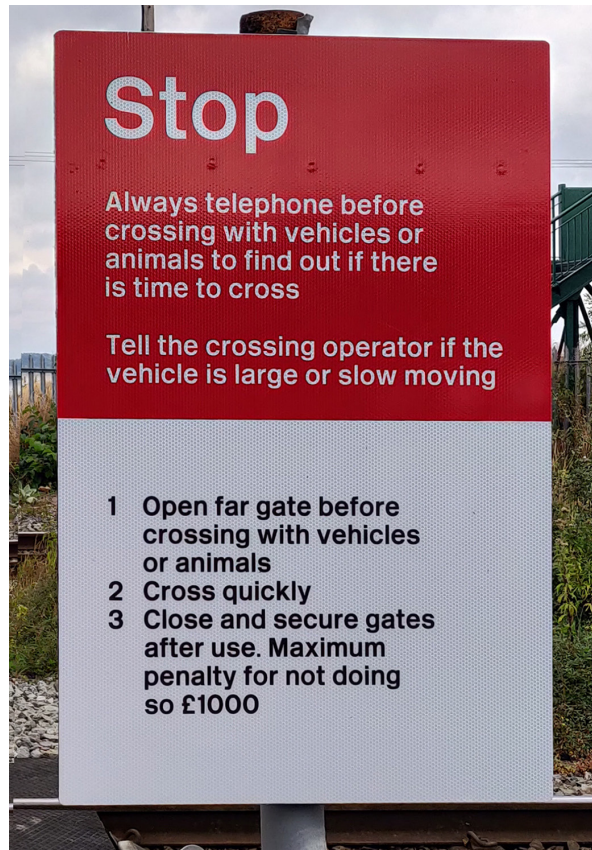
Figure 9: Instruction sign at Bagillt UWC-T

52 There is no definition of *'large or slow-moving'* on the signs and no clear definition elsewhere in Network Rail's UWC-T processes (paragraph 79). The crossing assistant routinely assisted articulated lorries used to carry scrap metal over Bagillt UWC-T (figure 10). Although these do not require special precautions when driven on the public highway (and are not abnormal vehicles as described at paragraph 15), the crossing assistant also considered these to be *'large'* and *'slow-moving'*.

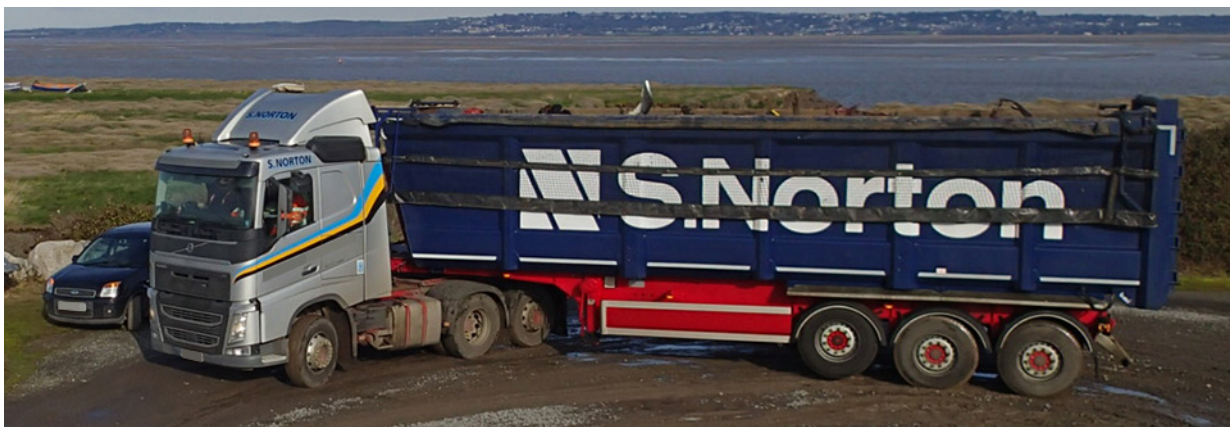
Figure 10: Typical heavy goods vehicle 'HGV' used on Bagillt UWC-T (not subject to special restrictions on the public highway)

- 53 Observations at Bagillt UWC-T showed that the crossing time for scrap metal lorries were only slightly less than the crossing time for the baler. A laden scrap metal lorry took 21 seconds and the baler took 28 seconds to travel from north to south over the crossing.
- 54 The crossing assistant stated that he usually described large vehicles as 'wagons' and that Network Rail staff had not asked him to clarify the size or weight of vehicles when they had previously observed him using the crossing. He also stated that no signaller and no Bagillt Car Spares staff had asked him to clarify the weight or size of the vehicle he was assisting to cross. No one had instructed him to treat the baler differently to the other vehicles used on the crossing, which were not abnormal vehicles.

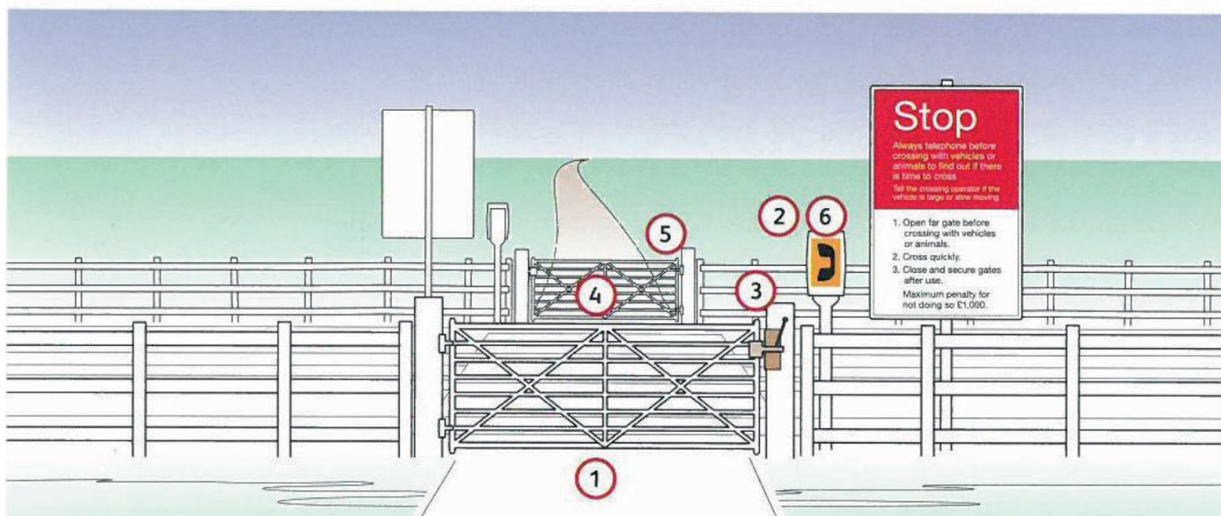
Figure 16: Instruction sheet provided by Network Rail to Bagillt Car Spares

- 112 Current Network Rail signs instruct users to tell the crossing operator (ie the signaller in most instances, including at Bagillt UWC-T) if they are crossing with a large or slow-moving vehicle. However, unlike signs provided for automatic half barrier crossings (paragraph 90), signs at UWC-Ts provide no guidance on what constitutes a large or slow-moving vehicle. This issue is not considered further in the present report as the content of signs at user worked level crossings is addressed by an existing RAIB recommendation (paragraph 156). Network Rail guidance provided to authorised users, for example the instruction sheet provided to Bagillt Car Spares (figure 16), does not provide this information.
