## Accident

<b>Aircraft Type and Registration:</b>	UAS Malloy Aeronautics T150	
<b>No &amp; Type of Engines:</b>	8 Electric motors	
<b>Year of Manufacture:</b>	2023 (Serial no: 120)	
<b>Date &amp; Time (UTC):</b>	27 June 2023 at 1443 hrs	
<b>Location:</b>	Field in South Scarle, Lincoln	
<b>Type of Flight:</b>	Training	
<b>Persons on Board:</b>	Crew - None	Passengers - None
<b>Injuries:</b>	Crew - N/A	Passengers - N/A
<b>Nature of Damage:</b>	Destroyed	
<b>Commander's Licence:</b>	General Visual line of sight Certificate (GVC)	
<b>Commander's Age:</b>	45 years	
<b>Commander's Flying Experience:</b>	150 hours (of which 2 were on type) Last 90 days - 5 hours Last 28 days - 5 hours	
<b>Information Source:</b>	AAIB Field Investigation

## Synopsis

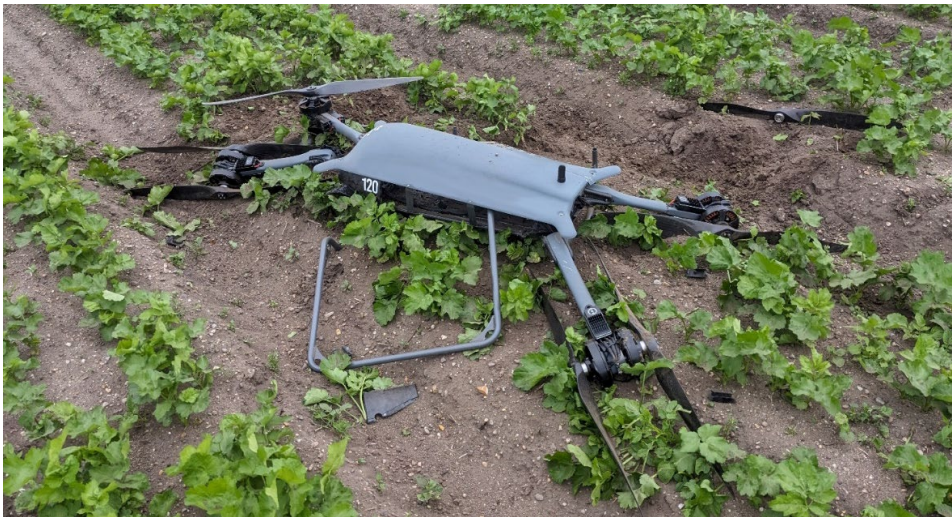
**Figure 1**

The aircraft diverged from level flight and was seen to follow an erratic flight path unfamiliar to the RP, during which it achieved a maximum pitch of  $-41^\circ$  and  $-60.9^\circ$  of roll. To regain control the RP increased the throttle to 100% which caused the aircraft to overcorrect, and it then pitched to  $85.3^\circ$  with  $60^\circ$  of roll before descending rapidly from a height of 37 m. The RP realised he could not regain control and switched to an automated mode (LOITER mode) but by this time the aircraft was heading towards the RP's ground position and he decided to close the throttle, bringing it to the ground (Figure 1). Twelve seconds had passed from the geofence breach before the aircraft struck the ground approximately 50 m from the RP's position and within the horizontal boundary of the geofence (Figure 2).

Malloy T150 unmanned aircraft at the accident site

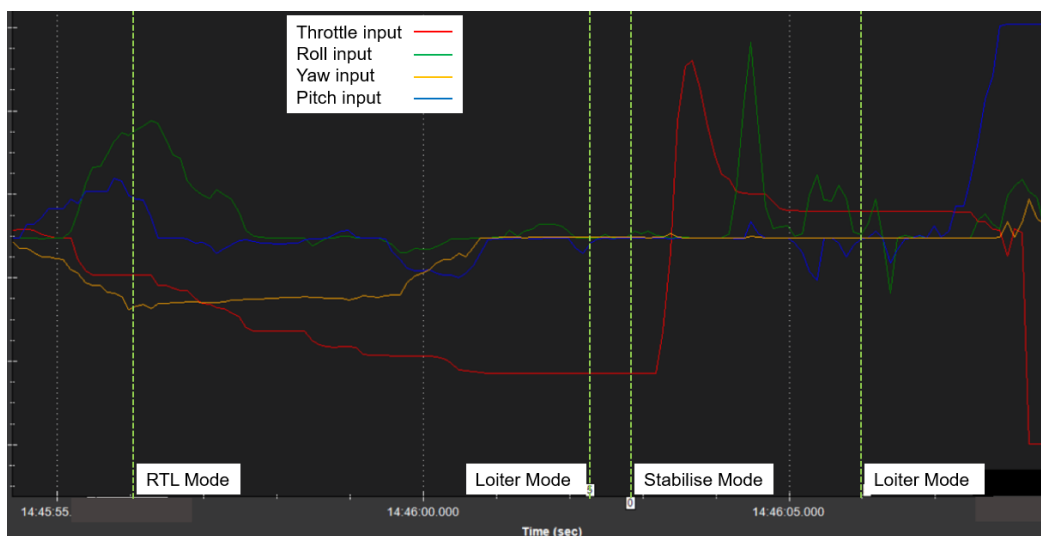
**Figure 3**

Data downloaded from the UA showed that at 1445:56 hrs (local) the aircraft entered RTL mode (Figure 3) and the throttle input was recorded as having reduced to 2.6% from an RP input; this had no effect in RTL mode. The mode then changed to LOITER for approximately 600 ms before going back to STAB where the throttle increased to 100% in less than 1 sec. A large roll input was recorded after which the mode was changed to LOITER. The aircraft deviated from normal flight attitude and was not under control. The throttle was recorded as reducing to zero. The aircraft then pitched up but as it was inverted, it struck the ground.

Pilot inputs

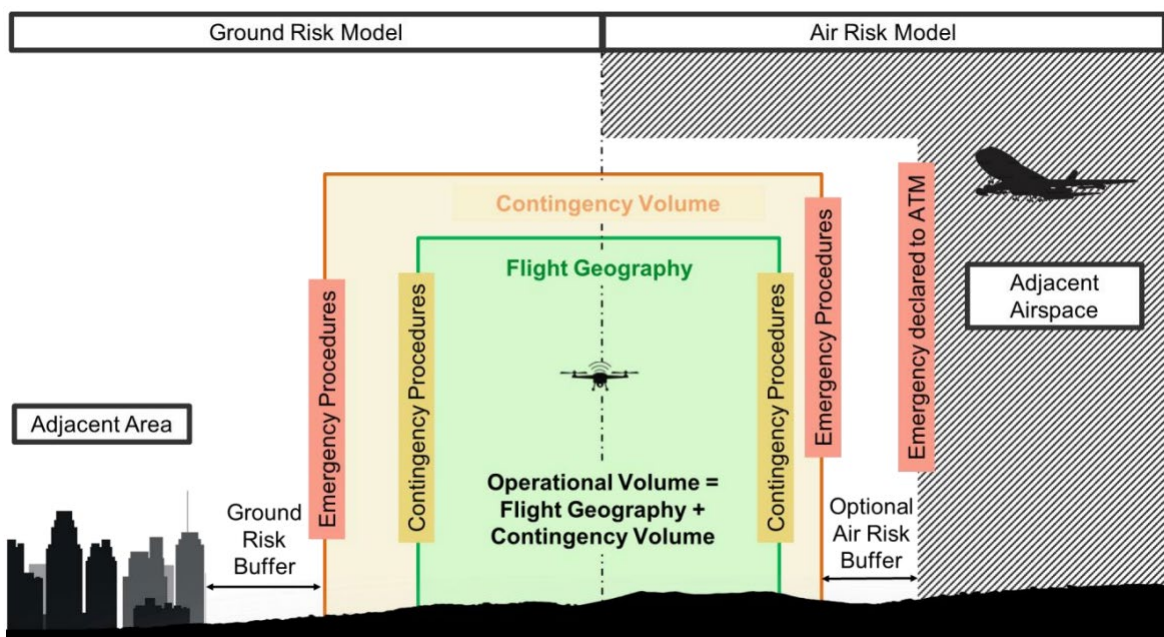
**Figure 6**

Volume 1 section 25.5 describes the software functionality of programming geofences and the interaction between the ADRU Pilot software and the Special Mission Computer. Figure 6 taken from the OSC, is the Safe Airspace Volume (SAV) diagram that RPs and mission commanders 'must understand' during flight planning. The origin of the diagram is from the graphical representation of the Joint Authorities for Rulemaking of Unmanned Systems (JARUS) Specific Operations Risk Assessment (SORA) Semantic Model to ensure a common usage of terminology for risk assessments. There are no specific requirements or information on how to define a suitable size related to the flight purpose, nor any RP procedures in the event of a geofence breach despite the statement that a 'breach of the Operational volume will require emergency action'. The operators understanding of the contingency volume is the maximum operating volume allowed under their OA which was 400 ft (120 m) above surface level and 500 m from the RP. The geofence on the accident flight was considered to be the flight geography volume.

SAV model / JARUS SORA Semantic Model

It was considered by the operator that all the RPs were experienced and therefore there was no requirement to detail the actions to be taken in the event of a geofence breach. The geofence diagram in the OSC states that when the aircraft crosses from the flight geography volume to the contingency volume there are '*Contingency procedures*' and '*Emergency procedures*' when the aircraft leaves the operational volume. The investigation could not find either contingency or emergency procedures for either case.
