GRENFELL TOWER INQUIRY: PHASE 2 REPORT

REPORT of the PUBLIC INQUIRY into the
FIRE at GRENFELL TOWER
on 14 JUNE 2017

Volume 4
Part 6 – The refurbishment of Grenfell Tower

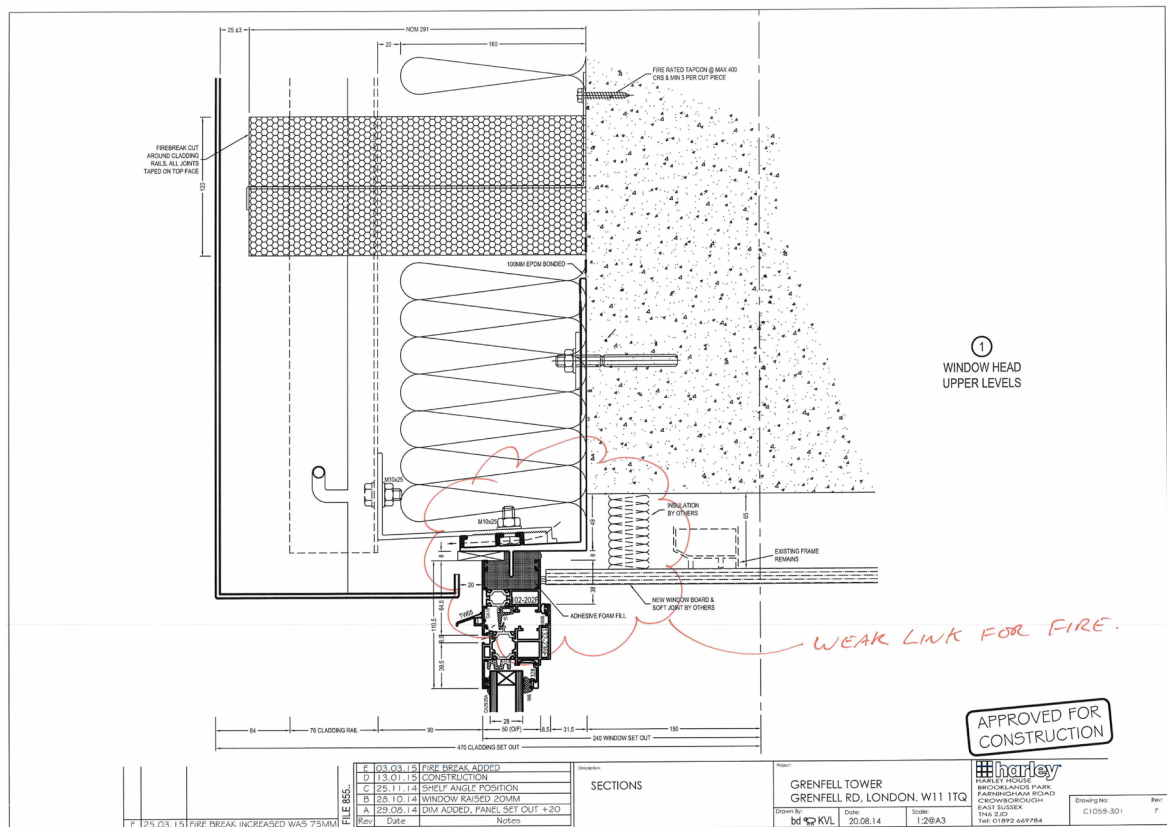
Figure 57.1 – Harley drawing 301

- 57.54** The second sketch which Mr Mort had prepared was based on a drawing produced by Harley, to which he had added a bubble containing the note "weak link for fire".²⁰¹³ The sketch showed the new window set back from the edge of the building, exposing a gap between the window brackets, as shown below.²⁰¹⁴
